Mechanical behaviour and damage mechanisms analysis of a flax-fibre reinforced composite by acoustic emission

Arthur Monti, Abderrahim El Mahi, Zouhaier Jendli, Laurent Guillaumat

Arthur Monti, Abderrahim El Mahi, Zouhaier Jendli, Laurent Guillaumat. Mechanical behaviour and damage mechanisms analysis of a flax-fibre reinforced composite by acoustic emission. *Composites Part A: Applied Science and Manufacturing*, Elsevier, 2016, 90, pp.100-110. 10.1016/j.compositesa.2016.07.002 . hal-01792109

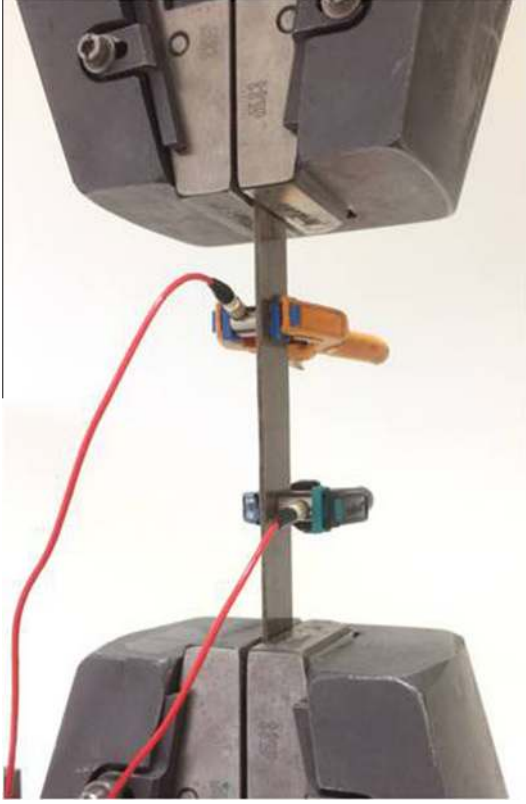
Fig. 1. Composite specimen with acoustic emission sensors. (For interpretation of the references to color in this figure legend, the reader is referred to the web version of this article.)

Five rectangular (25 mm × 250 mm) samples of each type of specimen were tested under uniaxial loading, according to the standard test method ASTM D3039/D3039M [23]. The tests were carried out with a tensile machine equipped with a 100 kN load cell. The strains in the tensile direction were measured by mean of an extensometer with a gauge length of 50 mm (Fig. 1a). The strains in the transverse direction were measured with 5 mm strain gauges. The tests were performed at room temperature with a displacement rate of 1 mm·min⁻¹. In addition, cyclic loading tests were performed on UD-0 specimens to emphasize the different behaviour phases of this specific configuration. The applied load was incremented by 20 MPa per cycle. For the acoustic emission records, another set of 5 samples from each series of specimens were also tested in uniaxial tensile loading. Two sensors with a bandwidth of 100 kHz to 1 MHz, provided by Euro Physical Acoustics were clamped to the specimens (Fig. 1b). A coupling agent was used between the sensors and the material. AE signals were registered with a sampling frequency of 5 MHz. Two preamplifiers with a 40 dB gain were used to amplify the signals. After preliminary trials, the acquisition parameters employed were set to the following values: PDT = 50 μs, HDT = 100 μs and HLT = 200 μs. Pencil lead break tests were performed before each tensile test, to verify that the system was functioning properly, and to define an amplitude acquisition threshold (fixed at 38 dB) to filter acoustic signals coming from the test machine or other external sources. Only events recorded in the gauge length delimited by the two sensors were recorded.

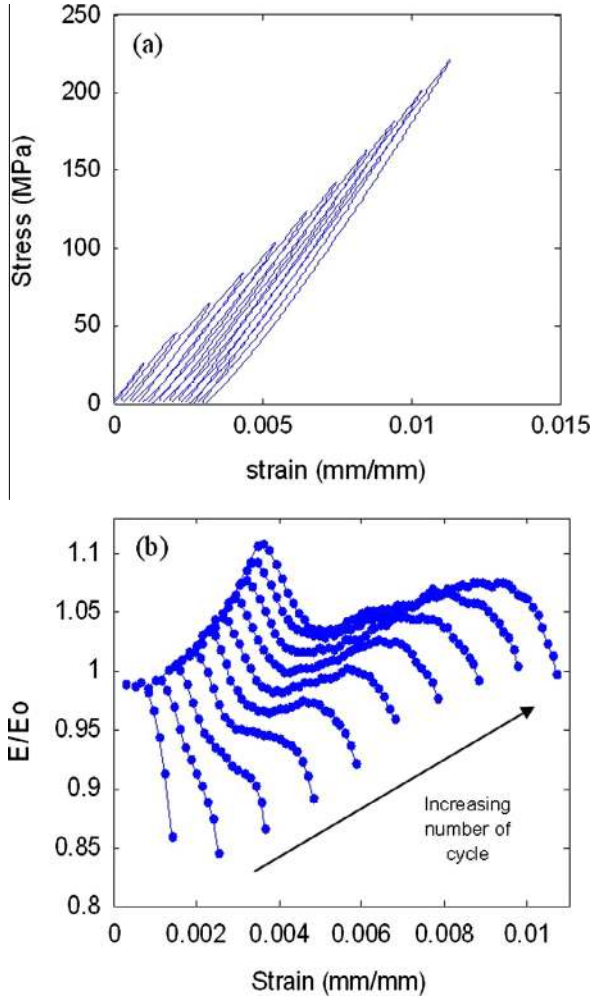
Fig. 3. Quasi static cyclic tests performed on UD 0° specimen. (a) Stress/strain curves and (b) stiffness versus strain for every cycle. (For interpretation of the references to color in this figure legend, the reader is referred to the web version of this article.)

$\epsilon_t + 2.5 \times 10^{-4}$]. Thus, the strain dependency of the stiffness was studied for every loading phase of the quasi static cyclic test. Every cycle induces an initial loss of stiffness which confirms that the “knee” mentioned for monotonic static tests exists for every loading phase. As a consequence, this knee cannot be attributed only to damage mechanisms (such as matrix cracking or fibre/matrix debonding), as it appears to be (at least partly) reversible. It may also be a consequence of the non linear behaviour of the flax fibres themselves. This behaviour has been noticed by several mechanical analyses performed on single flax fibres, and is attributed to the yielding and viscous behaviour of the lignin and amorphous cellulose of the fibre because of shear stresses in the cell walls [4,26]. However, damage mechanisms occur at every loading phase. As long as the strains never exceed 0.3–0.4%, every cycle induce a reduction of the initial stiffness of the next cycle. This is no longer observed for cycles that load the specimen above a strain of 0.3%. The initial stiffness of the successive cycles starts to increase, until it reaches more than 10% of its initial value. This phenomenon seems to indicate that stiffening mechanisms occur. It has recently been observed by Shah [25] for a flax fibre composite with an epoxy matrix. To explain this phenomenon, one of the state of the art hypotheses [25,26] is that the reorientation of cellulose microfibrils is driven through a “stick-slip” mechanism. Shear stress inside the cell wall can provoke a viscous flow of the matrix

However, every cycle also creates irreversible damage mechanisms as the applied load increases. This is confirmed by the loss of stiffness visible as a decrease of the slope at the end of every stress-strain curve (Fig. 3a). The shift of the curves as the number of cycle increases indicates that plastic strains are created with every successive loading phase beyond the elastic domain. As a conclusion, every cycle induces an initial loss of stiffness and a final stiffness decrease. Between these two parts, a stiffness stabilization phase is observed, during which the tangent modulus slightly increases for the last cycles. At the fibre scale, this stiffness increase can be attributed to the partly irreversible reorientation of the cellulose microfibrils described previously. Moreover, the amorphous cellulose is suspected to crystallize under shear stress [26,27]. Therefore, this fibre specific behaviour cannot be observed at the composite scale unless the fibre matrix interface is good. Moreover, no tension was applied on the fibres while positioning them during the manufacturing phase. As a consequence, macro reorientation of the fibres may occur above a certain level of strain. The plastic deformation of the matrix may help to make this phenomenon partly irreversible. However, additional tests should be performed to verify this hypothesis.

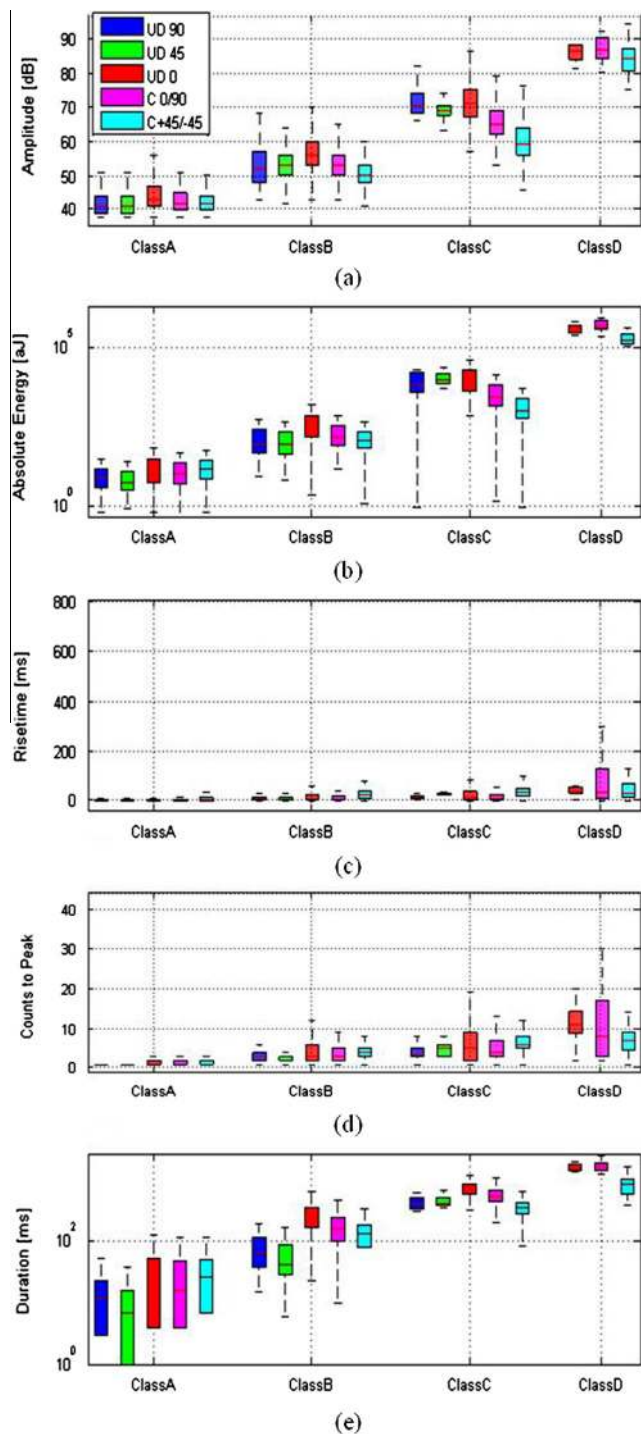
Fig. 9. Statistical dispersion of the AE classes for every classification feature. (a) Amplitude, (b) absolute energy, (c) rise time, (d) counts to peak and (e) duration. (For interpretation of the references to color in this figure legend, the reader is referred to the web version of this article.)

The AE classes shown previously were obtained by an unsupervised pattern recognition algorithm, which means that they constitute the best separation of the data regarding mathematical considerations, without really taking physics into account. As a consequence, to see if the class named “A” in a specific configuration was the same as the one also called “A” in the four other cases, the average properties of the classes of every specimen in every configuration were compared, as well as their statistical spread. Fig. 9 shows box and whiskers plots of the four AE classes for the five types of specimens tested and according to the five classification features chosen. The borders of the box correspond to the first quartile q_1 and the third quartile q_3 . The second quartile (or median) is the line cutting through the box. The whiskers indicate the lower and upper values located in the interval $[q_1 - 1.5(q_3 - q_1), q_3 + 1.5(q_3 - q_1)]$. Values outside this interval, considered as outliers, were not printed. It is clear that classes A and B present quite similar statistical characteristics for every specimen configuration and for every classification parameter. Class D presents more spread regarding number of counts to peak and rise time. These two features are very sensitive to undesired concatenated signals which may not have been totally filtered by the timing acquisition parameters previously defined. As a consequence, extreme values are probably responsible for this abnormal dispersion. AE class C presents more differences between the different specimens and features. However, this spread may have been emphasized by the huge difference in the number of vector hits between the different specimens. Regarding the different loading configurations, this may also indicate that class C cannot be attributed to a unique damage mechanism. Fig. 10 presents a comparison of the average values of the selected features in the five specimen configurations. The star diagrams clearly show that acoustic signatures can be attributed to each class. The average properties for each specimen are indeed very similar, despite the differences noticed previously regarding their statistical dispersion.
