# **Mechanism of Fatigue in Micron-Scale Films of Polycrystalline Silicon for MEMS Applications**

*C. L. Muhlstein<sup>1</sup>, E. A. Stach<sup>2</sup>, and R. O. Ritchie<sup>1</sup>*

July 2001

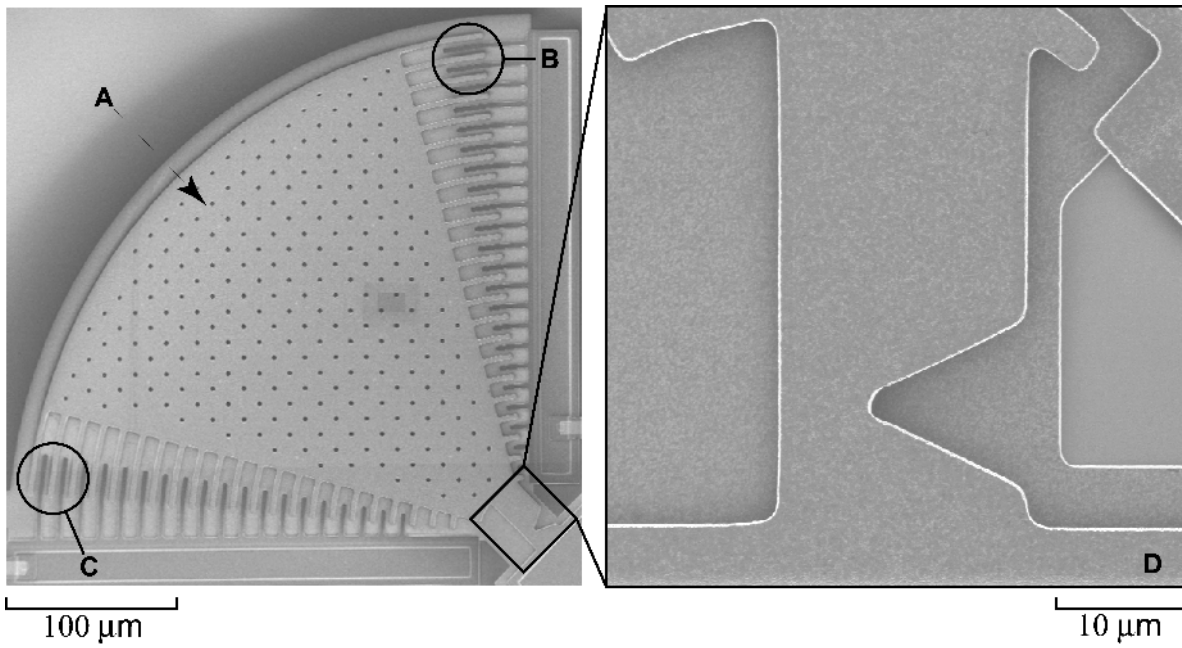
Figure 1 Scanning electron micrographs of the fatigue life characterization structure used in this investigation. The (A) mass, (B) comb drive actuator, (C) capacitive displacement sensor, and (D) notched cantilever beam specimen (inset) are shown. This 2 μm thick, surface micromachined structure was fabricated from LPCVD, n<sup>+</sup>-type, polycrystalline silicon.

If thin film silicon is fatigued at high enough stress amplitudes, cracks will initiate, grow, and the material will eventually fail. To characterize the mechanical properties of thin films such as these, an effective strategy is to manufacture the mechanical testing system directly from the material of interest. In our research we have used a micron-scale fatigue characterization structure that is analogous to the specimen, load frame, and displacement transducer found in conventional mechanical testing systems (Fig. 1) (7-11). This structure is reminiscent of the geometry used in commercially available inertial sensors and filters and therefore provides insight into their durability and reliability. The fatigue specimen is a notched cantilever beam that is in turn attached to a large ( $300 \mu\text{m}$

square) perforated plate that serves as a resonant mass. This simple harmonic oscillator is excited at resonance using electrostatic forces applied via one set of interdigitated “fingers,” or a “comb drive,” located on the edges of the mass. The opposing comb drive is used to measure the resulting motion. This tiny mechanical testing system applies large, fully reversed sinusoidal stresses at about 40 kHz to the material. The stress amplitude remains constant for a given test, but is varied across tests to characterize the behavior of the material. The natural frequency of the system is monitored; this frequency decreases as fatigue damage accumulates and eventually leads to failure of the specimen. If we plot the amplitude of the applied stress,  $\sigma_a$ , as a function of the number of cycles to failure,  $N_f$ , we generate what is referred to as a fatigue stress-life, or  $S/N$ , diagram, as shown for 2- $\mu\text{m}$  thick films of polycrystalline silicon in Fig. 2 (11). Note how the films can fail at stresses approximately one half of their (single cycle) fracture stress after large numbers of fatigue cycles. This information can be used for component design and life prediction, and for evaluating different forms of the material.

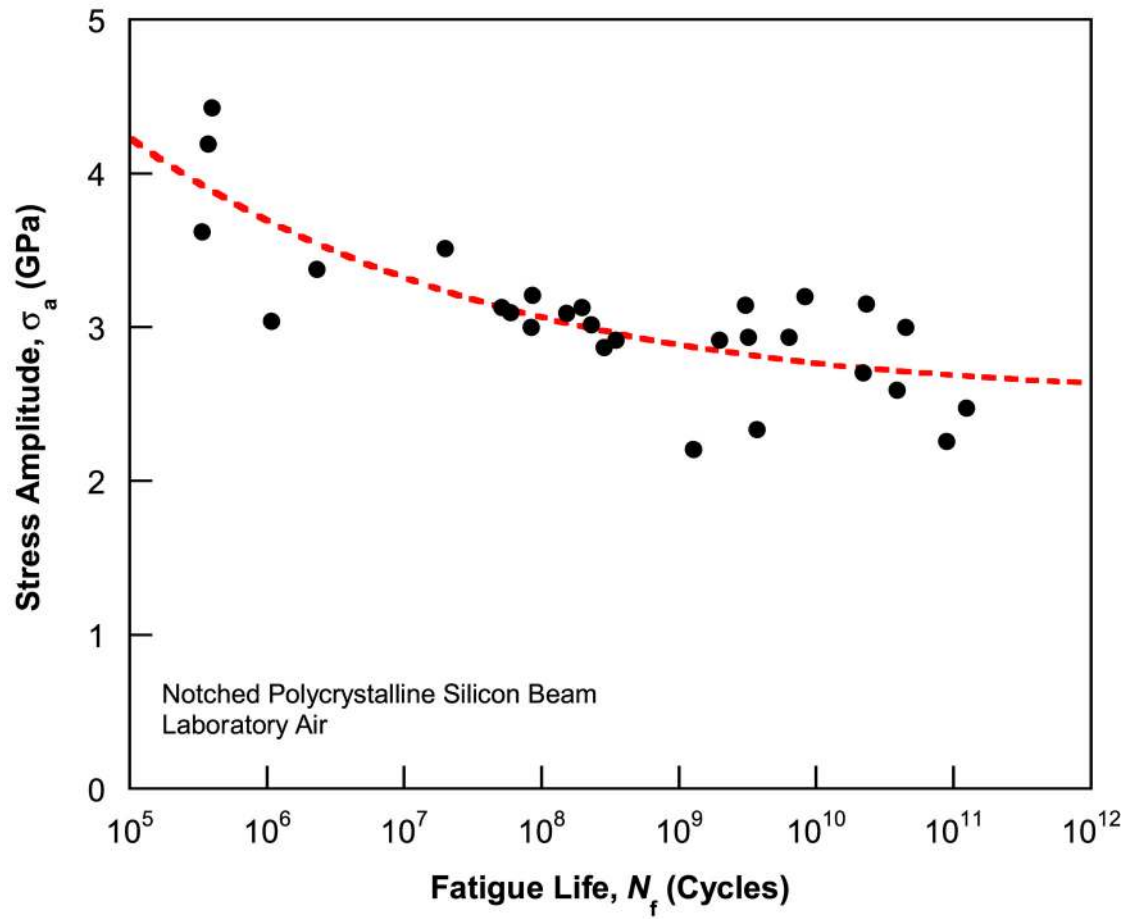
Figure 2 Typical stress-life ( $S/N$ ) fatigue behavior of the 2  $\mu\text{m}$ -thick, polycrystalline silicon at 40 kHz in moist room air under fully reversed, tension-compression loading (9,11). The dashed line is a fit of the stress-life power-law relation that is commonly applied to metals.

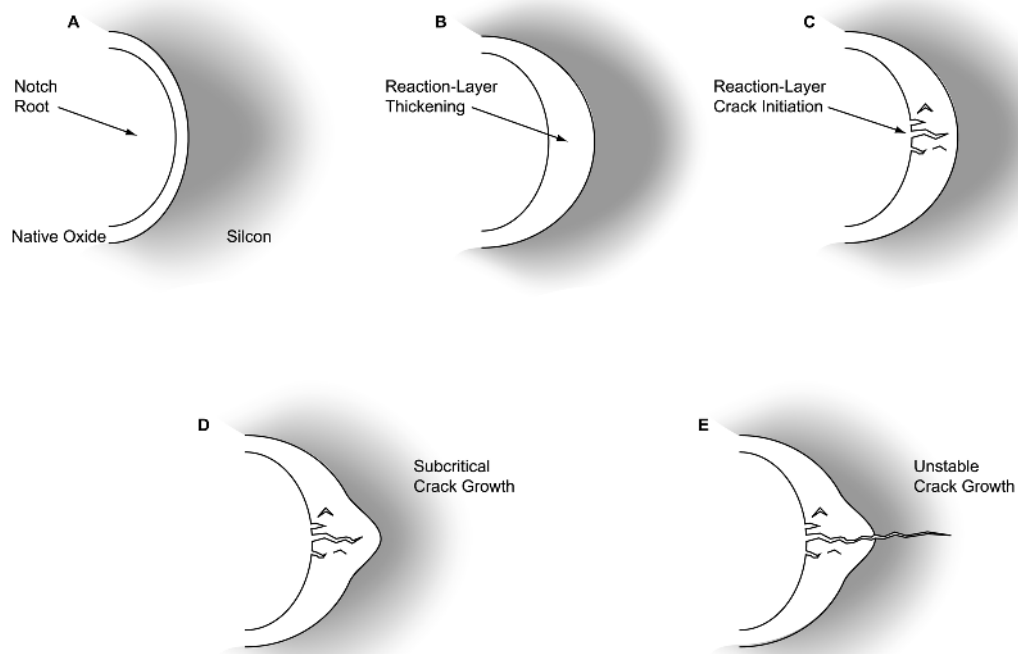
Figure 3 Schematic of the reaction-layer fatigue mechanism at the notch of the polycrystalline silicon cantilever beam. **(A)** Reaction layer (native oxide) on surface of the silicon. **(B)** Localized oxide thickening at the notch root. **(C)** environmentally-assisted crack initiation in the native oxide at the notch root. **(D)** Additional thickening and cracking of reaction layer. **(E)** Unstable crack growth in the silicon film.

Our research suggests that fatigue of silicon thin films occurs through a novel process of sequential, mechanically induced oxidation and environmentally-assisted cracking that we term *reaction-layer fatigue*. This progressive accumulation of fatigue damage, depicted schematically in Fig. 3, was observed experimentally as a continuous decrease in the stiffness of the specimen during fatigue loading (11) and was visualized directly using high voltage, transmission electron microscopy (HVTEM). Initially, a native oxide forms on the exposed silicon surfaces, with thickness and composition dictated by the environment and processing history of the thin film. In the case of the 2  $\mu\text{m}$  thick, low pressure chemical vapor deposited (LPCVD), phosphorous-doped ( $n^+$ -type)

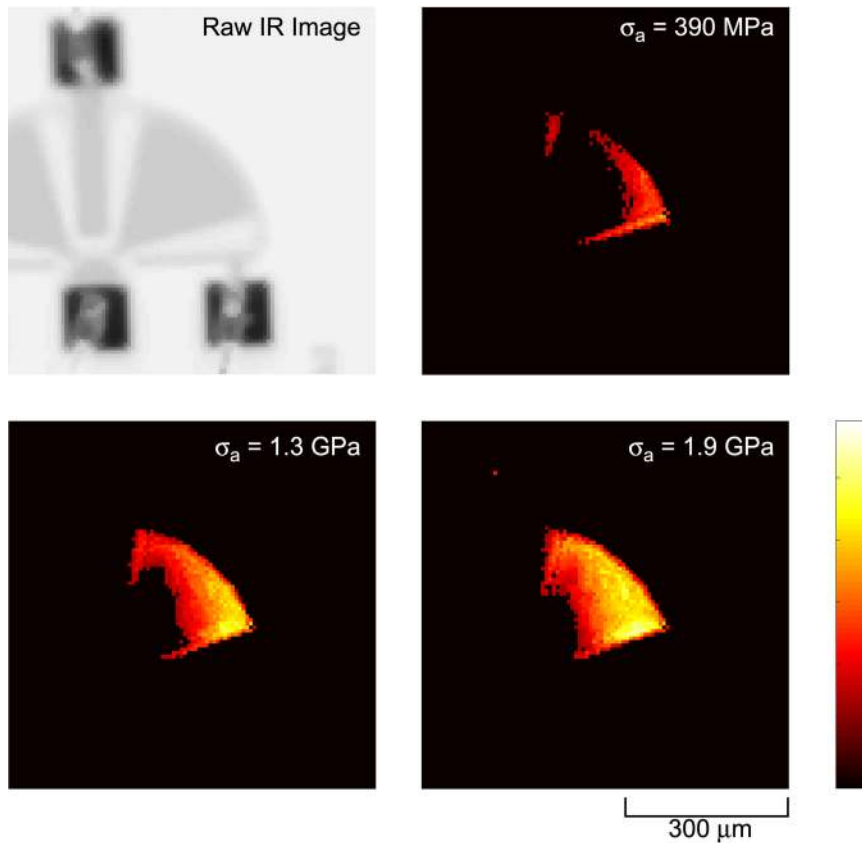
Figure 4 High resolution (20 mK) infrared (IR) images of the fatigue characterization structure. Each image was created by plotting the difference between IR images collected while the structure was resonated at the indicated stress amplitude,  $\sigma_a$ , and at rest. Individual IR images were collected by averaging over 2 seconds at an acquisition rate of 50 Hz. The absence of a difference in the IR images in the vicinity of the cantilever beam specimen indicates that the notch root oxidation process during reaction-layer fatigue is mechanical in origin. The slight warming of the mass is believed to originate from friction of the silicon with air as the structure resonates at  $\sim 40$  kHz and has not been quantified. The vertical scale represents temperature changes less than 1 K.

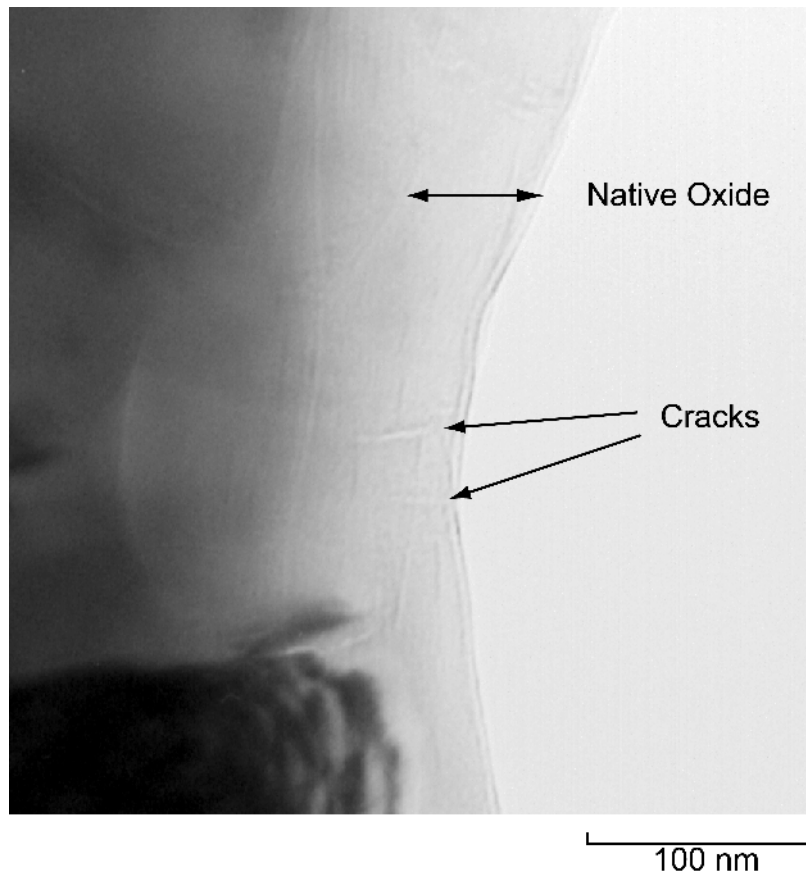
Figure 5 High voltage transmission electron micrograph (HVTEM) showing stable cracks in the native oxide of a notched, polycrystalline silicon beam formed during cyclic loading. Testing of this sample was interrupted after  $N = 3.56 \times 10^9$  cycles at a stress amplitude,  $\sigma_a$ , of 2.51 GPa. The micrograph was taken at 800 keV without thinning or other modification of the sample prior to imaging. The presence of cracks was confirmed by observation of the Fresnel fringes as the image was moved through focus, indicating an absence of material at the cracks. Furthermore, the size of the cracks is consistent with those predicted by numerical models of the experimentally observed damage accumulation. Prolonged exposure of the cracks to the 800 keV electron beam leads to healing of the cracks in a matter of minutes. This image was intentionally defocused to facilitate the observation of the cracks.

polycrystalline silicon used in this study, the initial oxide was about 30 nm thick. During subsequent fatigue loading, the oxide at the root of the notch thickened significantly. The oxide thickening process can cause up to a three-fold increase in amount of oxide at the notch, as documented using the HVTEM. One might expect this phenomenon to be attributed to heating induced by the high frequency loading and to be further accelerated by the tensile stresses. However, high-resolution infrared imaging of the fatigue characterization structure showed that while the temperature of the resonating mass may have warmed slightly due to friction with the air during cycling, the silicon specimen remained within 1 K of ambient (Fig. 4). Thus we believe that this oxide thickening process is *mechanical* in origin. Cracks are then initiated in the thickened amorphous layer assisted by the well-known vulnerability of amorphous SiO<sub>2</sub> to stress-corrosion cracking (14-16); indeed, these stable cracks were observed directly in the HVTEM (Fig. 5) by interrupting fatigue tests prior to failure. We believe that the fatigue of silicon proceeds via the propagation of these cracks by successive oxidation and environmentally-assisted cracking of the reaction layer, until a critical crack size is reached when failure occurs in the underlying silicon structure. In addition to the experimental data and HVTEM observations, numerical models also support this reaction-layer fatigue mechanism. Finite element models of the fatigue characterization structure (11) show that the change in resonant frequency and crack lengths observed experimentally are consistent with each other. Given this understanding of the mechanism of silicon fatigue, it is now possible to pursue our ultimate objective of engineering silicon films with superior resistance to fatigue failure.

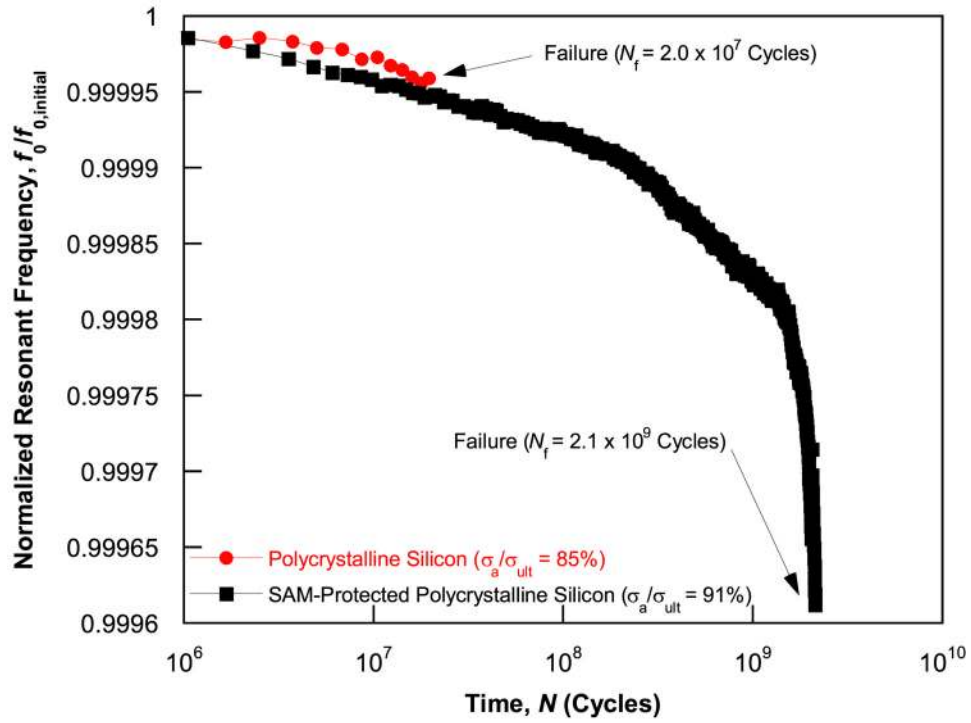
Figure 6 Damage accumulation in polycrystalline silicon and SAM-protected polycrystalline silicon thin films. The accumulated fatigue damage, i.e., notch-root oxidation and cracking, changes the natural frequency of the structure,  $f_0$ , as cycles,  $N$ , accumulate during the test. The accumulated damage with respect to the natural frequency of the structure at the start of the test,  $f_{0,initial}$ , is shown as a function of cycles,  $N$ , for both SAM coated and uncoated samples. The fatigue life of the SAM-protected silicon was improved by two orders of magnitude compared to uncoated silicon, despite being subjected to more severe fatigue loading conditions.

In order to test this theory, an alkene-based monolayer (1-octadecene,  $C_{16}H_{33}CH=CH_2$ ) was applied to the polycrystalline silicon fatigue characterization structure before the native oxide formed. This was achieved by creating a hydrogen terminated surface using aqueous HF and applying the SAM in a reactor containing a solution of one part 1-octadecene in nine parts hexadecane (17). This hydrophobic, self-assembled monolayer (SAM) bonds directly to the (hydrogen-terminated) surface atoms of the silicon film (no oxide is allowed to form) and acts as an effective barrier to oxygen and water (17). We hypothesized that if the silicon does, in fact, fatigue by the reaction-layer mechanism, preventing formation and stress corrosion of the native oxide should suppress fatigue failures. Initial results on SAM-protected polycrystalline silicon confirmed that lifetimes were not affected by the applied cyclic stresses. Indeed, as anticipated, damage accumulation was dramatically altered and fatigue lives considerably extended in the coated samples (Fig. 6); this provides additional support for the proposed mechanism. One should note, however, that there is an unexpected penalty for using the SAM for suppressing fatigue failures. Although the coated films do not appear to be as

susceptible to premature failure by fatigue, their (single cycle) fracture strength is degraded. For example, the average fracture strength of the SAM coated polysilicon was 2.6 GPa compared to 3.9 GPa for the uncoated polysilicon. It is believed that the native oxide smoothes the surface of the film, whereas its suppression leaves extremely thin, sharp features that lower the strength (due to stress concentration). Such degradation in strength was not observed in previous testing of perfluorodecyltrichlorosilane (PFTS) and octadecyltrichlorosilane (OTS) SAM coatings on polysilicon (18). In principle, there are two methods for avoiding this problem. First, the processing of the film may be refined to improve its surface roughness. A more pragmatic approach, however, may be to use a hydrophobic layer on the native oxide. This would act to smooth the film surface through the presence of the initial oxide layer, yet at the same time restrict further access of the environment, thereby suppressing the formation of stress-corrosion cracks and hence inhibiting fatigue damage in the silicon film.
