Micro-Structural Observation of the Bonding Interface between Au Wire and a Platinum Electrode[†]

Abstract

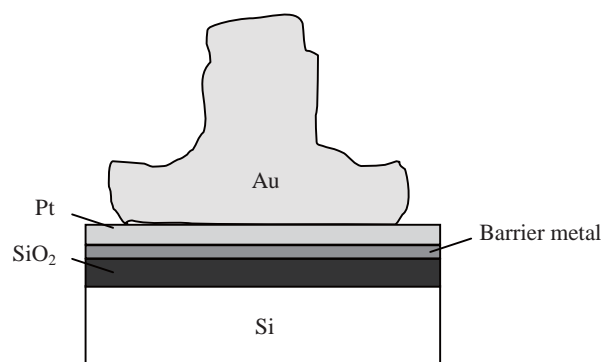
Fig. 1 Drawing of a cross-section of Au-Pt bonding.

Specifications of test chips used in the experiment are shown in **Table 1**. A schematic drawing of an outline and a cross section of a bump is shown in **Figure 1**.

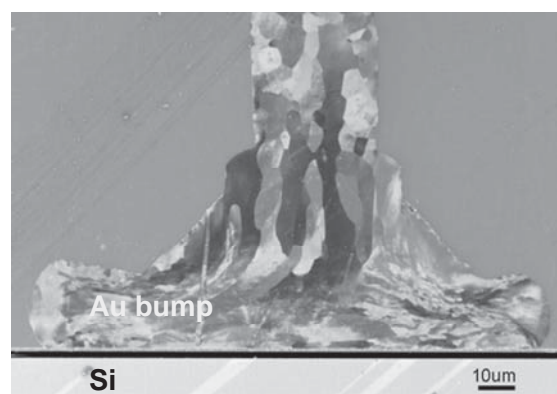
Fig. 2 Observation of Au bump form.

The bonding strength of the Au wire and the Pt bonding pad was studied. A relationship between shear strength and heat treatment was evaluated by using four samples (N = 4) having an Au bump form shown in **Figure 2**. The result is shown in **Figure 3**. The bonding

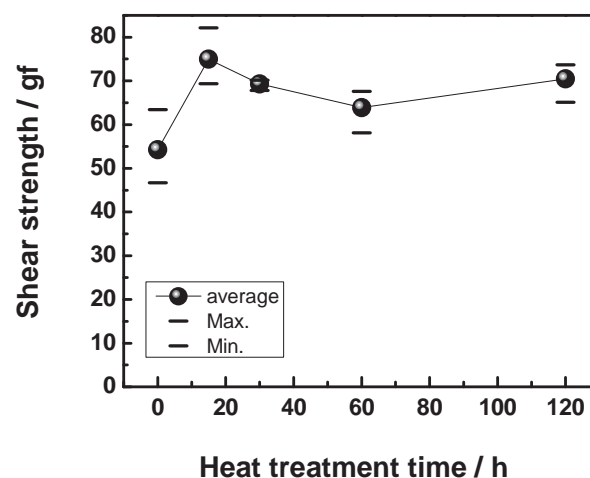
portion of the Au bump and Pt showed bonding strength of approximately 50 gf without heat treatment. The bonding strength was stabilized by the heat treatment and was not greatly decreased. From this result, it is expected that the Au-Pt bonding portion may have high thermal stability.

Fig. 3 Relation between heat treatment time and shear strength of the Au bump.

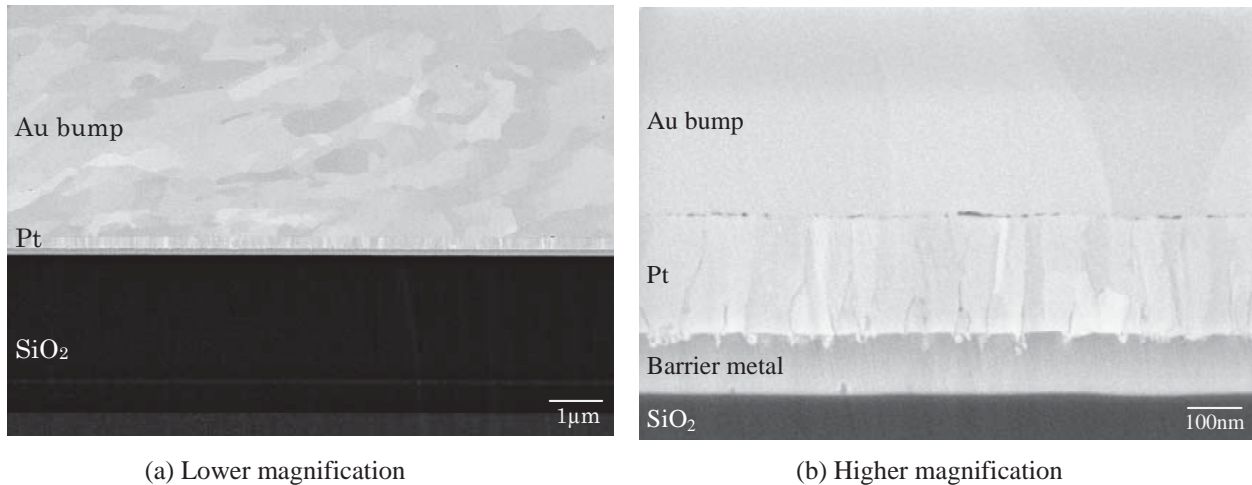
Fig. 4 SEM images of Au-Pt interface.

In order to investigate the bonding condition of Au and Pt, cross-section observation was performed by SEM as shown in **Figure 4**. As shown in **Fig. 4(a)**, the bonding portion had a bonding interface which was very similar to those of the pairs of Au/Au⁴⁾, and the Au-Pt interface was intermittently connected. **Fig. 4(b)** shows a cross section of the bonding portion observed at a higher magnification by SEM. As shown in **Fig. 4(b)**, in the Au-Pt interface, an intermetallic compound layer due to alloying reaction was not observed, and crystal grains due to recrystallization were not observed.

The crystal structure of the Au bump side was extremely different from the crystal structure of the Pt bonding pad side. That is, the interface of the Au bump side was mainly made of granular crystal grains having a size of submicrometers to several micrometers. On the

other hand, the Pt bonding pad was a polycrystalline film and was made of columnar crystals. In the Au-Pt interface, crystal grains due to recrystallization of the both metals were not observed. From these result, the Au-Pt bonding was not a local fusion bonding and was not a diffusion bonding. That is, it is expected that the Au bump and the Pt bonding pad were adhesively bonded with each other.

the Au-Pt interface was not greatly changed before and after the thermal aging test, and bonding areas were intermittently observed. Specifically, in the inside of the Au wire, coarsened crystal grains of Au were clearly observed as shown in **Fig. 4(a)** and **Fig. 7(a)**.

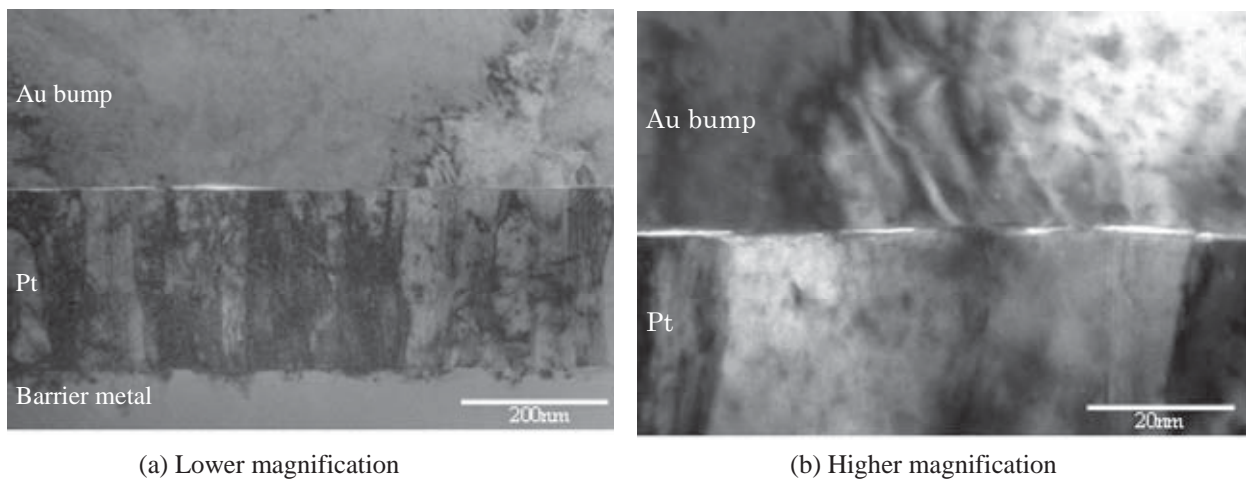
Fig. 5 TEM images of Au-Pt interface.

Figure 5 shows an image of an Au-Pt bonding interface that was observed at a relatively low magnification by TEM. The Au-Pt bonding interface was sharply defined. Specifically, a great amount of voids (unbonded areas) were observed at the interface, whereas the voids were not clearly observed by SEM. Moreover, a fine subgrain structure was clearly observed in the crystal grain which was previously observed by SEM.

As shown in **Fig. 5(b)**, crystal grains specific for Au and Pt were observed in the vicinity of the interface and crystal grains due to recrystallization were not observed. Accordingly, it is expected that the Au wire and the Pt bonding pad were adhesively bonded with each other, and the Au atoms and the Pt atoms directly contacted with each other. In this case, crystal structures were not observed at white contrast portions in the vicinity of the bonding interface, and therefore, the white contrast portions were unbonded portions. The area of the white contrast portions was large.

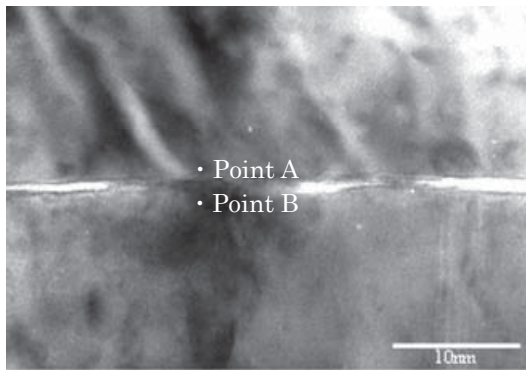
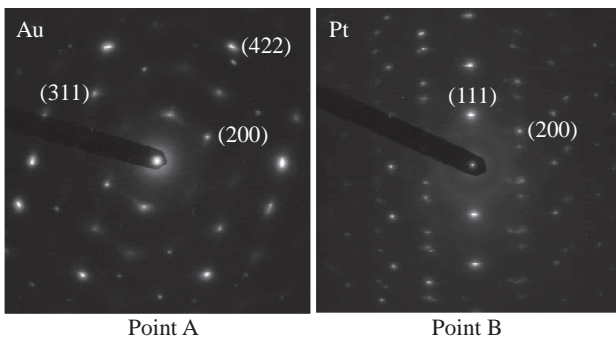
We focused on two crystal grains that were bonded with each other and had an interface between them. The two crystal grains were analyzed by electron beam diffraction, and the result is shown in **Figure 6**. As shown in **Fig. 6**, diffraction patterns of two measuring points (A, B) were different from each other. In this case, the measuring point A had lattice constants corresponding exactly to the lattice constants of Au, which is 2.04 Å (200), 1.23 Å (311), and 0.83 Å (422). The measuring point B had lattice constants corresponding exactly to the lattice constants of Pt, which is 2.27 Å (111) and 1.96 Å (200). Accordingly, an alloying reaction due to diffusion did not occur at the Au-Pt bonding interface.

Fig. 6 TEM images of Au-Pt interface and diffraction pattern.

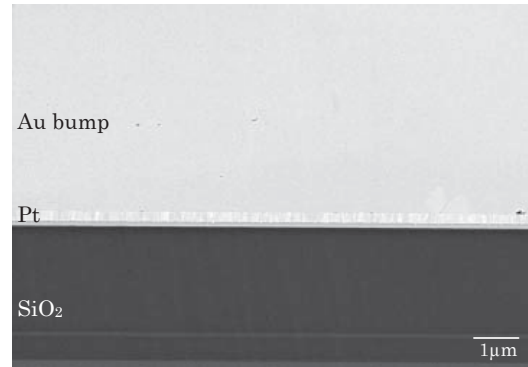
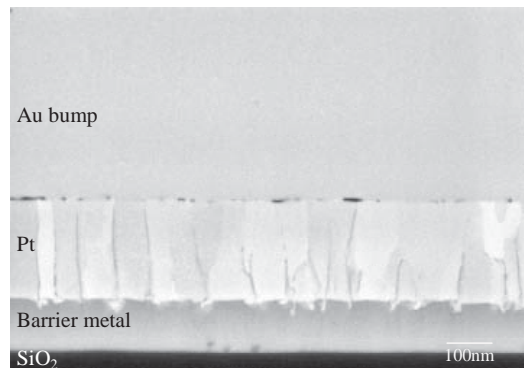
(a) Lower magnification

(b) Higher magnification

Fig. 7 SEM images of Au-Pt interface after thermal aging test.

Recrystallization of Au was caused by the heat of the thermal aging test. According to this finding, it is expected that interface strength may be decreased by the coarsening of the crystal grains of Au. However, since the structure of the Au-Pt interface was not greatly changed before and after the thermal aging test, the strength is not greatly affected by heat as described in the discussion of the shear strength.

Figure 7 shows the SEM images of an Au-Pt interface after the thermal aging test and **Figure 8** shows the TEM images of an Au-Pt interface after the thermal aging test. As shown in **Fig. 7** and **Fig. 8**, the structure of

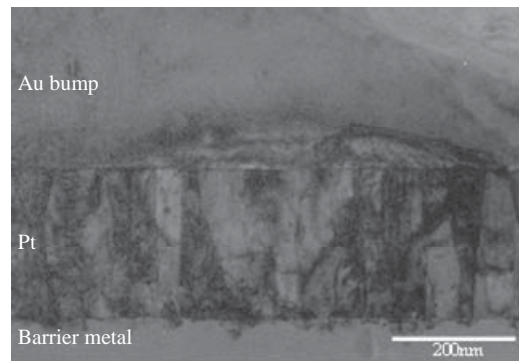
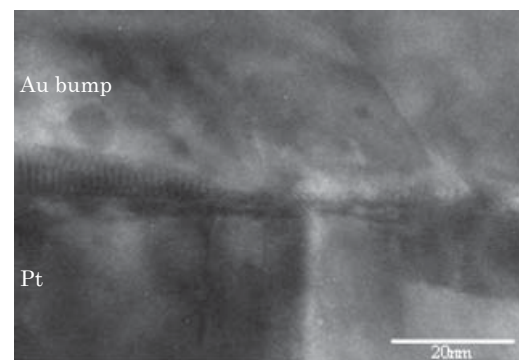
(a) Lower magnification

(b) Higher magnification

Fig. 8 TEM images of Au-Pt interface after thermal aging test.
