Microanalytical Study of Defect Formation in Thin Bismuth Strontium Calcium Copper Oxide Films

R.H. Howell, A. Chaiken, R.G. Musket, M.A Wall M. Balooch, D. Phinney and M.J. Fluss Lawrence Livermore National Lab Livermore, CA 94550

> Prepared for submittal to OE/LASE '94, Los Angeles, CA January 22-29, 1994

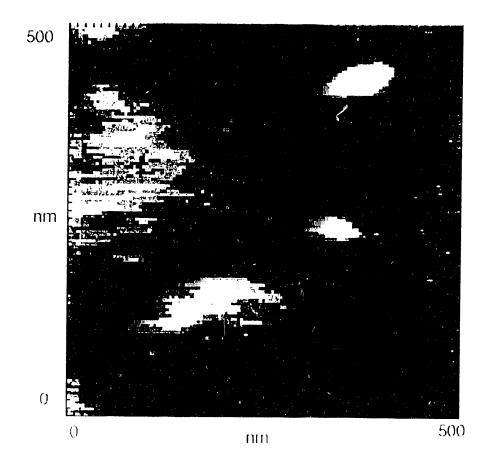
Figure 3

Atomic force microscope image of the defect-free surface of the BSCCO heterostructure pictured in figures 1 and 2. The full vertical range is 7.7 nm -1 lat regions of about 100 nm in diameter and step heights of 1 to 2 nm are seen.

The oriented defects are usually confined to one corner of the wafers, which often have low defect concentrations overall. Both microscopic elemental analysis using the ion microscope and macroscopic analysis using RBS were performed at several locations on these wafers, including the high-defect corner and the center region which is nearly defect-free. Significant variations in the elemental concentrations were found in RBS and reproduced in the ion microscope. The strong correspondence of the microscopic and macroscopic measurements suggests that elemental concentrations are varying on a length scale of millimeters rather than microns. In the RBS data shown in table 1, both changes in the overall sample thickness and the locally determined stoichiometry were seen for copper and bismuth Statistically useful results were not obtained for calcium, strontium and oxygen in the film as their peaks were obscured by scattering from the strontium titanate substrate. The 10% variation in the elemental concentrations in this film is large compared to other films with fewer defects. Particle-induced x-ray emission (PIXE) spectra were also taken on these same films for comparison to the RBS and SIMS. This particular sample contained films of (2201) and (2212). The expected elemental concentrations are given in table 1. The measured elemental concentrations were nominally as expected for bismuth and copper-rich by all three techniques. In spite of being copper-rich, large areas of the sample were flat like the area shown in Figure 3.

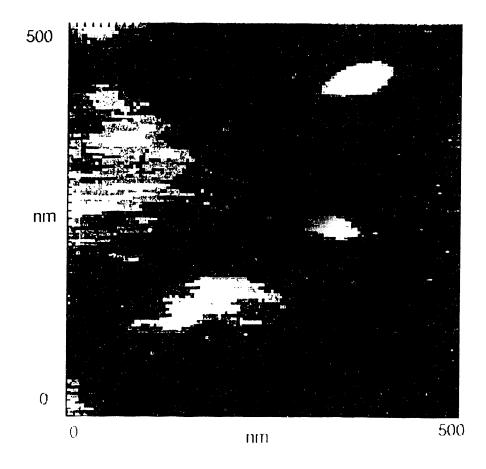
Figure 3.

Atomic force microscope image of the defect-free surface of the BSCCO heterostructure pictured in figures 1 and 2. The full vertical range is 7.7 nm Flat regions of about 100 nm in diameter and step heights of 1 to 2 nm are seen.

Dramatically different defect patterns may sometimes be found in widely separated regions on a single wafer. This suggests that the initiation of defect growth is not random and may be the result of some specific stimulus. A typical AFM image of the corner of a highly defected film is shown in figure 4. In this image we see a series of micron-sized, rectangular asperities aligned with the underlying axes of the (2212) film. There are also some roughly circular asperities seen as well. The height of the rectangular defects is 100 nm and of the circular defects is 20 nm. These features are spaced at separation of about 5 microns. In between the asperities are flat regions similar to those imaged in figure 3. It appears that these defects rise up from an otherwise smooth and well ordered film.

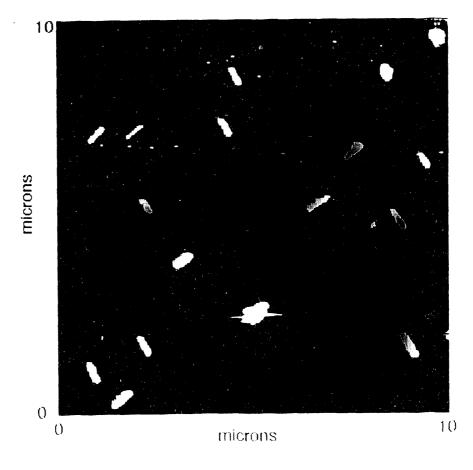
Figure 4.

Atomic force microscopy image of defect -rich corner of a BSCCO superlattice. Large irregular regions and smaller oriented defects both protrude from the smooth sample surface.

The features seen in the defect distribution in figure 4 are typical of those from all the wafers we have scanned. The lateral scale of the features is typically one micron or less. There have been occasional defects larger than a square micron in area. The variation in height and shape can be more extreme. One film had asperities extending as much as 1000 nm above the film surface along with defects of only a few nm high. While the area of the defects is uniform, the height and shape of the asperities can vary greatly. The regions between defect structures are smooth at the BSCCO unit cell level.

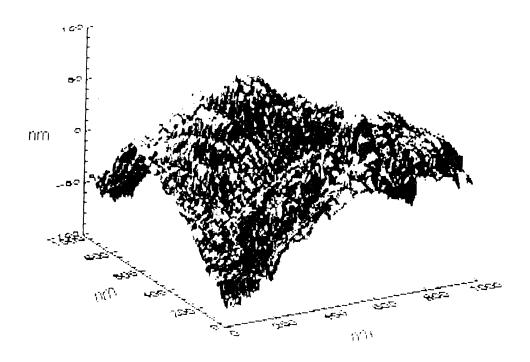
Scanning transmission microscope unage taken on the site of a protrucing defect on the surface of a BSCCO film Oriented corrugations can be seen in these defects Images taken with the AFM only show the shape of the surface features and leave several important questions unresolved For instance, the defects may be precipitate phases segregated from the film in order to preserve the overall stoichiometry. In this case the chemical composition and electrical transport of the defects may be different from the surrounding (2212) film. STM probing of the defects can in principal determine the resistivity of the defects and highlight differences between the defects and the rest of the film. Figure 5 shows an STM image of a defect similar to that imaged by AFM in figure 4. Preliminary I-V characteristics taken in air showed that in general the defects were more conductive than the flat areas of the film. However possible surface contamination prevents more definitive conclusions. The structure of the defect imaged in figure 5 is typical of the asperities which are laterally oriented with respect to the (2212) film. There are corrugations on the surface of the defect suggestive of steps or layers running perpendicular to the film surface and over the top of the defect. This corrugation is not seen in the film surface and is evidence that the defect is not simply a cluster of BSCCO material. The defects pictured in figure 5 appear to have a crystal structure with a strong symmetry plane in the vertical direction. STM results have only been obtained for oriented defects of this type. Other types of defects may show different structure and electrical properties.

Larger asperities are also observed the surfaces of these heterostructures. Some of these asperities rise above the film surface as much as 1 micron, but they are more typically 10 to 100 nm high. Areal dimensions of one square micron are most common, but appear to be an upper bound. The nucleation source of these defects remains undetermined. The defects measured so far have chemical composition similar to the surrounding film. Some of the asperities have corrugated surfaces, with layer

planes apparently growing up perpendicular to the plane of the film. a-axis growth may be the source of these features. Further measurements in progress are underway to confirm this hypothesis.
