Microstructures and Corrosion Properties of X80 Pipeline Steel in Alkaline Sand Soil

KEY WORDS: (X80 pipeline steel), (heat treatment), (weld fusion zone), (heat affected zone), (microstructure), (corrosion properties), (alkaline sand soil)

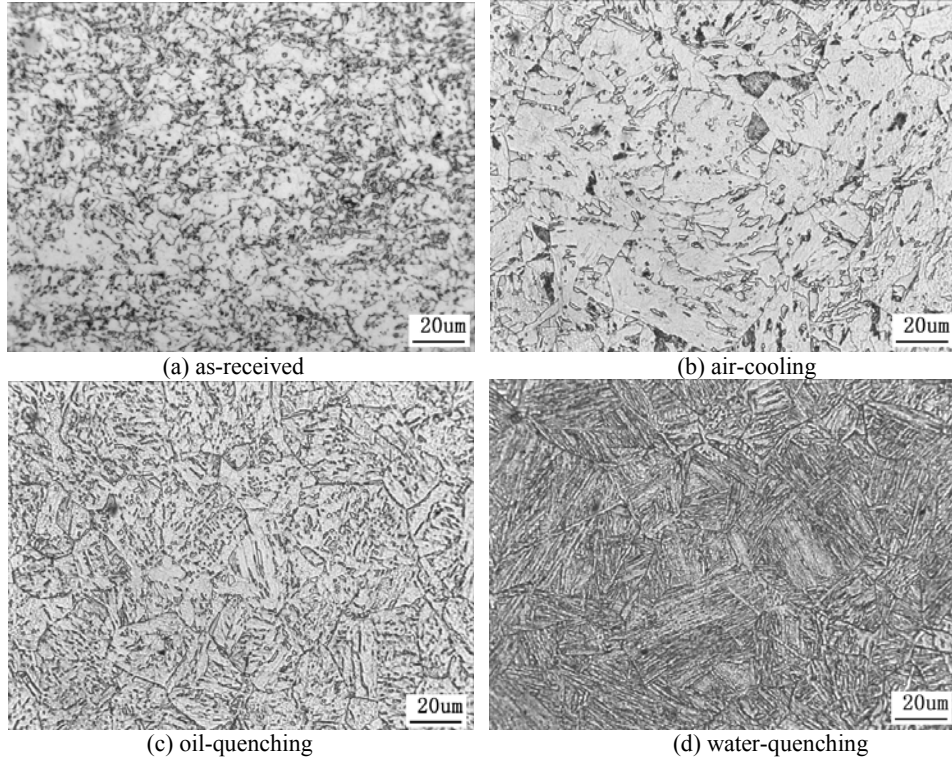
Fig.1 Metallographic views of the microstructures of X80 steel as-received (a) and with different heat treatments of (b) air-cooling, (c) oil-quenching and (d) water-quenching

The metallographic views of the microstructures of X80 pipeline steel with the different heat treatments are

shown in Fig.1. It is seen that the microstructure of as-received steel (Fig.1a) is a uniform acicular ferrite(AF) structure which consist of granular bainite (GB), polygonal ferrite(PF) and a small amount of pearlite (Fig.1a)[12]. Upon air cooling, the microstructure of X80 steel which simulated the softening zone in the welding heat affected zone (Fig.1b) contained granular bainite(GB), polygonal ferrite(PF) and a certain amount of pearlite (dark areas). The microstructure obtained by oil-quenching which simulated welding coarse grain heat affected zone (CGHAZ) region(Fig.1c) was composed of lath-shaped granular bainite and mlarge martensite/austenite (M/A) constituent. The steel icrostructure obtained by water quenching which simulated the hardening zone in HAZ (Fig.1d) consisted of upper bainite(lath-shaped bainite ferrite and discontinuous short clavite cementite) and well-distributed lath martensite [5]. The microstructure grains of X80 after the three different heat treatments grew to a great extent, and the microstructure inhomogeneity increased.

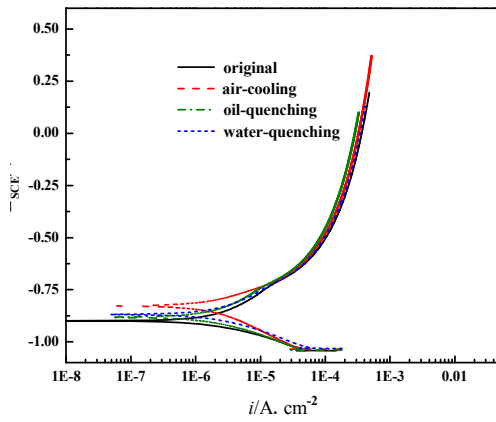
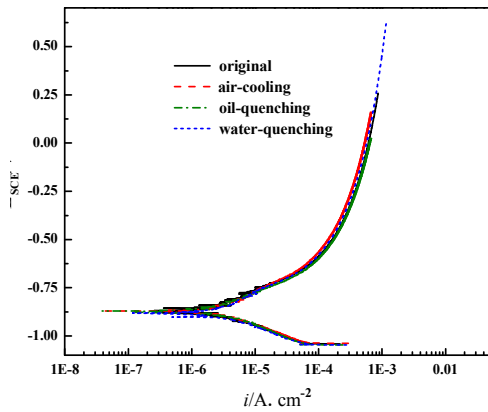
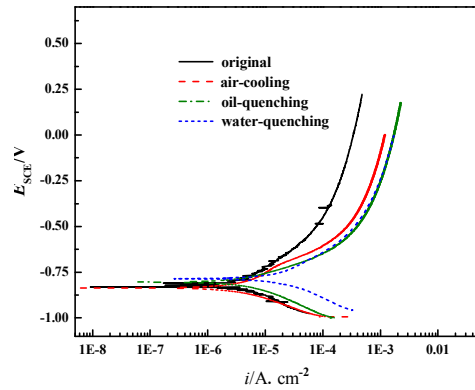
Fig. 2 Polarization curves of X80 steel with different microstructures that buried in alkaline sand soil
Table1 Fitted results of polarization curves for X80 steel

Fig.2 shows the potentiodynamic polarization curves of X80 steel with different microstructures buried in soil for 10, 30 and 50 days, respectively, where E is the corrosion potential, and i is the corrosion density. There was a common feature for the measured the potentiodynamic polarization curves of X80 steel, i.e., there is no obvious passive region, which indicates no protective layer or a stable passive film is formed on the sample surface in yulin water-saturated soil. There is an obvious tendency for polarization curves to shift "right" (to higher current densities) with 50 days corrosion on as-received, air-cooled, oil-quenched and water-quenched steels respectively. The fitting results for the open circuit corrosion potential(E_{corr}) and corrosion current density(i_{corr}) are listed in Table 1. At four different microstructures, the i_{corr} increased significantly with the increase of corrosion time. After 10 and 30 days corrosion, the i_{corr} with four different microstructures varied with in a small range, there was the largest i_{corr} for water-quenched steel after 10 days and the smallest i_{corr} for as-received steel after 30 days corrosion. After 50 days corrosion, there was the smallest i_{corr} for as-received steel and the largest i_{corr} for water-quenched steel, the values of the i_{corr} fitted on air-cooled and oil-quenched steels were between these extremes.

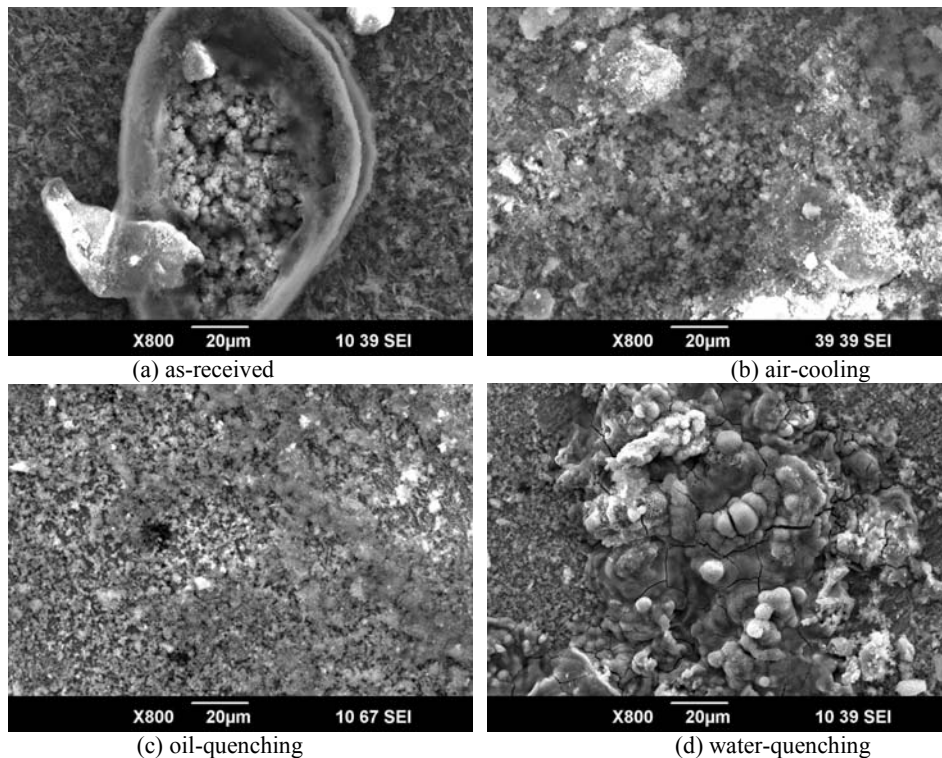
Fig. 3 The surface topographies of X80 steels after corrosion for 50 days in alkaline sand soil (a)as-received, (b)air-cooling, (c)oil-quenching and (d)water-quenching

It is seen that corrosion product on as-received steel was compact(Fig.3a),and covered uniformly the specimen surface, resulting in a low corrosion rate. As seen in Fig.3b and c, corrosion products were loose and porous. Furthermore, the corrosion product on the water-quenching X80 steel(Fig.3d) were quite loose, with many wider cracks in the oxide layer. Therefore, the different corrosion rates of steels with the different microstructures are attributed to the compactness and completeness of the corrosion product layer formed on the steel surface. EDS analysis showed that the corrosion products on X80 steels with four different microstructures were basically iron oxide. The composition of corrosion products was determined by XRD analysis, is basically α -FeOOH, γ -FeOOH and Fe_3O_4 . The combined analysis of SEM, EDS and XRD showed that the different microstructures of steel result in the different physical structure and compactness of corrosion product, rather than different composition, leading consequently to the different corrosion rate of steel.
