# Moisture-induced degradation of interfacial bond in FRP-strengthened masonry

This paper, tackling one of the aspects related to durability of these systems, presents an experimental investigation on the effect of long-term (one year) water immersion on the performance of GFRP-strengthened bricks. The tests include materials' mechanical tests, as well as pull-off and single-lap shear bond tests, to investigate the changes in material properties and bond behavior with immersion time, respectively. The effect of mechanical surface treatment on the durability of the strengthened system as well as the reversibility of the degradation upon partial drying are also investigated. The experimental results are presented and critically discussed.

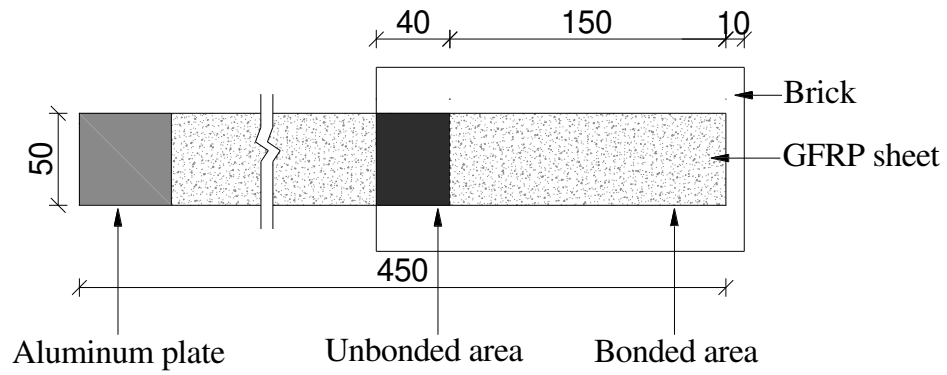
Fig 2. Geometrical details of the specimens for (a) pull-off tests; (b) debonding tests (dimensions are in mm).

The specimens prepared for material characterization tests included 40 mm cubic brick specimens, see Fig 1(a), dog-bone shaped epoxy and primer specimens, see Fig 1(b), and GFRP coupons, see Fig 1(c). The epoxy resin, primer and GFRP coupons were prepared according to the manufacturer's technical datasheets and ISO 527-1 [18] specifications. The specimens were cured for two months in the laboratory conditions before performing the tests as also followed in [12,13]. Two groups of specimens were prepared, following the wet lay-up procedure, for bond characterization tests. The first group was prepared without application of any mechanical surface treatment on the bricks' surfaces (denoted as ORG-specimens). These specimens were prepared for pull-off and debonding tests. The second group, consisting of only single-lap shear test specimens, was prepared using bricks with grinded surfaces (denoted as GR-specimens). In both sets of specimens, the bricks were initially cleaned and dried in an oven (for 24 hr at 100°C) followed by application of a primer layer on the brick's surfaces. The epoxy resin was then used for impregnation of the glass fibers and their application to the bricks' surfaces according to the geometrical details shown in Fig 2. The GFRP sheets were applied on the bricks' surfaces over a 180×70 mm<sup>2</sup> area for the pull-off test specimens, Fig 2(a). In case of the debonding test specimens, the GFRP sheets with 50 mm width were applied in a 150 mm length of the brick's surfaces leaving a 40 mm unbonded length at the loaded end, Fig 2(b).

For performing the pull-off tests, two 50 mm diameter partial cores (with a depth of around 5 mm) were drilled on each specimen, see Fig 2(a). Thereafter, aluminum disks were glued over the GFRP surface by means of a high-strength epoxy paste adhesive. The specimens were placed on a rigid steel frame and firmly clamped to it to perform the tests. The pull-off tests were then carried out using a closed-loop servo-controlled testing machine by applying tensile forces to the aluminum disks with a displacement rate of 0.2 mm/min, see Fig 4(a). Two specimens were tested (resulting in four tests) in each immersion period.

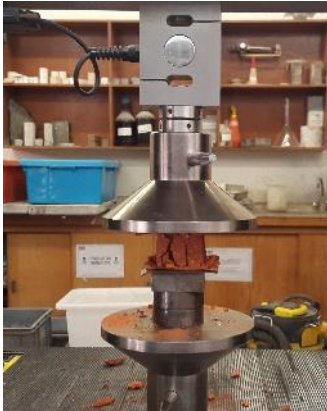
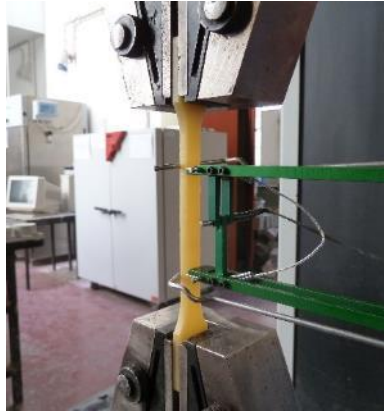
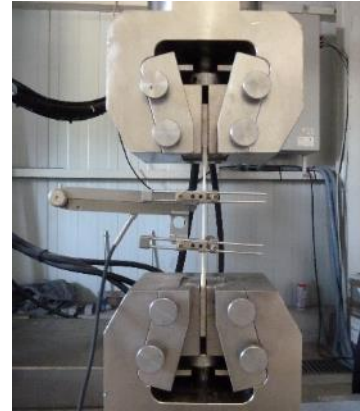
Fig 3. Mechanical tests setup: (a) brick compressive test; (b) epoxy and primer tensile test; (c) GFRP tensile test.

Material tests included compressive tests on cubic brick specimens and tensile tests on epoxy resin, primer and GFRP coupons. The test setup for each material characterization test is shown in Fig 3. Five specimens were tested for each material and testing type according to relevant test standards. The summary of the mechanical properties of the reference specimens is presented in Table 1.

The compressive tests were performed on 40 mm brick cubes according to the specifications provided by ASTM C67 [19] and EN 772-1 [20]. The tests were conducted with a Lloyds testing machine at the rate of 150 N/min in the flatwise direction to obtain the compressive strength of the bricks.

The tensile tests on epoxy resin and primer were conducted according to ASTM D638 [21] to obtain the tensile strength and elastic modulus. The tests were carried out with a Lloyds testing machine at a displacement rate of 2 mm/min. Deformation of the specimens was monitored by a clip gauge placed on the middle of the specimens. The modulus of elasticity was obtained from the stress-strain curves as the slope of the chord between 20% and 60% of the maximum tensile stress.

The tensile tests on GFRP coupons were performed according to ASTM D3039 [22] and ISO 527-1 [18]. The tests were performed with an Instron testing machine at a displacement rate of 2 mm/min. The mechanical properties were obtained in terms of tensile strength and elastic modulus. As the specimens prepared following the wet lay-up procedure do not have a uniform thickness, fabric equivalent thickness was used for stress calculations according to ACI 440.3R [23] specifications. The elastic modulus was again obtained from the stress-strain curve as the slope of the chord between 20% and 60% of the maximum tensile stress.

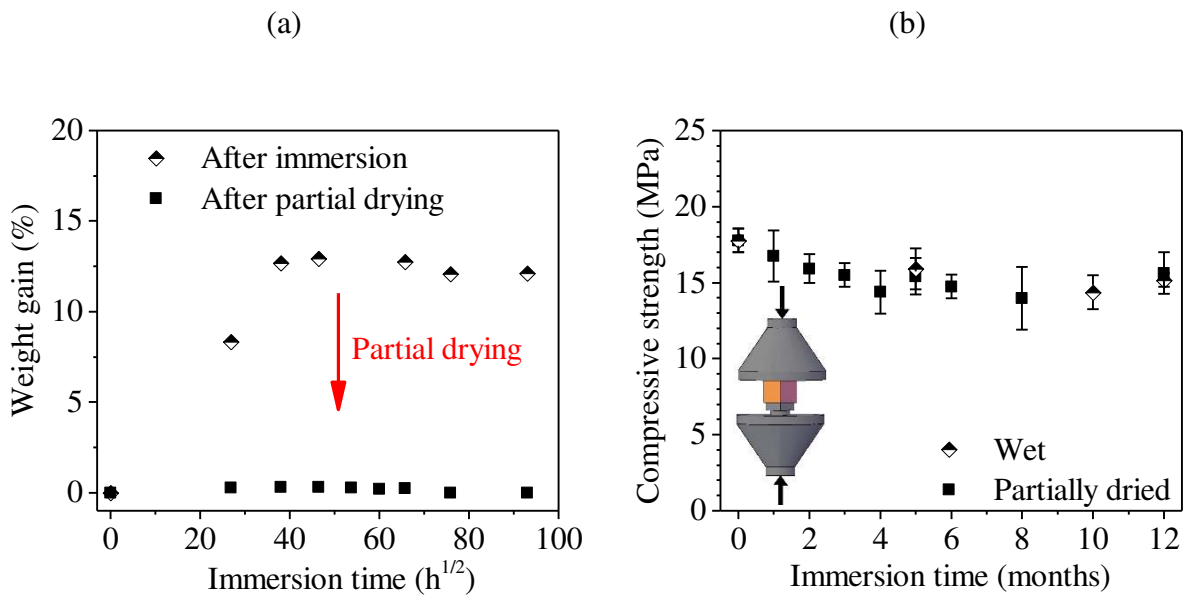
Fig 6. (a) Moisture absorption curve of cubic brick; (b) Brick's compressive strength with immersion time.

The water absorption curve and the changes in the compressive strength of the bricks with water immersion are shown in Fig 6. A slight reduction of compressive strength can be observed in the specimens with a total reduction of about 12% after twelve months of immersion. As expected, the brick specimens became saturated in the first days of immersion (with 12.6% mass water absorption) and therefore the weight of the specimens did not change significantly throughout the tests, see Fig 6(a). The results also show that the degradation in the specimens is not reversed upon partial drying, although the brick specimens lost the whole absorbed water after one month drying in the laboratory conditions (around 0.3% mass water remained after one month laboratory storage).

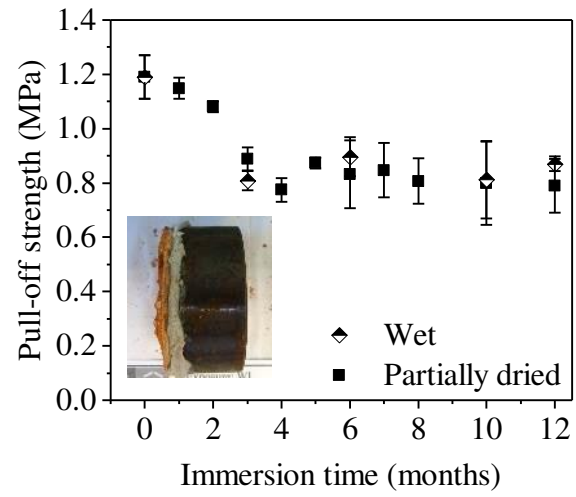
Fig 11. Pull-off strength with immersion time.

The variation of pull-off bond strength with immersion time together with typical failure mode is presented in Fig 11. As explained before, the pull-off tests were only performed on ORG-

specimens. It can be observed that a severe degradation occurred during the first four months of water immersion. Thereafter, the pull-off strength reached a plateau with the total drop of 34% in twelve months of water immersion. It seems that partial drying of the specimens did not have any reversible effect on the bond strength. The typical failure mode in all of the specimens, including “wet” and “partially dried” ones, was cohesive failure with the fracture inside the brick. However, the thickness of the detached brick continuously decreased with increment of immersion period until reaching the primer impregnated depth, as also reported in [5].

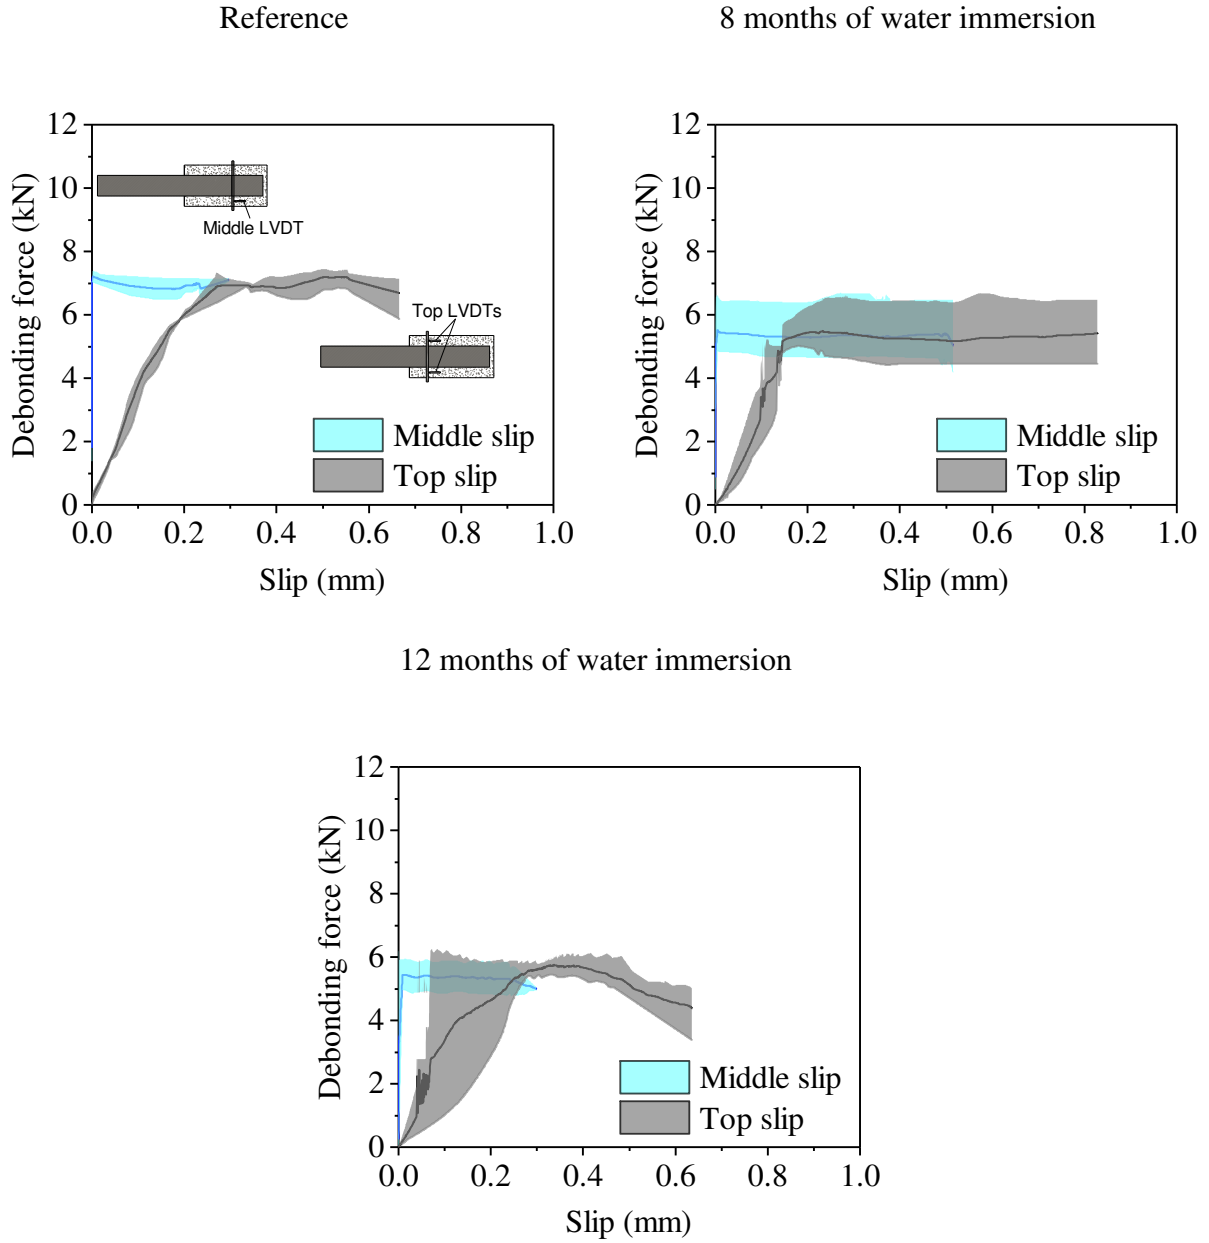
Fig 12. Force-slip curves of “partially dried” ORG-specimens with water immersion.

The envelop of the load-slip curves obtained from single-lab shear bond tests are presented in Fig 12 and Fig 13 for different periods of water immersion. A reduction of debonding force and bond stiffness (defined as the initial slope of the load-slip curves) can be observed with immersion time. This reduction is generally more in ORG-specimens which can be attributed to the lower adhesion quality in these specimens. Grinding the bricks’ surfaces in GR-specimens results in removal of the top (weak and low porous) layer of the bricks, and thus improvement of the bond quality by better impregnation of the primer layer. It can be observed that the reference GR-specimens showed higher debonding force (23%) and slip (36%) than the reference ORG-specimens, see the reference curves in Fig 12 and Fig 13.

The load-slip curves corresponding to the middle LVDTs, see Fig 12 and Fig 13, show that the FRP slip is negligible in the middle, in comparison to the loaded end slip, until debonding initiates. Upon this point, the moment in which the load is at peak, the slip at the middle increases until complete debonding of the FRP. This is due to the fact that the effective bonded length is less than 50 mm (the distance between loaded end and middle LVDTs) in the (reference) specimens used in this study [31]. Effective bonded length is defined as the bonded length in which the

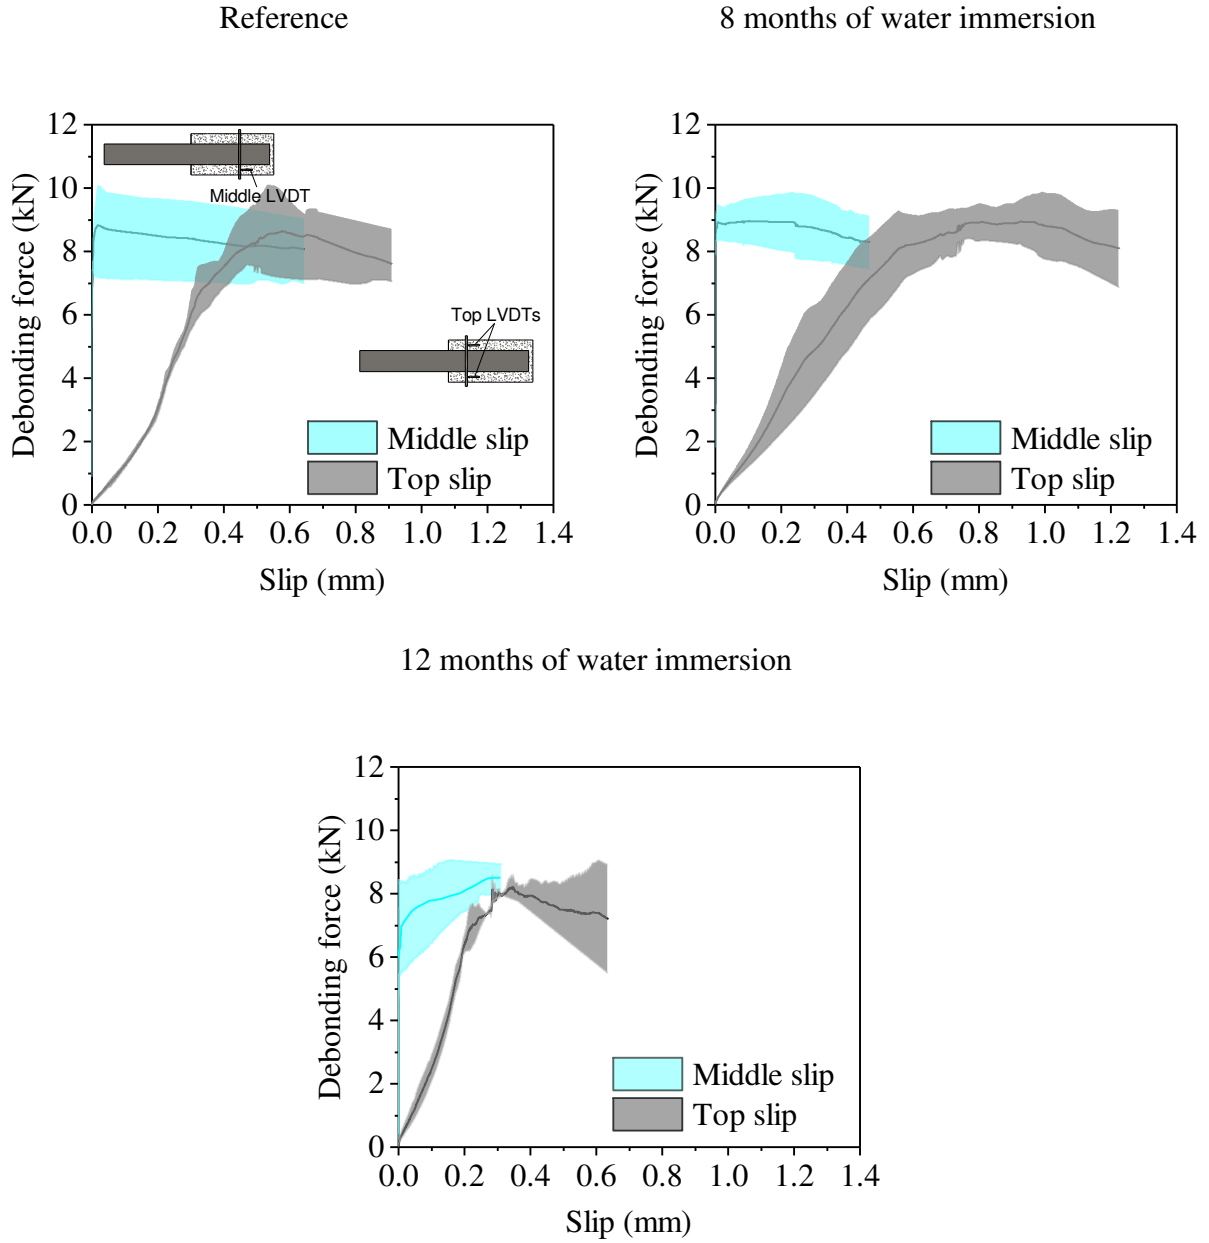
Fig 13. Force-slip curves of “partially dried” GR-specimens with water immersion.

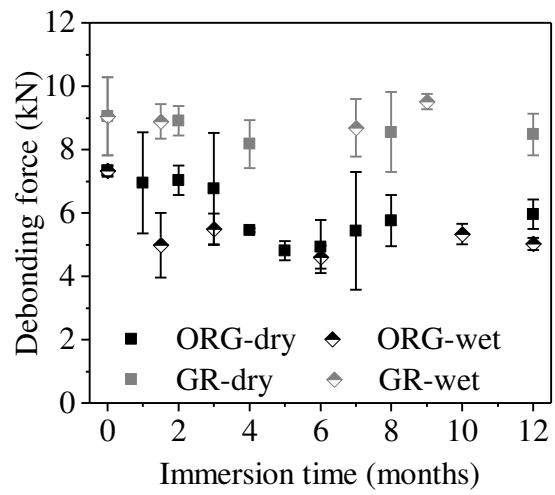
Fig 14. Debonding force with immersion time.

The variation of the debonding force with immersion is illustrated in Fig 14 for both specimen types. A significant degradation is observed in ORG-specimens during the first six months of water immersion (around 33%). Afterwards, no bond degradation is observed and it seems that the strength has reached a plateau. A relatively similar degradation (35%) has also been reported in [5] for GFRP-strengthened bricks (handmade bricks with lower compressive strength) during six months of water immersion. A slight enhancement of the debonding force upon drying can be observed in the first months of immersion in ORG-specimens. However, this enhancement diminishes as the immersion period increases. In contrary to ORG-specimens, GR-specimens suffered only a slight reduction of 6% after 12 months of immersion. The results show that surface preparation has significantly affected the degradation level, as expected.

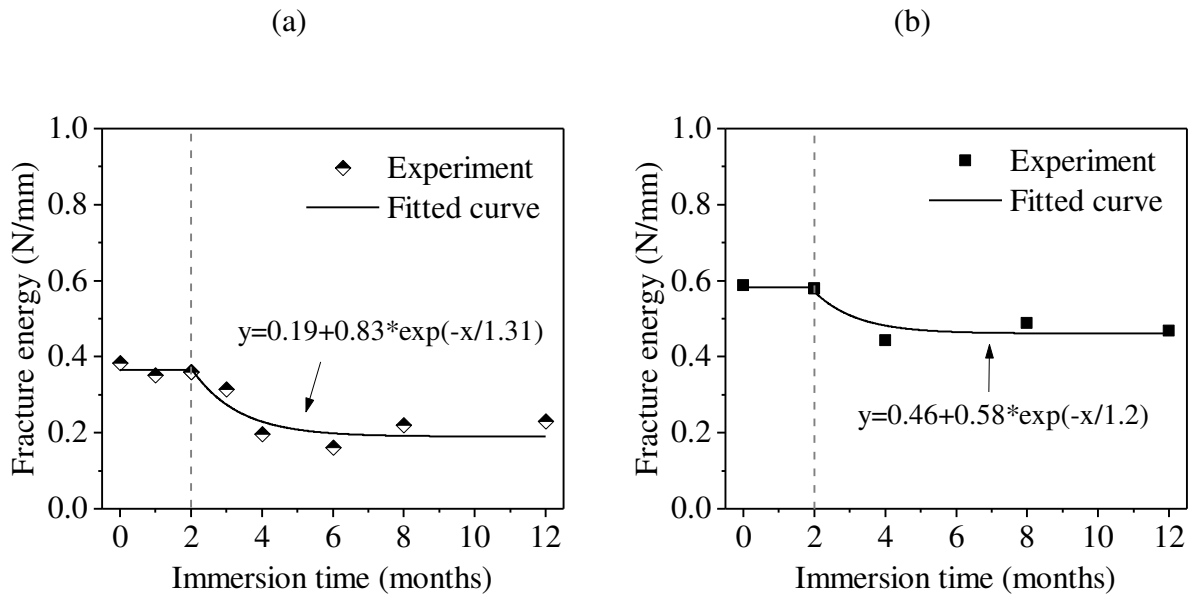
Fig 16. Bond fracture energy with immersion time in (a) ORG-specimens; (b) GR-specimens.

where  $P_{max}$  is the debonding force,  $b_f$  is the FRP width,  $E_f$  is the FRP elastic modulus, and  $t_f$  is the FRP thickness. The  $b_f$  and  $t_f$  are assumed to be constant during the tests. Having the variation of the debonding force and FRP's elastic modulus, the changes of the bond fracture energy with water immersion can be obtained, see Fig 16. It seems that the fracture energy has not changed during the first two months of immersion. Afterwards, the degradation has initiated following an exponential trend until reaching a residual strength (after around six months of immersion) with 49% and 25% of reduction in ORG- and GR-specimens, respectively. The observed trend is very similar to degradation of bonded joints attacked by interfacial degradation and epoxy plasticization [33,34]. An exponential degradation model is used here for simulating the changes in the bond fracture energy, the solid line in Fig 16, assuming that the degradation only starts after two months of immersion.
