Article

Monitoring Concrete Deterioration Due to Reinforcement Corrosion by Integrating Acoustic Emission and FBG Strain Measurements

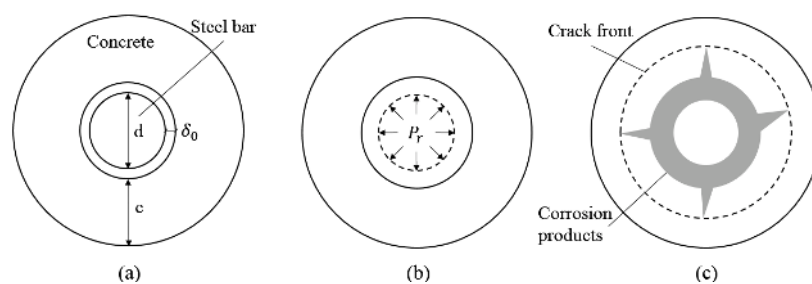
Figure 1. Schematic diagram of corrosion-induced concrete cracking process: (a) initial unrestrained reinforced concrete; (b) internal expansive pressure for concrete in restrained condition; (c) corrosion products deposited within open cracks.

According to the corrosion cracking model for reinforced concrete described by Zhao and Jin [29], the steel corrosion process can be divided into three stages, namely, the free expansion of the corrosion products, stress build-up in the concrete cover and the cracking of concrete cover. Figure 1a illustrates the initial unrestrained condition for a reinforced concrete cylinder with a steel bar of initial diameter d and a clear cover of thickness c . There exists a porous zone around the steel–concrete interface that has a mean thickness of δ_0 . Once the steel starts corroding, the corrosion products will expand freely until the porous zone is filled and then the uniform expansive pressure P_r begins to develop on the surrounding concrete wall. As the corrosion progresses further, the expansive pressure will induce tensile stresses and strains on the internal concrete wall, as shown in Figure 1b. In the meantime, the corrosion products will also be restrained and condensed by the surrounding concrete. When the hoop tensile stress at any part of an inner circumference exceeds the tensile strength of the concrete, the corrosion-induced cracks will occur firstly at the steel–concrete interface and then gradually expand towards the outer cover surface, as depicted by Figure 1c. The concrete cracking process due to reinforcement corrosion will be monitored by an acoustic emission technique, whereas the concrete expansion process will be measured by FBG strain sensor.

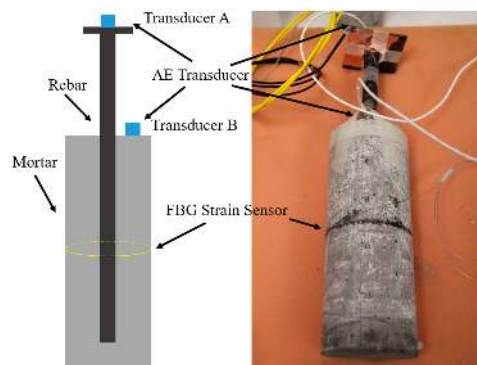
Figure 2. Reinforced mortar specimen and sensor installation.

The cylindrical reinforced mortar specimen was 80 mm in diameter and 200 mm in height, as shown in Figure 2. The cement used was ordinary Portland cement (OPC) and the cement, water, sand mix ratio was 1:0.5:2 by weight. One deformed rebar 16 mm in nominal diameter was embedded longitudinally into the center of the mortar cylinder. The rebar was 300 mm long with one end embedded approximately 20 mm away to the bottom of the mortar cylinder. A small steel plate was welded to the exposed end of rebar for the convenience of AE transducer installation. The mortar was removed from the PVC mold one day after being casted. It was cured in moist environment for seven days and dried in air for another 20 days under room temperature.

Two AE transducers were mounted on the specimen. One transducer was on the top of the steel plate, and the other was on the top surface of the mortar, as shown in Figure 2. The purpose of such an arrangement was to study the characteristic of AE signal propagating via different media. Lubricant grease was applied on the mounting surface before attaching AE transducers in order to ensure good contact for signal detection between transducer surface and specimen surface. The AE transducers were then mounted on the surface and tightened using adhesive tape. An FBG strain sensor (central wavelength: 1544.878 nm, strain coefficient: 1.15 pm/ $\mu\epsilon$) was circumferentially bonded around the mortar surface in the middle cross section, as depicted in Figure 2. The middle section was chosen in order to record a more uniform expansion. The FBG strain sensor was pre-stressed about 300 μm . A thin layer of epoxy (Epoxy GEL, Devcon, Danvers, MA, USA) of 17 MPa strength was then applied for sensor protection. To eliminate the influence of temperature variation, an FBG temperature sensor (central wavelength: 1549.335 nm, temperature coefficient: 10.3 pm/ $^{\circ}\text{C}$) was also connected in line with the strain sensor. The FBG temperature sensor was prepared by putting a bare FBG into a small stainless steel tube, followed by sealing both ends of the tube using epoxy, to ensure that the FBG is only sensitive to temperature variation.

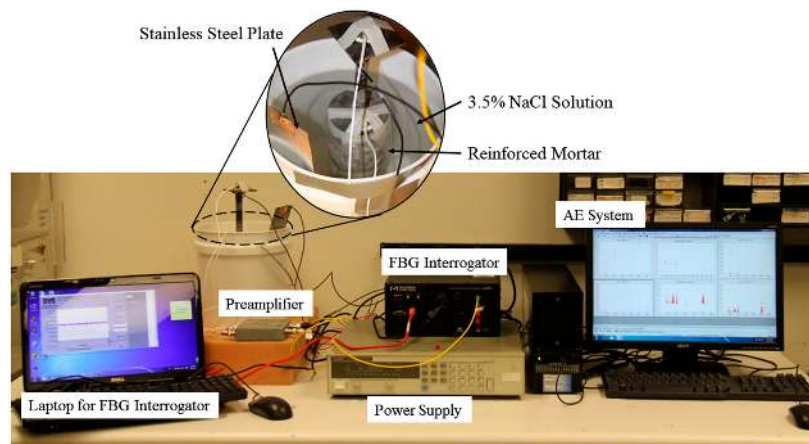
Figure 3. Reinforced mortar specimen and sensor installation.

The corrosion monitoring systems consists of two separate systems, namely, the AE corrosion monitoring system and the FBG strain monitoring system. The layout of these two systems are depicted in Figure 3. The AE instrumentation made up of AE transducers, preamplifiers and an AE system (Micro-II Digital AE System, Physical Acoustic Corp. (PAC), Princeton Junction, NJ, USA).

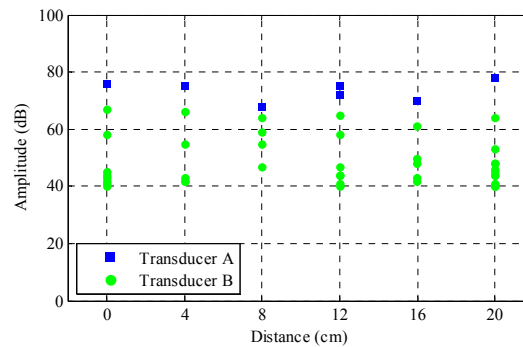
Figure 4. Amplitude from both transducers at different locations.

Attenuation of the generated acoustic emissions was considered as having a major influence on the sensitivity of the transducer and accuracy of the collected data. A pencil lead break test was used to produce similar AE events and check the sensitivity of each transducer. The signal amplitude received from both transducers during the pencil lead break test is shown in Figure 4. Each column in the

graph represents a different pencil lead breaking location starting from the top to the bottom of the specimen with increments of 40 mm. As can be seen, both transducers are quite sensitive to the AE source located at any place of the specimen, capable of reaching 60 dB in amplitude. Transducer A, which was mounted on the reinforcement, is more sensitive than Transducer B, which was attached to mortar. The difference of highest amplitude between the transducers is approximately 10 dB.

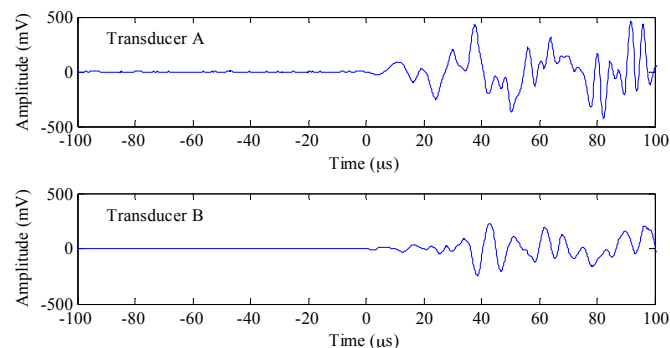
Figure 5. Waveforms from pencil lead break tests for both transducers.

Figure 5 shows the recorded waveforms corresponding to events of highest amplitude at the same testing location. The amplitude from Transducer A is much greater than that from Transducer B. The waveform that propagated through the mortar was more attenuated as compared to the one that propagated through the steel reinforcement, that is to say, the mortar provides greater damping effect on the acoustic signal than the steel reinforcement. The pencil lead break test confirms that attenuation of the AE signal transmitted in mortar is greater than that in reinforcement.

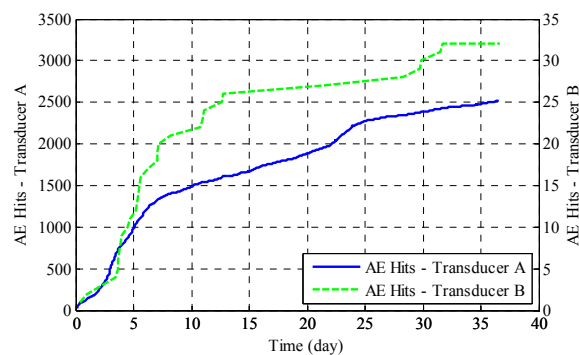
Figure 6. AE hits during the accelerated corrosion test.

AE hits from both transducers during accelerated corrosion of the reinforced mortar specimen are shown in Figure 6. The hits number measured by Transducer B is far less compared to Transducer A, indicating that the mortar attenuated the AE signal at a much greater rate than did the steel, much in the same way as in the earlier pencil-break tests. Since only an insignificant amount of AE events was captured by Transducer B (only 30 events), the interpretation from Transducer B will be very inaccurate. Thus, in the following analysis, we will focus our discussion on results obtained from Transducer A. The curves from Transducer A show a high similarity with the phenomenological model of reinforcement corrosion in marine environments [30]. The corrosion activity is strong in the early stage, followed by an evident decrease in the corrosion rate after around seven days. In this period, the flow of oxygen and water, which are essential to steel corrosion, is inhibited by the buildup of corrosion products, thus slowing down the corrosion process. The corrosion proceeded further after

22 days with the assistance of anaerobic corrosion until cracks were observed on the concrete surface on around the 36th day.

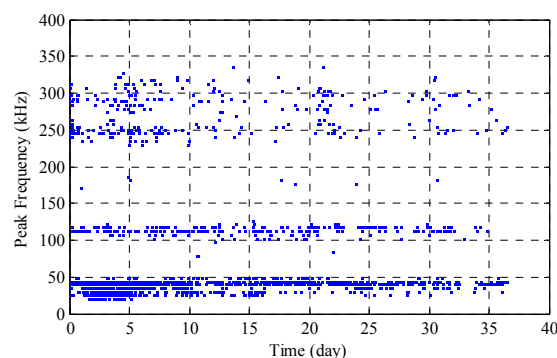
Figure 7. Peak frequency content from Transducer A.

Peak frequency is the frequency with the maximum magnitude as determined by a fast Fourier transform (FFT) of the time domain signal. The peak frequency can serve as a good indicator for different AE sources arising from reinforcement corrosion. Other indicators of frequency, like average or central frequency, share the same properties. Figure 7 shows the peak frequency corresponding to each hits from Transducer A. It can be seen that the population can be divided into three major parts: one below 50 kHz (denoted as Type I), one around 110 kHz (denoted as Type II) and another part with peak frequency higher than 240 kHz (denoted as Type III). Specifically, the majority (75%) of the hits exhibit peak frequency lower than 50 kHz, while 11% are around 100 kHz and 14% are scattered in the highest band above 200 kHz. These three types of frequency bands are in close relation to different AE sources due to reinforcement corrosion. Mazille and Rothea [31] stated that bubble evolution in the liquid medium gave low frequency AE signals (~50 kHz); therefore, Type I can be attributed to the evolution of hydrogen bubbles from electrochemical reaction between anode and cathode. As suggested by Yoon's work [32], AE signals from micro-cracking and macro-cracking are of short duration and of relatively high frequency (180 kHz to 350 kHz), and the AE signals associated with debonding are of longer duration and their frequencies peak at 120 kHz. Li et al. [17] concluded that the peak frequencies for a typical concrete crack signal were high frequencies, ranging from 275 kHz to 350 kHz. It is reasonable to state that Type II appears to correspond to the generation and movement of corrosion products and reinforcement/mortar interface debonding while Type III peak frequencies comes from micro-crack development and crack propagation. All of these three types of peak frequencies occurred for the whole span of the corrosion test. Therefore, in our case, we can surmise that the process of final mortar cover cracking is an accumulative process, which is comprised of a large amount of micro-cracking events before final cover cracking occurs. Figure 8 presents typical waveforms of these three types and their corresponding fast Fourier transform (FFT).

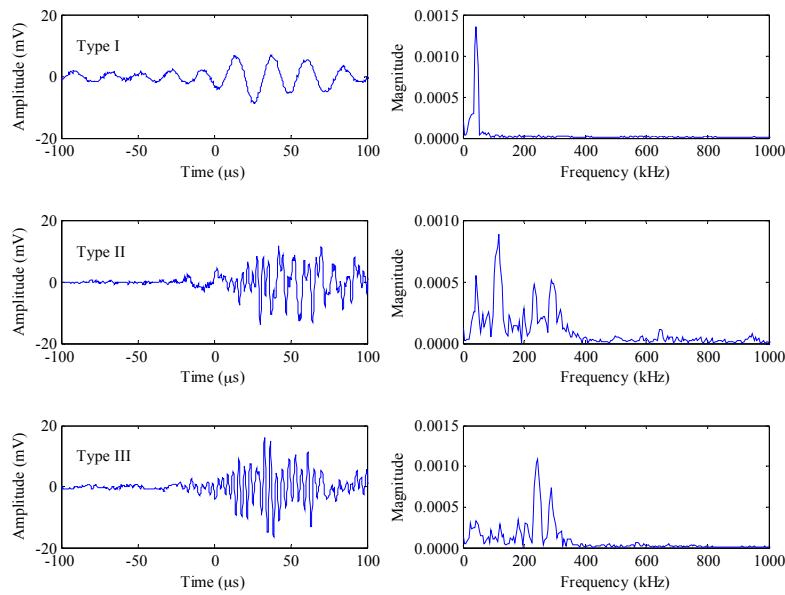
Figure 8. Typical waveforms of different types and their fast Fourier transform (FFT).

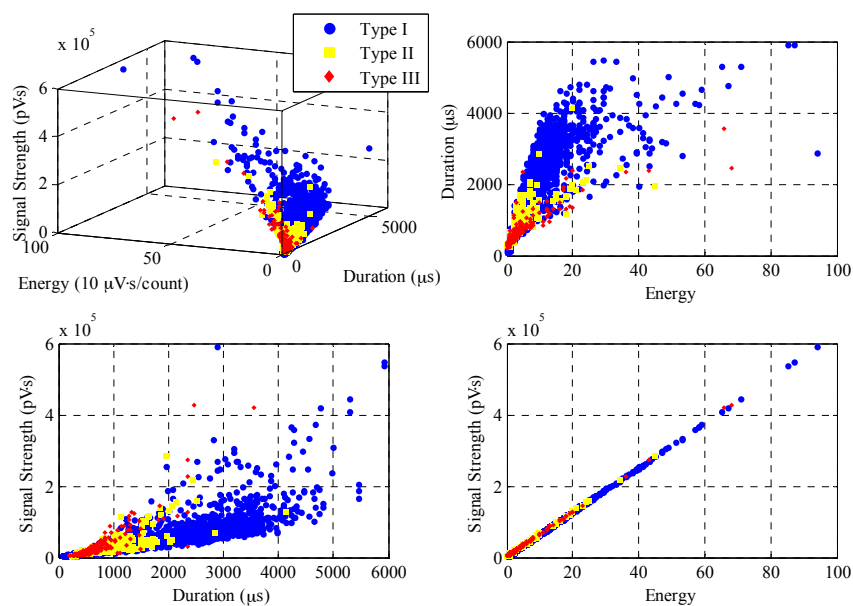
Figure 9. 3D cross-plot of duration, energy and signal strength and its perspective plots.

The cross-plot is an effective technique to analyze the features of an entire AE signal for the purpose of distinguishing signal characteristics. Figure 9 shows the results of a 3D cross-plot of duration, energy and signal strength of AE signals obtained from Transducer A. The circles represent AE events from Type I and squares indicate AE events from Type II, whereas diamonds are those from Type III. Duration is defined as the time from the first threshold crossing to the end of the last threshold crossing of the AE signal. Energy is defined as the integral of the rectified voltage signal over the duration of the AE hit. Signal strength is defined as the measured area under the amplitude time envelope. It can be noted that Type I AE events are spread over the plot, characterized by long duration, high energy and strong signal strength and Type II AE events feature shorter duration, lower energy and weaker signal strength, whereas Type III AE events are more tightly clustered and have the smallest value of the three parameters above. Overall, these three types of AE events, due to reinforcement corrosion, can be easily recognized.

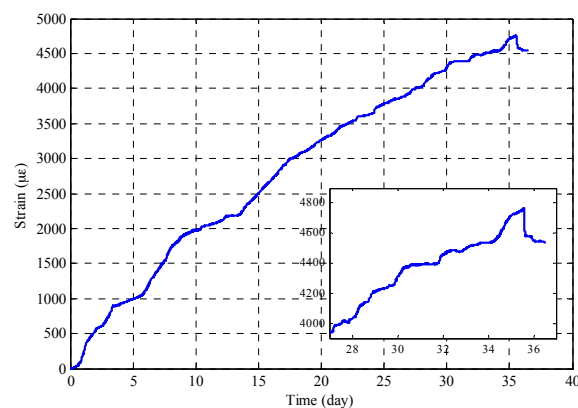
Figure 10. Strain history from FBG strain measurement.

The circumferential strain variation of the reinforced mortar was measured using an FBG strain sensor. Measurement commenced the moment that the current was applied all the way to when the specimen cracked. The strain data over the time span of about 36 days is shown in Figure 10. The original wavelength variation was converted to strain variation by adopting a strain sensitivity coefficient of $1.15 \text{ pm}/\mu\epsilon$, which was calibrated beforehand. As can be seen, the strain increased with time as the corrosion products accumulated and exerted internal pressure on the mortar. The strain grew approximately $1000 \mu\epsilon$ every five days, and slowed down to about $500 \mu\epsilon$ every five days in the later period. The change in the strain rate can be attributed to the formation of cracks, which provides new space for corrosion products. The corrosion products fills the crack before building up stress on the mortar when cracks were generated. Notice that, after 24 days, the strain curve exhibited a jagged variation that results from the redistribution of the corrosion products into the widening cracks as the crack front propagates further into the cover. This period can be identified as the crack propagation stage. The embedded plot partially shows an enlarged view of the jagged curve. The crack reached the outer surface on around the 36th day and was marked by a sudden drop in strain reading. After many days of internal pressure buildup from the accumulation of corrosion products, the whole mortar cylinder has become stressed. When the pressure in the mortar surface exceeds its tensile strength, surface cracking occurs and the pressure on the mortar surface suddenly releases, resulting in a drop in stress or strain on the surface. It is noteworthy that surface microcracking occurred throughout all of the stages as long as the stress exceeds the tensile strength of the concrete. As reinforcement corrosion continued, microcracks developed into macrocracks. The macrocrack, which had a width of 1.391 mm , is shown in Figure 11. The crack width estimated from strain measurement was 1.141 mm ($4540 \mu\epsilon \times \pi D$), which shows good agreement with results from direct measurement.

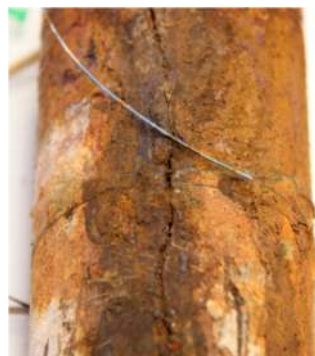
Figure 11. Illustration of cracking of the specimen.

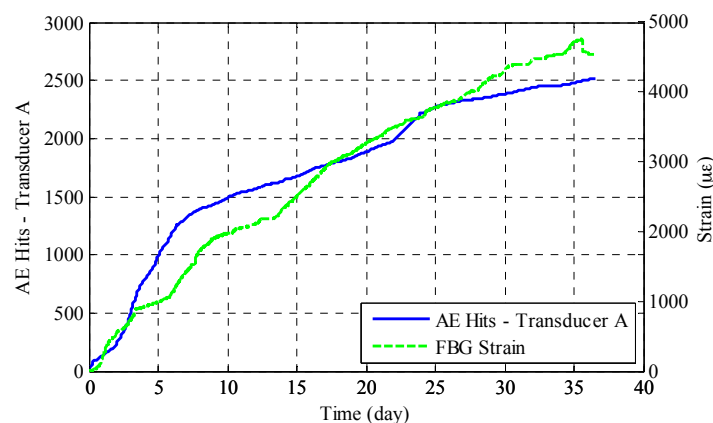
Figure 12. Simultaneous evaluation of acoustic emission activity and strain measurement.

Figure 12 is a plot that shows both acoustic emission hits and FBG strain measurement. These two different corrosion monitoring methods interpret the phenomenon of reinforcement corrosion from two different aspects; one is from acoustic emission aspects and the other is from expansive strain development aspects. As can be seen, the AE hits and FBG strain show a similar trend and confirm that the level of acoustic emission activity and the development of surface strain generally had a positive correlation as the corrosion of the reinforced concrete progressed. This agreement is qualitative, and, for a more detailed understanding and analysis of the AE signals, the adoption of advanced signal processing techniques and pattern recognition algorithms would be helpful.
