Morphological changes due to marine aggregate extraction for beach nourishment in the German Bight (SE North Sea)

F. Mielck¹ · H. C. Hass¹ · R. Michaelis¹ · L. Sander¹ · S. Papenmeier¹ · K. H. Wiltshire¹

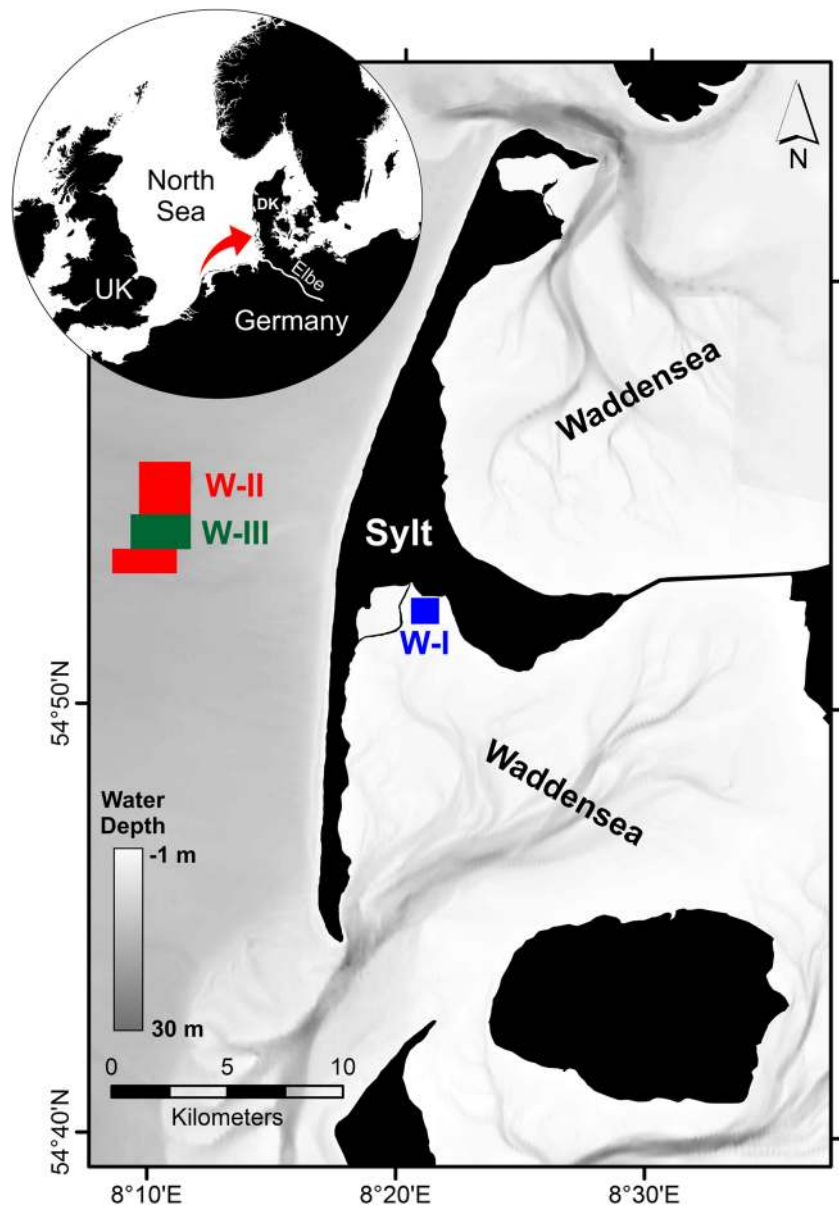
Fig. 1 Research area WDA consisting of Westerland II (W-II) and Westerland III (W-III) located west of the barrier island of Sylt as well as the abandoned dredging site Westerland I (W-I). Depth values are indicated in meters below MSL (mean sea level), according to the Federal Maritime and Hydrographic Agency, Germany, and own singlebeam measurements from 2008/2009

The investigation site for this study comprises the largest dredging areas in the German Bight, known as *Westerland Dredging Area* (WDA). It is located approximately 7 km west of Sylt and includes recent dredging zones (W-III) and previously exploited sand deposits (W-II), as well as untouched seafloor. With a length of approximately 5 km in north-south direction and a maximal width of 2.8 km, it has a size of approximately 10 km² (Fig. 1). Water depths range between 14 and 34 m.

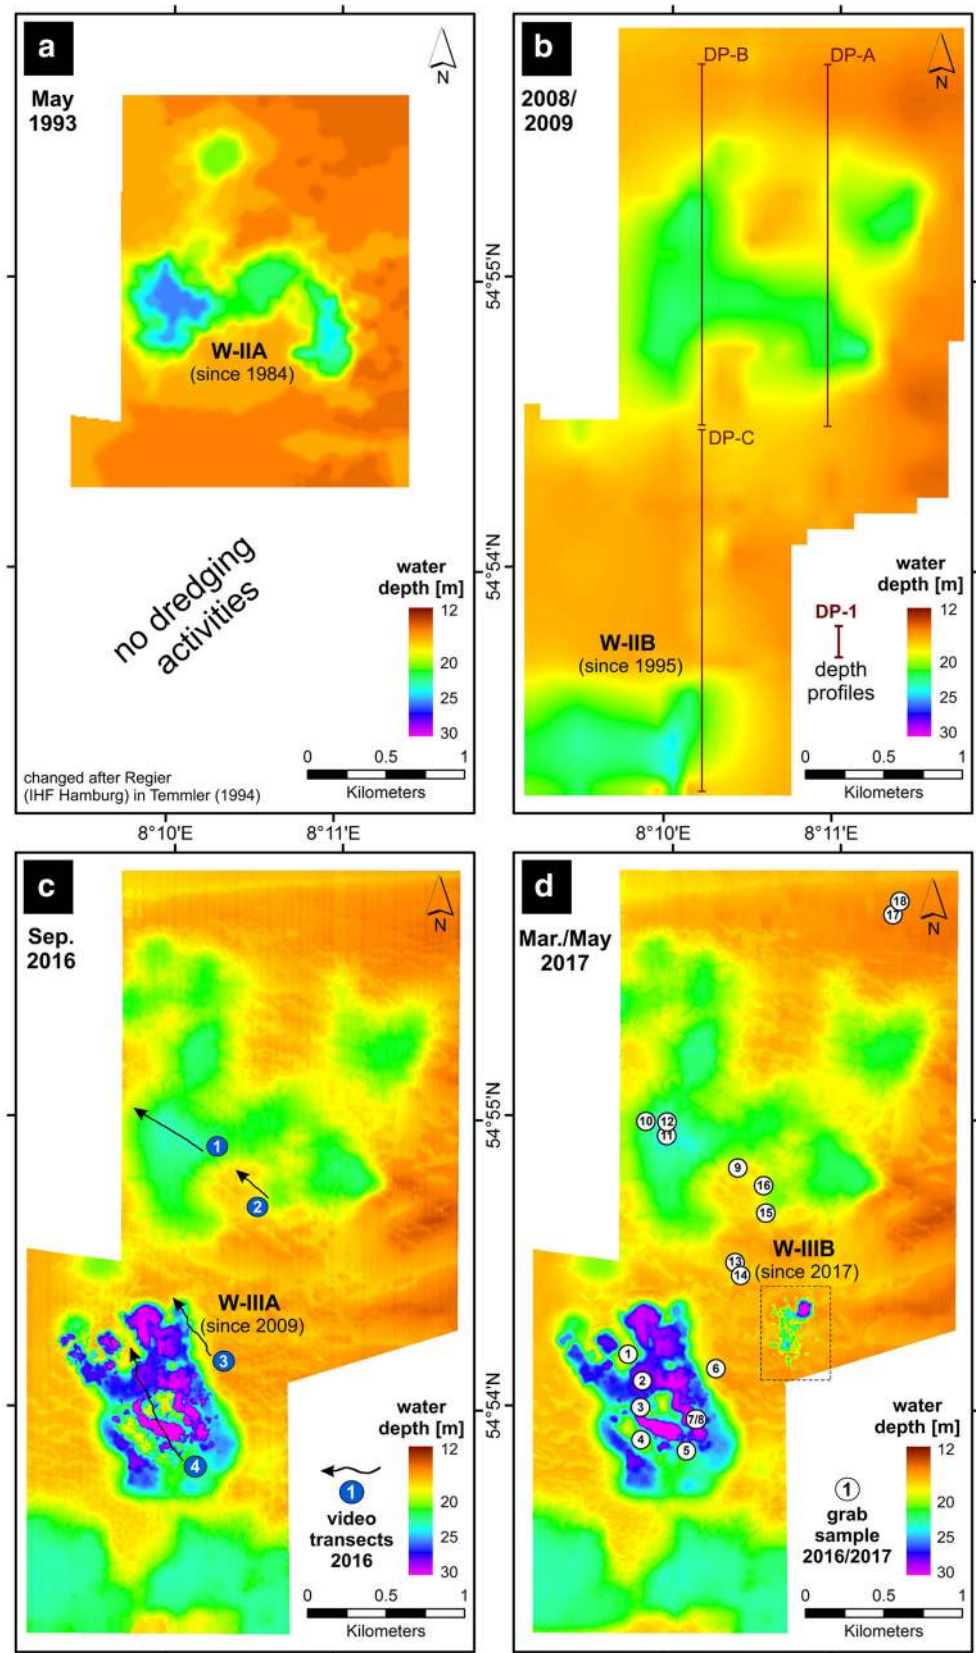
Fig. 2 Bathymetric maps of the study area W-II and W-III from **a** the year 1993 (modified after IHF Hamburg), **b** 2008/2009, including position of the bathymetric profiles **c** 2016, and **d** 2017. Video transects and grab sample stations are shown in **c** and **d**. The year beneath the name of the dredging area indicates the start of the dredging activities in the respective areas

Between 1984 and 1995, the dredging activities were concentrated on the northern part of the study area (*W-IIA*, Fig. 2a). Here, singlebeam data were collected in May 1993 (Temmler 1994). The measurements show that the dredging pits have a depth of approximately 12 m below the seafloor and are located in a water depth of 25.5 m. In 1995, the extraction area was expanded to the south (*W-IIB*, Fig. 2b). The post-dredging pits in *W-IIA* show depths of 23 m, while in 2008, the maximum water depth in *W-IIB* is ~ 24.5 m. At this point of time, the excavation work was almost completed in these areas (with few exceptions at the edges in the north of *W-IIA* and in the southeast of *W-IIB*), because sufficient material was no longer available. Since 2009, the dredging operation mainly focused on *W-III*A.

Figure 2c illustrates the results of the multibeam measurements recorded after the dredging season in September 2016. This bathymetric map shows the full extent of *W-III*A consisting of deep pits and furrows with maximum water depth of 33 m. The coastal authorities stopped the extraction of sand in this area in September 2016, because of the exhaustion of the sand resource at this place (LKN-SH 2017). In spring 2017, new excavation work had already started a few weeks before the following multibeam survey took place in May 2017. The position and extent of the new site called *W-III*B is indicated in Fig. 2d. Here, the deepest pits have a water depth of ~ 34 m. The progression of sand removal/depletion is highlighted through the changes in bathymetry. Since natural backfill processes make it difficult to calculate the exact amount of withdrawn material, accurate data from the coastal authority were used (see Table 2).

Excavation marks dredged in 2016 (Fig. 2c) became smoother in 2017 (Fig. 2d). Steep slopes caused by the dredging process reveal a loss of sediment (Fig. 3) likely due to slope failure. This was also concluded based on the underwater videos and the cross sections (Fig. 5g and Fig. 4c). The material from the slopes seems to have backfilled sections of the ~12-m-deep dredging pits up to 5 m in less than 7 months. Such relatively quick backfillings were also observed by Temmler (1994) and Zeiler et al. (2004) based on comparative investigations.

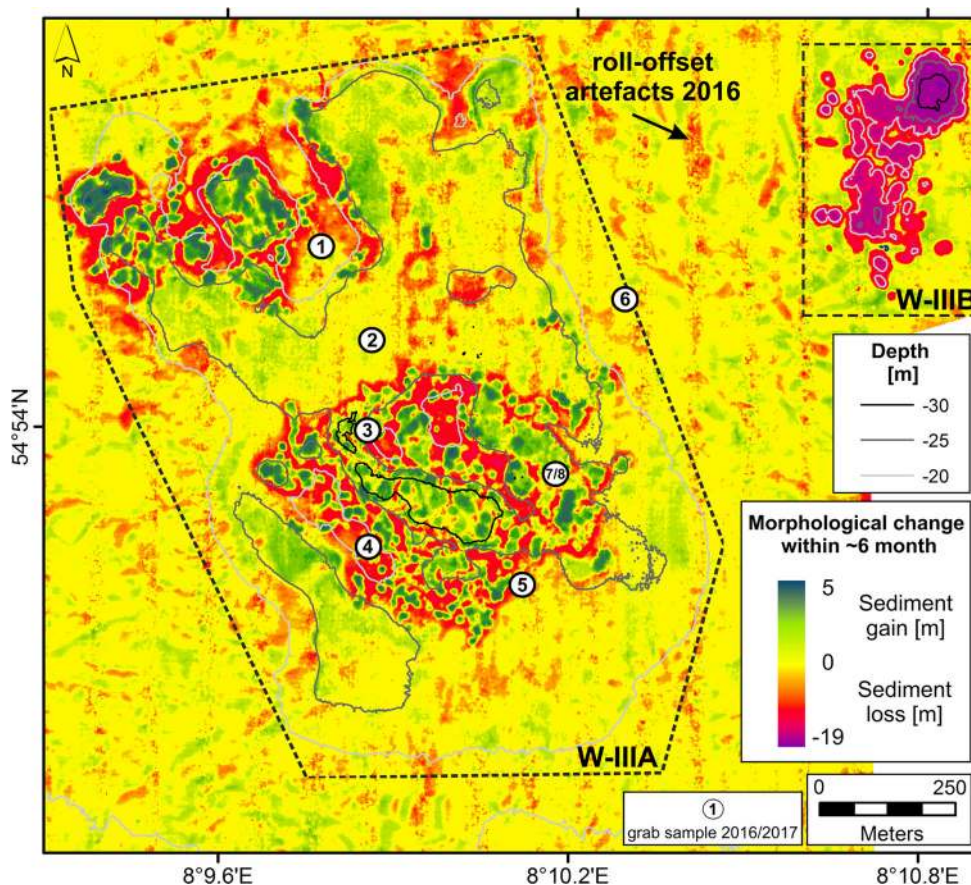
Fig. 3 Short-term morphological change in the seabed. Differences between September 2016 and spring 2017

By comparing the two bathymetric maps from 2016 and 2017 (Fig. 2c and d), the short-term changes within *W-III* become visible (Fig. 3). Within the yellow areas, no bathymetric change could be detected. The figure shows that in *W-III*B, ~ 19 -m deep pits (this corresponds to a water depth of ~ 33 m) were dredged within 6 weeks of continuous extraction in

Weak vertical red stripes visible in Fig. 3 are artifacts produced by roll-offset errors along the track lines during the

survey in 2016 (cf. Schmitt et al. 2008). If any, these have only minor influence on the calculations presented in this figure. They mainly appeared in the nadir of the multibeam swath and could not be filtered out afterwards.

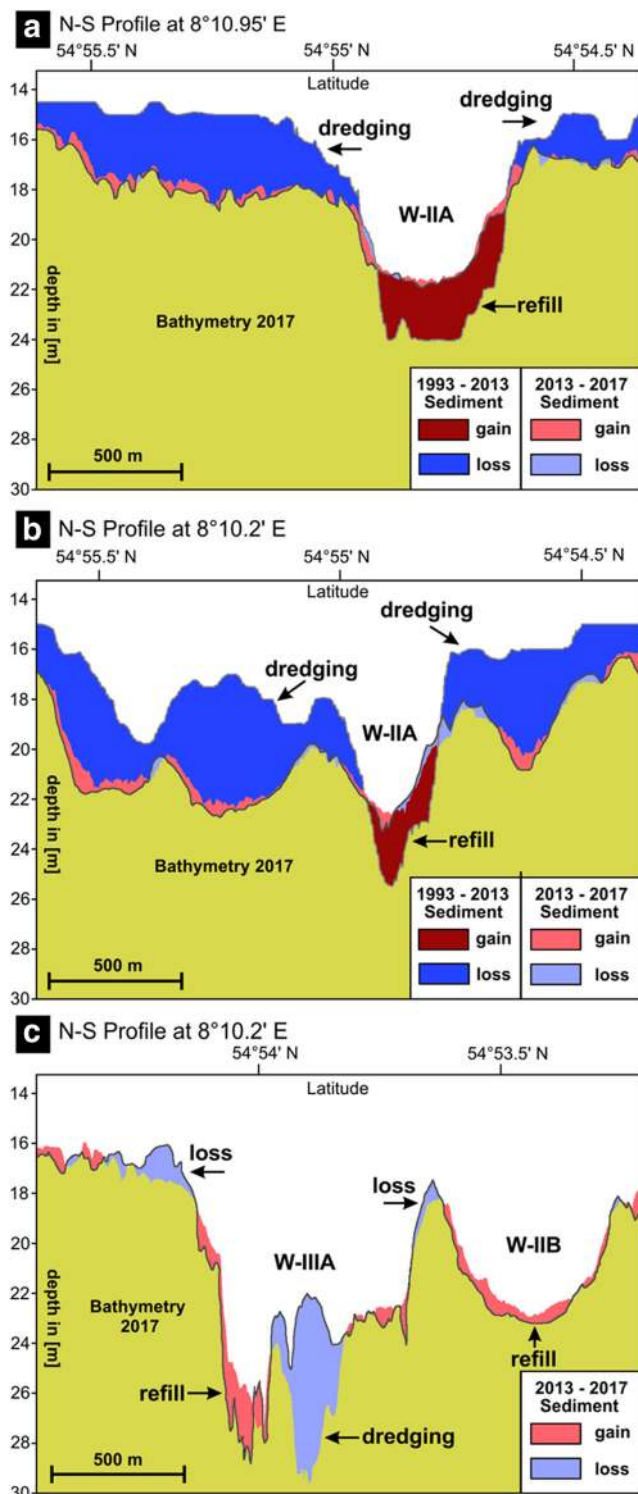
Fig. 4 Comparison of three vertical bathymetric profiles (a–c) of the years 1993, 2013, and 2017. The location of the profiles is shown in Fig. 2b

In order to assess the amount of sediment loss and gain over a longer period, the bathymetric data from 2017 were compared with soundings from the years 1993 and 2013. Figure 4 shows three bathymetric profiles that cross the study area in north-south direction (positions are illustrated in Fig. 2b). A comparison between the cross sections from the years 1993, 2013, and 2017 shows a strong sediment loss in the surrounding of W-IIA from up to 5 m (Fig. 4a and b) as well as approximately 8 m in the area of W-IIIa (Fig. 4c) due to dredging activities in the last decades. Minor sediment losses are also detectable at the rims of the fresh dredging holes (Fig. 4c). Within the pits, sediment gains are

observable: ~3 m between 1993 and 2017 in W-IIA, ~0.5 m between 2013 and 2017 in W-IIB.

When comparing the bathymetries of 2013 and 2017 (Fig. 4), the backfill rate appears to have strongly decreased and even ceased at the older dredging pits. Backfillings of only ~0.5 m were detected. Such decreasing backfill-rates were also observed by Zeiler et al. (2004).

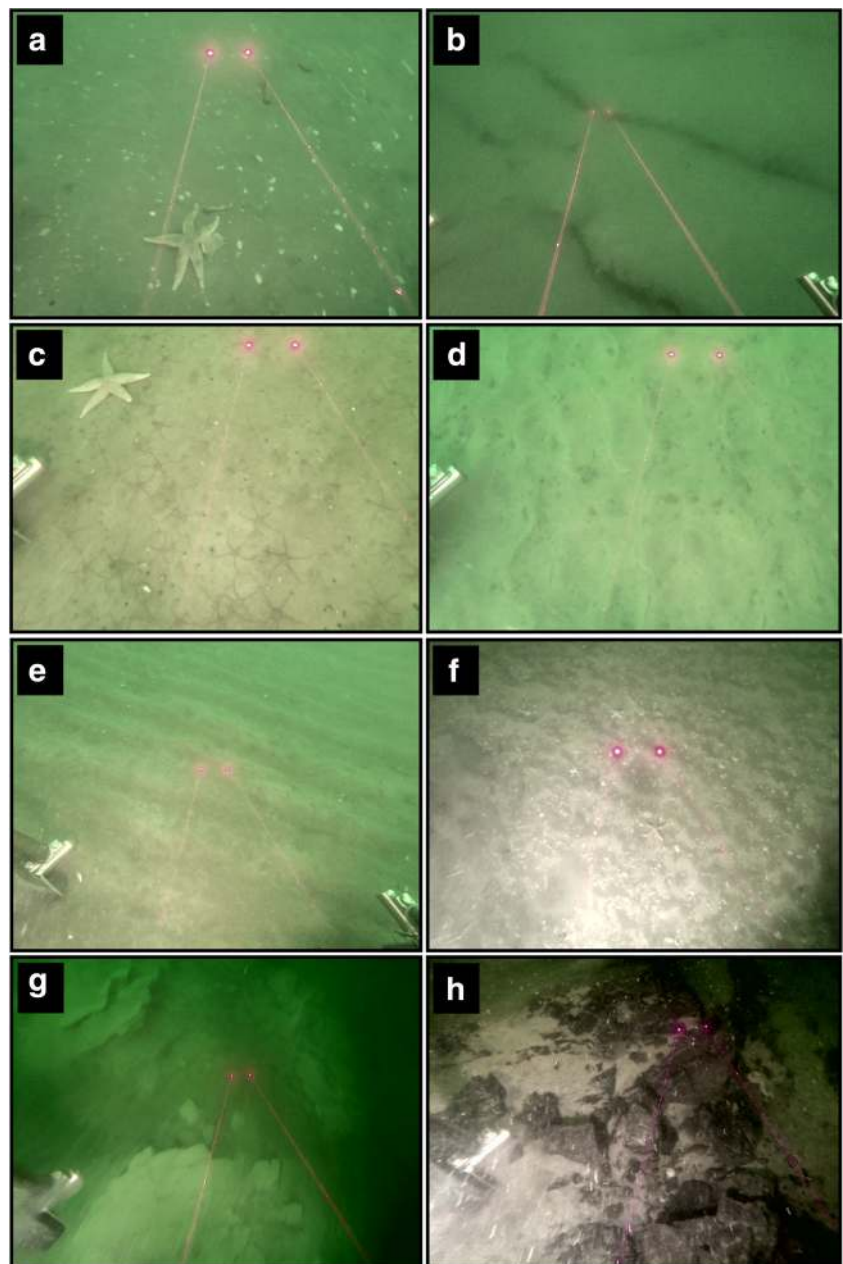
Fig. 5 Snapshots of relevant underwater features (**a, c** muddy seafloor; **b** mass movements; **d, e** bedforms; **f** mixed fine sediments; **g** fresh dredging pit; **h** stones). Distance of 10 cm between laser points serve for size comparison

For a more precise insight on the seafloor character, four underwater video transects were surveyed (for positions see Fig. 2c). The first transect run through *W-IIA*. The recordings show muddy material with occasionally shell fragments (Fig. 5a). In the deeper parts, stones and shell fragments are very rare. Here, the videos allow to identify evidences of mass movements perpendicular to the slopes of the pits (Fig. 5b).

Video Transect no. 2 leads from *W-IIA* on a slight slope into shallower water. The deeper part shows a relatively homogenous seafloor with many brittle stars (*Amphiura filiformis*) settling on a flat muddy seafloor (Fig. 5c). In the northwest, the seafloor characteristics changes upslope to more sandy material that displays small bedforms with crest distances of ~10 cm (Fig. 5d).

Video Transect no. 3 started at the edge of *W-III A* and leads along the slope across an approximately 10-m-deep dredging pit (corresponding to a water depth of ~25 m). In the shallower part, long-crested ripples consisting of sand are observable (Fig. 5e). In the deeper parts of *W-III A*, a mix of fine dark and bright sediments becomes apparent (Fig. 5f). The bright sediment seems to form small flat bedforms, while the darker material fills the troughs of the ripples. The amount of dark sediment increases with increasing water depths.

The last video survey (Transect no. 4) runs along a transect crossing a fresh dredging mark in *W-III A*. Here, the last sand extraction was carried out by a suction hopper dredger only a few days prior to our investigation. At the edge of the fresh dredging pit, irregular sediment structures (Fig. 5g) and piles of stones were recorded (Fig. 5h). In the deepest part with a water depth of 33 m, a similar sediment mixture as presented in Fig. 5f was identified.
