Noise and vibration on the bogie of a mass rapid train[†]

Abstract

Keywords: Noise and vibration; Slewing ring bearing; Bogie noise and vibration; Dynamic simulation; Friction induced vibration; Design of experiments

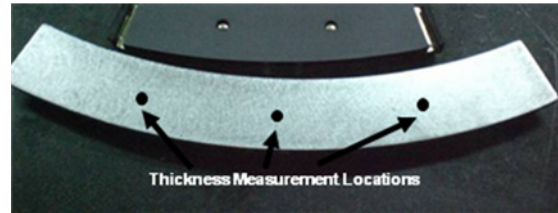
Fig. 12. Locations of rubbing plate thickness measured.

The thickness was measured at three locations, as shown in Fig. 12. The nominal thickness of the rubbing plate was 8 mm.

For factors 4 and 7, the uneven distributed thicknesses of the friction blocks and rubbing plates caused uneven contact forces between them. The uneven contact condition became more severe when the un-uniformity of thickness was larger.

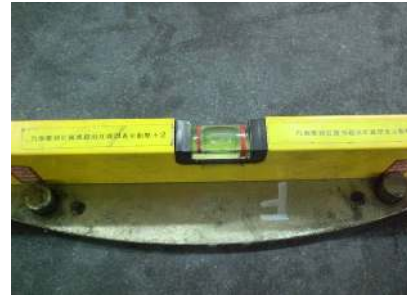
Fig. 13. Warping/deformation check for rubbing plates.

The check was done on a level check table, as shown in Fig. 13.

For factor 8, the warping/deformation of the rubbing plate affected the contact condition between the rubbing plate and friction block. As the warping of the plate increased, the noise and vibration got more sever. If the warping was bigger than 1 mm, the part was suggested to be replaced. However, for factor 5, due to the high flexibility of the friction block, the warp-

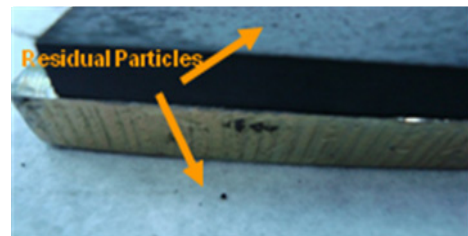
Fig. 15. Residual particles and films.

Residual particles and films between the friction block and rubbing plate were checked, as shown in Fig. 15.

For factor 10, the residual particles and films were always found unevenly distributed between the friction block and rubbing plate after several running cycles. The existence of uneven distributed residual particles and films caused un-uniform friction forces between the friction blocks and rubbing plates and led to noise and vibration. If the turning continuously repeated back and forth, the film would get thicker. Because of the friction, the temperature of the contact surfaces got higher, and the film made the friction block and rubbing plate sticky to each other. The residual film was examined. The average value of the dynamic friction coefficient was 0.54. From the friction test, it was noticed that the residual film caused the adhesion between the rubbing plates and the friction blocks when the contact surfaces were rubbed up to the temperature above 150°C. Since the length of the friction block is smaller than that of the rubbing plate, the temperature was measured at the two ends of the rubbing plate contact surface, as shown in Fig. 16. While the friction block moved toward one end of the rubbing plate, the other end of the rubbing plate surface was open up for temperature measurement.

Regular maintenance checks were performed to check the residual particles. The residual particles would be blown off to keep the cleanness of the contact surfaces. Parts with uneven film would be re-processed.

The factors 1, 2, 4, 7, and 8 could be well maintained during the regular maintenance. However, for the 10th factor, the residual particles and films could be formed prior the regular maintenance. For a better result, preventing the particles or films from forming should be the long term solution. Therefore, the following section utilized a dynamic simulation to analyze the behavior caused by factor 10. It predicted the residual particles and films led un-uniform friction forces and sticky condition between friction blocks and rubbing plates.

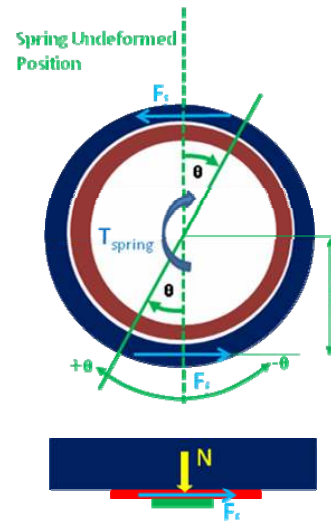
Fig. 18. Free-body diagram.

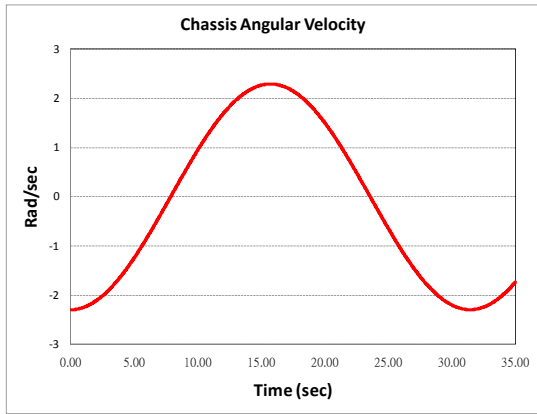
A relative rotation motion between the wheels and train body was applied to simulate the wheel turning. Assume the train started with counter-clockwise turn. The wheel had the angular displacement of amplitude of 0.2 and frequency of 0.0318 Hz, $\theta = -0.2 \sin(1/5)t$, where t was time in second. The wheel angular velocity was shown in Fig. 22.

Fig. 22. Angular velocity between wheels and train body.

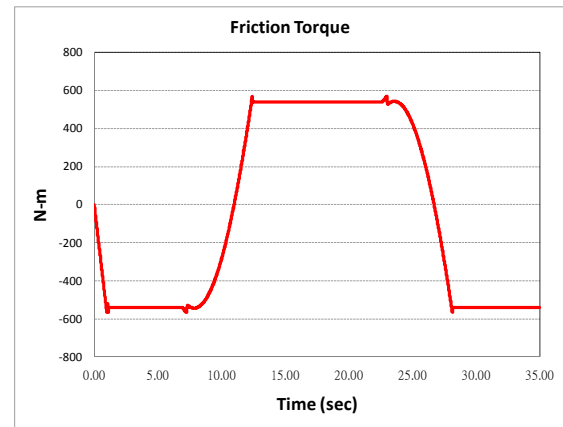
Fig. 25. Friction torque between inner and outer rings (ceramic friction material).

vibration. The average value of its kinetic friction coefficient was around 0.4, even the temperature of the contact surfaces became high due to repeated surface rubbing. The normal contact forces between the rubbing plates and friction blocks were adjusted to maintain the same resistance torque as before. A dynamic simulation was performed with the same setting and wheel angular displacement, but a static friction coefficient of 0.42, and the kinetic of 0.4. The analysis results were shown in Figs. 25-26. Fig. 25 showed no oscillation in the friction torque curve. The positive and negative friction torques were due to the rotation direction changes while wheel turned left and right. Fig. 26 showed the relative angular velocity between the inner and the outer rings. The relative angular velocity remained small all the time except several peaks. The first peak was to overcome the static friction force from rest. The peak around 7.8 sec and the one next to it were due to wheels turning from left to right and its torque build-up. Similarly to the peak around 23.6 sec and the one next to it, this time was due to the wheels turned to left. All the peaks had values less than 11 rad/sec, and were much smaller than the original friction block with peak of 150 rad/sec in Fig. 23. This new proposed friction block material would not expect to have a similar friction induced noise and vibration.

Regular maintenance was used to check the residual particles or films. Different types of material for the friction blocks were investigated. A ceramic compound matrix with copper fiber was identified as a potential substitute for the original neoprene rubber. The ceramic compound had stable and predictable friction characteristic. It's commonly used in brake systems. It provided stable braking performance without generating sticky residual films. The material itself also had damping features that would help in diminish some noise and

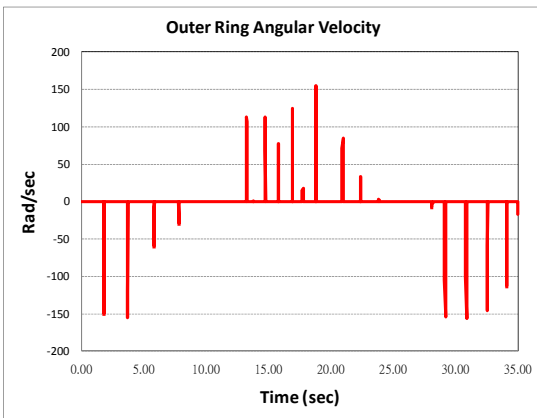
The outer and inner rings were together at the beginning of the wheel turning since the spring torque was smaller than the static friction torque. While the turning went further, the driving spring torque increased and eventually became higher than the static friction torque. And the outer ring abruptly slipped

Fig. 23. Relative angular velocity between inner and outer rings.

and rotated relative to the inner ring. After the spring energy was quickly released and dissipated by the friction force, the outer ring stopped rotating relative to the inner ring. And this motion repeated through the whole wheel turning process, and led several large relative angular velocity impulses as shown in Fig. 23. The highest one could go up to more than 150 rad/sec. This periodic stop-and-go motion could cause

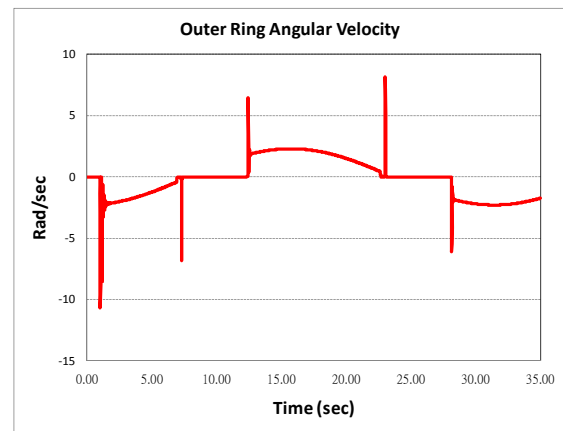
Fig. 26. Angular velocity between inner and outer rings (ceramic friction material).

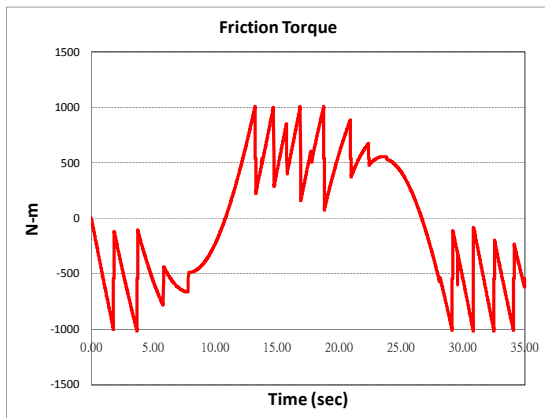
Fig. 24. Friction torque between inner and outer rings.

vibration and noise at the outer ring and the parts connected to it. The fluctuation of friction torque between the inner and the outer rings could be seen through the whole wheel turning process as shown in Fig. 24. It's in sync with each velocity change and the stop-and-go motion. The phenomenon confirmed the initial investigation that the vibration/noise came from the slewing bearing system. It happened when the friction set was heated-up after a period of running hours. The residual particles and films were the side products of the friction set from repeated rubbing. They created adhesion, high stickiness and caused un-uniform friction forces and torques during the turning motion.
