Observations on the Mechanisms of Fatigue in Eutectic Pb-Sn Solder Joints

D. Tribula, D. Grivas, D.R. Frear,
and J.W. Morris, Jr.

August 1988

LBL-25831

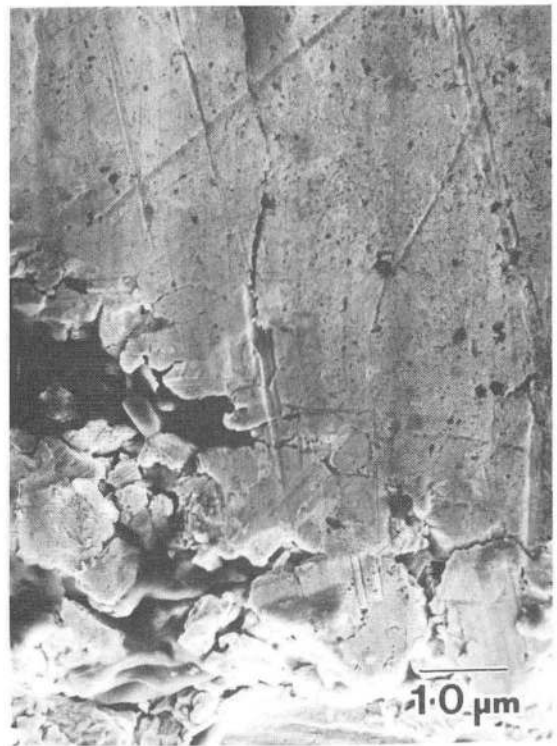
Figure 6

6. Optical micrograph of a coarsened band showing the coarse grain structure and intergranular fracture between Sn-rich grains.
7. Sample configuration used for isothermal creep experiments. Due to the slot configuration cut in in sample, when the sample is pulled in tension the solder regions between the slots are strained in nearly simple shear.

to form a growing thermal fatigue crack. The cracking mechanism, which is illustrated in Figure 6, involves the intergranular fracture of Sn-rich grains followed by the gradual failure of the intermediate Pb-rich material.

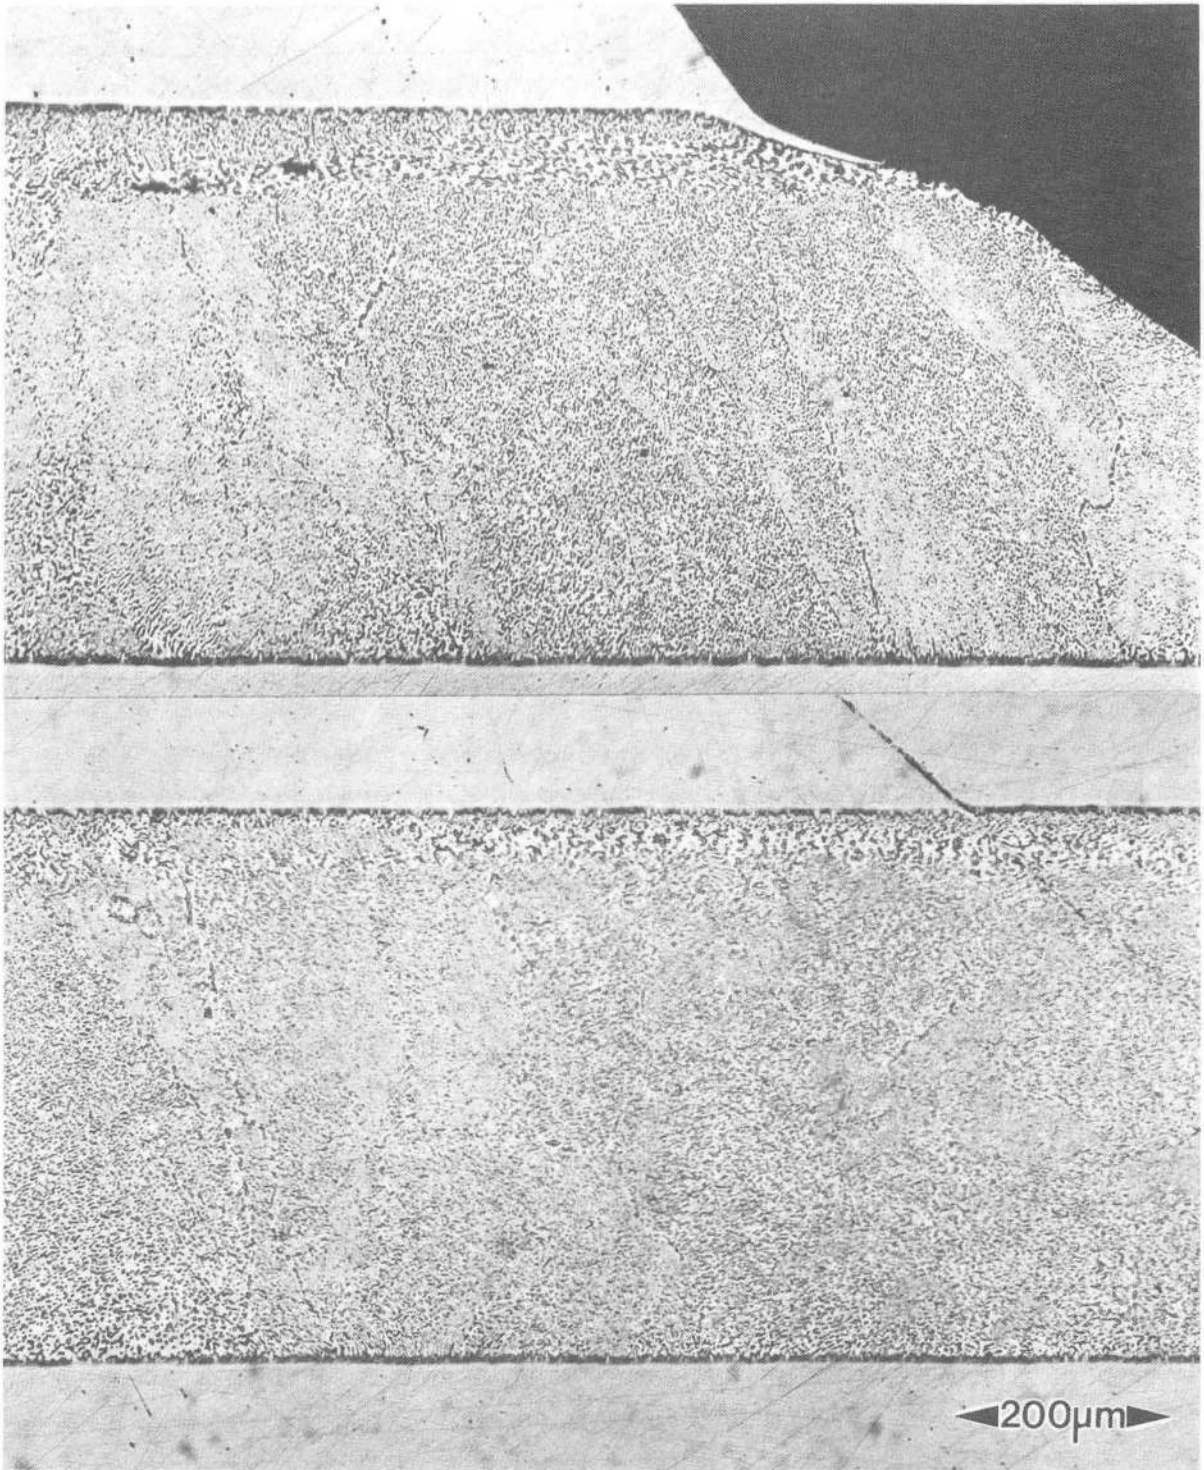
Figure 11

11. a. Optical micrograph showing initiation of the coarsened band at a free surface. b. The same coarsened band propagates along the length of the joint terminating within the solder.

In all cases the parallel deformation band originates at one side of the lateral surface of the solder joint. Finite element analyses [13] suggest that the point of origin is near the principal stress concentration point in the sample. The coarsened band that leads to fracture in the sample is always coincident with the parallel deformation band described above, and forms first at the terminus of the deformation band at the free surface, Figure 11a. It then slowly grows along the deformation band into the sample. Figure 11b, for example, shows the partly developed coarsened band of Figure 11a that terminates in the solder.
