Open Guided Waves: online platform for ultrasonic guided wave measurements

Structural Health Monitoring
2019, Vol. 18(5-6) 1903–1914
© The Author(s) 2018
Article reuse guidelines:
sagepub.com/journals-permissions
DOI: 10.1177/1475921718817169
journals.sagepub.com/home/shm

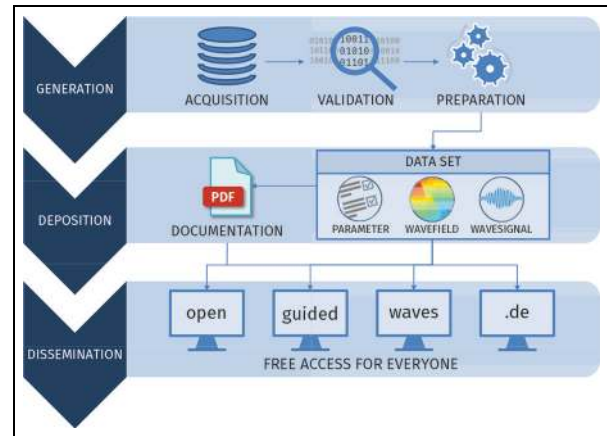
Figure 1. Workflow illustrating data generation, deposition, and dissemination.

The underlying idea of the proposed OGW platform is shown in Figure 1 which illustrates the whole process from data acquisition to its distribution. A first test structure, described in section “Description and characterization of the test structures,” is given by carbon-fiber-reinforced polymer (CFRP) plates with clearly defined geometry and embedded piezoelectric transducers. To characterize the baseline state, ultrasound and X-ray testing were performed. Material properties in the form of stiffness tensor and sample density were measured, validated, and compared with theoretical predictions. A discussion of the reversible damage model used in this work is presented in section “Relevance of reference damage.” Next, section “Guided wave measurements part I: 3D acoustic wave field measurements” describes the acoustic wave field measurements by a three-dimensional (3D) scanning laser Doppler vibrometer characterizing guided wave propagation in the structure for a broad range of frequencies. This dataset will be helpful in the verification of numerical methods simulating wave propagation in

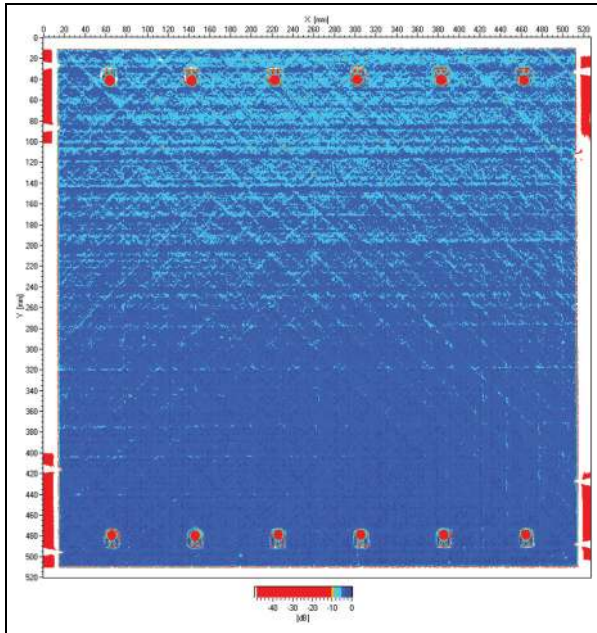
Figure 3. Backwall echo of ultrasonic NDT of the “SHM plate” with 12 co-bonded piezoelectric transducers.

Figure 3 depicts the amplitude of the backwall echo in decibels for the “SHM plate.” The specimen has been evaluated for damage following the 6-dB method described in Schnars and Henrich²⁹ and Brandt and

Maaß.³⁰ In that technique, a composite laminate is considered damage-free if the backwall echo does not drop 6 dB or more in comparison with a defect-free area within the same material, thickness, and stacking sequence. The amplitude of the backwall echo in Figure 3 remains between -4 and -10 dB, indicating the pristine state of the specimen.

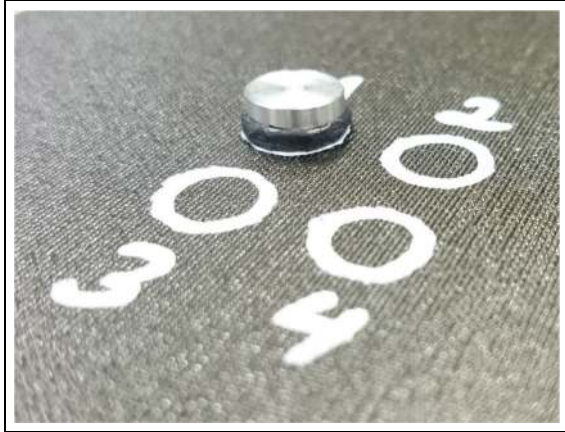
Figure 7. Photograph of the reversible damage model in the form of an aluminum disk with a diameter of 10 mm coupled to the structure by tacky tape. White circles indicate four closely spaced damage positions (cf. Figure 12).

In this work, we employ a reversible defect model where an aluminum disk is mounted on the surface of the CFRP plate by a tacky tape as introduced in Beard et al.⁴⁴ (cf. Figure 7). Although this reference damage is simplified with respect to the geometry of an actual delamination, its interaction with guided waves behaves similarly in terms of dedicated features such as change in time of flight or decrease in amplitude as quantified in Bach et al.⁴⁵

The reference damage (see Figure 7) was placed at location $x = -0.059$ m and $y = 0.045$ m (in the coordinate system of the laser Doppler vibrometer setup shown in Figure 10).

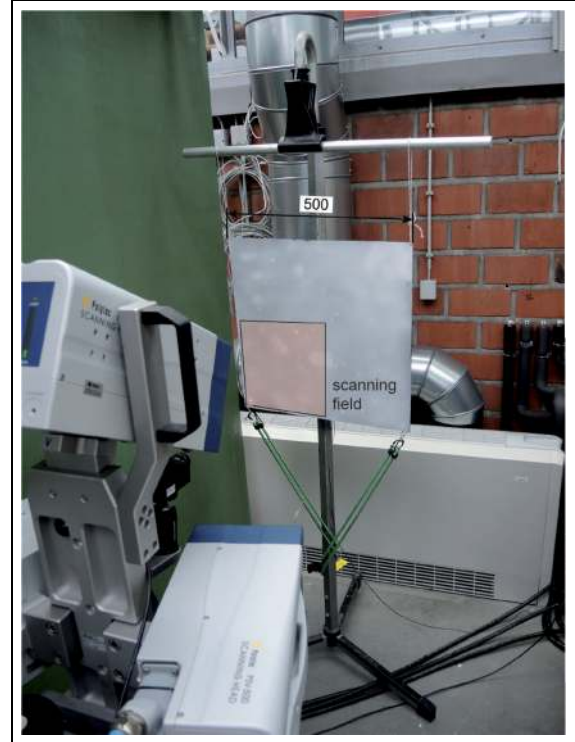
Figure 8. Experimental setup with the scanning laser Doppler vibrometer and the “wave field plate.”

As shown in Figure 8, full-wave field measurements were carried out by a 3D scanning laser Doppler vibrometer PSV-400-3D from Polytec GmbH (Waldbronn, Germany) using a measurement range of ± 200 mm/s. To increase sampling rate to 2.56 MHz, the PCI 6110 National Instruments measurement card was used. Measurement subject was the “wave field plate” introduced before with a central transducer placed exactly in the middle of that structure. The excitation signal is a 5-cycle Hann-filtered sine wave amplified to ± 150 V. To minimize the influence of random

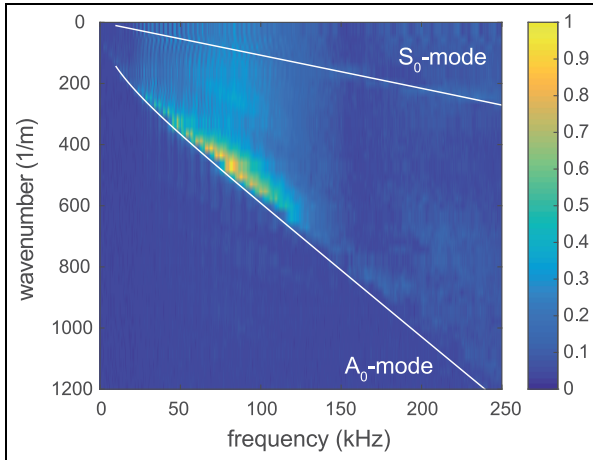
Figure 9. Comparison between theoretically predicted and experimentally measured dispersion properties of the “wave field plate” in 0° direction (see Figure 2). Multiple narrowband measurements were combined to model a broadband pulse. The experimental dispersion graph was normalized to the maximum amplitude of the antisymmetric wave mode. Theoretical dispersion curves were computed with the global matrix method.³⁶

Figure 9 depicts the measured wavenumbers of the “wave field plate” along 0° direction (see Figure 2) as a

result of a 2D Fourier transform in relation to theoretically predicted dispersion curves in the multilayered laminate. The theoretical dispersion curves are in good agreement with the experimental dispersion curves. In addition, mode tuning behavior can be observed which describes the capability of piezoelectric transducers to excite and detect Lamb waves.⁴⁶ In the present case, the maximum of A_0 -mode excitation is in the region of about 80 kHz and decreases to lower and higher frequencies, respectively.

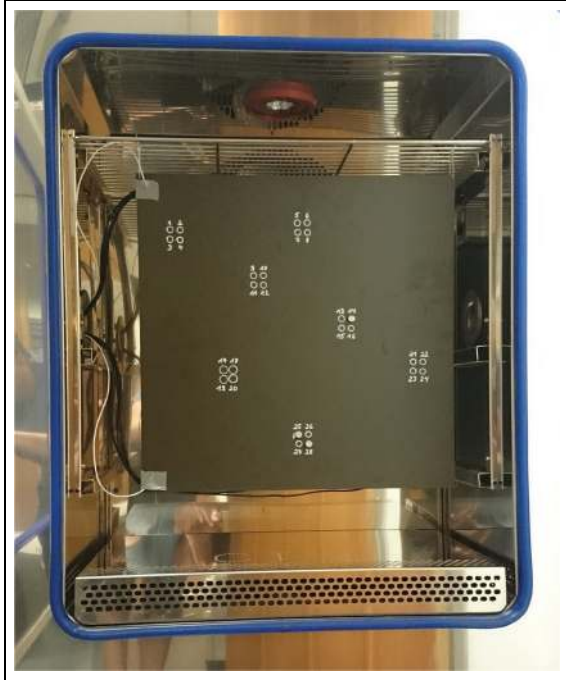
Figure 11. Photograph of the “SHM plate” in the climate chamber, where the tests were performed at 23°C and 50% RH. Two temperature sensors were installed on the top left and bottom left to measure the surface temperature of the samples.

Figure 11 shows the experimental setup with the “SHM plate” placed in a climate chamber at a constant temperature of 23°C and 50% RH (DIN EN ISO 291). On the top and at the bottom of the structure, Pt-100 temperature sensors were attached to the plates’ surface to assess potential temperature gradients. The temperature sensors were coupled to a PT-104A device (Omega Engineering GmbH, Deckenpfronn, Germany) that allows temperature measurements with a resolution of 0.001°C and an accuracy of 0.01°C . One temperature measurement was recorded for each dataset. Similar to

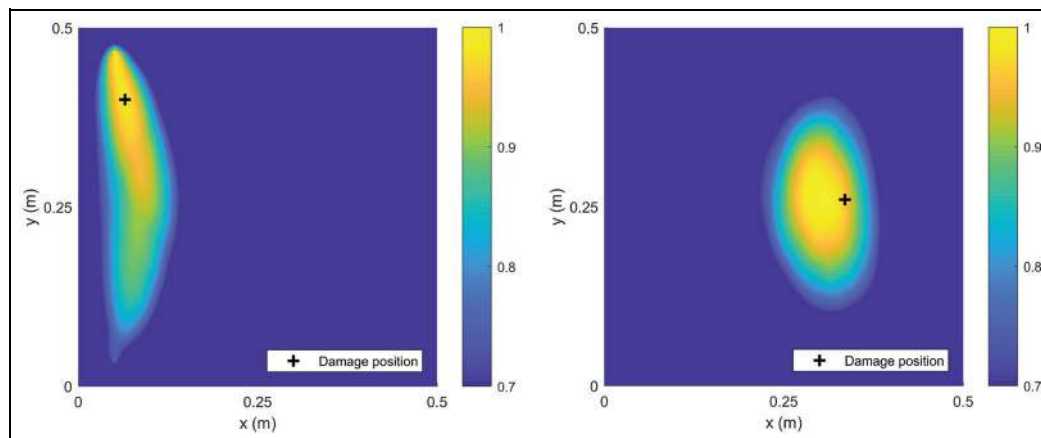
Figure 14. Guided wave tomographic image reconstruction at 40 kHz for damage D_4 (left) and damage D_{16} (right). The scaling parameter of the RAPID algorithm was defined here as $\beta = 1.1$.

The reconstruction algorithm for probabilistic inspection of damage (RAPID), described by Hay et al.,⁵² is well known as a damage localization technique in composite materials. This method was used here to demonstrate the localization capability of guided waves in the proposed CFRP plate. Figure 14 shows the two exemplary image reconstruction results based on

40 kHz measurements. It is shown that damage D_4 and D_{16} were localized in both cases. In the analysis, only those datasets that have transducer pairs on opposite sides (top and bottom) were included, that is, where the damage is in the direct path of an actuator and its corresponding sensor.
