# Performance Evaluation of an Actuator Dust Seal for Lunar Operation

NASA/TM—2013-216587

## Summary

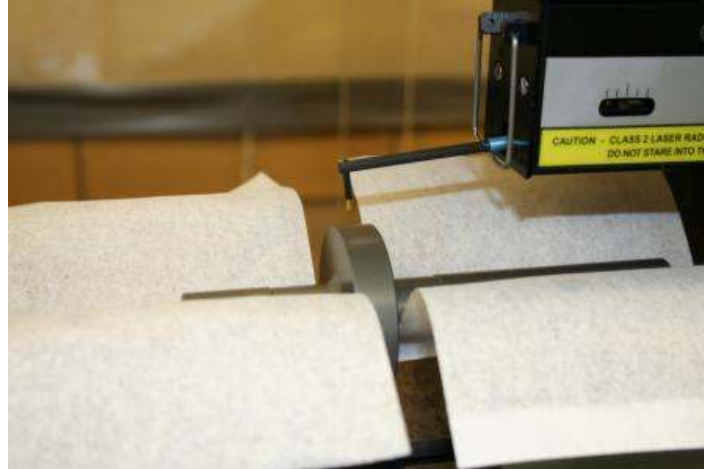
Figure 2.—Profilometry of Aeroflex Test Shaft.

Two seals were delivered to GRC for evaluation. The seal comprised both a primary and secondary sealing interface. Surface finish measurements were made of the Aeroflex test shaft using a Taylor-Hobson PGI 1200 Form Talysurf at four circumferential locations resulting in an average surface finish of 13  $\mu\text{m}$ ., Figure 2. Figure 3 shows pre-test data at one axial location on the shaft surface.

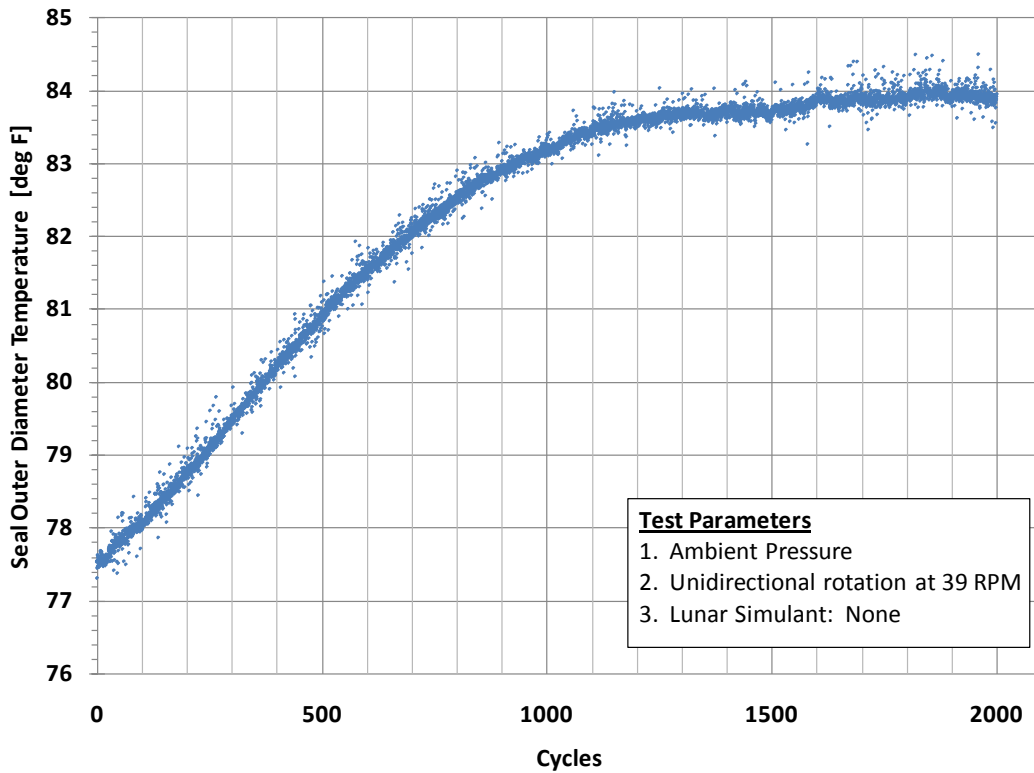
Figure 8.—Aeroflex Dust Seal Performance Test at GRC. Test 5, Table 3.

The first series of tests were performed for intentionally short durations at ambient conditions to slowly break in the seal and shaft into a matched set. The run-in period was continued until torque and temperature measurements approached steady-state values. Four main tests runs of 2,500, 2,000, 12,000, and 1,048 cycles provided break-in seal temperature and seal drag torque data. Approximately 18,000 cycles were completed during break-in runs, Table 3. Torque data from break-in tests show a repeatable quick initial rise to peak values followed by a relatively slower asymptotic to steady-state values. Data scatter increasingly varied from 1 to 4 lbf-in., Figure 7. The data scatter is likely due to inadvertent misalignment at the right-angle gearbox to test shaft connection followed by premature wear of the gearbox housing bearings. The gearbox housing was replaced and realigned with the test shaft prior to Phase 2 testing. Additionally, Braycote 601 was applied to the gearbox prior to the start of each subsequent test. Temperature data during break-in tests show a relatively linear rise to steady-values with data scatter less than 1 °F, Figure 8.

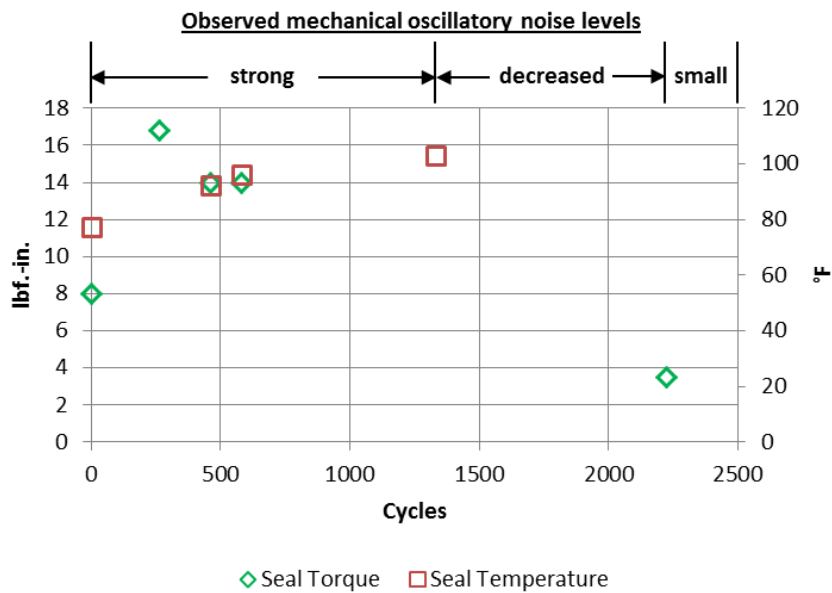
Figure 9.—Reconstructed data for the initial 2,500 cycle test for the Aeroflex Dust Seal at ambient conditions with no simulant.

Data for the initial 2,500 cycle break-in test was lost due to data acquisition issues. Reconstruction of the data by the test engineer is shown in Figure 9. Characteristically, seal torque values appear to peak early (16.79 lbf-in. at 266 cycles) in the test run followed by a gradual decrease in levels towards the end of the test. Similarly, seal temperature values follow a gradual rise to peak levels (103.2 °F at 1,333 cycles). During the 2,500 cycle break-in run strong mechanical oscillatory noise levels were observed from the test set-up. At approximately 1,333 cycles a noticeable drop in noise levels was observed. From 2,223 cycles to the end of the test sound levels were negligible. It is likely that the inadvertent misalignment mentioned earlier at the gearbox to test shaft connection led to unwanted axial and periodic once-per-rev seal wear in addition to the expected circumferential wear.

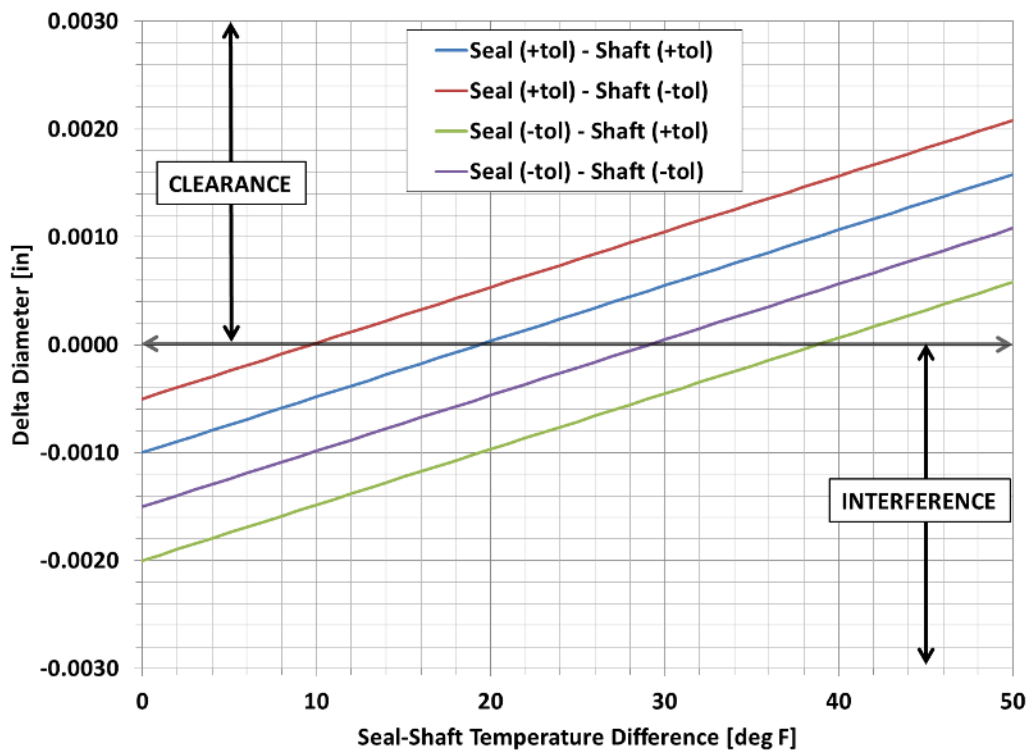
Figure 10.—Calculated final diameter differences between seal and shaft interfaces after temperature rise.

Consider also at the end of every test, based on the seal/shaft diametral tolerances and corresponding CTEs, the secondary sealing surfaces will tend to cool first due to their higher CTE than the shaft. It is speculated that the secondary sealing surfaces may briefly contact the shaft until thermal equilibrium is re-established. The amount of seal-shaft interference would depend on component wear levels and initial assembly interference fits. During Phase I testing the maximum temperature rise, ~26 °F, corresponded with the peak torque of 16.7 lbf.-in. Because of the misalignment found during post-test inspection, the heat generated would be a combination of initial interference fit and misalignment. Subsequent tests during Phase I testing showed less than a 10 °F temperature rise. Corresponding seal drag torque levels were also well below the 16.7 lbf-in. peak, with levels no higher than approximately 6 lbf-in.

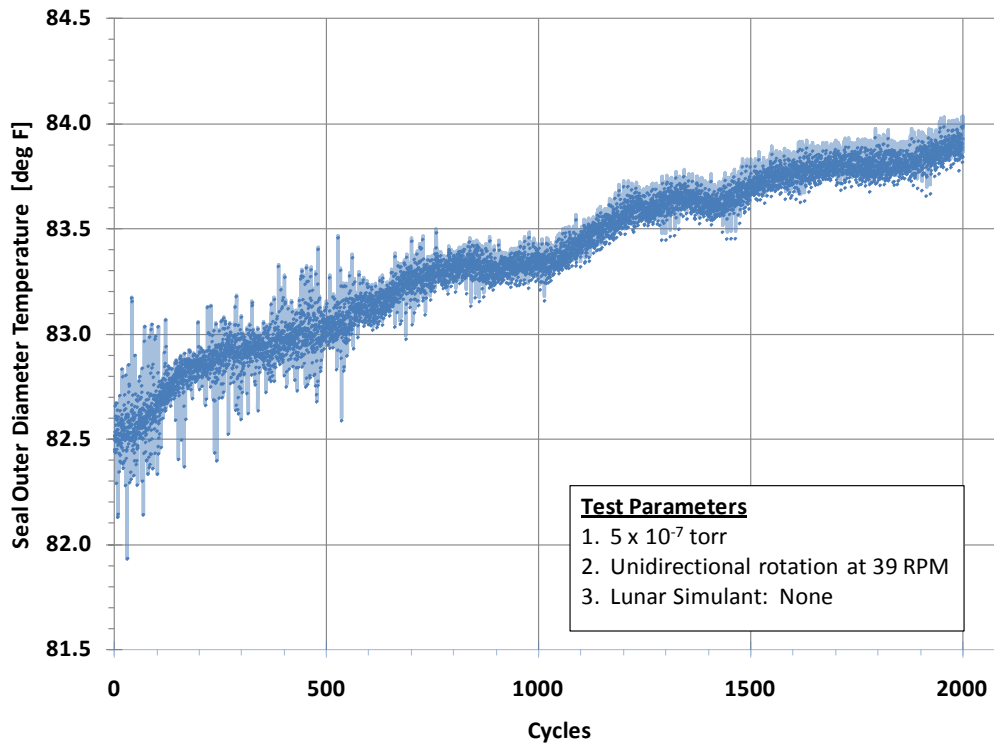
Figure 14.—Aeroflex Dust Seal Performance Test at GRC. Test 10, Table 3.

Since testing priority centered on obtaining seal performance data in vacuum with simulant and because of the various testing issues encountered and overcome during the seal break-in period, the decision was made to perform one test in vacuum without simulant and then to move on to the vacuum/simulant tests. This decision also took into account the limited number of prototype seals available to test and also a concern that the seal life might have inadvertently been used up due to the misalignment issues in the previous test set-up. Thus, the effect of vacuum on seal drag torque or temperature rise without simulant would not be suitably addressed. A 2,000 cycle run was performed in vacuum, approximately  $5 \times 10^{-7}$  torr, and 39 RPM but without simulant. Figure 13 and Figure 14 show the seal drag torque and temperature results of the 2,000 cycle run in vacuum. Seal drag torque levels were between 0.6 to 0.8 lbf.-in. with 0.1 lbf.-in. of data scatter. Corresponding seal temperatures rose approximately  $1.3^\circ$  from 82.6 to 83.9 °F with a data scatter of 0.25 °F. Steady state values were not attained for either seal drag torque or temperature because of the relatively short test run.

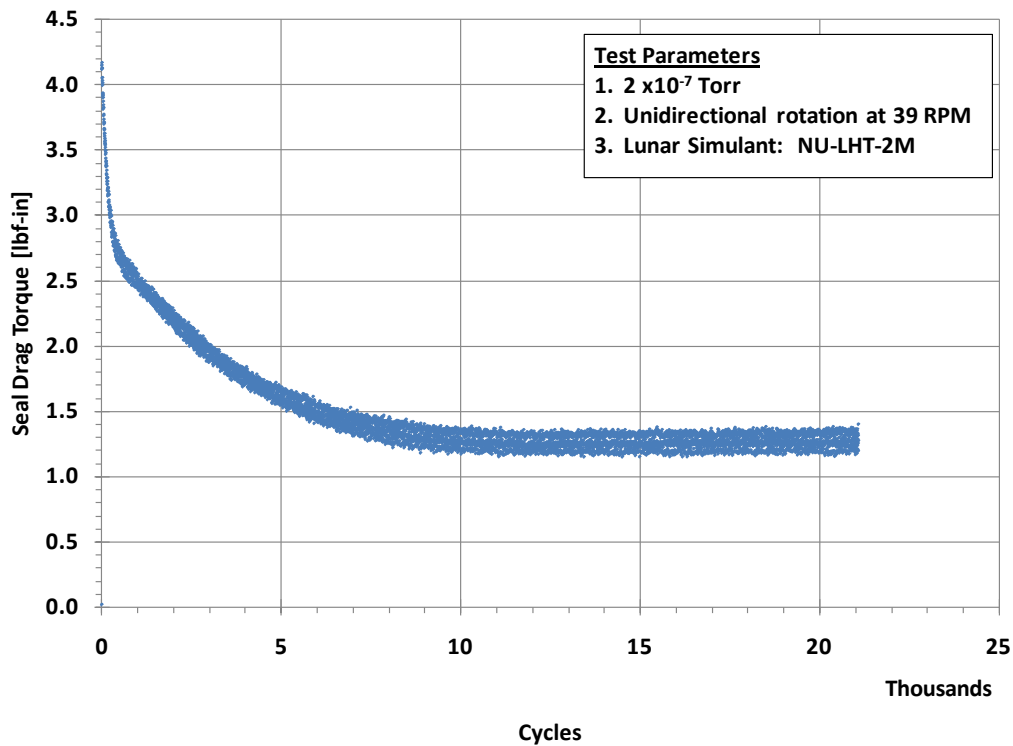
Figure 15.—Characteristic Seal Drag Torque versus Cycle Curve. Test 14, Table 3 .

Seal drag torque curves in vacuum with simulant differed from those run at atmospheric conditions without simulant mainly by the lack of a steady rise in torque levels at the start of the test. In fact, nearly all tests run in vacuum with simulant started with an almost immediate maximum in torque levels. Figure 15 and Figure 16 show typical torque and temperature curves. As observed previously, both data sets show a gradual trend to asymptotic values. This immediate maximum was observed to increase to a maximum level on the first eight consecutive tests. Figure 17 shows peak torque levels ranging from approximately 1.2 lbf-in. at the start of the vacuum tests with simulant to 7.6 lbf-in. around 120,000 cycles.

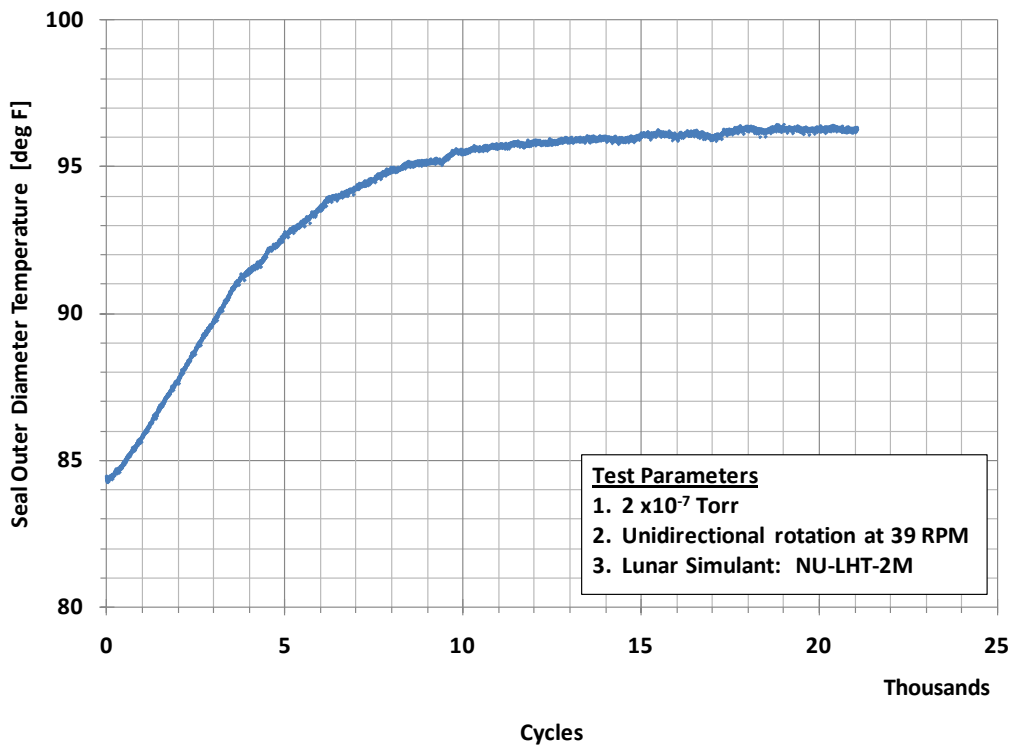
Figure 16.—Characteristic Seal Outer Diameter Temperature versus Cycle Curve. Test 14, Table 3 .

Daily runs of 10,000 to 20,000 cycles per day were run in vacuum with the lunar simulant, NU-LHT-2M, Table 3, Tests 11 through 44. The shaft speed was constant at 39 RPM. The initial plan was to check for dust penetration through the seal-shaft interface at preset intervals. Upon further consideration, it was likely that disturbing the test set-up would confound subsequent test results and prevent comparison to previous test data. More specifically, in the current designed test set-up, precise re-alignment of the shaft and seal could not be guaranteed. Thus, seal torque and temperature would have to be monitored closely to determine if the simulant had penetrated the seal-shaft interface. A good indication of simulant penetration through the interface would be if seal drag torque levels fell below zero. Accounting for the accuracy of the load-cells a calculated value of 0.14 lbf-in. was determined as a seal drag torque lower limit for potential simulant penetration through the interface. Further, a decrease in the seal temperature rise during daily tests would be indicative of reduced friction or interference between the seal and shaft. While a zero temperature rise would certainly suggest little to no friction between the shaft and seal, this test parameter would not clearly indicate simulant penetration through the interface. Some friction may result from rubbing of the simulant between the shaft and seal.

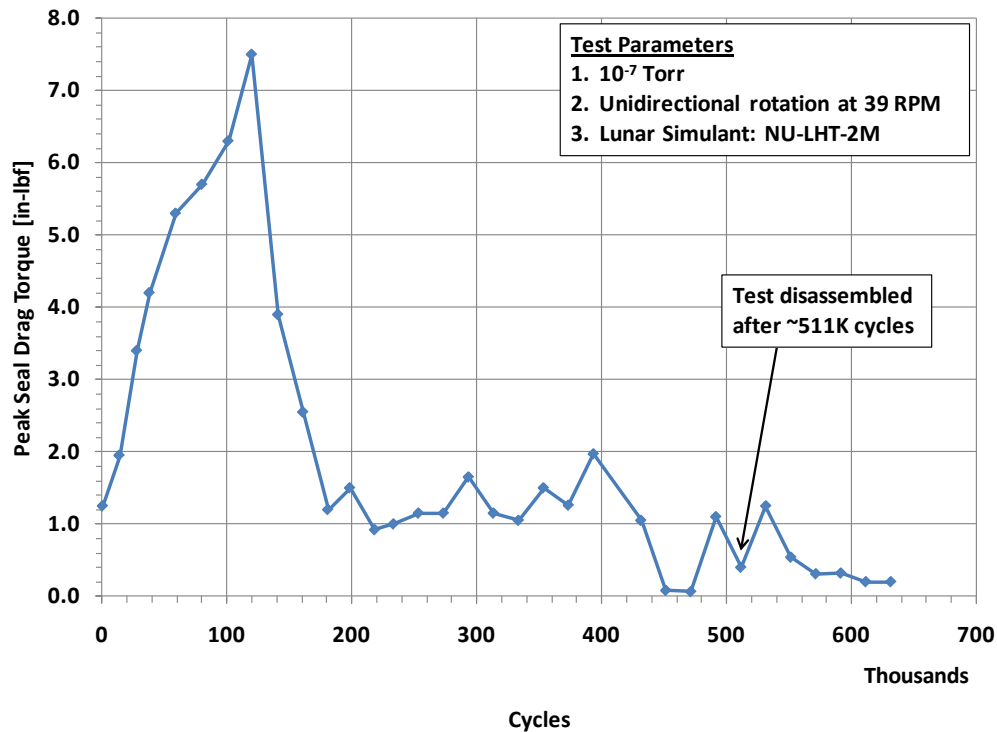
Figure 17.—Aeroflex peak seal drag torque at test start (39 RPM, Vacuum, NU-LHT-2M).

The drop in peak torque levels is indicative of further wear-in of the seal-shaft during this test phase. The initial increase in torque at each test start may also be due to test operations. It is possible that since testing was stopped each day, simulant may have entered the seal-shaft interface via gravity, minute vibrations in the vacuum system, the existing chip in the secondary sealing surface, and possibly small gaps between the seal and shaft due to wear. Without disassembly of the test set-up for reasons already mentioned previously, these hypotheses are noted and unconfirmed. Following these initial test observations, the peak torque level was observed to decrease during successive tests (4.0 and 2.5 lbf-in.) through 160,000 cycles, thereafter remaining in the 1.0 to 2.0 lbf-in. range for the remainder of the tests. The drop in peak torque level is indicative of a much longer break-in phenomena of the seal and shaft pair through 160,000 cycles. Also, it was observed for each test run that the cyclical time period to decrease from peak torque levels to 25 percent of that value decreased with each run through the first 140,000 cycles, Figure 18. This value remained well below 1,000 cycles for the remainder of the testing in vacuum with simulant, indicating a decrease in the long-term seal-shaft wear phenomena discussed previously. Finally, the data provided by Figure 18 provide additional insight into the seal-shaft pair operational start-up torque characteristics.

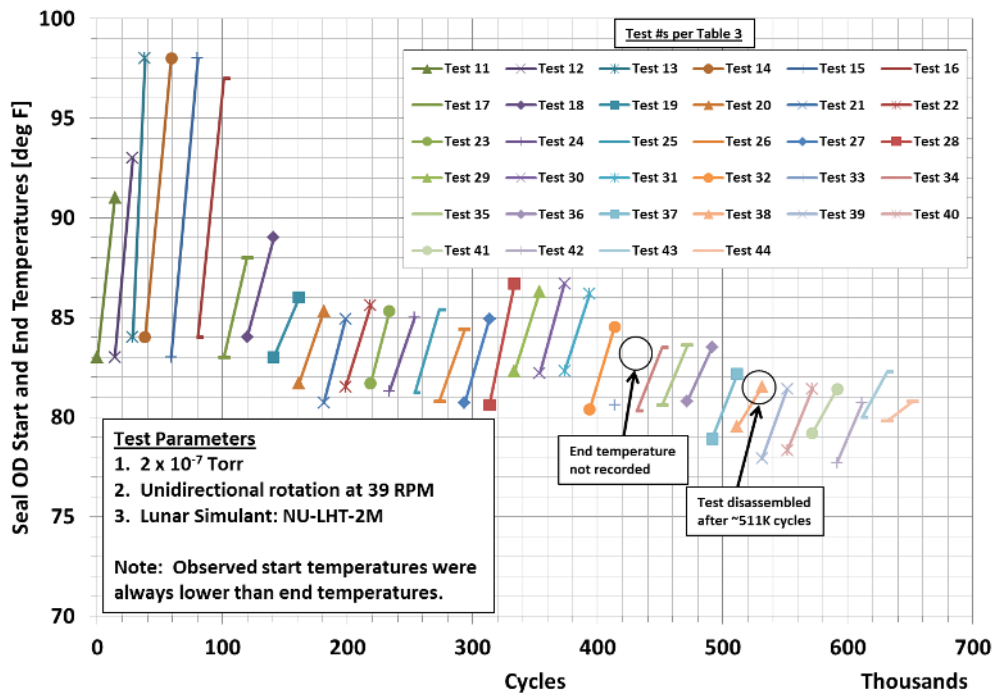
Figure 19.—Seal outer diameter temperature during tests in vacuum with simulant.

Figure 19 shows the starting and ending seal outer diameter temperatures over the 600,000+ cyclic test period. Note that the actual seal-shaft interface temperature would be higher than observed at the seal outer diameter. The seal temperature rise for each test during the first 100,000 cycles (8 to 14 °F) were greater than the remainder of the test period (<5 °F) in vacuum with simulant. This generally coincides with the peak torque levels seen in Figure 17. Figure 20 shows a plot of seal temperature rise per 50 cycles over the total number of cycles in vacuum with simulant. This rise in seal temperature has generally been observed at the start of each test until approximately 1,000 to 2,000 cycles had been completed. Again, larger temperature rises were observed during the first 120,000 cycles (0.06 to 0.11 °F per 50 cycles) than during the remainder of tests (0.02 to 0.06 °F per 50 cycles). The highest values are 9 times less than the maximum observed during previous break-in runs (0.96 °F per 50 cycles). These data sets also suggest further wear-in of the seal and shaft during the initial 100,000 to 120,000 cycle time period during tests in vacuum with simulant. They also provide potential operational insight into the seal-shaft temperature rise at start-up.

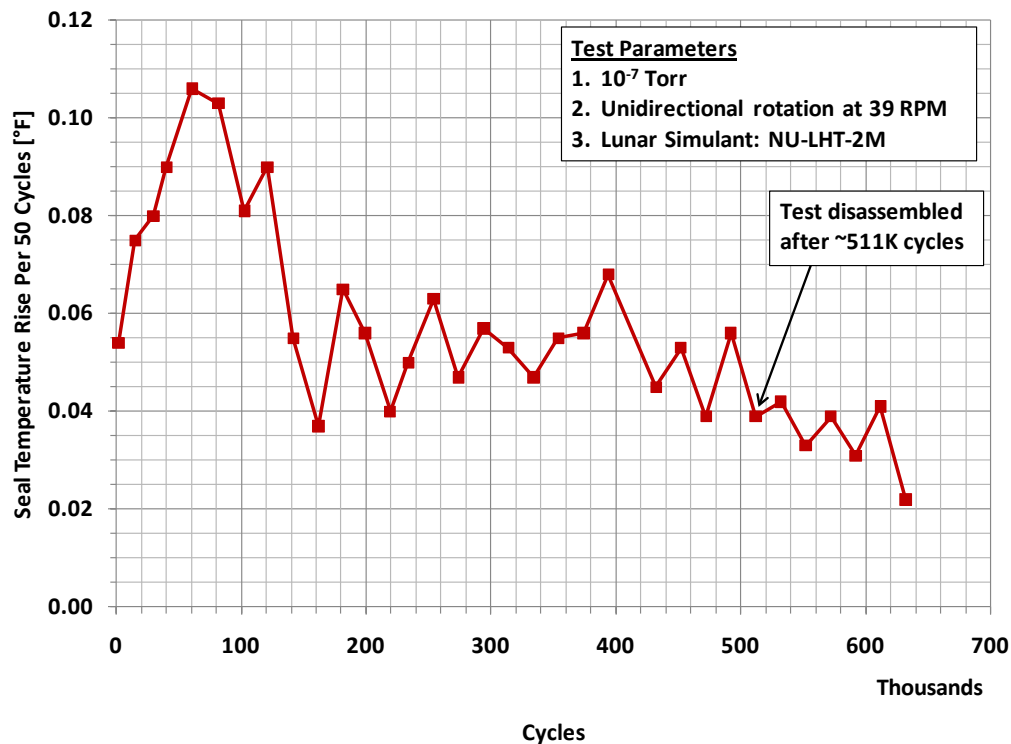
Figure 20.—Seal temperature rise per 50 cycles at start of tests in vacuum with simulant.

- During tests in vacuum with NU-LHT-2M the seal temperature rise remained below 0.11 °F per 50 cycles compared to a peak of 0.96 °F per 50 cycles during break-in runs.

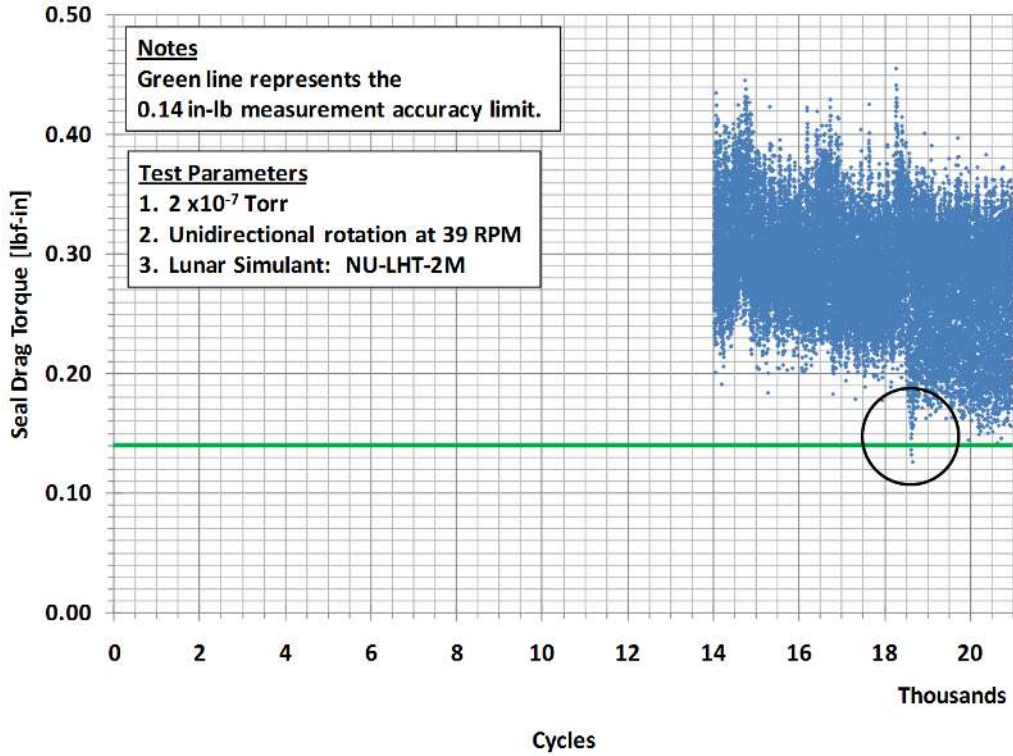
Figure 21.—Seal drag torque approaches statistically zero levels. Approximately 141,000 cycles in vacuum with simulant completed. Test 18, Table 3.

Based on the 0.14 lbf.-in. load cell accuracy limits, Figure 21 shows the first time seal drag torque levels were low enough that a statistically zero torque value was plausible. Some simulant penetration through the seal-shaft interface is possible because of the minimal interference between the seal and shaft. The low torque values were observed towards the end of the test at approximately 141,000 total cycles in vacuum with simulant, Test 18, Table 3. Over the next 300,000 cycles with each day of testing completed, more of the torque versus cycle curve would approach this statistical limit. At approximately 471,000 total cycles in vacuum (Test 35, Table 3), seal drag torque values approached essentially 0 lbf.-in., Figure 22. The torque spike that occurred 16,500 cycles for this test may have due to simulant penetration through the seal-shaft interface. Data acquired during the next two days of tests confirm seal drag torque values dropping to zero levels towards the end of the 20,000 cycle run. Thus at 511,000 completed cycles (Test 37, Table 3), the decision was made to check the Teflon disk for simulant. The disk located below the seal-shaft assembly as shown in Figure 5 was designed to capture simulant that penetrated the seal-shaft interface. The remaining simulant located on top of the seals/shaft assembly was carefully vacuumed prior to disassembly of the test fixture. Although seal drag torque measurements were indicative of potential simulant penetration through the interface, upon disassembly of the seal and shaft, approximately  $0.4 \pm 0.2$  mg of simulant were found, Figure 23, which was far less than expected. Table 4 shows the results of the analysis performed which involved carefully weighing four pieces of tape, ‘capturing’ the simulant in the Teflon disk with the tape, and then weighing the tape and simulant together. The seal and shaft were ‘clamped’ together at disassembly to minimize any misalignment in the test set-up. Thus, no further wear observations or measurements were possible on either the seal or shaft.

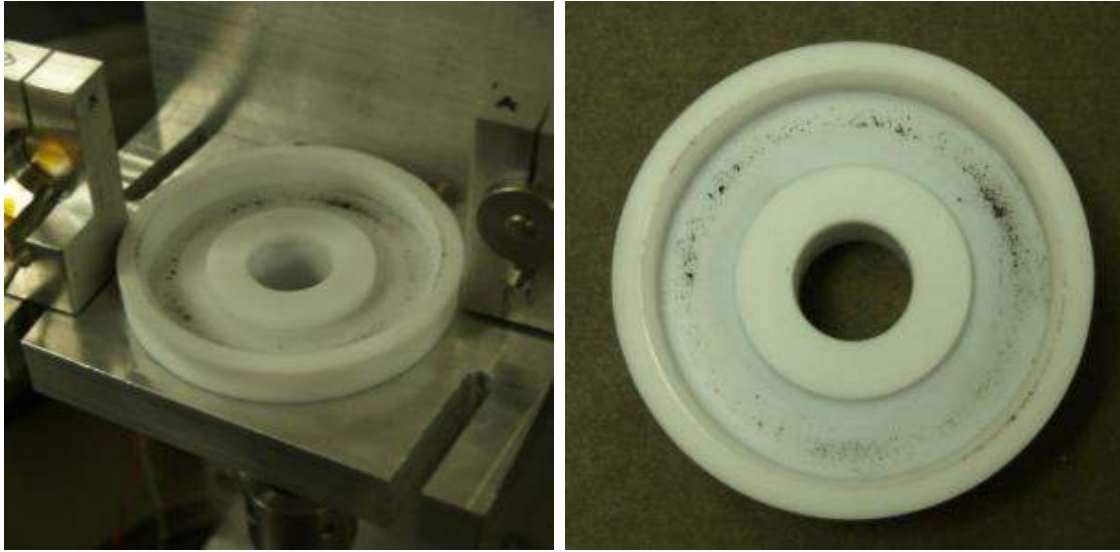
Figure 23.—NU-LHT-2M simulant found (~0.4 mg) at base of Teflon cup after 511,000 cycles in vacuum.

- Only 0.4 mg of NU-LHT-2M had passed through the seal and shaft interface into the Teflon cup after approximately 511,000 cycles testing in vacuum despite a small chip in the secondary sealing surface.
- Reassembly and test of the seal for an additional 140,000 cycles found 1.8 grams of NU-LHT-2M passing through the seal/shaft interface.

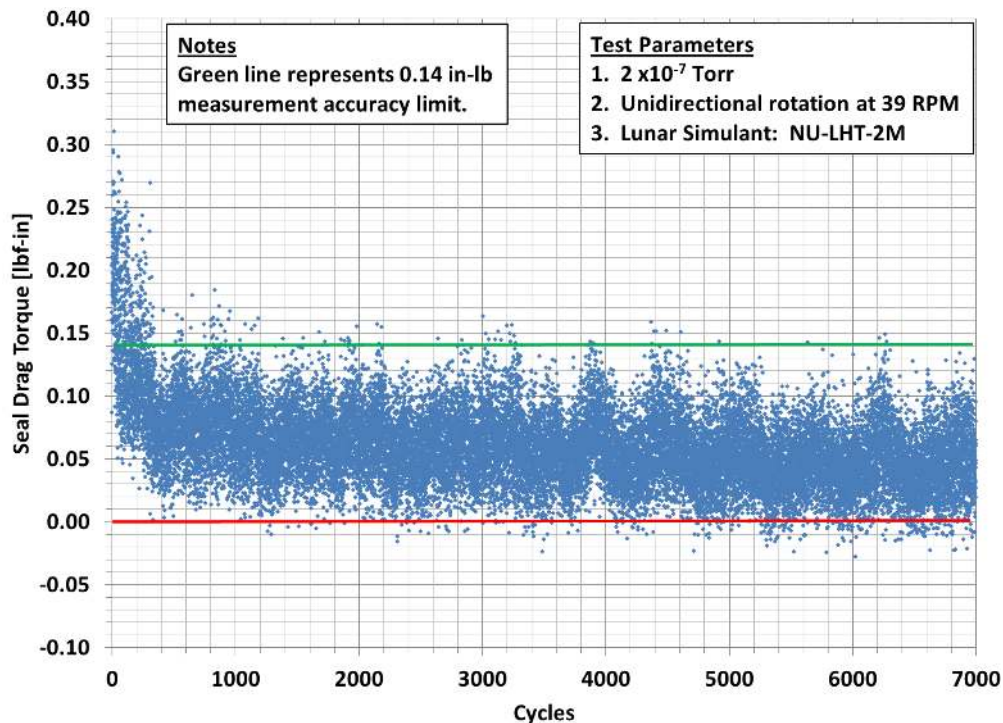
Figure 24.—Seal drag torque beginning to drop below zero levels. Approximately 570,000 cycles (Vacuum and Simulant) completed at start of this test. Test 41, Table 3.

- Approximately 471,000 cycles were completed when seal drag torque measurements approached zero levels.
- At approximately 570,000 cycles, seal drag torque measurements were consistently approaching zero levels.

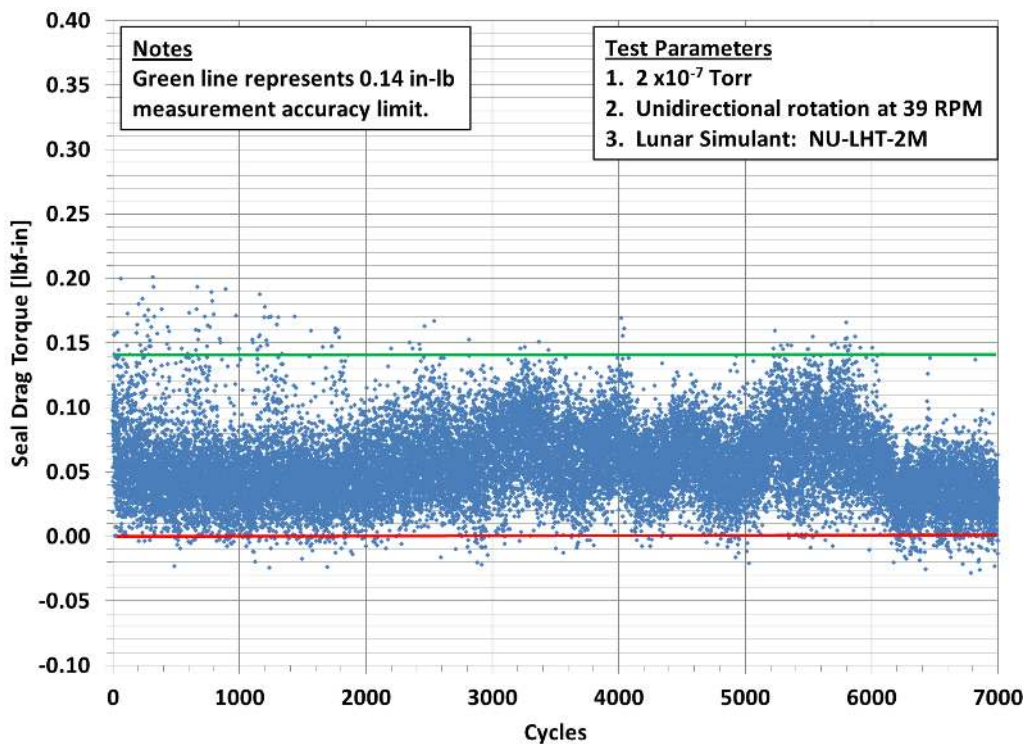
Figure 25.—Seal drag torque dropping below zero levels at test start. Approximately 630,000 cycles (Vacuum & Simulant) completed at start of this test. Test 44, Table 3.

Since a goal of the test program was to attain 1,000,000 cycles under vacuum with simulant, the seal and shaft were carefully reassembled and 11.9 grams of simulant were poured into the opening at the seal-shaft interface located at the top of the assembly. Another 140,000 cycles (seven tests at 20,000 cycles each) were completed after this check on simulant penetration through the interface. As seen in Figure 17, aside from one test at approximately 530,000 cycles, where the starting torque was over 1.0 lbf-in., the remaining seven tests showed starting torque levels under 0.6 lbf-in. Ending torque levels were nearly zero. The cyclical time to 25 percent of the starting torque level for each individual test was attained by 100 cycles for the final seven tests, Figure 18. Seal temperature rise, Figure 19 was limited to 2 to 3 °F for each of these seven tests. Plots of the daily torque-cycle curves showed torque levels approaching 0 lbf-in. at approximately 800 to 1,000 cycles rather than the 18,000 to 20,000 cycles prior to the simulant check. Testing between 570,000 and 590,000 total cycles (Test 41, Table 3) in vacuum with simulant showed a drop to zero torque within 2,000 cycles of the start of test, Figure 24. Finally, Figure 25 (Test 44, Table 3) shows where torque levels drop to zero values within 200 cycles. These observations are indicative of little to no wear between the shaft and seal. Upon disassembly at the conclusion of over 650,000 cycles, approximately  $1.8407 \pm 0.0007$  grams of simulant were found in the Teflon cup at the bottom of the fixture, Figure 26 and Table 5. The decision was made to stop the performance test on the Aeroflex seal and begin disassembly of the test set-up.

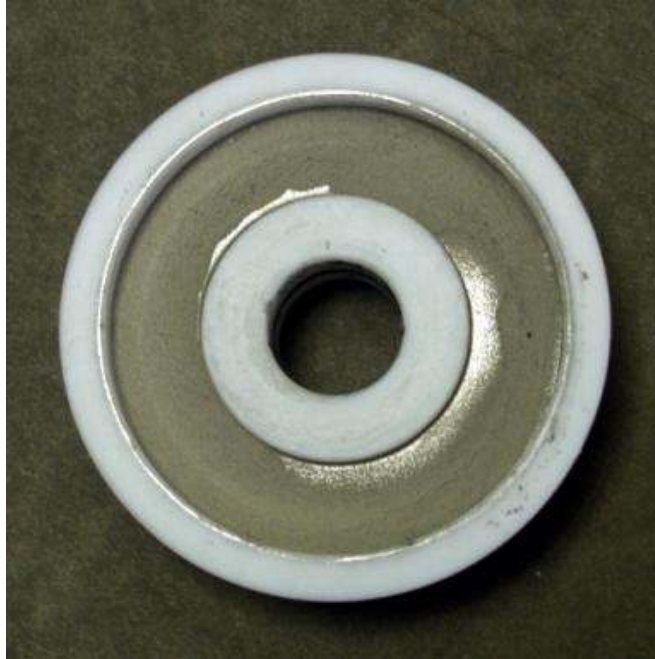
Figure 26.—NU-LHT-2M simulant found (~1.8 g) at base of Teflon cup after ~650,000 cycles testing in vacuum.
