PERMEABLE GROYNES: EXPERIMENTS AND PRACTICE IN THE NETHERLANDS

W.T. Bakker*, C.H. Hulsbergen**, P. Roelse*, C. de Smit***
and J.N. Svasek***

ABSTRACT

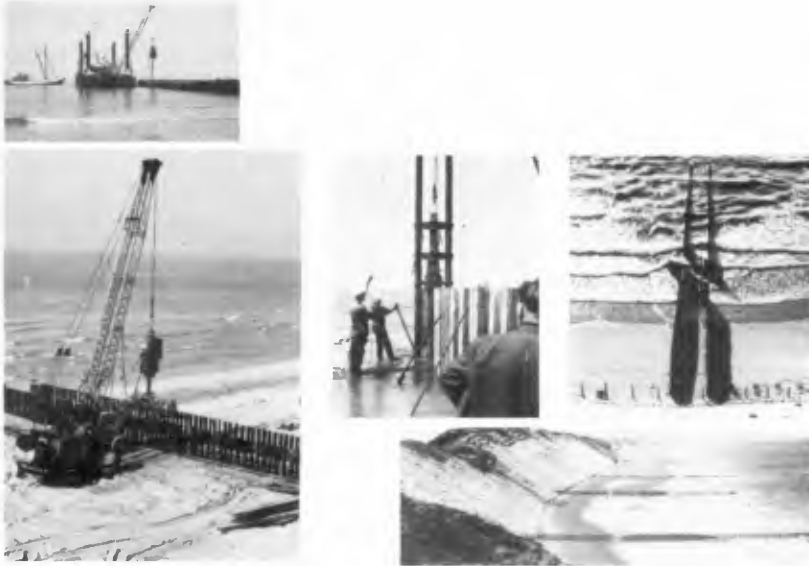
FIG.8 Construction of screens

Obviously, aspects of local materials, construction operations and costs may interfere with the ideal functional design. In the Netherlands only wooden piles (oak or tropical) with round or square cross-section (0.25 - 0.30 m) have been used. Piles of square cross-section may be placed in a diamond pattern rather than orthogonally in order to save material for the same hydraulic resistance. These piles may be subject to borers and/or marine growth; concrete may be an alternative.

The toplevel of the piles is partly determined by the workability conditions (waves and tides). The total length of the piles must allow for natural variations in local bed elevation; as a rule 60% of the total length is in the bed. A typical screen is shown in Fig. 8. When a double screen is applied (which is cheaper than 2 single rows), their mutual distance is 3 m. In order to allow traffic on the beach an oblique opening is provided. The piles may be jetted or rammed with a conventional rig on the dry beach. Beyond the low water line there are several options, viz. working from a floating barge, from a mobile platform (Fig. 8), from a temporary jetty, or working over the top of the finished part (double screens only). The costs of screens increase rather fast if they extend seaward of the low water line. A rough idea is given in Fig. 9, where three screen configurations are shown with their cost per 1000 m¹ of beach length as compared to typical traditional massive groynes.

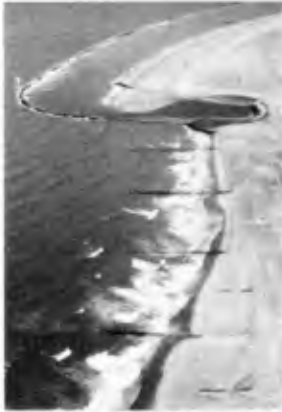
FIG.21 Screens near Europort (7)

- Just south of the new entrance to Europort (Fig. 10, (7)) a new coastal defence system was necessary in order to protect the reclaimed harbour area [Svasek and de Nekker, 1977]. Instead of the original design, which consisted of a section of 4000 m of rubble mound breakwater, an artificial beach and dune combination was proposed, saving about 80 million dollars on construction costs. In order to maintain the artificial beach, an artificial sand supply of 400,000 m³/yr would be required [Svasek and Versteegh, 1977]. Further optimization calculations resulted in a project with seven pile screens (Fig. 21) plus a limited sand supply of 200,000 m³/yr [Bijker et al., 1981]. Four double pile screens extended to the depth contour of MSL - 3 m, and three short single screens down to MSL - 0.5 m were placed in between. The 0.3 m diameter piles were spaced 0.3 m apart. To determine the pile length, a seasonal depth variation of 1 m was assumed. As the planned sand supply of 200,000 m³/yr was not effectuated, a local erosion of about this same rate should be expected. Based on frequent detailed soundings and beach levelings in the area concerned, a comparison was possible (Fig. 22) between the calculated erosion (with pile screens but without sand supply), and the observed erosion which amounted to 220,000 m³/yr. This is in good agreement, taking into account the feasible accuracy of the levelings and soundings. As the area concerned is approximately 600,000 m² large, the average erosion in 2 years was about 0.6 m with local scour of more than 1 m. About 2½ years after construction, the most southern two long screens lost about 30% of their piles (mainly in the deepest section) during a severe storm.

The main causes for this failure are:

- Artificial feeding was omitted, causing the bed to be eroded locally below the storm season profile, for which an overdepth of 1 m was designed.
- The tidal channel "Gat van Hawk", which was shoaling and stable

in position at the time of design, moved unexpectedly in shoreward direction.

- Some of the washed-out piles did not meet the design length requirements.

Later on, this pile screen project was abandoned.
