Pillar and Roof Span Design Guidelines for Underground Stone Mines

Information Circular 9526

Gabriel S. Esterhuizen, Dennis R. Dolinar, John L. Ellenberger, and
Leonard J. Prosser

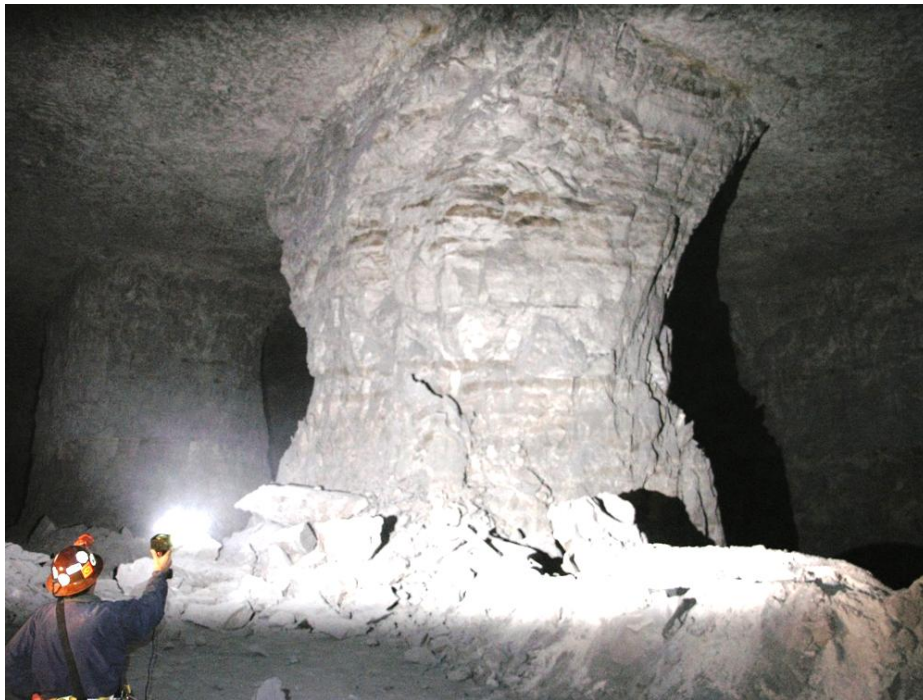
Figure 3. Partially benched pillar failing under elevated stresses at the edge of bench mining. Typical hourglass formation indicates overloaded pillar. The width-to-height ratio is 0.44 based on full benching height and the average pillar stress is about 12% of the UCS.

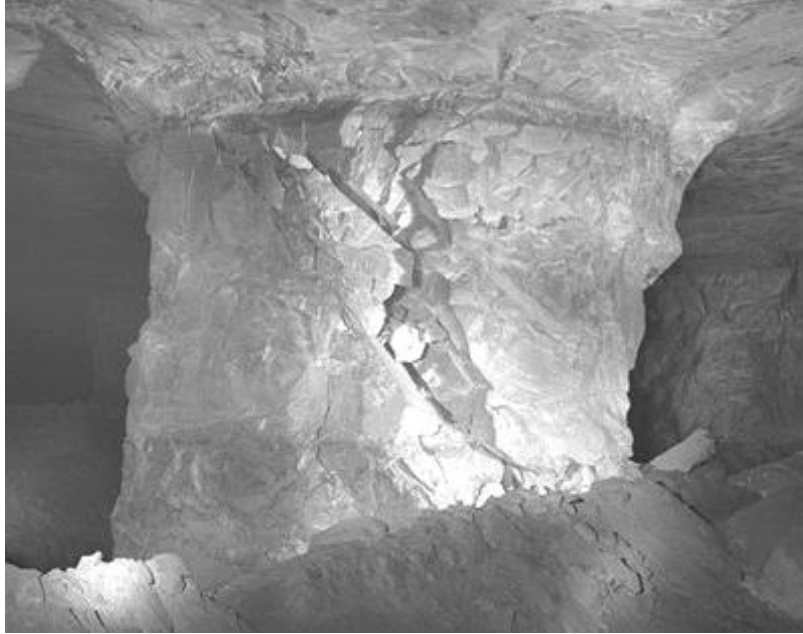
Figure 4. Partially benched pillar that failed along two angular discontinuities. Width-to-height ratio is 0.58 based on full benching height; average pillar stress is about 4% of the UCS.

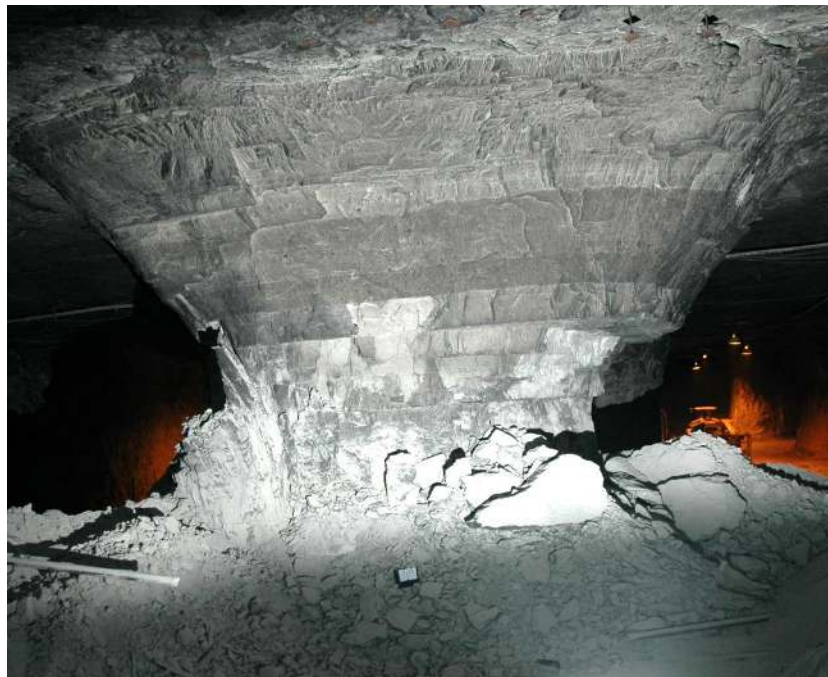
Figure 5. Pillar that had an original width-to-height ratio of 1.7, but failed by progressive spalling. Thin, weak beds are thought to have contributed to the failure. The average pillar stress was about 11% of the UCS prior to failure.

The pillars shown in Figures 5 and 6, listed as case 10 and 11 in Table 3, are examples of pillars that appear to have failed by this mechanism. In both cases the average pillar stress was only about 11% of the UCS of the limestone beds at this mine. Other pillars at the same mine seemed to be at an early stage of the same failure mechanism, where spalling is associated with the presence of weak, soft bands within the pillar. Figure 17 is an illustration of a partially failed pillar that appears to have failed by the same mechanism.

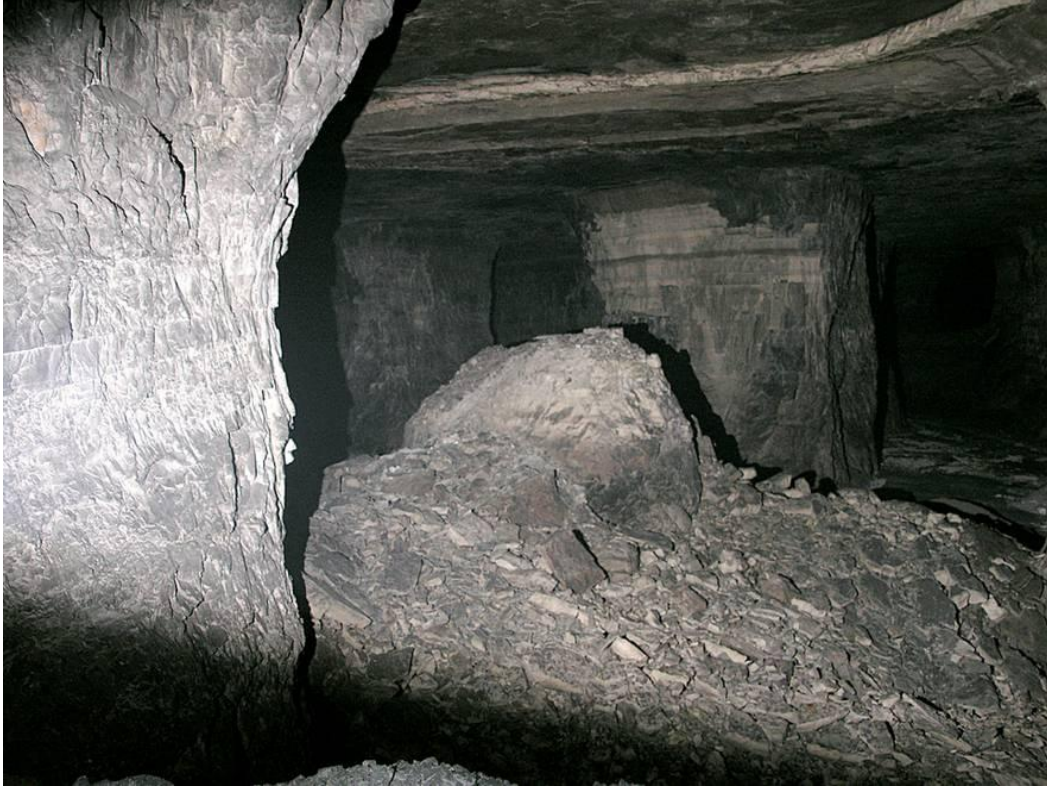
Figure 6. Remaining stump of a collapsed pillar in an abandoned area. Thin, weak beds in the pillar and moist conditions are thought to have contributed to the failure. The width-to-height ratio was 0.82 and average pillar stress about 11% of the UCS.

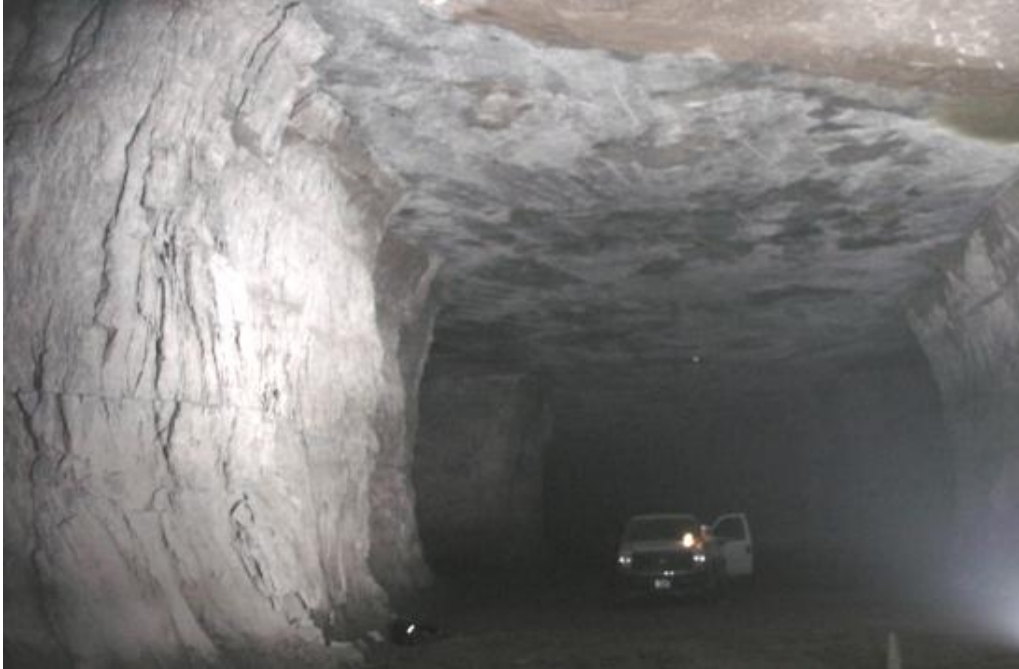
Figure 7. Example of rib spalling and resulting concave pillar ribs that can initiate when average pillar stress exceeds about 11% of the UCS.

Rib spalling is one of the early signs of elevated pillar stress. Figure 7 shows an example of rib spalling at approximately 270 m (900 ft) of cover. Spalling is characterized by fractures through the intact rock that are parallel to the direction of the maximum stress. Spalling normally initiates at the pillar corners and can spread to the pillar ribs, resulting in slightly concave ribs, shown in Figure 8. Rib spalling was observed to initiate when the average pillar stress exceeds about 11%–12% of the UCS. However, not all pillars that exceeded the 11%–12% stress ratio showed signs of rib spalling. It should, therefore, be interpreted as the lower limit for the onset of rib spalling. Rib instability can additionally be caused by unfavorable jointing in the rock mass or by poor blasting practices. The hazard associated with rib spalling can be mitigated by barring-down the loosened material, but this has the detrimental effect of reducing the pillar size. In some cases mine operators installed rib support, such as chain link mesh and bolts, to secure the rib walls, as shown in Figure 9.

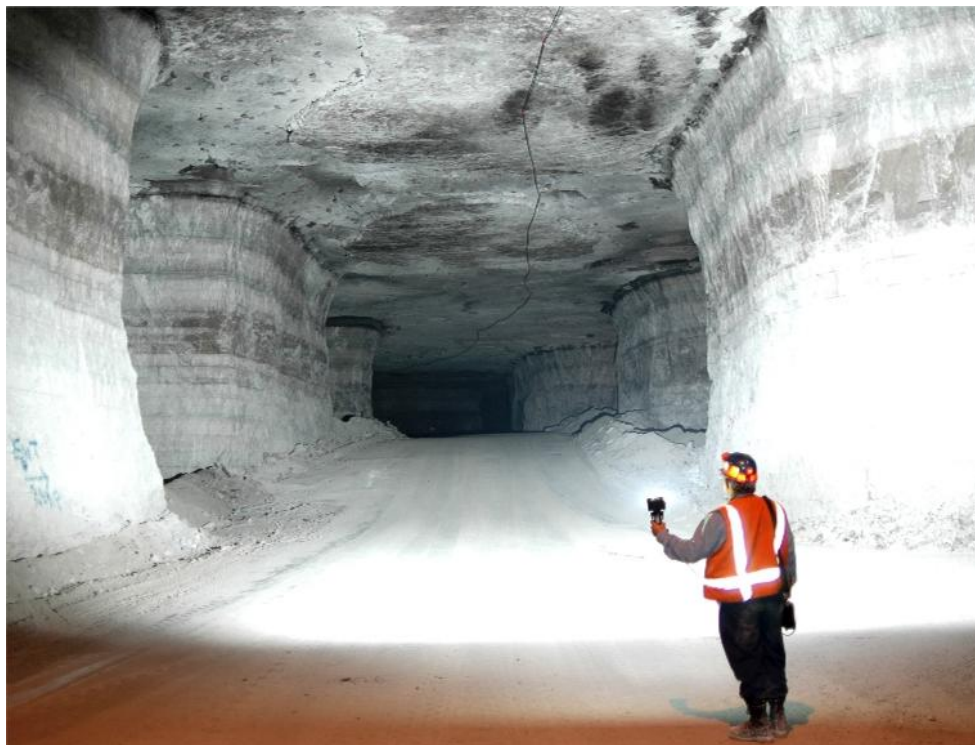
Figure 8. Stable pillars in a limestone mine at a depth of cover of 275 m (900 ft). Slightly concave pillar ribs formed as a result of minor spalling of the hard, brittle rock.

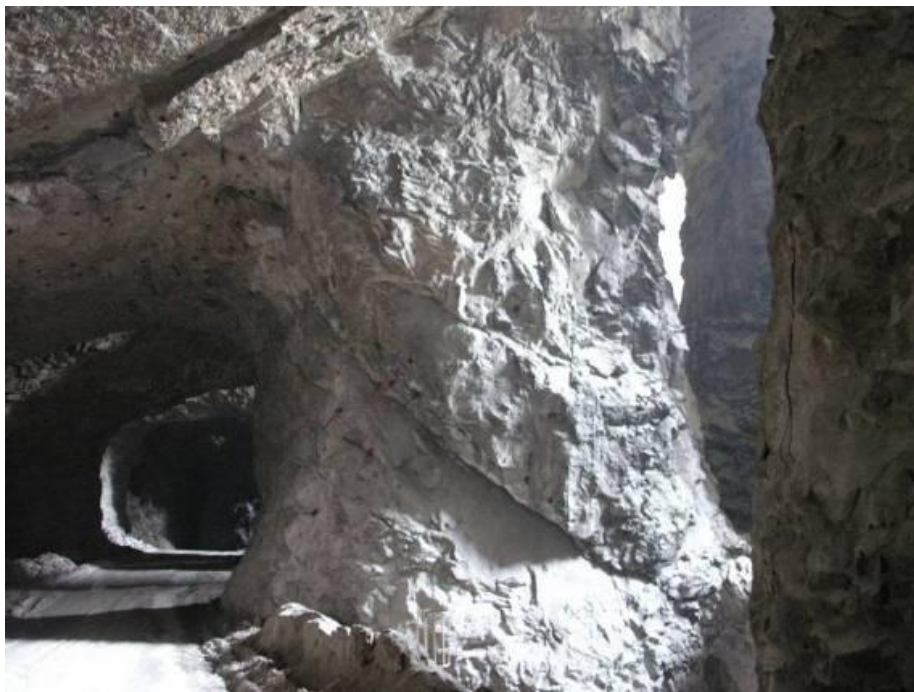
Figure 13. Example of a pillar that is bisected by a large, angular discontinuity.

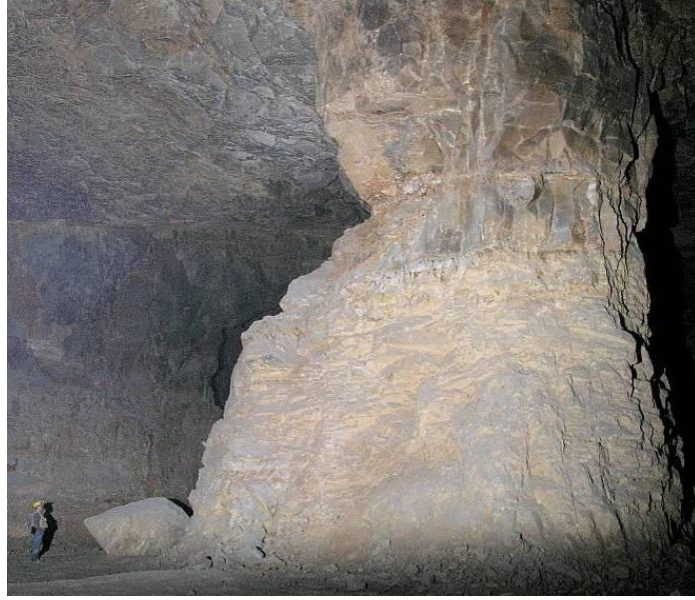
Figure 14. Rib failure related to large, angular discontinuities adjacent to a fault zone.

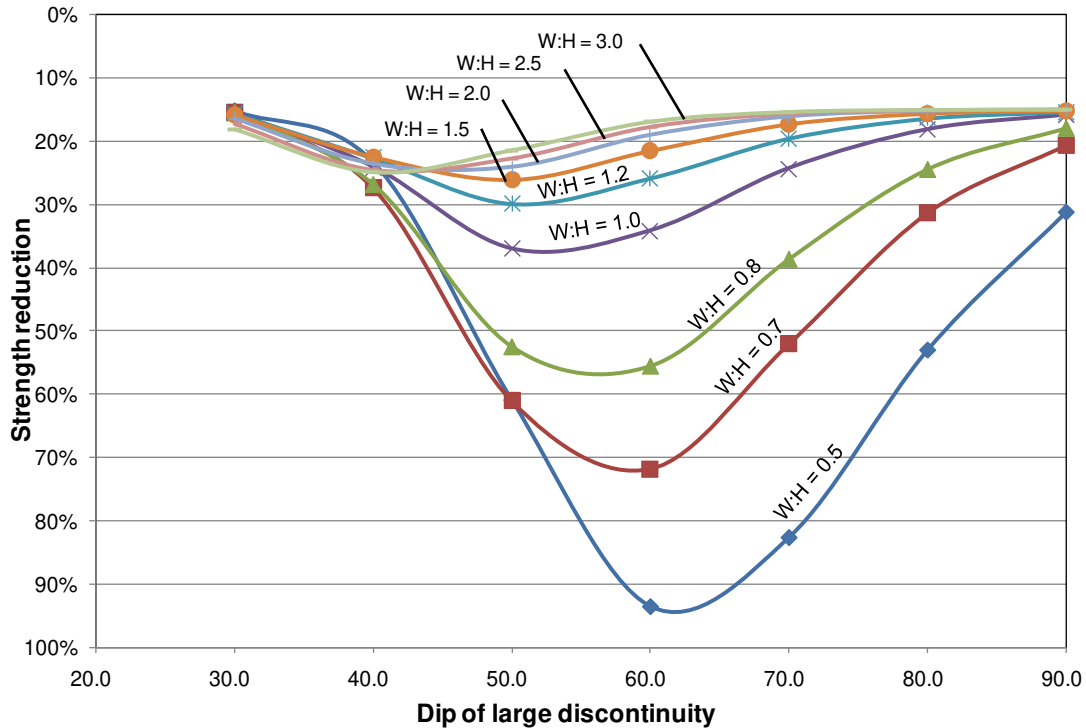
Figure 16. Chart showing the impact of large, angular discontinuities on the strength of pillars, based on the results of numerical models.

These findings are a further confirmation that excessively slender pillars should be avoided. The pillar strength calculation procedure, described in the Pillar Strength Equation for Stone Mines section, takes into account the weakening effect of large, angular discontinuities.

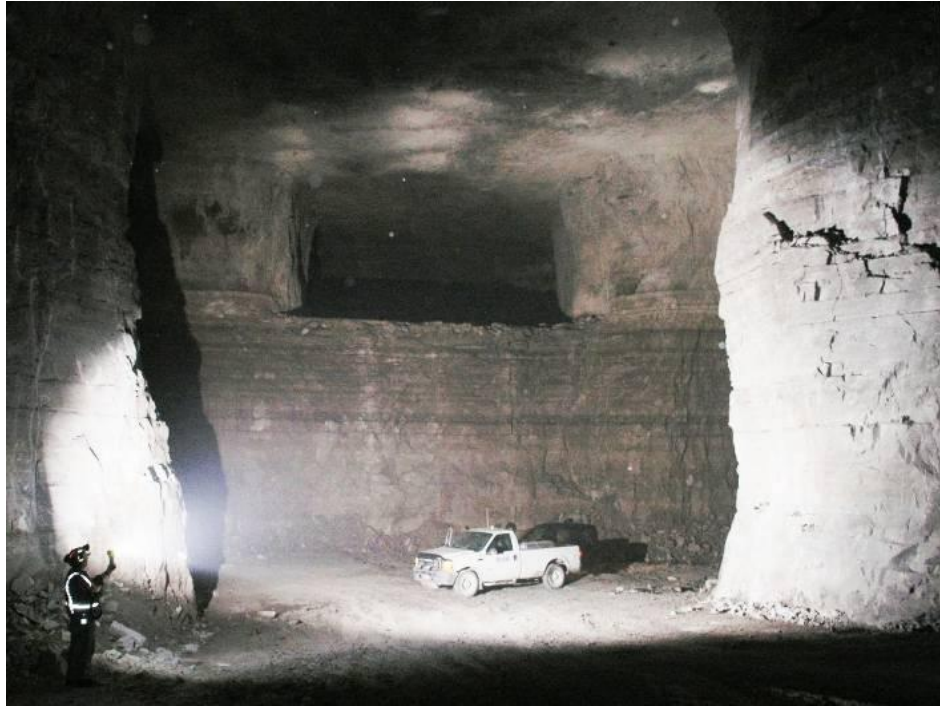
Figure 19. Example of bench mining of the floor between pillars in a limestone mine.

Bench mining of the floor between pillars is a common practice in stone mines where the formation thickness exceeds the practical height of initial development mining. Bench drilling equipment from open pit mines is often used resulting in a highly efficient method of production. Figure 19 shows a floor bench with partially benched pillars on the upper level and fully benched pillars in the foreground. Observations showed that pillars can become unstable at the edge of the benching operations. Table 4 summarizes the cases in which pillar instability was associated with bench mining. Benching operations were halted in two of the observed cases owing to instability of the partially benched pillars. Several cases were observed in which the pillars at the perimeter of the benching area showed signs of increased loading. In addition, instability was observed when bench mining exposed large joint structures in the pillar ribs.

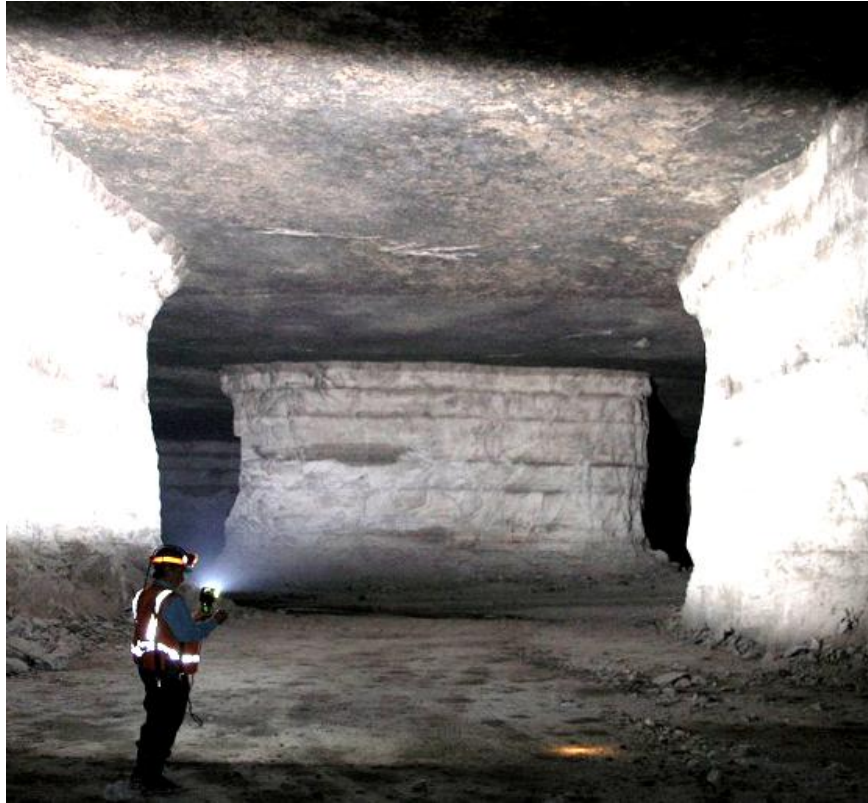
Figure 27. Naturally stable 13.4-m (44-ft) wide roof span in a stone mine.

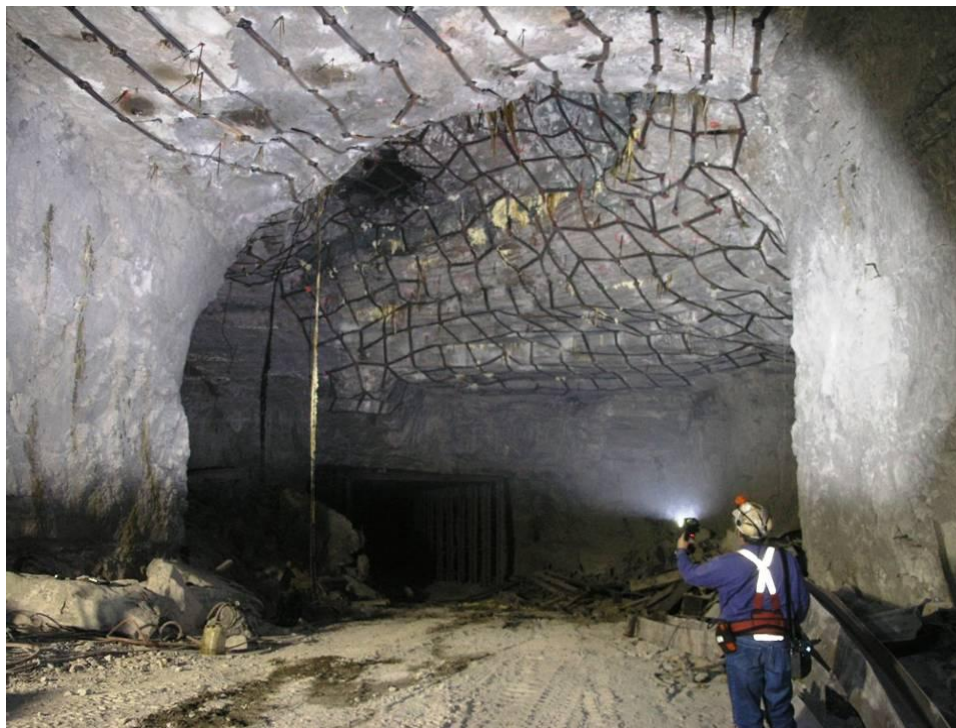
Figure 28. Bolts, straps, and injection grouting used to rehabilitate the roof at the site of a major roof fall.

Although the large roof falls only make up a small percentage of the total roof exposure, their potential impact on safety and mine operations can be very significant. Most cases of large roof falls required barricading off or abandonment of the affected entry. When large roof falls occur in critical excavation areas, the repair can be very costly. Figure 28 shows a case where extensive support was required to rehabilitate a large roof fall.

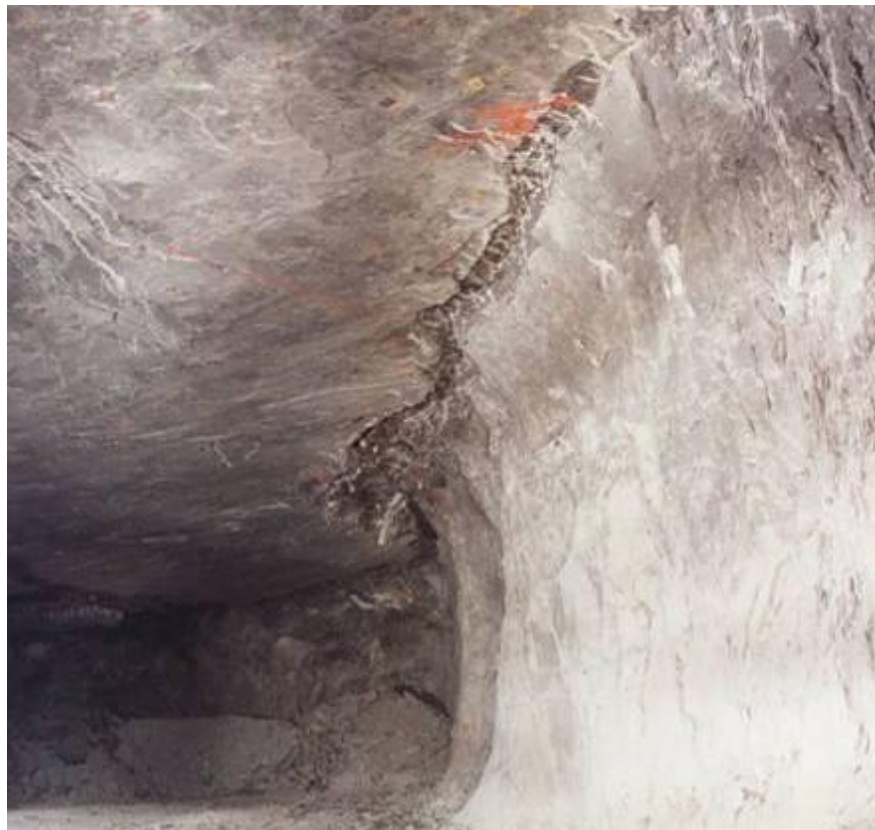
Figure 31. Roof guttering at the pillar-roof contact.

Horizontal stress can cause beams within the roof to buckle and fail in shear [Iannacchione et al. 2003]. Failure can initiate as guttering in one corner of an excavation, (i.e., called “cutter roof” in coal mines), as shown in Figure 31, and can propagate to a large-scale roof fall, as shown in Figure 32. Falls related to horizontal stress typically line up in the direction perpendicular to the regional maximum horizontal stress and are oval shaped when seen in plan view, as shown in Figure 33. The falls tend to propagate laterally in the direction perpendicular to the main horizontal stress, and can snake through the mine, as shown in Figure 34. Careful observation of the roof falls, their direction of propagation, and other signs of excessive stress can assist in identifying the orientation of the maximum horizontal stress [Mark and Mucho 1994].
