# Power loss and hotspot analysis for photovoltaic modules affected by potential induced degradation

Mahmoud Dhimish<sup>1</sup> and Andy M. Tyrrell<sup>1</sup>

*npj Materials Degradation* (2022)6:11 | <https://doi.org/10.1038/s41529-022-00221-9>

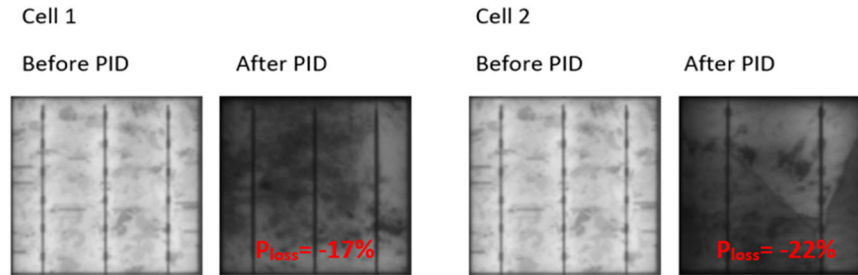
**Fig. 1** EL images were taken before and after the PID test. The EL images are captured using Brightspot EL imaging setup, and the power loss ( $P_{loss}$ ) was estimated under the standard test conditions.

To identify the consequence of PID on PV modules, electroluminescence (EL) imaging is usually performed<sup>19–21</sup>. For example, in Fig. 1, the EL image is shown for two different solar cells before and after the PID experiment was performed. The darker exhibition of the cells under EL testing corresponds to less efficiency, with an estimated power loss of –17% and –22%, respectively. However, other researchers<sup>22,23</sup> have suggested using photoluminescence (PL) imaging to consider the effects of PID on cells. PL imaging is more practical for inspecting large-scale PV modules. PL imaging cannot identify inactive areas in the cells, and the interconnection failure, whereas an EL imaging setup can identify both failure modes<sup>24</sup>.

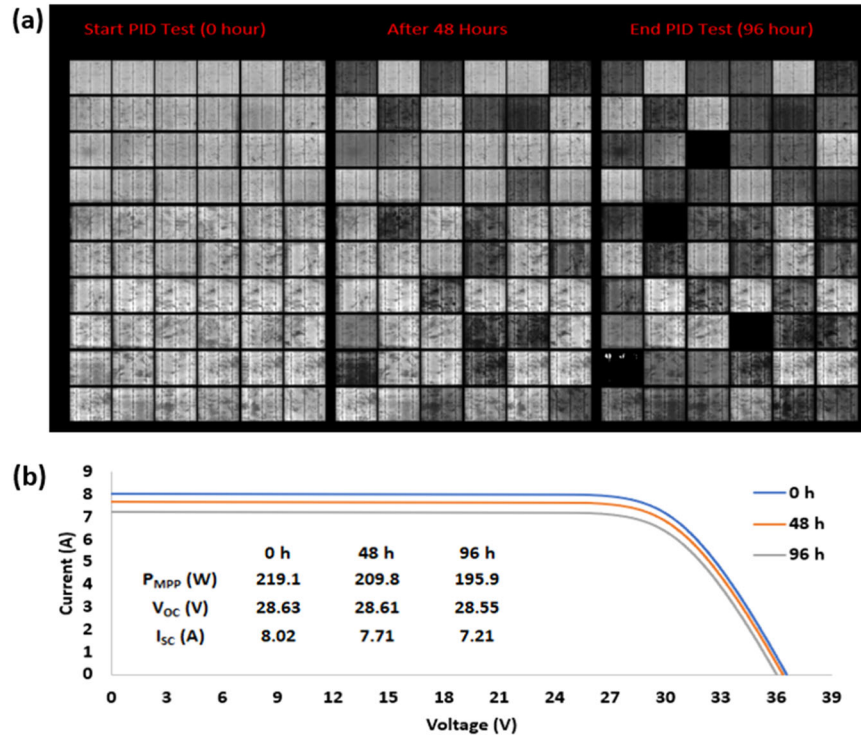
**Fig. 2** Results of the PID test. **a** EL image of a PV module before and after the PID test is performed at 0, 48, and 96 h. **b** Measured  $I$ - $V$  curves under the standard test conditions.

The PID tests were performed on the 28 tested PV modules. For example, Fig. 2a, shows the EL images of one of the examined PV modules at 0, 48, and 96 h. It is clear that the PID test develops a complete degradation mode for several cells, leading to a drop in the output power. Figure 2b shows the module's measured  $I$ - $V$  curves; as time progresses, as can be seen from these graphs there is a significant drop in the output power. Using Eq. (1), the output power loss is equal to  $-10.58\%$  after completing the PID testing. Consequently, there is a notable drop in the  $I_{SC}$ , however, there is only a slight change in the  $V_{OC}$ .

The  $V_{OC}$  slightly decreases as the module temperature increases. Accordingly, there is an expected increase in the module temperature after performing the PID testing. However, this increase is insufficient to drop the  $V_{OC}$  drastically. In comparison, a more significant drop in the  $I_{SC}$  is distinguished because the short-circuit drops when several factors change, such as a decrease in the solar cell area (i.e., cracks development in the cell) and a reduction of the number of photons observed by the cells.

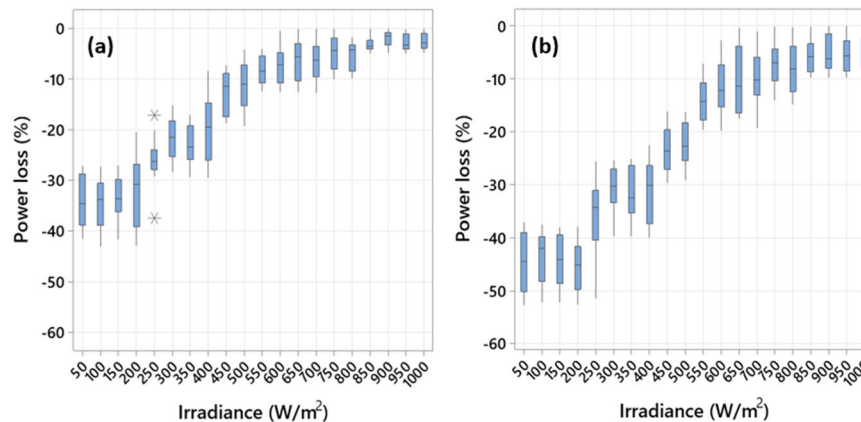
**Fig. 3** Calculated power losses versus irradiance. **a** PID test at 48 h, **b** PID test at 96 h. The irradiance step change is  $50 \text{ W/m}^2$  taken for the 24 tested PV modules, and the temperature is maintained at  $25^\circ\text{C}$ . The error bars represent the average collected data of the 28 tested PV modules.

For all tested PV modules, the correlation between the measured power losses vs irradiance during the PID test at 48 and 96 h were measured (Fig. 3), the values at 0 h have not been considered as the power losses are minimal. The power losses at  $50$ – $200$   $W/m^2$  is 2–4 times higher than at  $1000$   $W/m^2$ . This effect is due to shunting, which increases while irradiance levels are decreasing. This result concurs with the scientific community, where the PID is closely associated with reducing shunt resistance<sup>29,30</sup>. A marginal plot is a scatterplot that compares two different experiments using the data samples histogram. Accordingly, a marginal plot has been obtained and demonstrated in Fig. 4 using the measurements of the PID experiment at the initial state (0 h) and by the end of the experiment (96 h). The x-axis and y-axis represent the power losses of the examined PV module at 0 and 96 h, respectively.

The results confirm a significant power loss in the examined PV module after being subjected to the PID test for 96 h. For example, if a PV module has  $-8\%$  power losses at the initial state of the PID test, the power losses would likely be in the range of  $-30\%$  ~  $-50\%$  after 96 h.

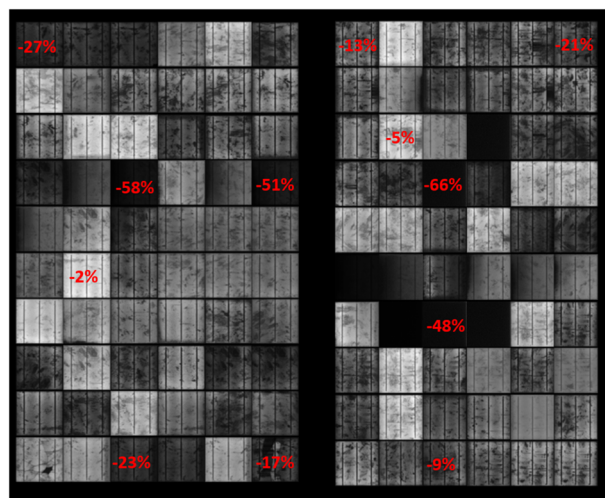
**Fig. 6** EL images after PID are completed for two different PV modules. The power loss labelled in red was estimated under the standard test conditions.

The correlation between the EL images and the actual power losses of the solar cells is shown in Fig. 6. Both PV modules EL images were taken after the PID was completed, at 96 h. This feature is already available using the EL software. It uses the difference in the light/spectrum of non-PID versus the PID images; hence, the power losses can be estimated. The “blackout” EL images does not necessarily resemble  $-100\%$  losses in the output power. This is because they have no illumination under the EL test; however, they still generate current. In contrast, it is relevant to reflect that few solar cells are unaffected after completing the PID test, and their output power losses remain below  $-5\%$ . This suggests that these cells were influenced by lower shading rates, heat, humidity, or any form of cracks during their working life.

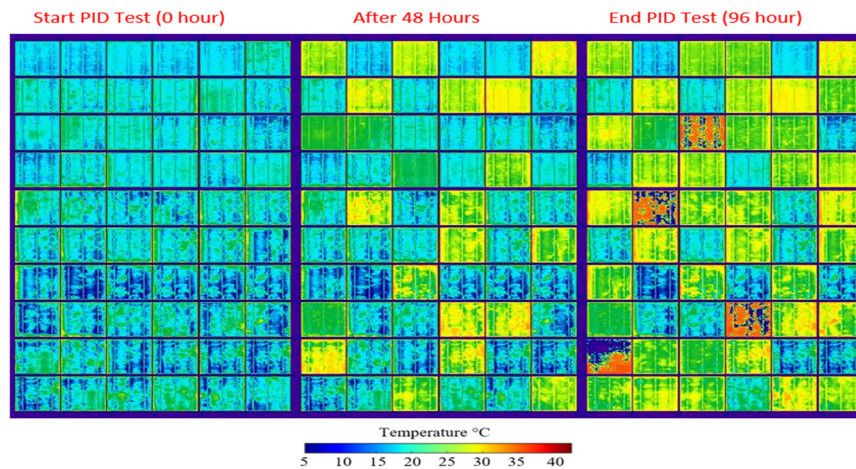
**Fig. 7 Thermal images for one of the examined PV modules taken under standard test conditions.** The EL image of this PV module is shown in Fig. 2.

The correlation between the PID and the increase in the temperature of the solar cell has also been investigated. Figure 7 shows that at the start of the PID test, 0 h, the surface temperature of the PV module is approximately  $22$  °C. After 48 h of PID testing, the PV modules develop nearly 20 hotspots with an increased temperature varying from  $25$  to  $30$  °C. At 96 h, the PID experiment has impacted the PV module with 30 hotspots, with four being affected by a significant increase in the temperature,  $45$  °C. The development of these hotspots will now affect the reliability and durability of the PV modules, making them less efficient and more difficult to operate than before the PID test.

Observing the evolution of the hotspots and considering the average surface temperature in the PV module, it can be observed that an increase in the PV module temperature after the PID test is likely to follow. It is also expected that multiple hotspots are being created in the module. The resultant hotspots in the module will impact the yield power, therefore, and as illustrated in Fig. 3, the power loss of the modules affected after the PID is completed can vary depending on the solar illumination, but, on average, there is  $-25\%$  drop in the output power.

According to Fig. 7, some solar cells are affected by a significant increase in their temperature, up to  $40^{\circ}\text{C}$ . This is because these cells are generating a much lower current compared with adjacent cells. Usually, this phenomenon occurs when the cells are being affected by cracks.
