# Preliminary analysis of a soft storey mechanism after the 2009 L'Aquila earthquake

## Abstract

## 2. Damage Observation

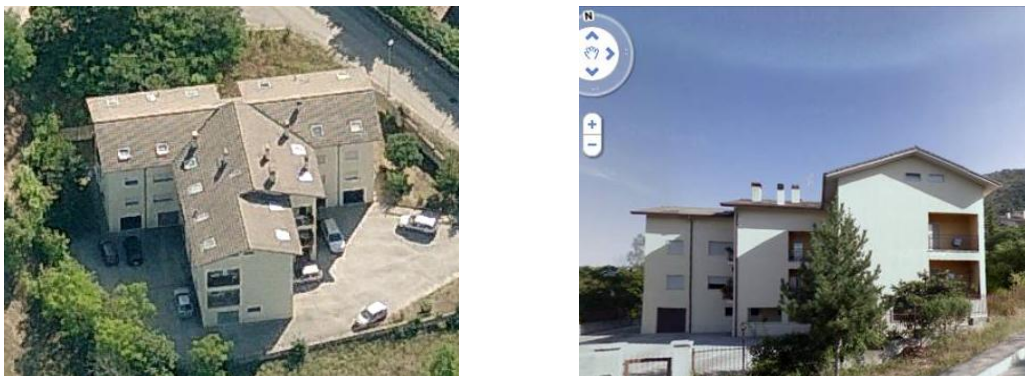
Figure 1. Pre-event view of case study building, placed in Pettino (L'Aquila) (Virtual Earth)

Figure 1 reports some aerial photographs of the building before the seismic event; some elements are clearly shown: the irregular plan, the number of storeys, the attic storey and the garage openings at the first level.

Infill distribution was determined by photographic documentation (see Figure 1).

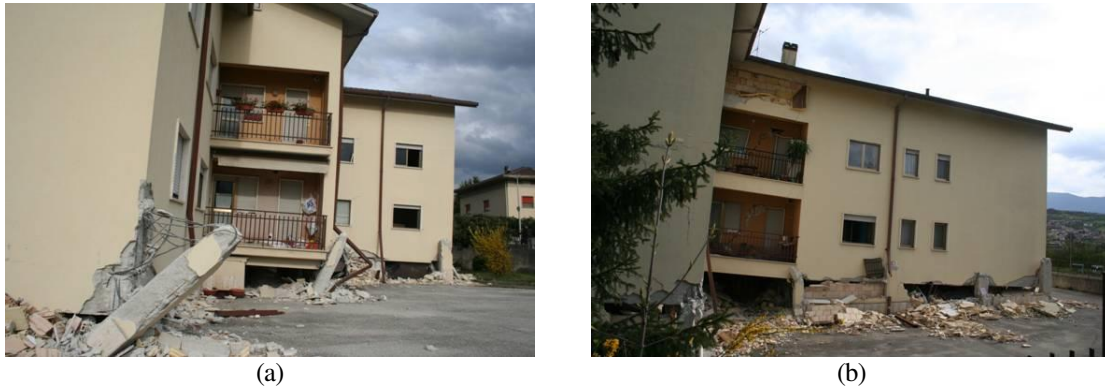
[Figure 2](#). Building collapse mechanism. Damage along South-East (a) and South-West (b) wings of the building [15]

Building collapse involved only first storey elements. In [Figure 2](#), moderate cracking in the upper storey infills is shown.

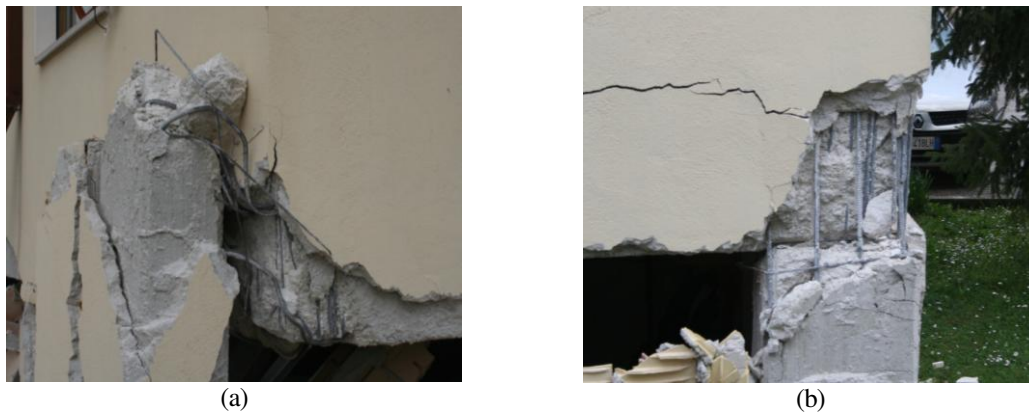
Figure 4. Damage highlights not properly treated casting surface (a, b) and absence of stirrups in the joint area (b) [15]

Failure is certainly due to a brittle mechanism. Nevertheless, columns' collapse appears to be different from a conventional brittle shear failure, due to a truss mechanism in compressed concrete or in transverse reinforcement. In this case, failure of the elements follows the development of diagonal cracks; moreover, crushed concrete struts and/or yielded transverse reinforcement can be clearly observed after failure. On the contrary, surfaces at the top of failed columns and at the bottom of corresponding joints in the present building are rather smooth (see Figure 4), leading to the hypothesis of a likely frictional failure, located along weak surfaces probably corresponding to a casting separation. Longitudinal bars crossing these surfaces were not restrained by transverse reinforcement, due to the stirrups spacing and to the complete absence of stirrups in beam-column joints. Moreover, transverse reinforcement is closed with 90 degree hooks, therefore not providing an effective anchorage. This kind of failure seems to be confirmed by damage shown in Figure 4b, in a structural element adjacent to a failed infill panel: concrete cover is crushed and longitudinal reinforcement is not restrained. There is no transverse reinforcement in the joint, and the first stirrup at the top of the

column is opened. A clean, deep crack has clearly developed along the interface between the top of the column and the joint.

In the case study structure the potential sliding surface corresponds to the casting separation between the top of the column and the beam-column joint, see Figure 4b. In authors' opinion, this surface highlights a poor treatment, similarly to what can be observed in other buildings in Pettino [16]. Therefore, the friction coefficient is given equal to 0.60, as proposed by ACI for untreated surfaces.

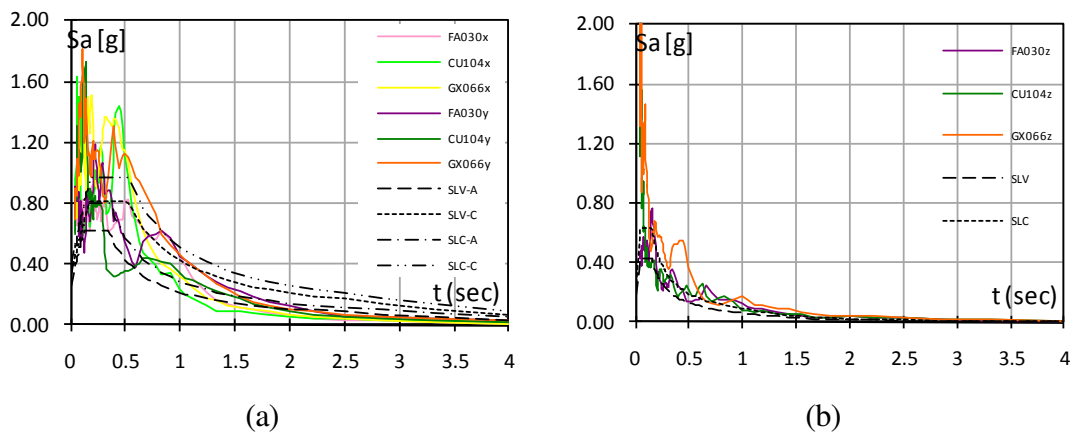
Figure 10. Elastic spectra for horizontal (a) and vertical (b) components of the record selected compared with target Italian code spectra for the site

Considering linear dynamic properties of each model (fundamental period) it is possible to predict roughly the expected response to each single record. For example horizontal components of the closest registered signal (GX066) in period range between 0.2 seconds and 0.25 seconds have spectral ordinates greatly higher than the horizontal components of the other two signals and it has the maximum vertical component in a wide range of periods. It is worth

If the dowel action is not considered (section 3.2), the sliding shear strength is proportional to the axial load. The failure occurs before than the previous case, when the dowel action mechanism is considered. This is true for all of the three signals, but above all for the GX066 signal, registered in the closest accelerometric station to the building (about 900 meters), which is probably the most representative one. Moreover, for this signal the vertical component is much severe than for the other signals, see Figure 10b.

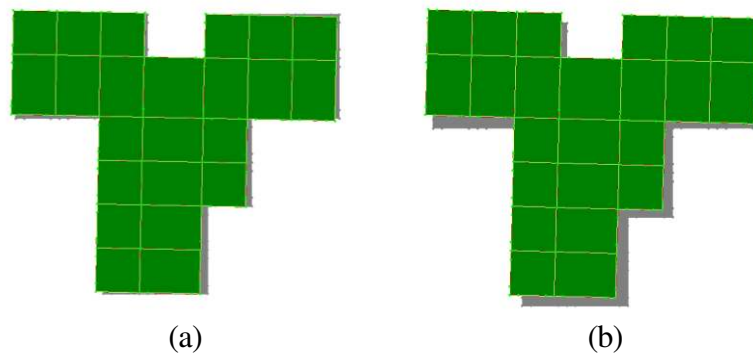
Figure 13. Plan deformed shape corresponding to the sliding shear failure, (a) without and (b) with dowel action contribution

Finally, due to the brittle mode of failure, the interstorey displacement demand at the different levels is quite low, following a deformed shape similar to the first modal shape (see Figure 13), and in infills the only cracking displacement is overcome and the maximum strength is not attained.

In particular, referring to column #3, when the sliding shear failure takes place at the top of the column, without considering dowel action, the interstorey drift ratio (IDR) is equal to 0.01% and the adjacent infill is still in elastic field (no cracking is attained), while if the dowel action is considered the IDR value corresponding to failure is 0.1% and the adjacent infill is cracked. The deformed shape after failure cannot be determined, since no shear hinge is included in the numerical model.
