# Quality Assessment of Milling Pavement Surface Using 3D Line Laser Technology

*School of Highway, Chang'an University, Middle Section of Nan Erhuan Road, Xi'an City, Shaanxi Province, China*

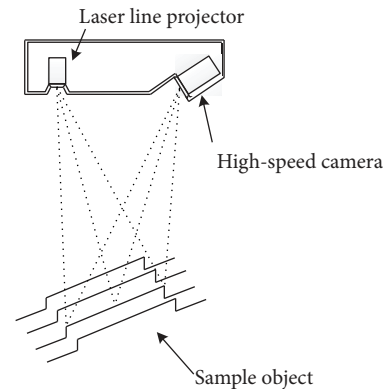
FIGURE 1: Triangulation principle of 3D laser detection.

This section briefly presents the principles of the 3D laser detection and the design of the laser scanning vehicular system that was used in this study. The 3D laser technology, which is based on the laser triangulation principle, was used to collect 3D continuous pavement transverse profile data. The laser line projector directs a continuous laser line onto the pavement, and the reflected laser line creates height information of the pavement surface. A high-speed camera captures the reflected laser line in subpixel images, as shown in Figure 1. Next, a subpixel peak measure algorithm is used to determine the location of the reflected laser subpixel to serve in 3D reconstruction of the pavement surface.

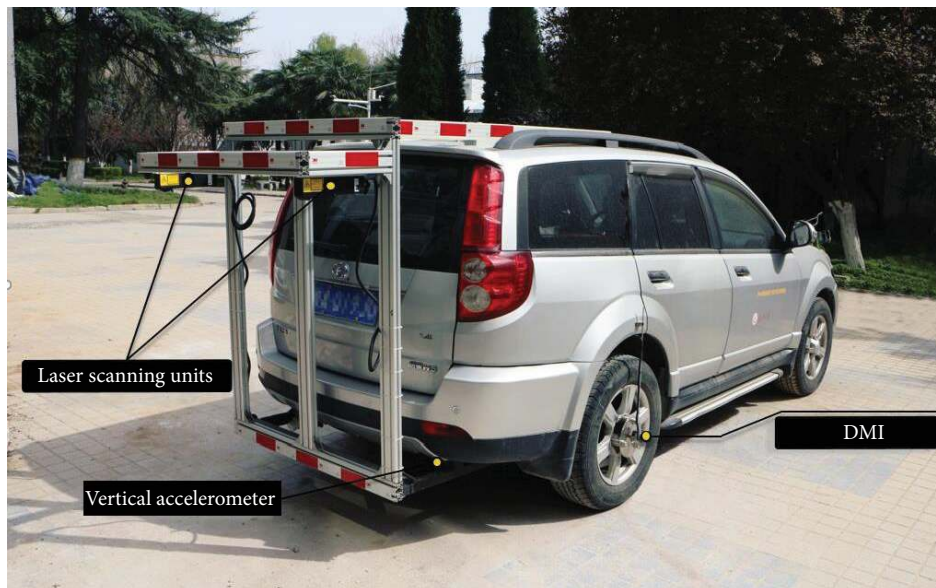
FIGURE 2: Configuration of the laser scanning vehicular system (LSVS).

The laser scanning vehicular system developed by Chang'an University is contained in a sports utility vehicle (SUV) that is equipped with two laser scanning units, a vertical accelerometer and a high-resolution distance measurement instrument (DMI), as shown in Figure 2. The laser scanning units are mounted beneath a metal brace on the back of the SUV to acquire 3D continuous transverse profile data. The vertical accelerometer is mounted under the vehicle to record the vertical displacement to synchronously correct the profile data output obtained by the laser scanning units. The DMI is mounted on the right rear wheel and controls the interval between two consecutive transverse profiles.

Two laser scanning units (Model Gocator-2380) are used to collect 3D continuous transverse pavement profiles. These units are approximately 1.8 m above the ground. Each unit collects 1.2 m wide transverse profiles with over 2000 3D laser points and cover a 2.4 m transverse field-of-view. When the vehicle speed is no greater than 40 km/h, the laser scanning unit controlled by the DMI can collect data at an interval of 2 mm in the travel direction and with a scan frequency of 4500 profiles per second. To ensure that these units can measure the milling texture, the two laser scanning units provide a 0.55 mm resolution in the transverse direction and at least a 0.5 mm resolution in the vertical direction after setting the device parameters.

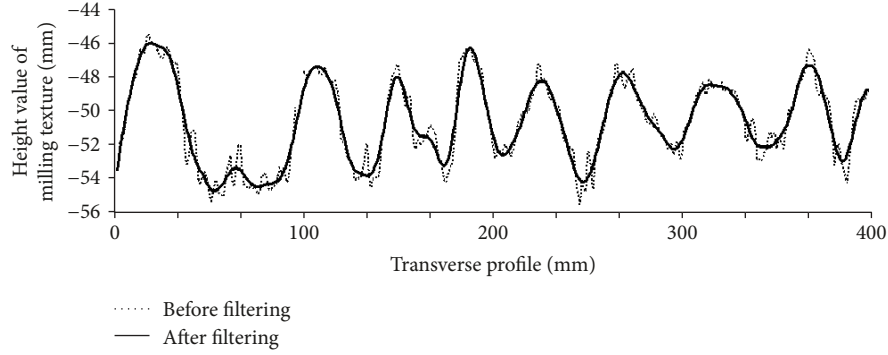
FIGURE 3: Filtering of the transverse profile data.

milled texture of the asphalt pavement, a locally weighted scatterplot filtering algorithm was used to process the laser transverse profile curves with MATLAB software. The transverse profile curve filtering with least squares and polynomial fitting was used to replace the original data. Figure 3 shows an example of the transverse profile curve filtering results when the width of the filtering window is set to  $0.5$ . The preliminary results of the curve filtering with 3D laser measurement demonstrate that the locally weighted scatterplot filtering algorithm can remove noise and unimportant texture characteristics; thus, this method is very promising for processing the transverse profile curve to improve the accuracy of the milled surface assessment.

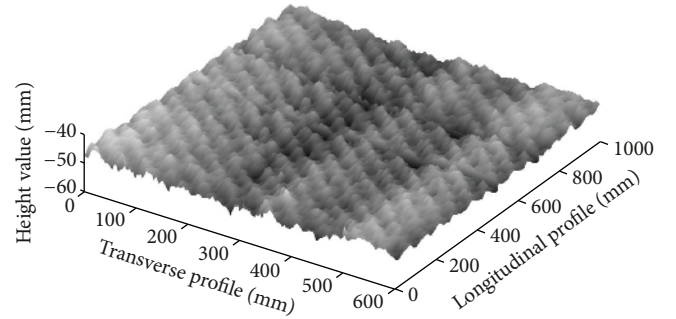
FIGURE 4: An example of 3D reconstructed model of milling surface.

of a 600 mm × 1000 mm milled surface texture model is shown in Figure 4; both the transverse and longitudinal resolutions of the model are equal to 0.5 mm. Figure 4 shows the milled texture of the model surface and its symmetrical distribution. The substandard milling area in the center of model, which might be attributed to residual distress on milled surface (such as rutting and subsidence of subgrade or loss of aggregates via the fatigue of the asphalt binder), is clearly captured by 3D laser detection. The preliminary results of the constructed milling model show that the locations and areas of poor milling can be identified using the laser milling data.

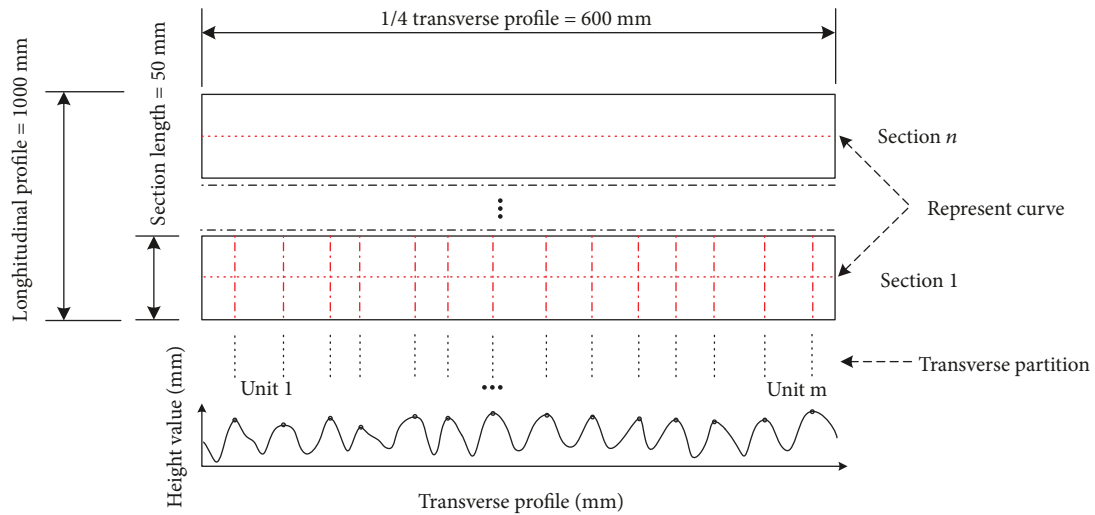
FIGURE 5: Divided sections and partition units from the model.

- (1) Partition a 2400 mm × 1000 mm scanning area into four blocks (blocks 1, 2, 3, and 4) along the transverse profile and construct a milling surface model for each part. Next, divide the milling surface model into several 600 mm × 50 mm rectangular sections (sections 1, 2, ...,  $n$ ) along the longitudinal direction and capture the midline curve of the laser transverse profile as the representative curve, as shown in

Figure 5, to describe the milling condition and texture conditions of each section.

- (2) With the curve peak extraction algorithm in MATLAB software, determine the peak points  $(x_i, y_i)$  and trough points  $(x_j, y_j)$  of the milling valley during 1.5 times the milling cutter spacing range from the representative curve, as shown in Figure 5. Next, partition the representative curve into several milling valley units (units 1, 2, ...,  $m$ ) with peak points of the milling valley.
- (3) Figure 6 illustrates the milling depth and texture depth of milling valley unit data used to calculate the milling depth  $h_i$  of milling valley number  $i$  using the formula

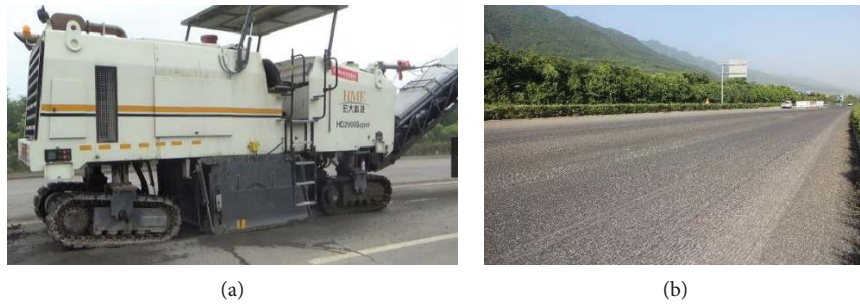
FIGURE 7: Milling operation on test field: (a) milling machine in the field and (b) milling surface in the field.

**4.1. Field Sites.** Field tests were conducted on a section of Highway S107 with a low longitudinal slope and straight asphalt pavement near Xi'an. Figure 7(a) shows the HD2000 super milling machine (which has a milling cutter spacing of 40 mm) used for this operation. The milled pavement is shown in Figure 7(b). The asphalt pavement's upper layer is AC-13; it was milled to a depth of 50 mm to repair rutting and cracking of the pavement surface. The field test is designed to evaluate the roughness and texture of the milling surface and the feasibility of operating the laser scanning vehicular system at common traveling speeds.

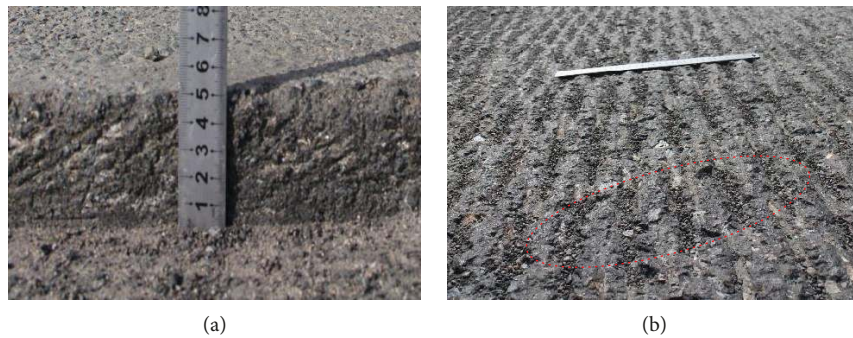
FIGURE 8: Milled pavement surface in the field: (a) milling depth after operation and (b) milling texture in the field.

With a vehicle speed of 45 km/h, the system acquires more than 5 million 3D data points from 2400 widths and 1000 mm long milling areas with substandard milling to describe the roughness and texture of the pavement surface in detail, as shown in Figure 8. Figure 8(a) shows the milling depth of the pavement, and an image of the measuring area is shown in Figure 8(b). A substandard milling area is marked on the image (Figure 8(b)); there, a loss of aggregate occurred, and the roughness is poor.

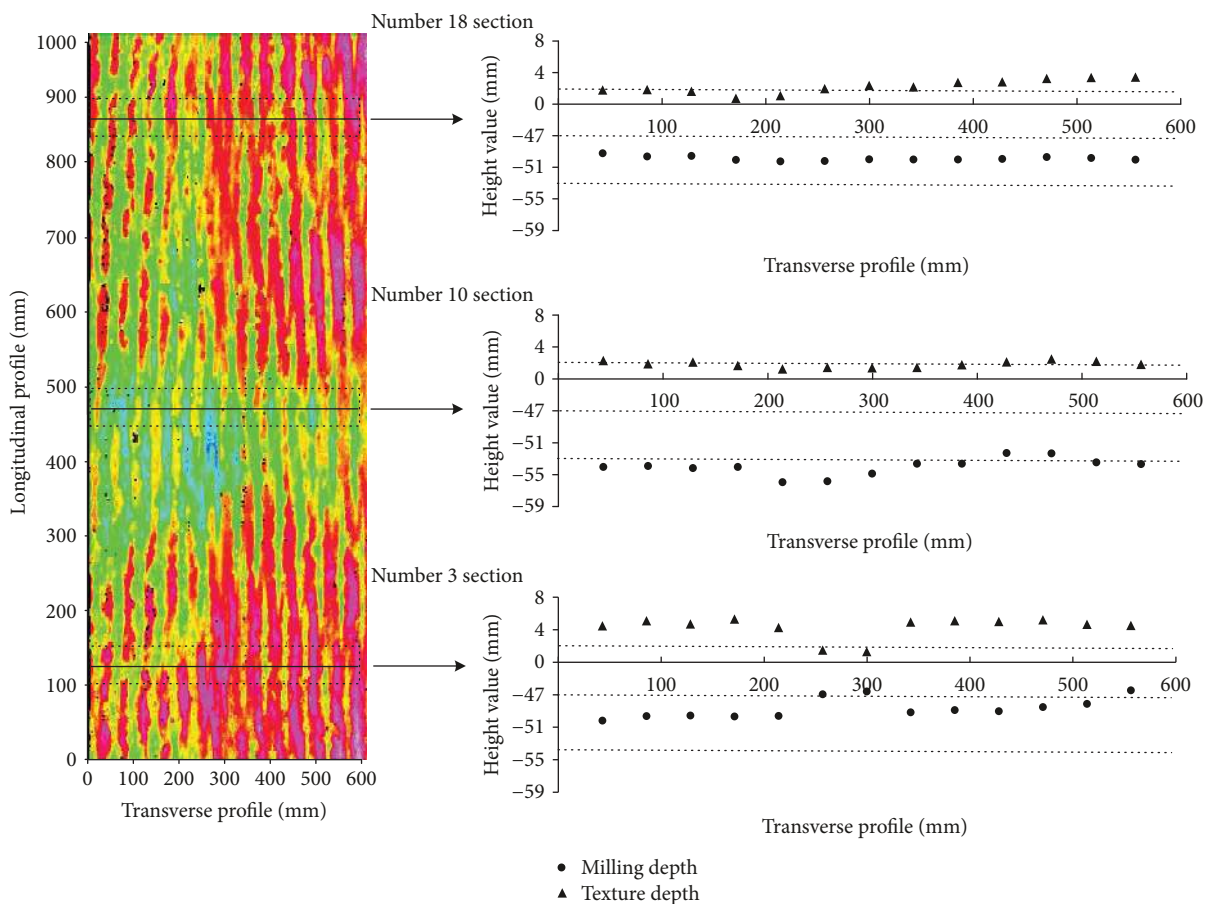
FIGURE 9: Example of texture depth and milling depth of block.

**4.2. Test Results and Analysis.** Figure 9 shows a 3D milling model of a block and an example of scatter plots of three sections of milling depths and texture depths. Twenty 50 mm long longitudinal sections with 13 milling units in block 1 were considered. The dotted line in the plot represents the critical access line of substandard milling in this operation: 2 mm for the texture depth and -47 mm and -53 mm for the milling depths.

The preliminary results of the texture depth and the milling depth of each block, as shown in Figure 9, demonstrate that the proposed method can accurately identify the location of the substandard area of milling and can calculate the proportion of the substandard area within the entire milled area. In section number 3, the milling depths of units 6, 7, and 13 exceed -47 mm, and the

texture depths in units 6 and 7 are less than 2 mm. In section number 10, all the milling depths, except those in units 10 and 11, are less than  $-53$  mm. In section number 18, the texture depths in units 1 to 6 are less than 2 mm. This situation may have been caused by the poor toughness of the original pavement; as a result, the milling quality is poor, leading to the loss of aggregate and uneven milling surface.
