## **“Quantifying Optical Loss of High-Voltage Degradation Modes in PV Modules Using Spectral Analysis”**

David C. Miller, Katherine Hurst, Archana Sinha, Joanna Bomber, Jiadong Qian, Stephanie L. Moffitt, Soňa Uličná, Laura T. Schelhas, Peter Hacke

Presentation Format/Supplementary Information

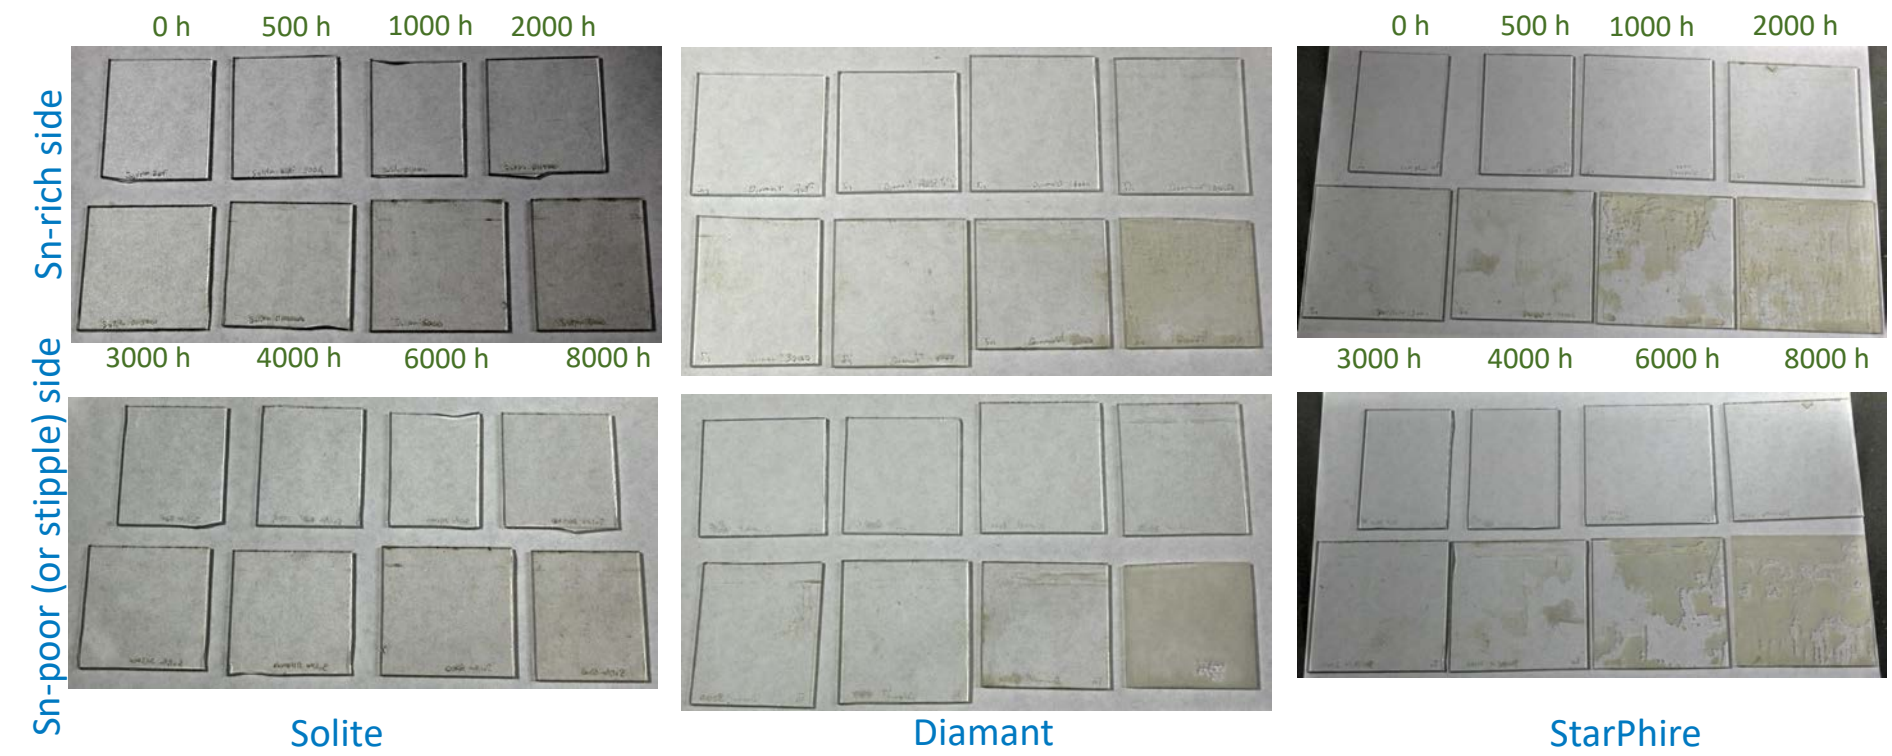
- Glass corrosion gives a (yellow) discoloration.

- StarPhire, Diamant: little, localized damage on Sn-rich side.
- Diamant: crystalline structure to corroded surface, Sn-rich & Sn-poor
- Solite: yellow/brown color often seen with localized corrosion. Difficult to image stipple surface.

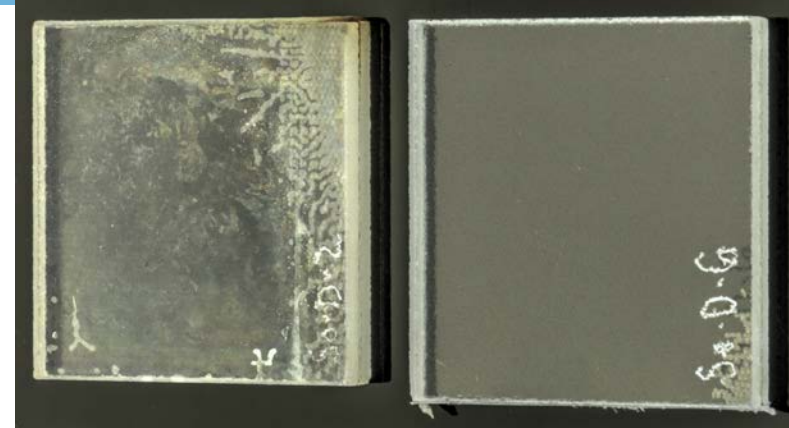
# Failure Analysis of DH4000: External Optical Microscopy (Solite & TPO-3, 30x)

- TPO-3 (Solite glass) gives external glass corrosion, with very limited evidence of internal haze formation.
  - Solite is a soda-lime glass that will corrode in Damp Heat.
  - PO has no acetate side groups: no acetic acid (internal to coupons).
  - Effect reduced for TPO relative to EVA (Solite).
  - Slight halo observed adjacent to periphery.
  - Transmittance initially increased, consistent with external glass corrosion.
- EVA-3 (silica glass) gives internal haze formation, with no evidence of external glass corrosion.
  - No glass corrosion would be expected for silica (no Ca, Na, or Mg).
  - EVA can still produce acetic acid (internal to coupons).
  - Effect reduced for EVA-3 (silica) relative to EVA-3 (Solite).
  - Less affected periphery from ready egress of water?

Camera photo (entire specimen).

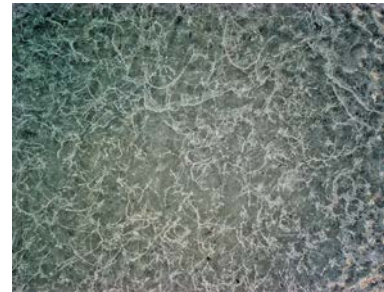
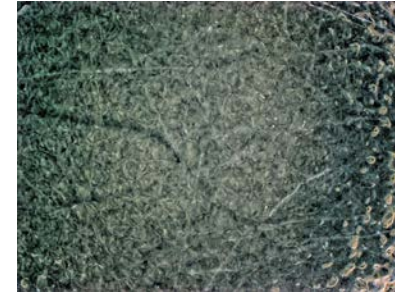
aged & cleaned

unaged

Representative microscope images, typically from the “center” location.

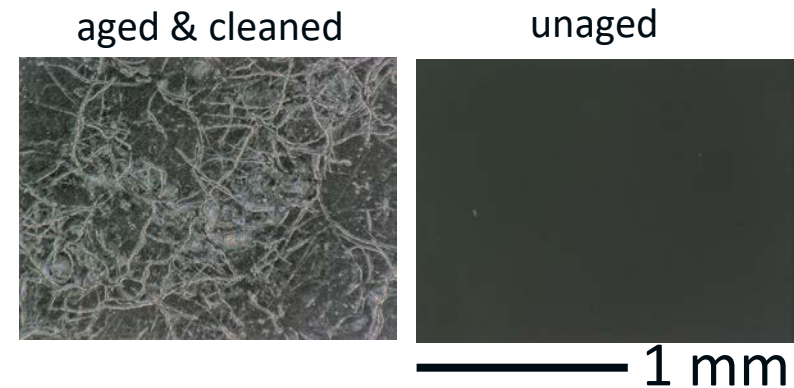
- External glass corrosion confirmed for aged Solite glass.

Representative microscope images, typically from the “center” location.

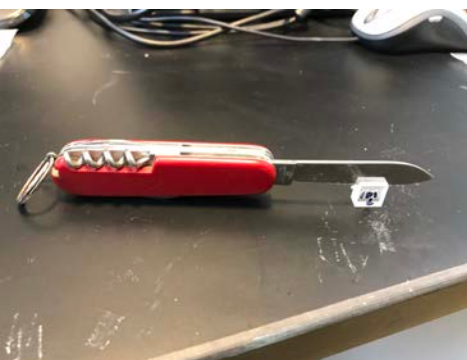
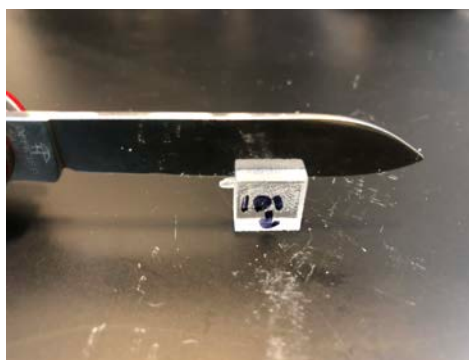
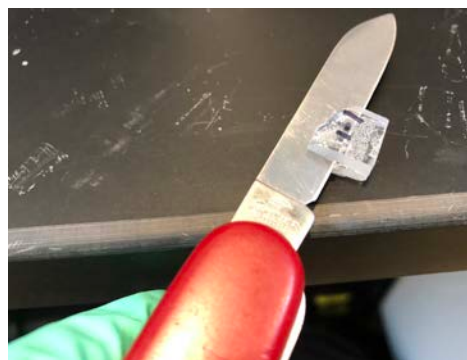
# Failure Analysis of DH4000: Internal Optical Microscopy (Solite & EVA-A)

Effect of optical polarization observed (EVA is birefringent) in only second session (DI soak & edge) for unaged EVA; DH samples did not show color though.  
DI: sprayed/rinsed samples 5x at faucet temperature, then soaked over in 50 mL DI, at ambient T

All samples imaged with innermost facing edge along bottom of screen (bottom of the image, this is the core of the anaerobic region).

- Good adhesion (encapsulant/glass) from manual separation force for unaged; reduced adhesion for DH4000.
- Internal glass corrosion confirmed for aged Solite glass.
- Bits of glass lost from Solite, embedded in encapsulant.
- Comparing the same location, modestly water-soluble material at interface aged samples.

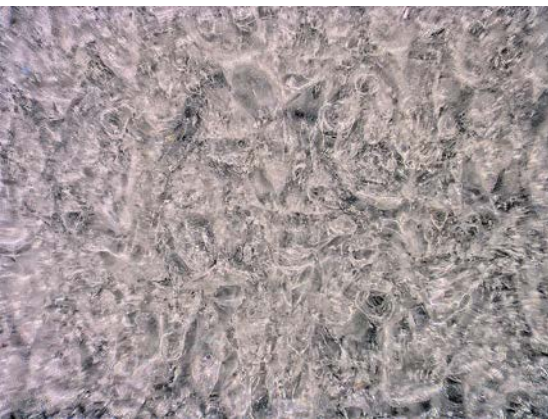
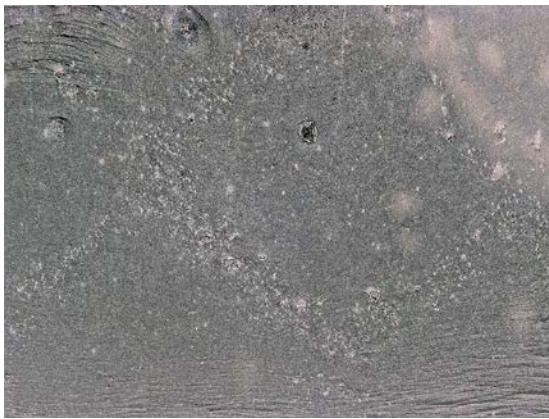
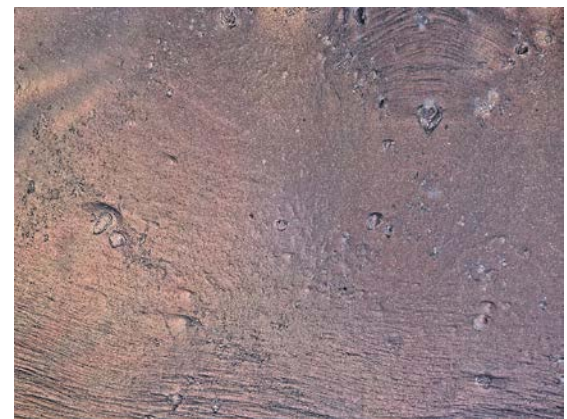
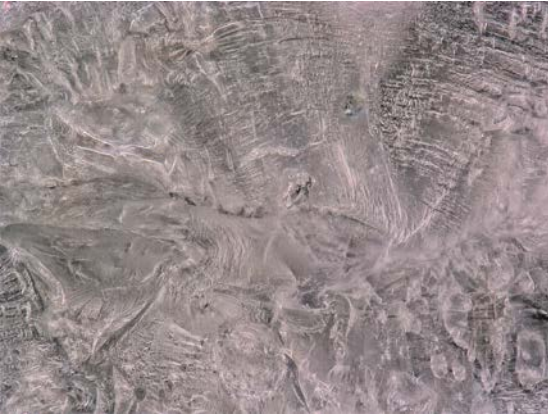
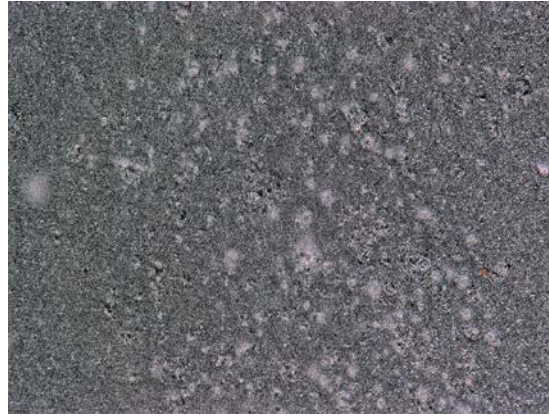
test (after DI rinse & soak)

Representative microscope images, from unaged and DH aged coupons, from the "center" location.

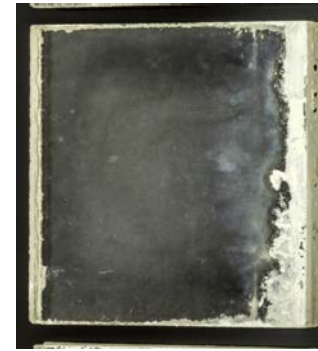
- >20%  $\tau_h$  loss confirmed on OMI.
- <https://doi.org/10.1109/JPHOTOV.2021.3122925>
- Precipitate formation, adhesion reduction observed at glass/encapsulant interface in destructive failure analysis.

- $\tau_h$  recovered in subsequent OMI examination!

Appearance of specimen G-DH-3 (Damp Heat aging).

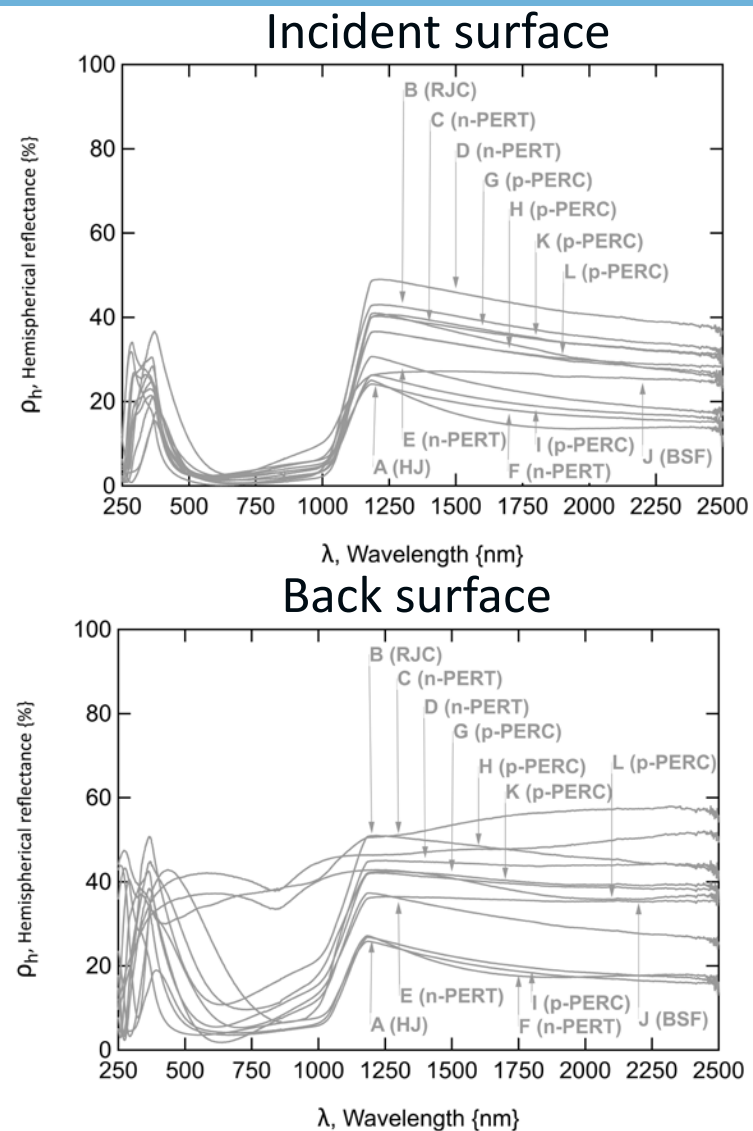
- $\rho$  of cells examined in this study was measured, both front (sun) & back (air) surface.
- Mostly contemporary cells examined (RJC, HJ, PERC, PERT) including mostly bifacial, few legacy cells (BSF).
- Difference in reflectance is expected for encapsulant/cell vs. air/cell configurations.
- Incident surface suggests localized performance improvement of SiN coating (with destructive interference) with the spectrum broadening effect of textured Si surface.
- Back surface reflectance is not as optimal (metallization and/or processing), including bifacial.

**Measured reflectance (in air) for the cells used in the screen test for this project, including cell front (top) and cell back (bottom)**

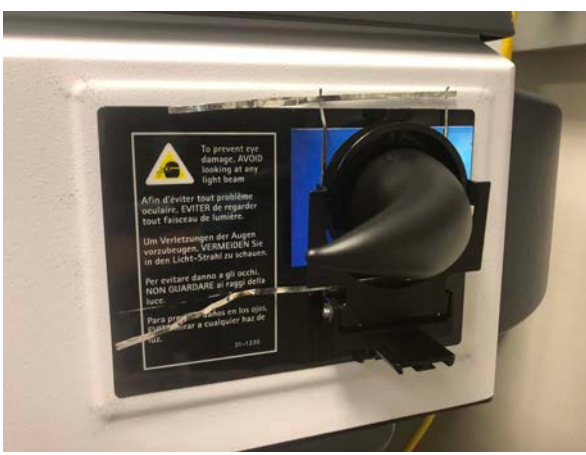
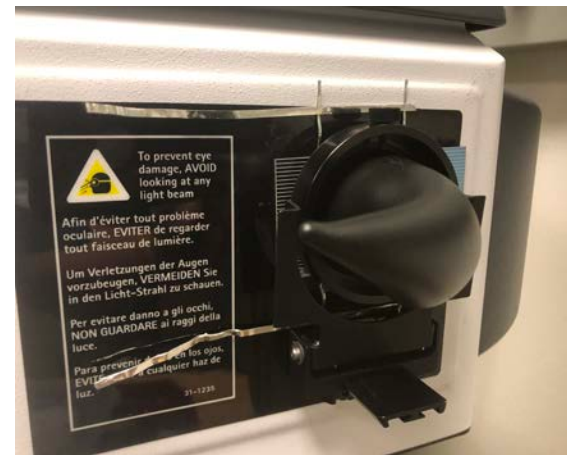
Test cell and light trap on the spectrophotometer.

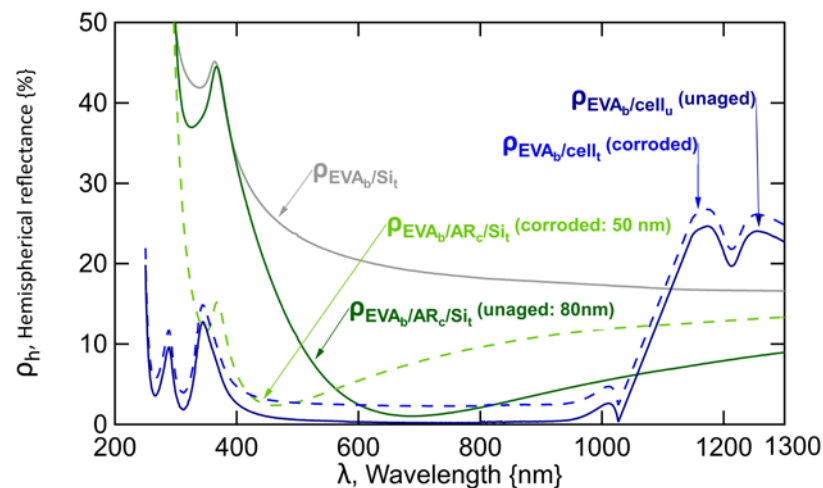
- Modeling effect of corrosion: an offset of 2.1% for  $\rho_{\text{EVA}_t/\text{ARC}/\text{Si-textured}}$  gives less red shift at 400 nm than  $\rho_h = c_1 (\rho_{\text{EVA}_t/\text{ARC}/\text{Si-textured}} - \rho_{\text{EVA}_b//\text{Si}})$ .

Spectra for packaged specimens (at interface with UV transmitting) showing the optical effects (reflectance) that might be encountered from degradation.
