Real-Time BIST Detector for BGA Faults in Field Programmable Gate Arrays (FPGAs)

James P. Hofmeister, Justin Judkins, Ph.D., Edgar Ortiz, Douglas Goodman,
Ridgetop Group, Inc.
3580 West Ina Road,
Tucson, Arizona 85741 USA
Hoffy@ridgetop-group.com, Justin@ridgetop-group.com

Abstract - In this paper we introduce a solder-joint built-in-self-test (SJ BIST) for detecting high-resistance and intermittent faults in operational, fully programmed field programmable gate arrays (FPGAs). The approach is simple to implement, offers a method to detect high-resistance faults that result from damaged solder joints, and uses a maximum of one small capacitor externally connected to each selected test pin or each group of two test pins.

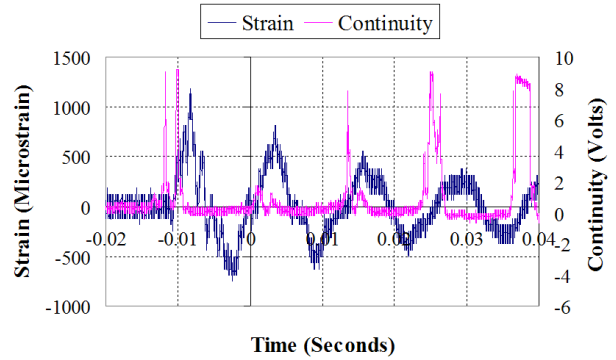
Figure 2: Shock-actuated Failure: Transient Strain and Resistance

These intermittent faults increase in frequency as evidenced by a practice of logging BGA package failures only after multiple events of high resistance: an initial event followed by some number (for example, 2 to 10) of additional events within a specified period of time, such as ten percent of the number of cycles of the initial event [8-10]. Even then, an intermittent fault of high resistance in a solder-joint network might not result in an operational fault. For example, the high-resistance fault might happen in a ground or power connection, or it might happen during a period when the network is not being written, or it might be too short in duration to cause a signal error. Figure 2 shows a shock-actuated intermittent OPEN (high resistance) of a package interconnect.

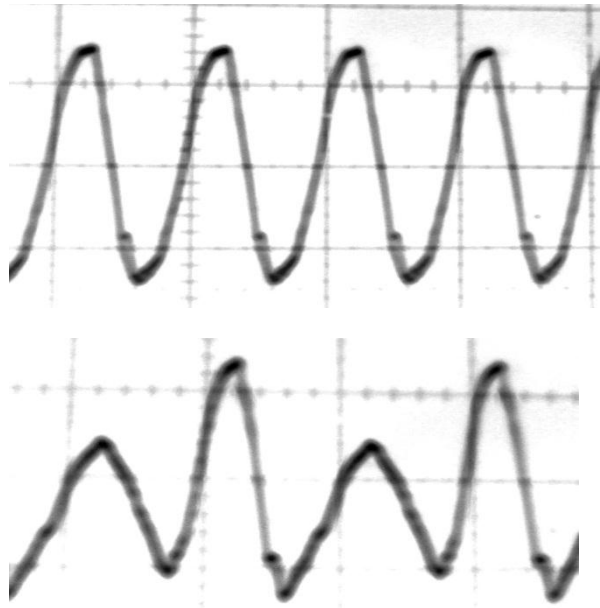
Figure 7: Solder-Joint BIST – Input 10MHz Clock: Signal Across Capacitance: Normal Resistance of <1 Ohm (top) and Resistance of 100 Ohm (bottom): 2 μ s x 2.0V Grid

A high-resistance fault in an I/O port causes the capacitor to fail to fully charge as shown in the oscilloscope view shown at the bottom of Figure 6 and Figure 7. Because of the increase in the network resistance, the charged voltage across the capacitor is less than 1.0V instead of 3.3V at the time of the read. This is logical '0' instead of a logical '1' – which is a fault. The SJ BIST detects it.

1MHz is shown in Figure 6; Figure 7 shows the test result at 20MHz.
