# Real-Time Coral Stress Observations Before, During, and After Beach Nourishment Dredging Offshore SE Florida

# REAL-TIME CORAL STRESS OBSERVATIONS BEFORE, DURING, AND AFTER BEACH NOURISHMENT DREDGING OFFSHORE SOUTHEAST FLORIDA, USA.

**Abstract.** Beach nourishment in Southeast Florida involves dredging sand source borrow areas located between offshore reefs. From May 2005 to February 2006 Broward County, FL. nourished 10.9 km of beach with  $1.5 \times 10^6$  m<sup>3</sup> of sand. As part of a program to monitor potential reef community impacts, a visual stress index was developed from laboratory experiments and histological analyses for three stony coral species (*Montastrea cavernosa*, *Solenastrea bournoni*, and *Siderastrea siderea*). Scoring involved healthy = 0; moderately stressed = 1 (polyp swelling, increased mucus); markedly stressed = 2 (coloration changes, increased mucus secretion, tissue thinning); and severely stressed = 3 (severe swelling/thinning tissue erosion/necrosis). Colonies were scored weekly at sites adjacent to borrow areas and control sites pre-, during, and post-dredging. Permit conditions were established which would suspend dredging based on mean

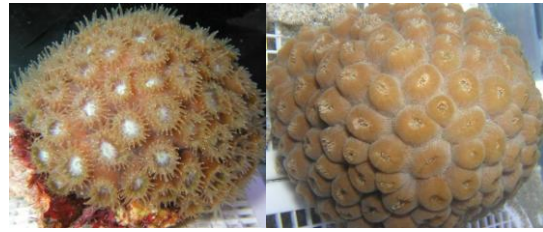
Figure 2a: STRESS LEVEL 0: Color appears normal; polyps are fully extended or loosely retracted; no tissue swelling; no apparent mucus sheets over colony.

The stress index was developed in the laboratory and verified histopathologically (Vargas-Angel, et al., 2006). Average values above 1.5 (n=6) at 50% of sites surrounding a particular borrow area would trigger cessation of dredging at that borrow until average stress fell below threshold. Figure 2 shows typical observable stress responses of *Montastraea cavernosa* for each stress index level. Treatment study sites were established adjacent to each borrow area (Figure 1) and control sites established 4-5 km north (3 sites) and south (5 sites) of the dredge operating area. Six colonies among the three species were selected at each site. Sites were visited and stress observations made weekly for thirteen weeks pre-construction, weekly during construction (38 continuous weeks with two exceptions due to tropical cyclone activity, and weekly for eight weeks post-construction. Additional observations from non-project colonies were made occasionally from outside

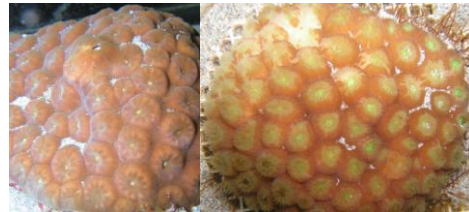
Figure 2c: STRESS LEVEL 2: Normal coloration to patchy bleaching. Normal texture lines begin to disappear; polyps appear "melted"; severe tissue swelling and apparent tissue thinning; presence of mucus sheets and sand accumulations between polyps.

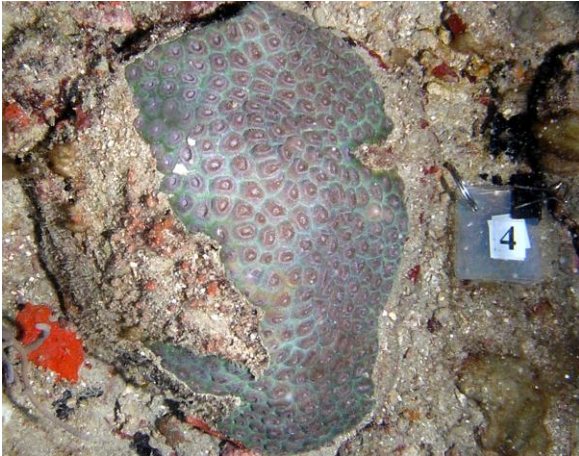
Figure 3a. Example of a monitored *M. cavernosa* colony at stress level 0 during construction on July 5, 2005.

Figure 3 presents photographic evidence that the observed level of stress for a *Montastraea cavernosa* colony from one of the treatment sites changed from level 0 to level 2 during construction and returned to

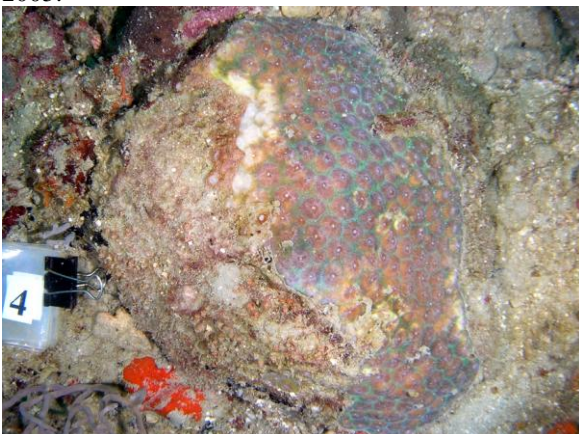
Figure 3b. The same colony at stress level 2 during construction on December 5, 2005, after the passage of three tropical cyclones.

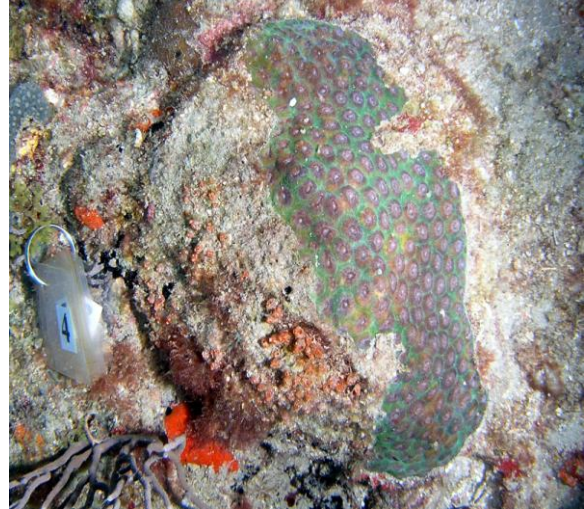
Figure 3c. The same colony showing some tissue loss in the upper left, however, the remaining colony has recovered to stress level 1 during post construction on March 22, 2006

level 1 after construction was completed. Average stress values (Figure 4) at treatment sites (n = 26 sites and 156 colonies) and control sites (n = 8 sites and 48 colonies) remained below 0.5 during the thirteen week pre-construction period and through the 14th week of dredging. The passing of Hurricane Katrina during construction week 15, Hurricane Rita during week 19, and Hurricane Wilma during week 24 contributed to immediate elevated observed average stress values between 0.5 and 1.0. Average histological stress was the highest during the summer maximum temperature (31.9°) that occurred in August, 2005 (Vargas-Angel, personal communication). Average stress remained between 0.5 and 1.0 for the eight weeks of post-event analysis, indicating a recovery period to pre-impact levels longer than 8 weeks.

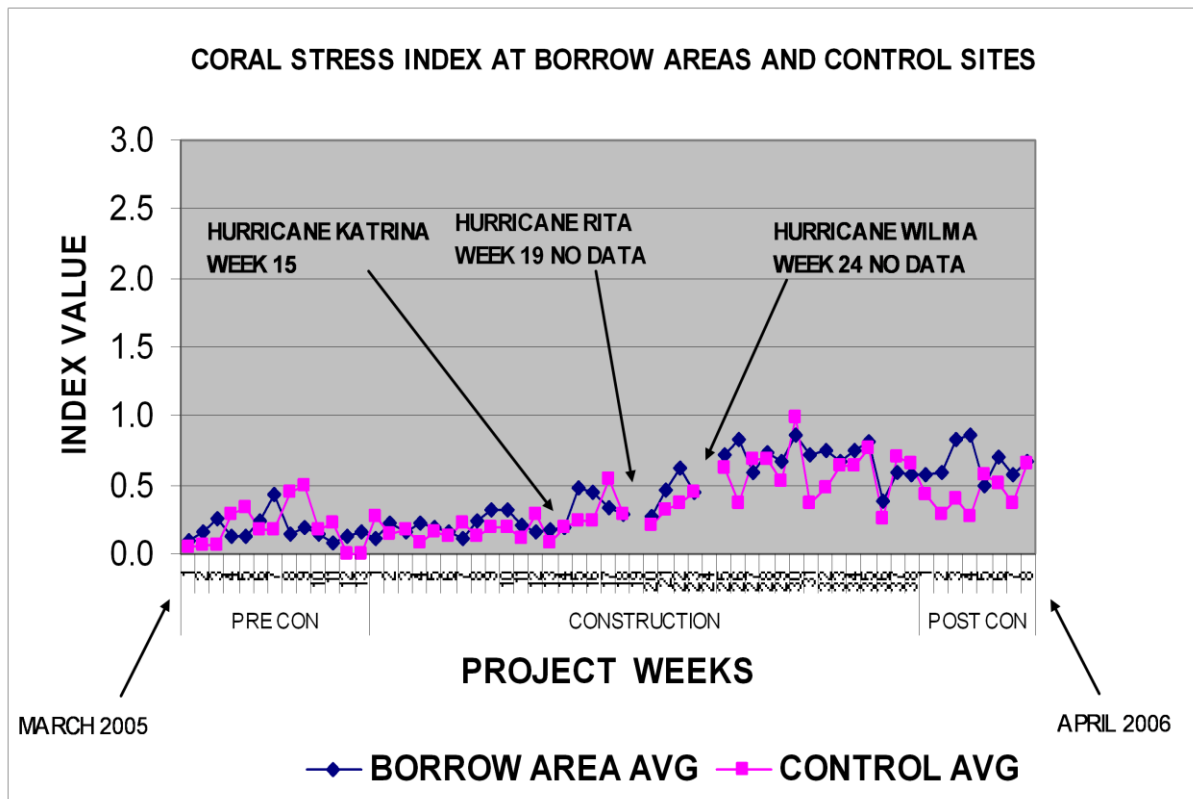
Figure 4. Mean observed stress index values for all corals at all monitoring sites pre- (precon), during (construction), and post-dredging (postcon). Stress values at treatment and control sites began increasing after the passage of Hurricane Katrina and remained elevated after the passage of Hurricane Wilma throughout the remaining monitoring period.
