Rehabilitation of Reinforced Concrete Deep Beams Using Carbon Fiber Reinforced Polymers (CFRP)

Shereen K. H. Hassan¹, Mu`tasim S. Abdel-Jaber¹ & Maha Alqam¹

¹ Department of Civil Engineering, The University of Jordan, Amman, Jordan

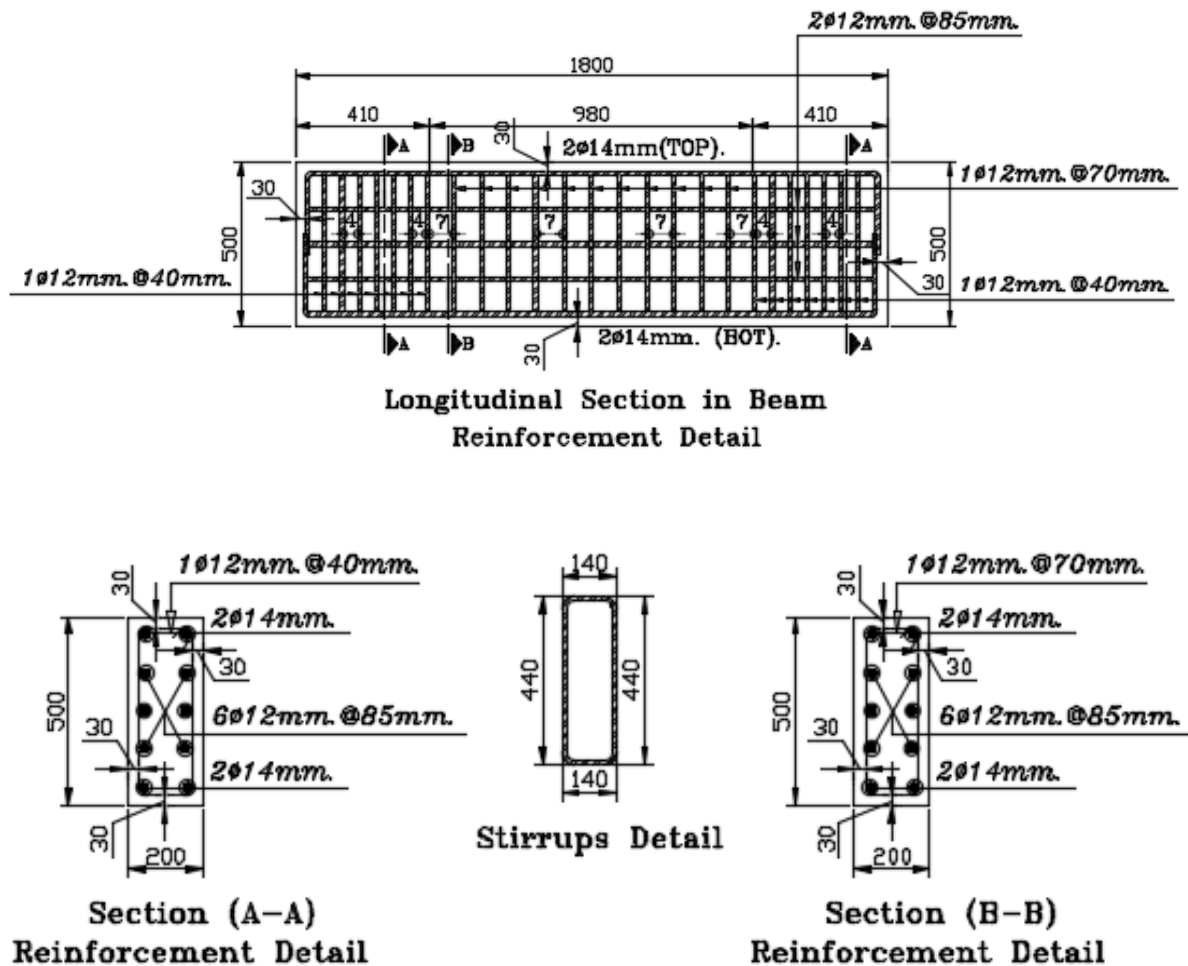
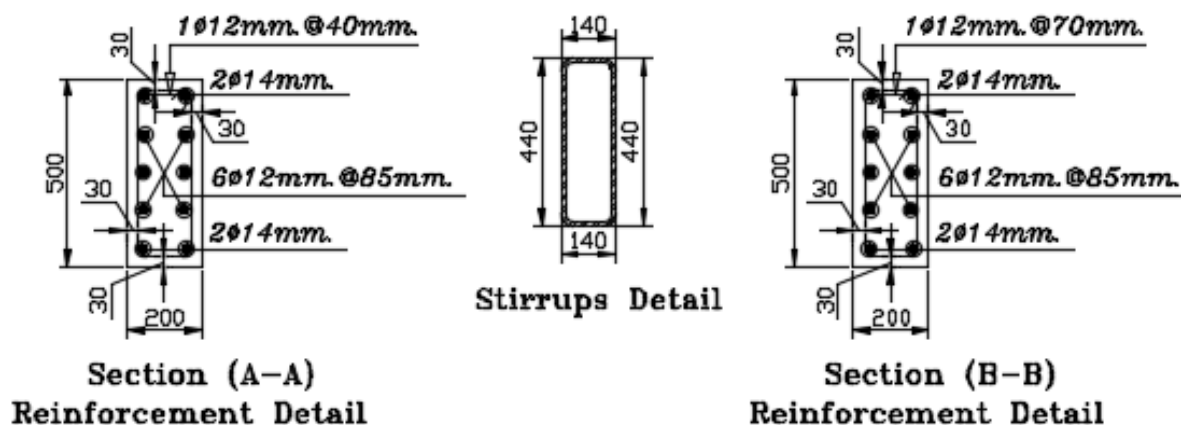
Figure 1. Dimension and Reinforcement Details of Test Specimens

All tested RCDBs had cross-sectional dimensions of 200 mm width, 500 mm depth and 1800 mm length. The ten test specimens were designed to fail in flexure rather than shear. Design of test specimens was according to ACI318M-14, ASTM C293-02 and ACI 440.2R-08 specifications. The type of reinforcement used in this test for all test specimens was high yield strength deformed bars of grade 60 (ksi) which have minimum yield strength of 420 (MPa). Two type of deformed bar reinforcement were used in RCDBs; and they are 2Φ14 as minimum longitudinal top and bottom reinforcement; 25Φ12 closed stirrups and three layers of 2Φ12 as horizontal reinforcement. Dimensions and reinforcement details of test specimens are illustrated in Figure 1.

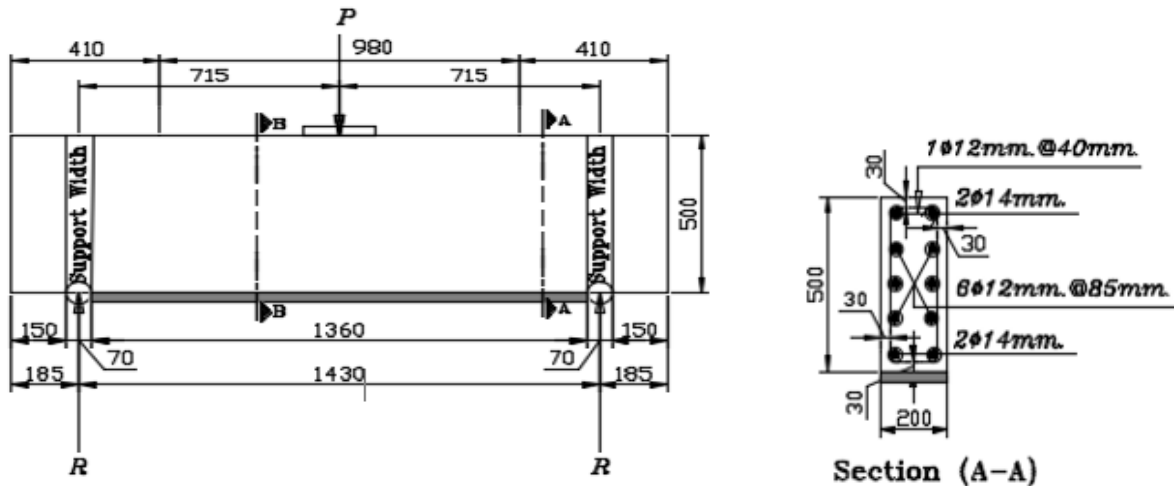
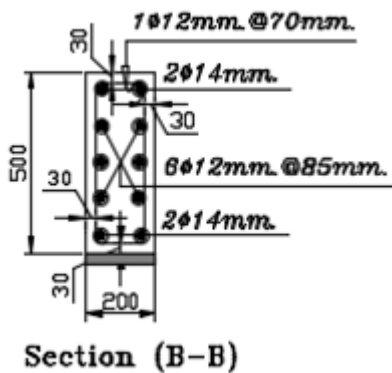
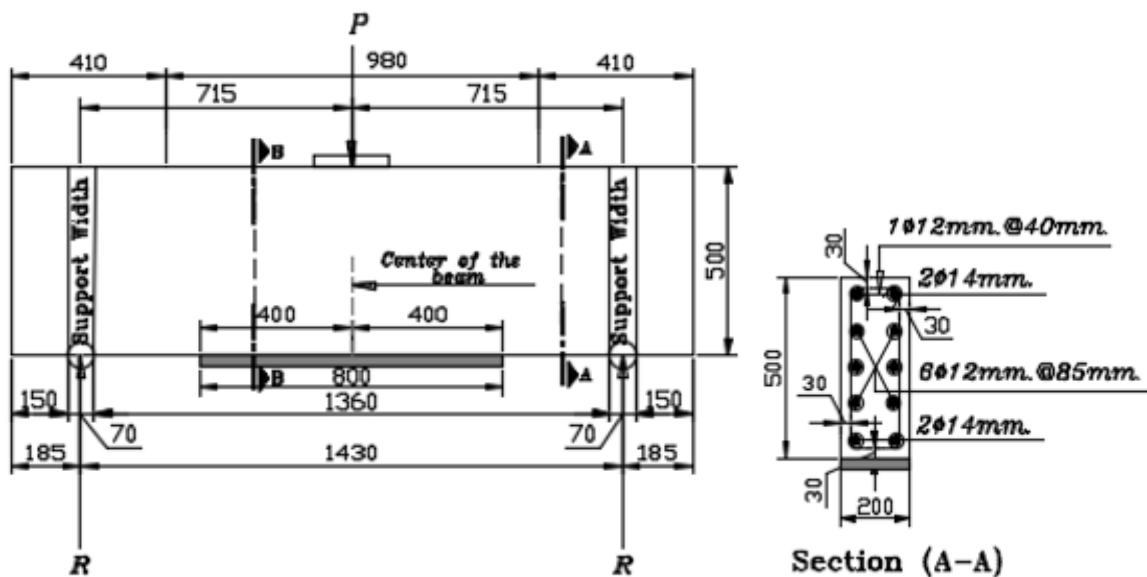
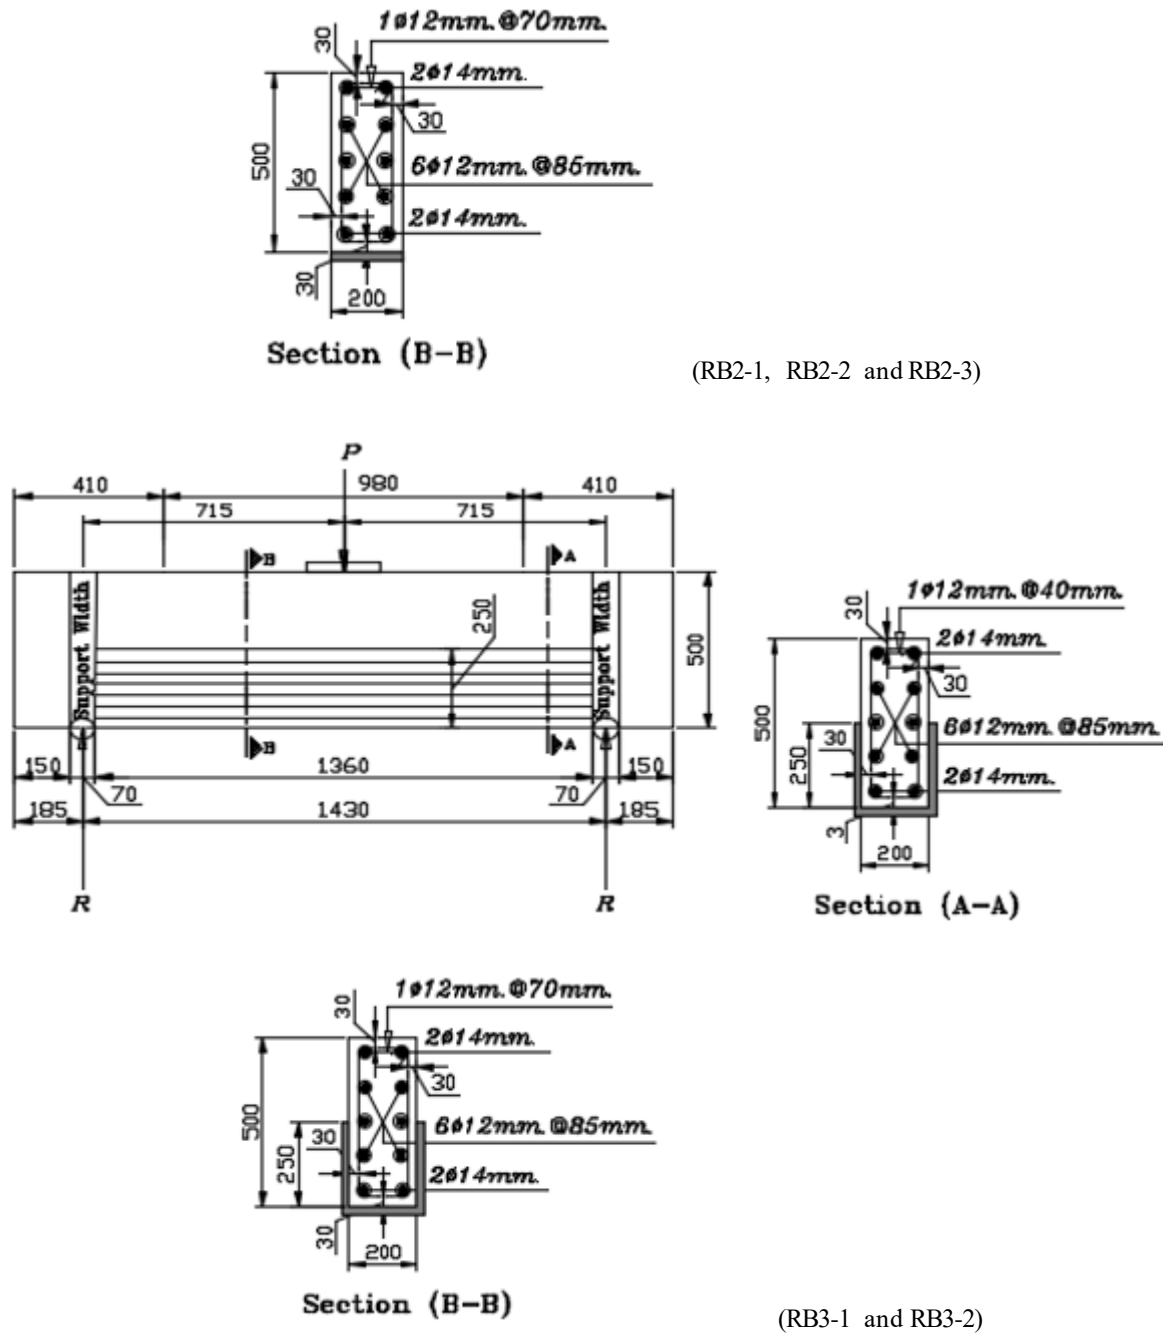
Figure 3. Schemes of CFRP Materials for Rehabilitated Test Groups

The second and third test groups were enhanced with two strips of MBrace laminate (each strip 100 mm wide) bonded externally to the bottom side of the beam and covering the full width of the beam between the supports in the 2nd test group and with a length equal to 400 mm from left and right side of centre line of the beam in the 3rd test group (i.e. with total length equal to 800 mm), while 4th test group was enhanced with a U-shape of MBrace Fiber 230/4900 covering full width of the beam between the supports and covering half of the depth from both sides of the beam. Schemes of CFRP materials of three rehabilitated test groups are illustrated in the Figure 3.

(RB1-1, RB1-2 and RB1-3)

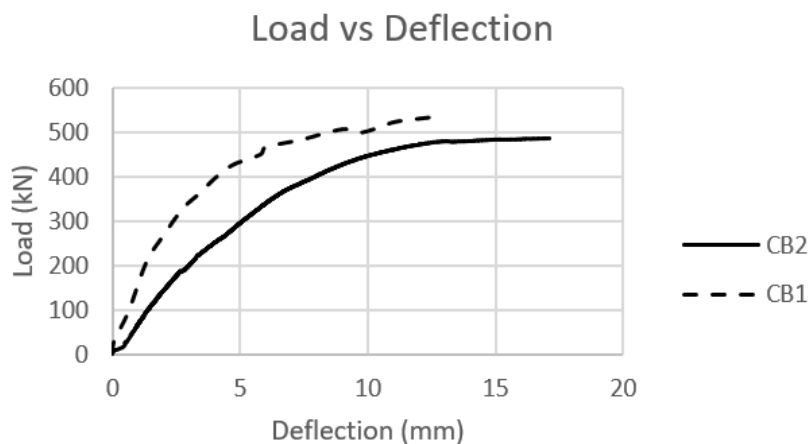
Figure 5. Comparison of Load versus Vertical Mid-Span Deflection between CB1 and CB2

According to Table 3 and Figure 5, there are some differences in the results between the two control beams, and this can be attributed to the difference in the testing machines with different load rates and the vibration process during casting might not have been the same between the two control beams since the vibration was manually undertaken due to the small spacing between stirrups.

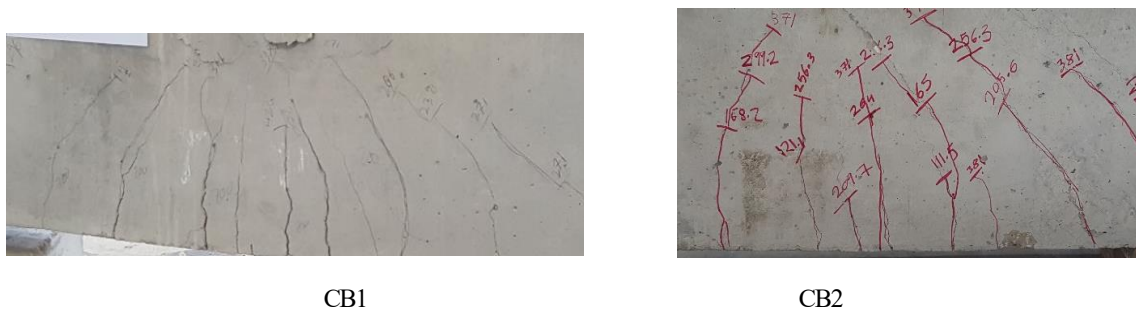
Figure 6. Pure Flexural Failure of CB1 and CB2 at Ultimate Load Capacity

Before reaching the ultimate capacity, obvious widening in vertical flexural cracks at the mid-span of the beam with a rapid increase in the deflection values were observed; the latter indicates that yielding of the longitudinal reinforcement started at this stage. Both control beams failed in a ductile manner as expected. Figure 6 illustrates pure flexural failure of both control beams.

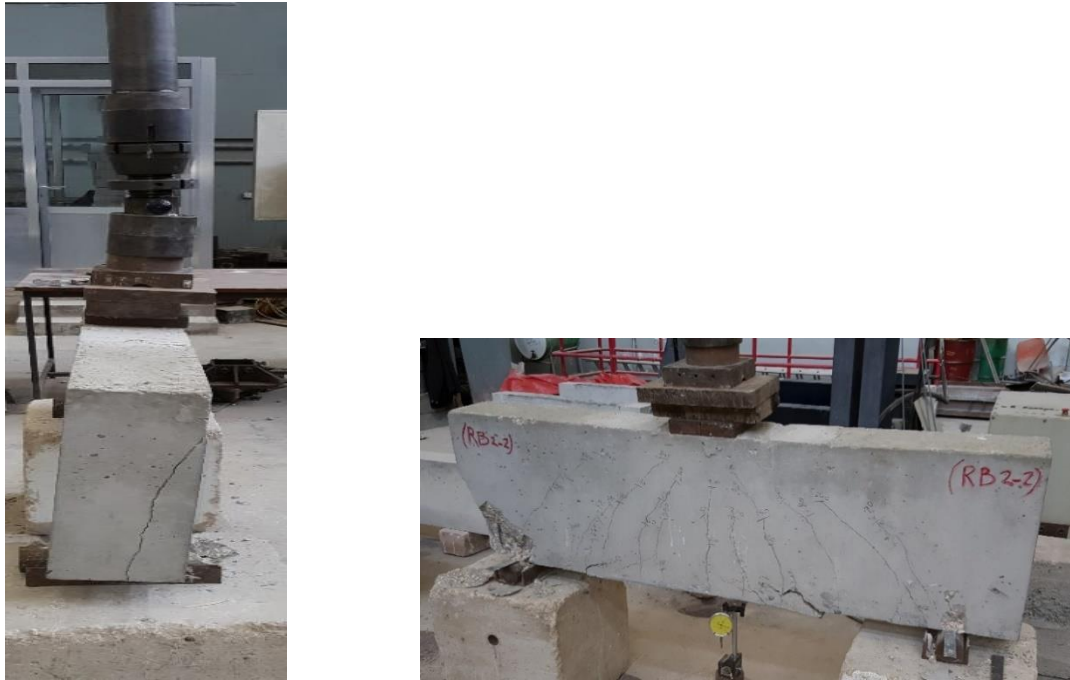
Figure 7. Tilting of Specimens

In this section, the results of the rehabilitated beam groups are presented in a comparison with the control beams group. From the eight rehabilitated beams, two beams (RB1-2 and RB2-2) are excluded from the results due to a sudden tilt in the hydraulic jack and the specimen. Figure 7 illustrates tilting of the two excluded specimens.

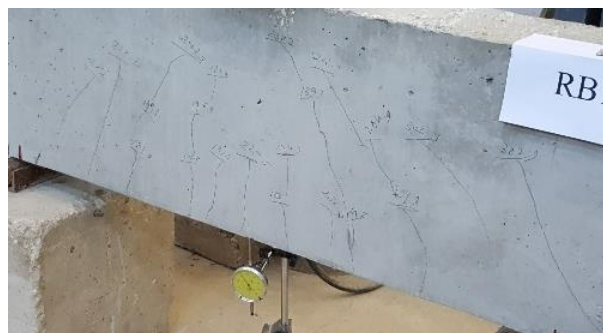
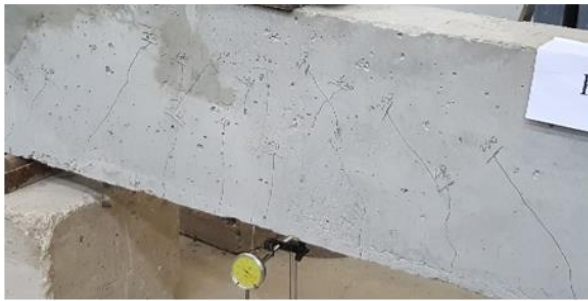
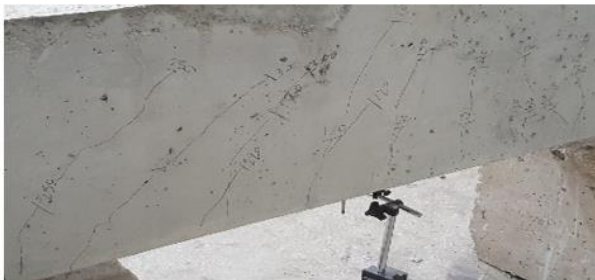
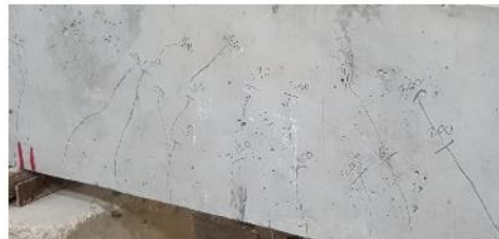
Figure 8. Cracks Pattern of Rehabilitated Beams in Pre-Cracked Phase

Figure 8 shows the crack patterns (first vertical hairline flexural cracks at mid-span of the beam and diagonal shear cracks in both left and right shear spans as well as diagonal shear cracks at one or both supports in some specimens) of six rehabilitated beams.

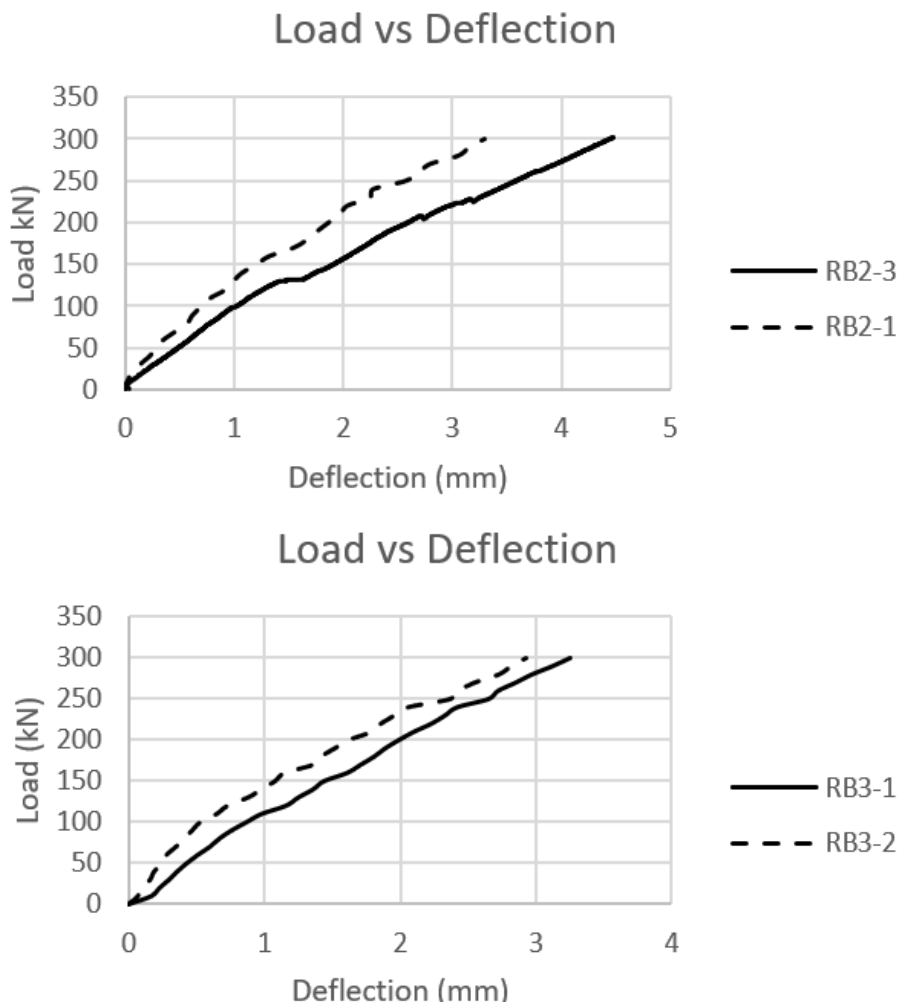
Figure 9. Comparison of Load versus Vertical Mid-Span Deflection between Rehabilitated Beams for Each Test Group

A comparison in the response of load against vertical mid-span deflection between rehabilitated beams of each test group is presented in Figure 9.

Referring to Figure 9, the response of load versus vertical mid-span deflection of rehabilitated beams are approximately the same in the pre-cracked phase.

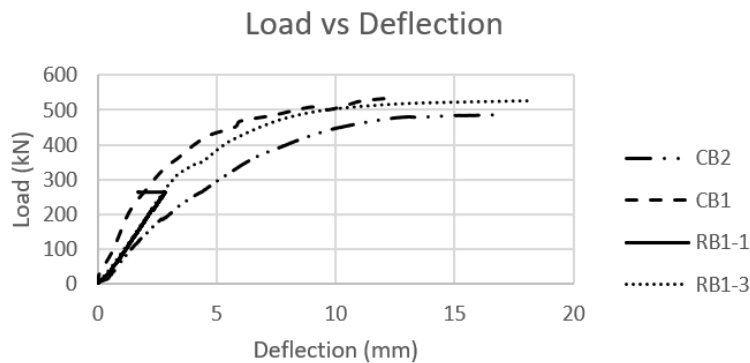
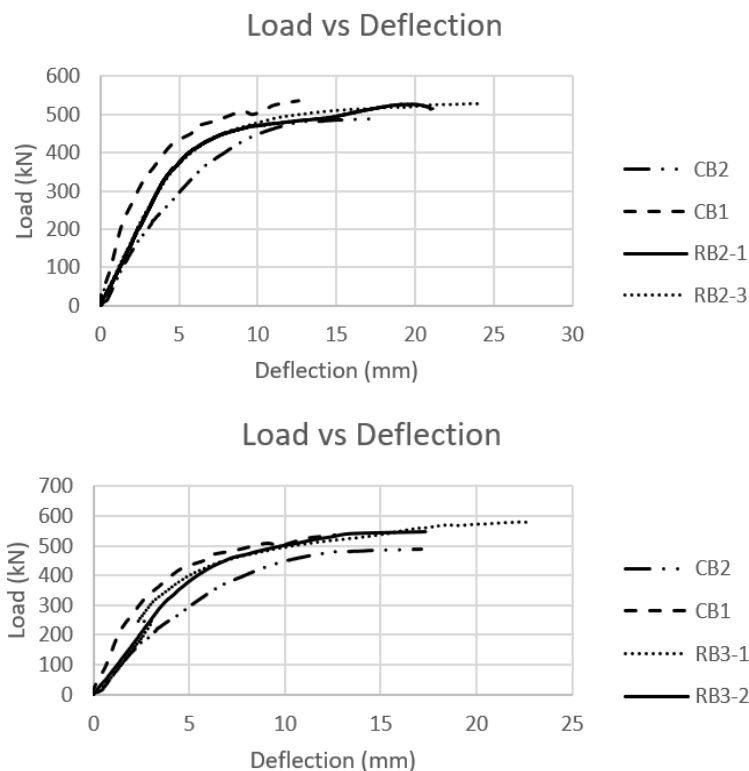
Figure 10. Comparison of Load versus Vertical Mid-Span Deflection between the Control Beam Group and the Rehabilitated Beam Groups

Referring to Figure 10 and regarding RB1-1, the deflection values were taken until the load reached 265.5 kN because after this reading debonding of CFRP occurred from the middle of the beam and the testing was continued by taking load values only. It is obvious that there was improvement in the response of load-deflection curve of the 2nd and 4th test groups in comparison to the average response of the control beams and this was due to the external attachment of CFRP to the rehabilitated specimens.

According to Figure 10, the response of the load-deflection curve of the 3rd test group was approximately the same as the average response of the control beams, which indicates that scheme of CFRP used in this case has no significant effect in the 3rd test group.

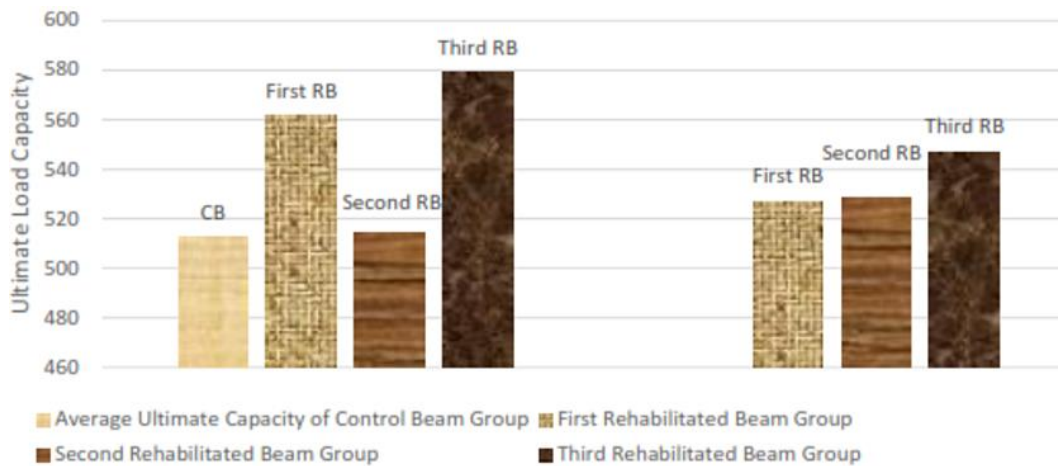
Figure 12. Results Summary Illustration

Figure 12 illustrates the enhancement in ultimate load capacity of each rehabilitated beam with respect to the average ultimate load capacity of control beams.

Referring to Figure 12, it is obvious that the results of rehabilitation in the 2nd and 4th test groups are close to each other, but with taking into the account the high cost of CFRP material, scheme of CFRP material in the 4th test group is more effective over the 2nd test group.
