Structure and Infrastructure Engineering

Relating the structural strength of concrete sewer pipes and material properties retrieved from core samples

Nikola Stanić, Jeroen Langeveld, Theo Salet & François Clemens

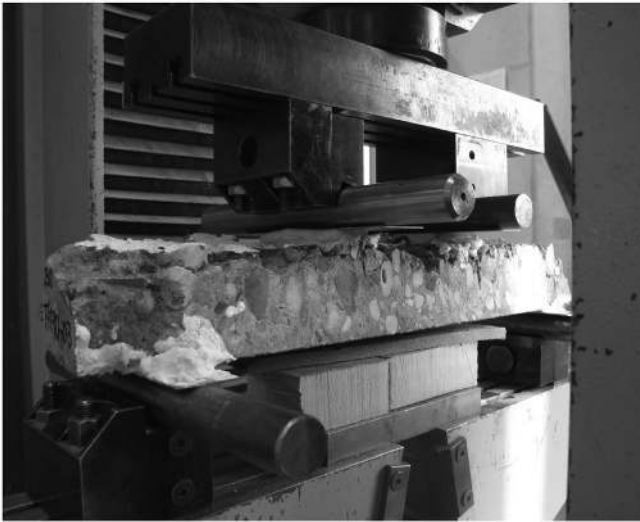
Figure 2. Test set-up used for four-point loading flexural tests.

The four-point flexural tests (Figure 2) were carried out on rectangular samples (with dimension of 105 mm \times 62–75 mm \times 480 mm) taken from the upper and lower part of broken pieces of the pipes in order to quantify the ability of the concrete to resist deformation under load – EN 12390-5 (European Committee for Standardization, 2009c). The specimens were positioned in the middle of the rollers. In order to achieve a uniform distribution of stresses, steel plates and soft board roles are placed between roller and sample, if necessary with some plaster for correction. The four-point loading flexural tests were carried out at a loading rate of .5 mm/min. The bending (flexural) strength of both outer and inner side of the pipe was determined.

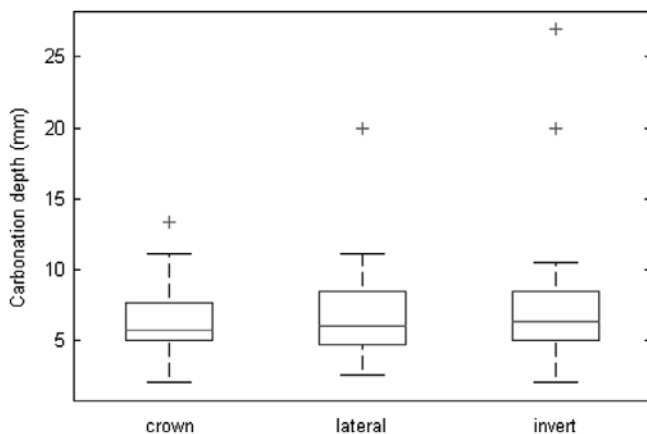
Figure 6. Boxplot for the carbonation depths at the outside for pipes P02, P06, P08 and P10; discriminating between crown, lateral and invert regions. On each box, the central mark is the median, the edges of the box are the 25th and 75th percentiles, the whiskers extend to the most extreme data points not considered outliers (approximately $\pm 2.7\sigma$), and outliers are plotted individually.

identical for all three regions (Figure 6). Soil surrounding pipes was probably acidic thus attacking concrete and in combination with acidic groundwater (in case of Breda, pipes P02 and P06) (Hobbs, 2001). Although the (bio-)chemical attack at the outside caused less damage than at the inside, the material deterioration is considerable, thus confirming the relevance of outside damage (Oualit et al., 2012).

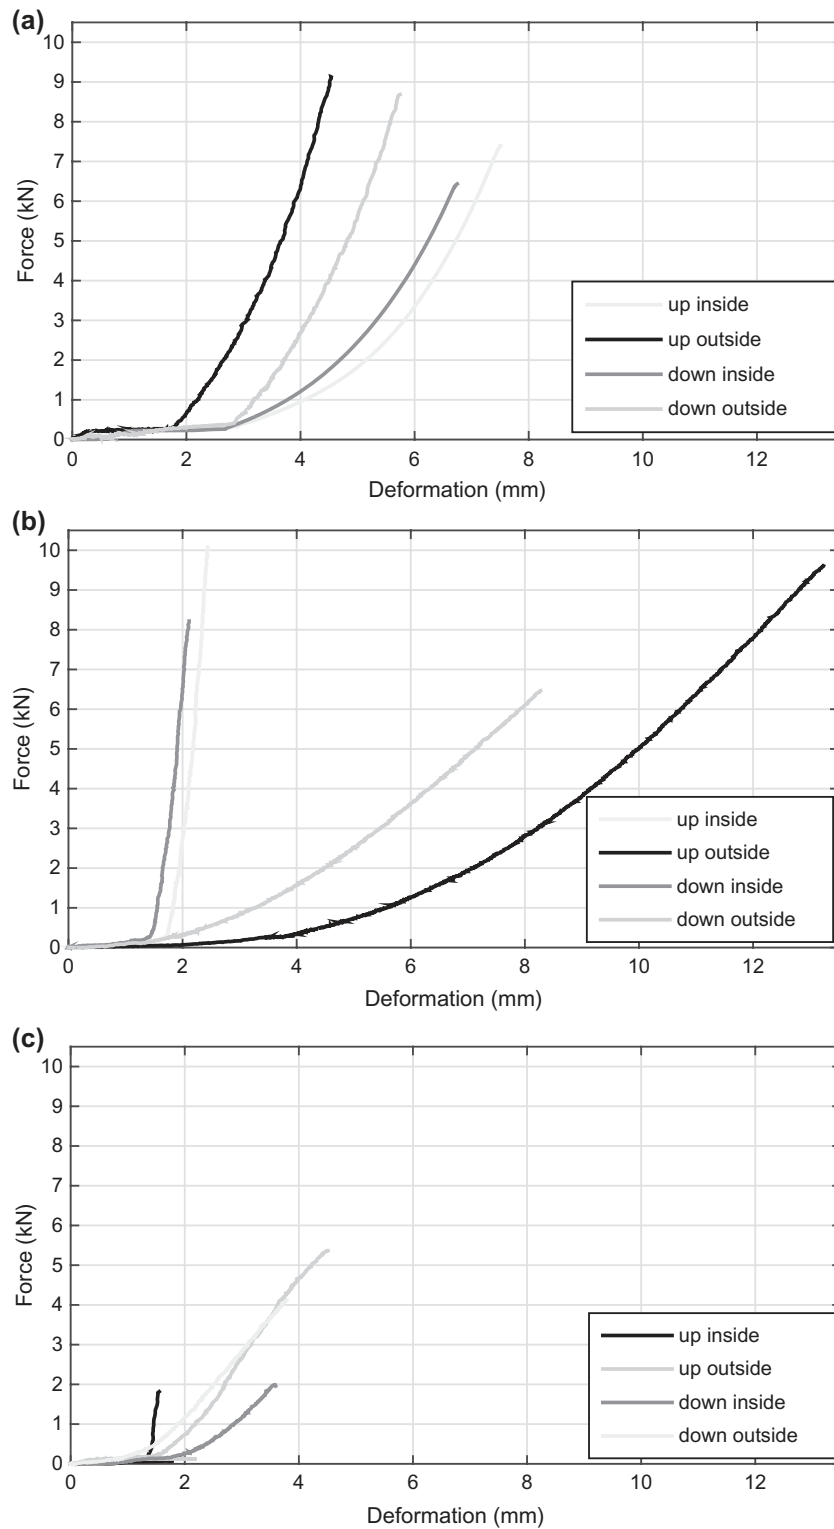
Figure 7. The four-pint flexural test force-deformation response for; (a) the new sewer pipe – P01; (b) the 60-year-old sewer pipe – P02; (c) the 90-year-old sewer pipe – P08.

The four-point flexural tests were carried out on rectangular samples (with dimension of 105 mm \times 62–75 mm \times 480 mm) taken from the upper and lower part of broken pieces of the pipes. Results show a high variability between samples per individual pipe and between samples between pipes (Figure 7). The variability may be partly due to the fact that the tested beams were not completely rectangular due to the shape of the pipes. In addition to the irregular-shaped beams, the 61 and 89 old pipes apparently did not deteriorate uniformly over the pipe length and circumference. Furthermore, the initial quality of the concrete is most likely not the same for the studied sewer pipes. However, this cannot be tested as there is no recorded information on the initial quality of the studied old concrete sewer pipes.

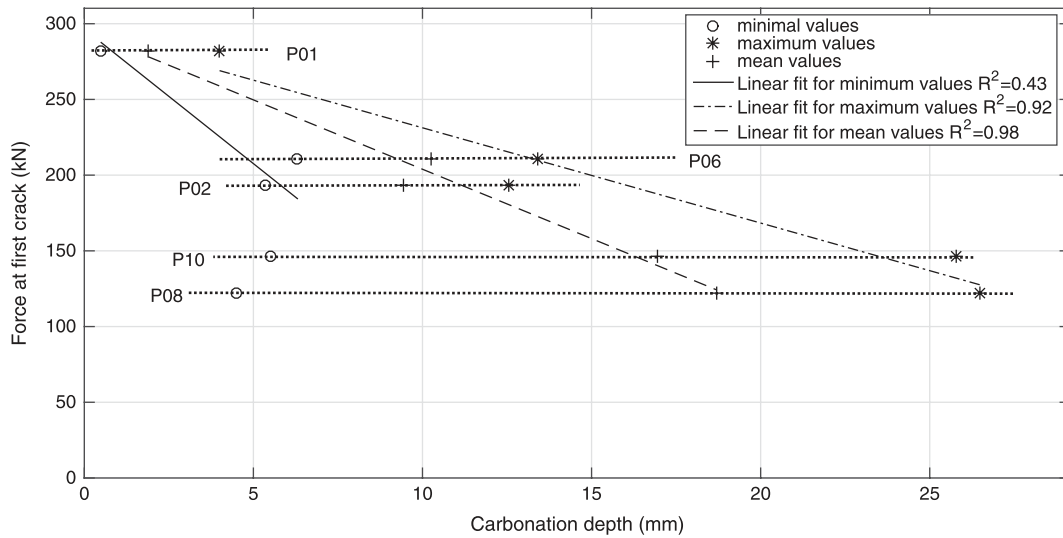
Figure 11. Relation between force at the first crack and the carbonation depth at the inside and outside wall of the pipes.

- With respect to carbonation depth, the sum of the inner and outer carbonation show a better correlation with $F_{v,max}$ than the values obtained for the inside wall alone. Further, it can be seen that the mean values ($R^2 = .98$)

correlate slightly better with $F_{v,max}$ than the maximum values observed ($R^2 = .92$). (Figure 10 and 11). With respect to carbonation depth, the mean value is therefore the most appropriate parameter.

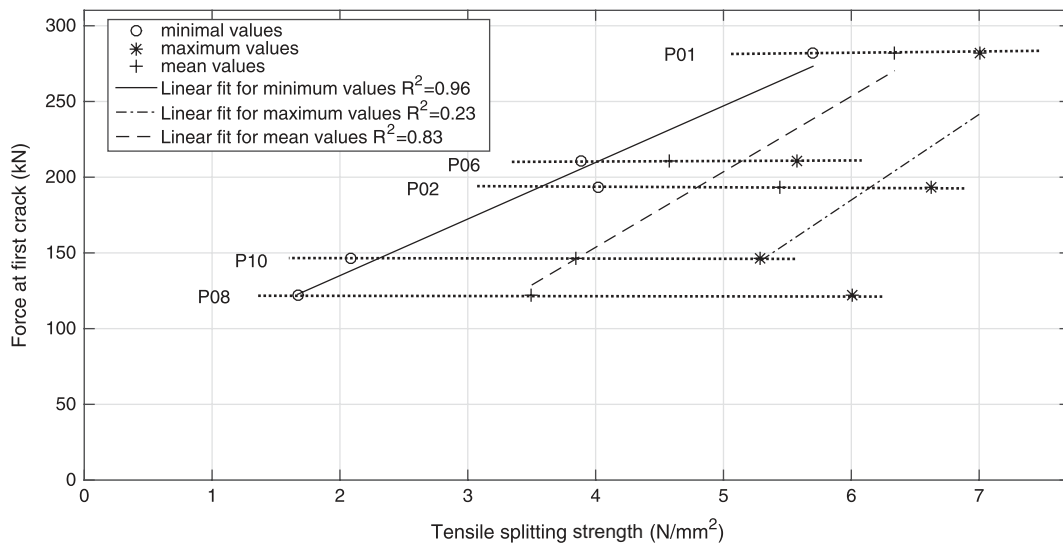
Figure 12. Relation between force at the first crack and the tensile splitting strength.

- With tensile splitting (Figure 12), the best correlation with $F_{v,max}$ is obtained for the minimum values found for the tensile splitting strength with an R^2 of .96. The correlation

with the mean splitting tensile strength, with an R^2 of .83 is still acceptable.

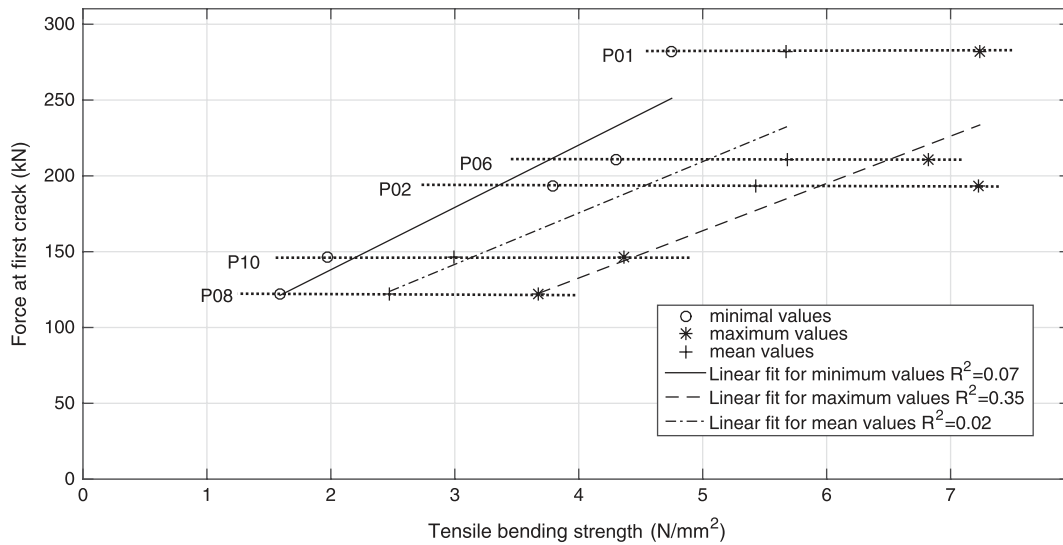
Figure 13. Relation between force at the first crack and the tensile bending strength.

- With respect to tensile bending strength (Figure 13), the values for the tensile bending strength show very low correlations for the minimum, mean and maximum. Tensile bending strength is therefore not a very suitable parameter to assess the material properties.

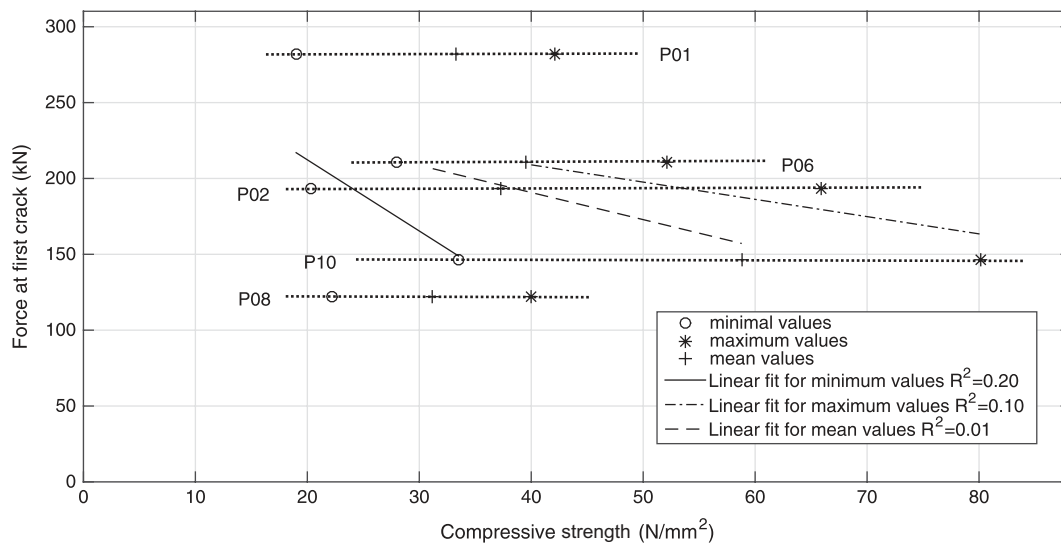
Figure 14. Relation between force at the first crack and the compressive strength.

- Compressive strength seems to have no significant correlation with $F_{v,max}$ (Figure 14) and is therefore also not a suitable parameter to assess pipe strength.
- The material properties water absorption and density (Figures 15 and 16) show only a significant correlation ($R^2 = .89$) for the minimum values found for the material density, with respect to water absorption only a very weak correlation ($R^2 = .35$) between the maximum values and $F_{v,max}$ was found.

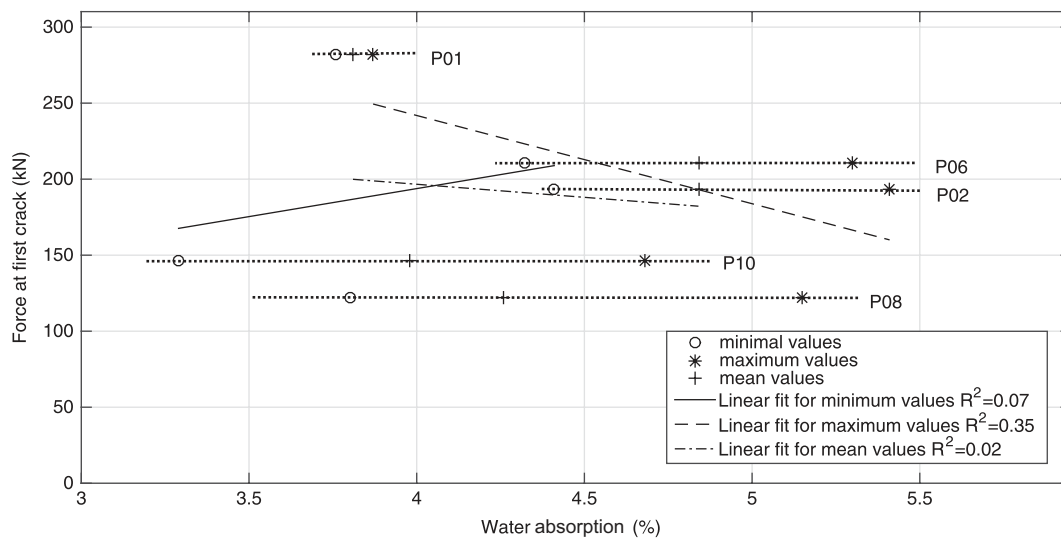
Figure 15. Relation between force at the first crack and the water absorption.

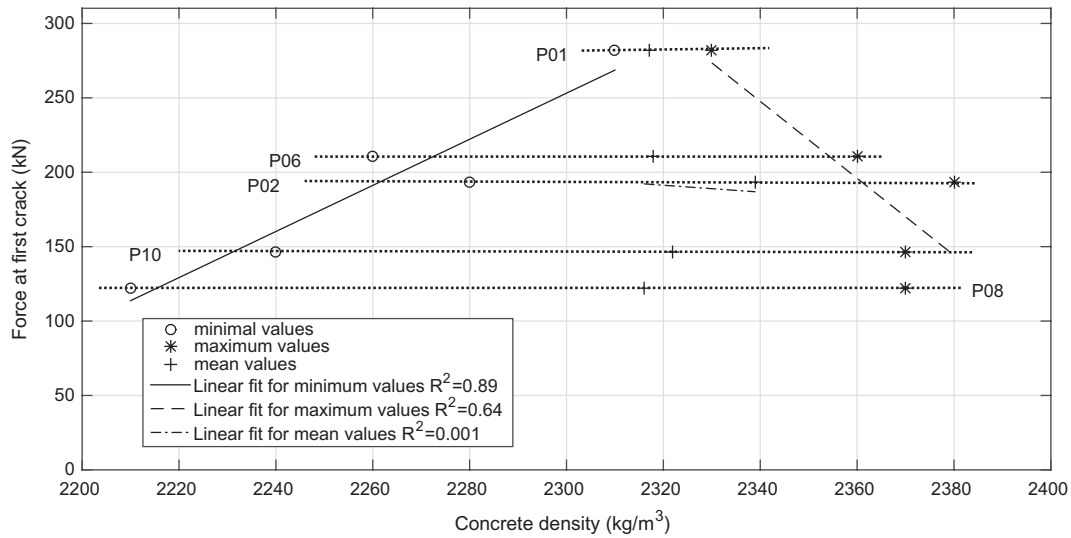
Figure 16. Relation between force at the first crack and the density of the concrete.

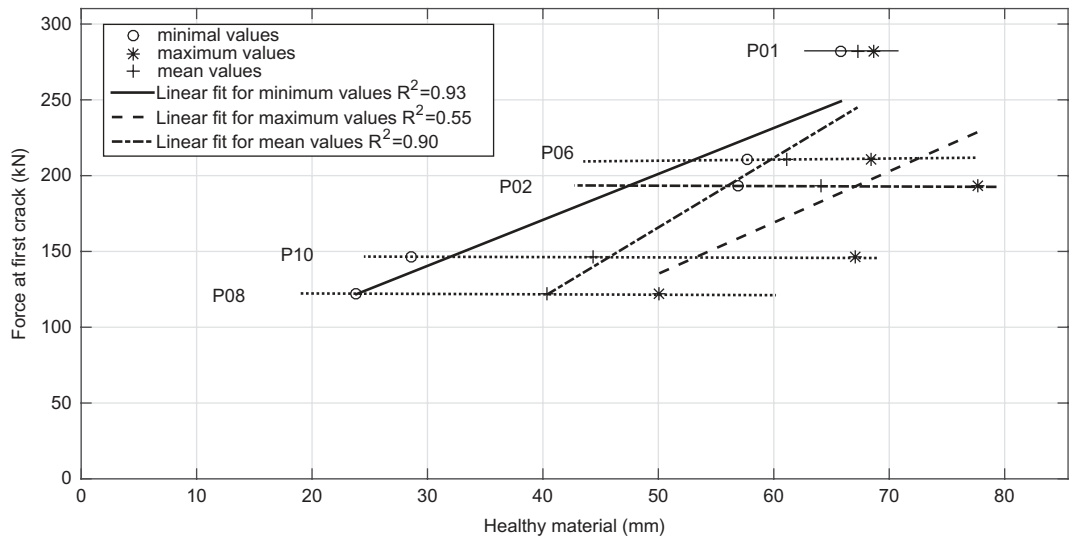
Figure 17. Relation between thickness of the remaining healthy material and force at the first crack.

The minimal tensile splitting strength apparently gives the best information with respect to the material's properties, while the carbonation depth gives the best information with respect to the geometry. The latter is illustrated when the remaining thickness of the healthy material is taken as a parameter. The thickness of the healthy material is defined by the measured wall thickness minus the values found for the carbonation depth on the inside and outside of the pipe. Figure 17 shows the results. Indeed, the mean and maximum values of the remaining healthy material have, respectively, a R^2 of .90 and .93 with the force applied when the first crack appeared.

the term ‘healthy material’ is regarded as the material that is not affected by the degradation process(es).
