# Reliability of flood marks and practical relevance for flood hazard assessment in southwestern Germany

Annette Sophie Bösmeier<sup>1</sup>, Iso Himmelsbach<sup>2</sup>, and Stefan Seeger<sup>3</sup>

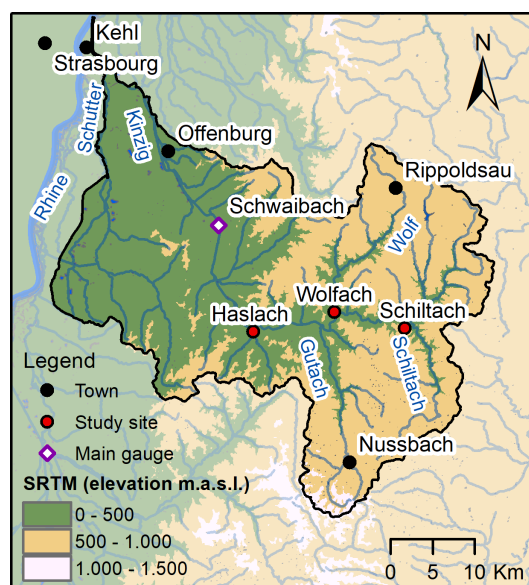
**Figure 1.** The Kinzig catchment with its main tributaries and relevant locations. Data are channel network and catchment shape from the Amtliches Digitales Wasserwirtschaftliches Gewässernetz (AWGN) provided by the LUBW and SRTM (Shuttle Radar Topography Mission; Jarvis et al., 2008).

The Kinzig catchment is located in the west of Baden-Württemberg, southwestern Germany (Fig. 1). It extends from the central Black Forest mountain range with an altitude of about 1080 m down to the southern Upper Rhine valley at 134 m. With a size of 1406 km<sup>2</sup>, it is the largest tributary to the Upper Rhine River from the western side of the Black Forest. The catchment is to a large extent covered by a hilly to mountainous landscape and has a compact shape and a large headwater area with a number of narrow sub-catchments with a steep gradient. This contributes to rapid flood generation and high flood discharges, e.g., 1050 m<sup>3</sup> s<sup>-1</sup> for the 100-year flood in comparison to the annual mean flow of 23.5 m<sup>3</sup> s<sup>-1</sup> at the main gauge Schwaibach. Data were made available by the Landesanstalt für Umwelt Baden-Württemberg (LUBW, Baden-Württemberg State Institute for the Environment; LUBW, 2015).

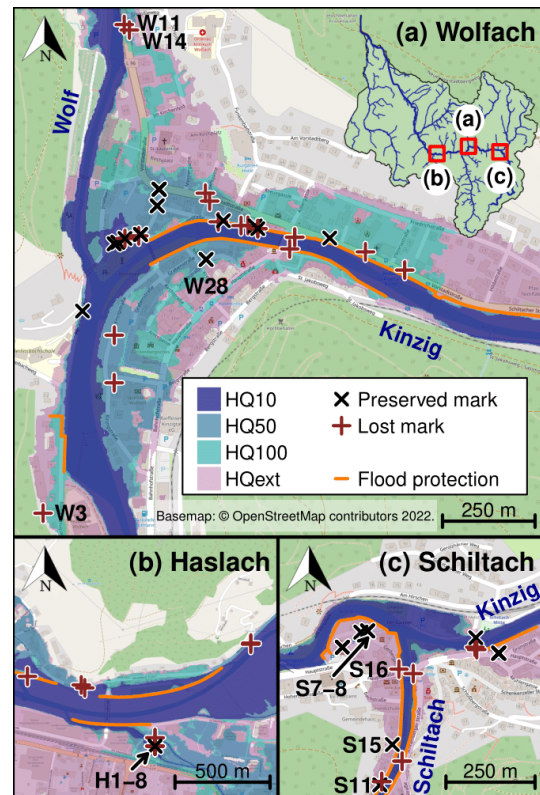
**Figure 2.** Locations of collected marks, both preserved and lost but documented, at the three study sites (a–c). The flood protection walls and the areas most likely to be flooded during HQ10 to HQextreme (HQext) flood events were extracted from the FHMs (LUBW, 2018). The labels, which refer to the mark location by the site initials and to the utilized sequential numbering, e.g., H1, are displayed for particular marks. Basemap distributed under the Open Data Commons Open Database License (ODbL) v1.0.

It appeared that flood marks were less likely to be lost when installed at houses in the town (Schiltach and Wolfach) than positioned directly along the river (Haslach; compare Fig. 2). Generally, flood marks that had been attached to bridges before the 20th century were not found anymore, as the bridges across the Kinzig and its tributaries were frequently destroyed and rebuilt. Similarly, flood mark stones or pillars positioned along the river embankment or on roads close to the river were mostly not preserved. Likely reasons may be construction activities along the river such as the renewal or extension of dams, walls, roads, or the river embankment. The higher degree of mark preservation within the settlement is a fortunate coincidence. It might be connected with a special mindset towards flood hazard, related to the long history of recurring floods and the dependence on the river with regards to the century-old tradition of timber rafting, which is a particularity of the Kinzig area. By contrast, examples of intentional removal of flood marks from private places are also known in the region and beyond, even though flood marks are in many places protected by law. But even at the three study sites along the Kinzig, marks on house walls often did not outlast the 20th century due to rebuilding or new construction of houses as well as weathering. Nevertheless, the positions of lost marks on buildings could be reconstructed fairly accurate utilizing the documented historical map sections and reference points such as other buildings in the street. Lacking such close points of reference, the positions of vanished flood mark stones along the river in Haslach could only be approximated. This also reduced their value for the comparison with FHM.

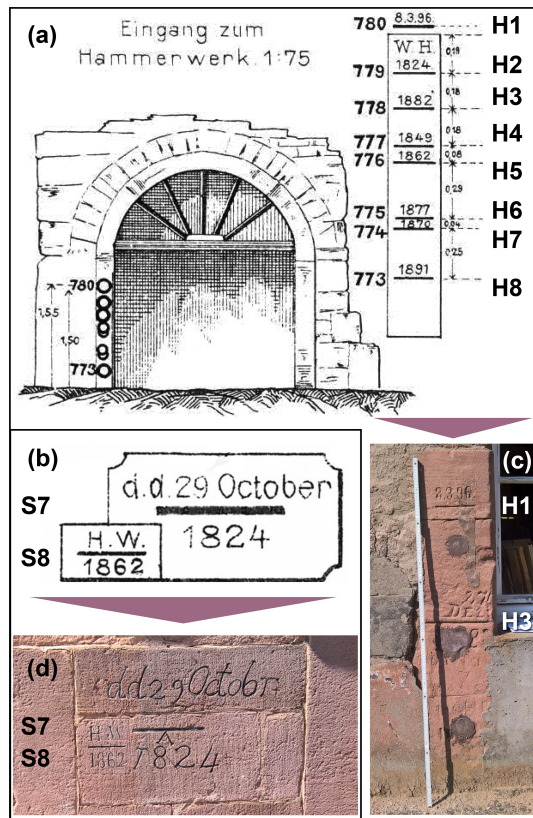
**Figure 3.** Historical documentation of flood marks (modified from CMH, 1908) in Haslach (a) and Schiltach (b). The remaining preserved marks at these sites in July 2018 are displayed in (c) and (d). The labels refer to Fig. 2.

slabs. Most of the collected flood marks are not only engraved but also painted. Some older marks appear repainted, obviously in order to preserve the signs (Fig. 3d); however due to weathering, it is not always clear whether or not they initially also had been engraved. Typically, the year of the flood event is inscribed next to the notch, frequently in combination with the labels “H.W.” or *Hochwasser*, which is German for “flood”. Some marks even show the exact date of the flood, occasionally with the prefix “d.d.”, which is an abbreviation for the Latin *de dato* (“from the date”; see Fig. 3b and d).

(Figs. 3a, c, and 5d). Then, 10 marks showed an insignificant height difference to their historical position, among them seven marks without and three with clear indications of reinstallation (Fig. 5d). Hence, some flood marks have been maintained and reinstalled close to the original after a new building construction. Nevertheless, even some marks in a very good condition – apparently maintained and repainted – were found to be significantly (about 30 cm) below their documented historical position (Fig. 5d, S24–27). Thus, clear signs of flood mark conservation are no proof for their trustworthiness. As a consequence, the historical information in CMH (1908) was generally assigned higher credibility if preserved marks showed considerable alterations. A precondition for this, however, was a successful plausibility check between the historical flood mark description and further written sources, as described above.

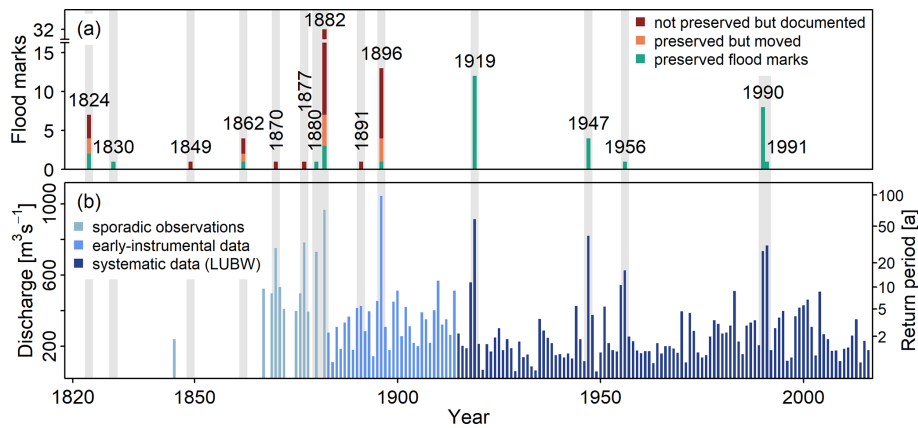
**Figure 4.** Number of collected flood marks in Haslach, Wolfach, and Schiltach with red and orange bars showing deviations from the historical flood mark survey (a) and associated peak discharges at the gauge at Schwaibach (b). The record of annual discharge maxima combines data reconstructed from peak water levels (1845–1914) with systematic measurements since 1915 (Bösmeier, 2020).

A large consistency was found between flood marks in Haslach, Wolfach, and Schiltach and discharge measurements as well as written documents. To begin with, the flood record in combination with documentary evidence confirmed that the majority of events represented by flood marks were severe on a local to regional scale. A long flood record at the main gauge in Schwaibach was combined by Bösmeier (2020) from early-instrumental and systematic measurements (Fig. 4b). The gauge is located in the lower catch-

The results of this consistency check showed that 10 out of 17 preserved flood marks likely had been moved and reinstalled (Fig. 4a, in orange). Yet, a considerable (> 15 cm) height difference between the historical and the current position was only found for seven marks, as shown in Fig. 5d. One potential reason may be the integration of cornerstones with engraved flood marks into new buildings, regardless of their original position, inducing significant alterations. This might have caused the 0.5 m height difference between the documented and preserved marks H1 and H3 in Haslach

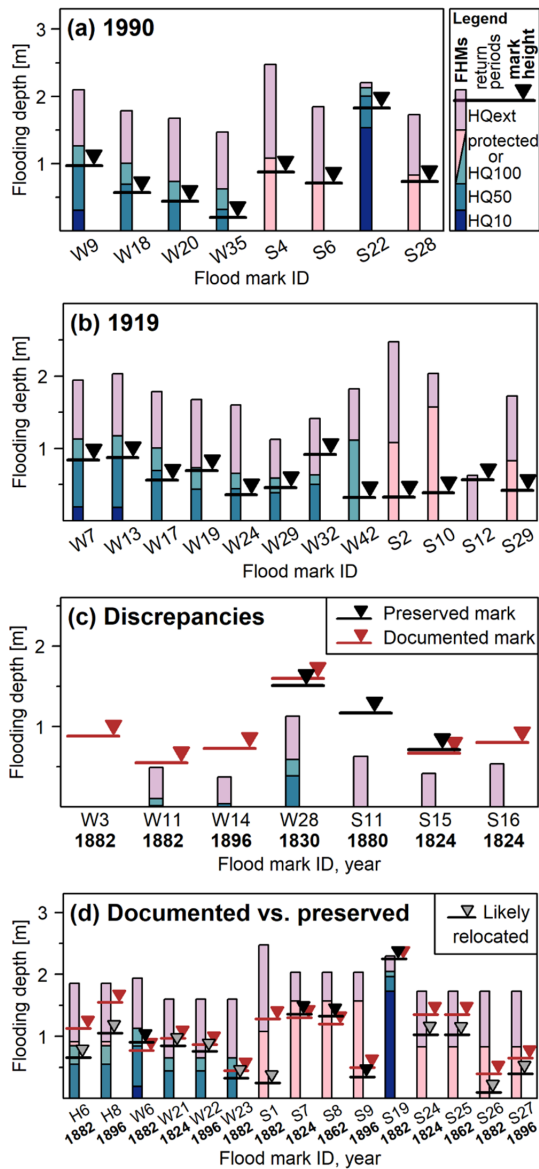
**Figure 5.** Flood marks and the local flooding depths of the flood hazard maps (LUBW, 2018). All marks in Wolfach and Schiltach are displayed which refer to the flood on 15 February 1990 (a) or the flood in December 1919 (b) or which exceeded the HQextreme (c). All other pairs of documented and preserved marks with an indication of likely reinstalled marks are displayed in (d).

A further systematic plausibility check demonstrated that the large majority of the marks are well supported by written sources, such as the chronicles of Schiltach (Christoph Trautwein, unpublished data) or Wolfach (Disch, 1920). These sources describe – in parts very detailed – the temporal evolution, extent, or severity of the floods. First, all flood marks, except one, could be associated with flood events that were documented by written information. Reports were only missing for the 1891 mark in Haslach, which as a consequence was classified as questionable. Second, the qualitative comparison between the marks and the content of the associated written documents did not reveal explicit and considerable discrepancies. By contrast, some statements literally verify particularly high marks by describing the extent or maximum water level in reference to specific landmarks, buildings, or bridges. One example represents the extreme flood in 1896, when the Kinzig tributary Wolf tore parts of the graveyard in Wolfach away (Disch 1920). Another example is the disastrous ice jam in 1830: according to the chronicle of Wolfach, the flood followed a very cold winter. Since a large amount of ice, unrooted trees, and other material blocked the riverbed in Wolfach, the Kinzig forged its way through the suburb (Disch, 1920). The consequence was an outstandingly high flood water level which even reached the first floor, as reports stated. This is documented by an extraordinary high mark in Wolfach (W28, Fig. 5c).

An event-specific relative comparison between marks and FHMs demonstrated overall good agreement, which can be considered a mutual verification between marks and modeled hazard maps. In February 1990, for instance, the Kinzig catchment was struck by a severe flood with a recurrence interval between 20 and 50 years at Schwaibach in the lower catchment, with several flood marks recording local flood levels (Fig. 5a). Since long gauge records were not available directly at the study sites, it was not possible to reconstruct and assign local return periods to the marks using conventional flood frequency analysis approaches (Bösmeier, 2020). Therefore, the absolute FHM flooding depths could not be verified directly and precisely utilizing the flood marks. However, a relative comparison was possible: all four marks in Wolfach are placed at heights approximately corresponding to HQ50, adding confidence to the HQ50 estimation and mapping. In Schiltach, one mark (S22) also points to a flood between HQ20 and HQ50. However, three other marks are situated within an area protected against floods up to HQ100 by walls at the waterside of the Kinzig and its tributary, the river Schiltach. Hence, local hydraulic conditions cannot be compared with the situation during the flood of 1990. This may also explain why the recurrence intervals in Fig. 5a do not match with the other marks. Similar results, yet with larger deviations, were found for the extreme flood in December 1919, which was an event between HQ50 and HQ100 according to the measurements at Schwaibach (Fig. 5b).

Finally, a number of marks with extreme heights in comparison to the FHMs were found. Seven marks exceeded the modeled flooding depths of an HQextreme event, most of them quite considerably (Fig. 5c). Searching for factors that could explain these discrepancies, the individual cases were examined. Two of the seven marks are located along the Kinzig: W3, which appeared plausible as aforementioned, and W28. The latter is a reminder of the massive ice jam in Wolfach in February 1830, and its plausibility could be verified (Sect. 4.1.2). Strikingly, five of the seven marks above the HQextreme level were situated along tributary rivers. In Wolfach, W11 and W14 existed along the Wolf roughly 500 m upstream of the confluence between the Wolf and Kinzig. In Schiltach, S11, S15, and S16 were or still are situated along the Schiltach River. There, protective walls have been installed (Fig. 2), which considerably improved the flood situation and changed hydraulic conditions. Nevertheless, the height of the marks is exceptional – note, however, that S11 might have been installed post hoc (compare Sect. 4.1.3) and may be questionable despite available reports about the flood in 1880. In any case, as opposed to
