## Remanufacture of Jet Engine Compressor Components

**MARTIN WEINSTEIN**

Vice President,  
Turbine Support Division,  
Chromalloy American Corp.,  
San Antonio, Tex.

A description of the various mechanical operations employed in the remanufacture of gas turbine engine compressor components such as blading, rotor disks and spacer, vane shroud assemblies and air seals are given. The operations described include tungsten inert gas, plasma needle arc and electron beam welding, furnace and torch brazing, glass bead and shot peening, magnetic particle and ultrasonic inspection, plasma spray and diffusion coating. Emphasis is given to the effect of these operations on the mechanical integrity of the engine component. For example, the effect of welding, brazing, peening and diffusion coating on the high cycle fatigue strength of compressor stator and rotor components is discussed. The effect of repair operations on jet engine compressor performance is also considered.

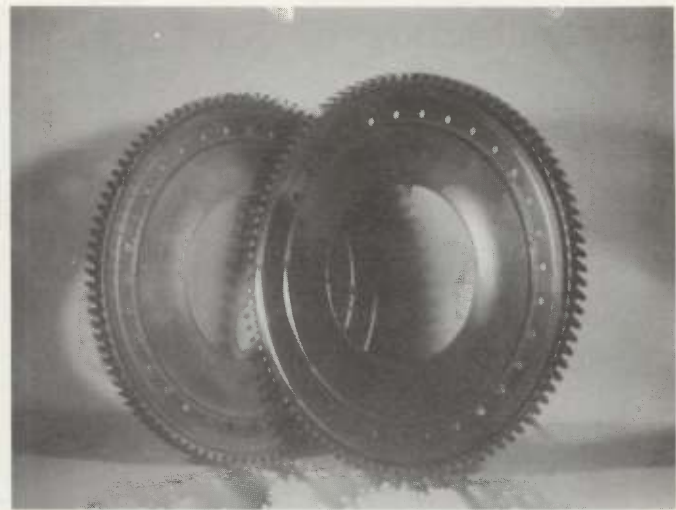
Fig. 2 Compressor disk without blading

Fig. 2 is a typical Pratt & Whitney disk. Very few repairs are allowable on this component because of the high stresses experienced during takeoff and loading. As indicated previously, disks are designed for low cycle fatigue failure. Therefore, no structural change such as may be found in weld heat-affected regions are allowable.

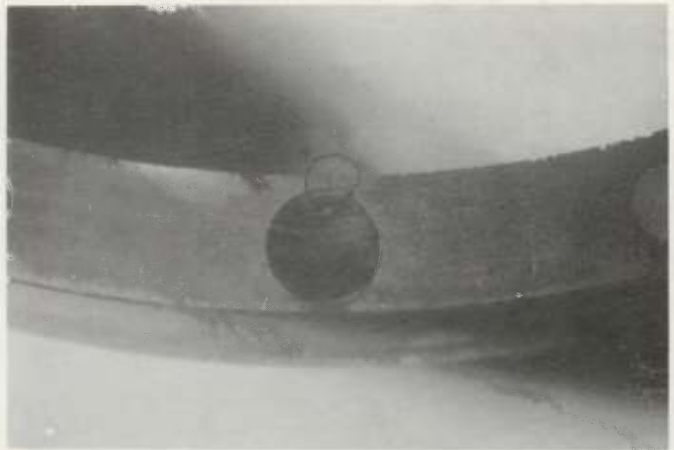
Fig. 5(a) Crack in compressor spacer

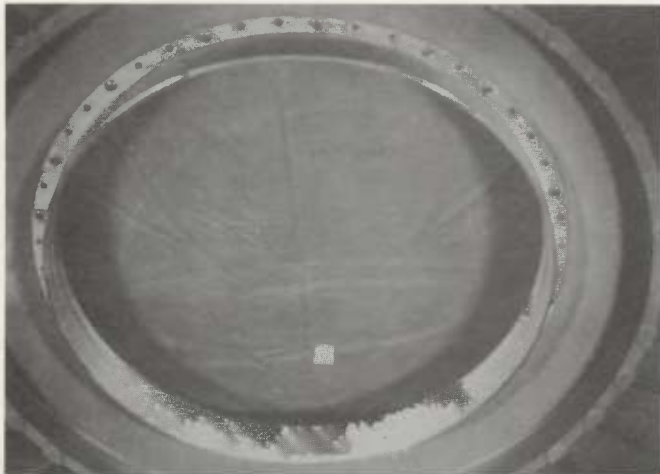
(Air Seal)

(In Assembly)

Fig. 9 Inner air seal for stator vane assembly after repair and installed in assembly

The inner air seal on the compressor stator is shown clearly in Fig. 9. In this case again, diameters of 16 in. must be machined and maintained to tolerances of  $\pm 0.005$  in. Repair build-up of these seals through Metco Ni-Al plasma spray is a common practice.
