## Case Report

# Replacement of Anterior Composite Resin Restorations Using Conservative Ceramics for Occlusal and Periodontal Rehabilitation: An 18-Month Clinical Follow-Up

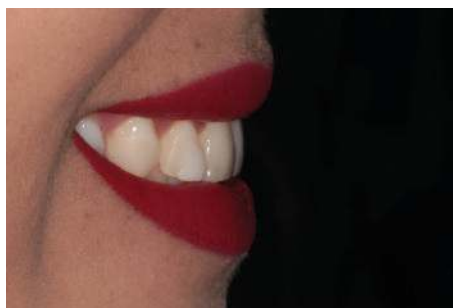
FIGURE 1: Initial smile of this patient.

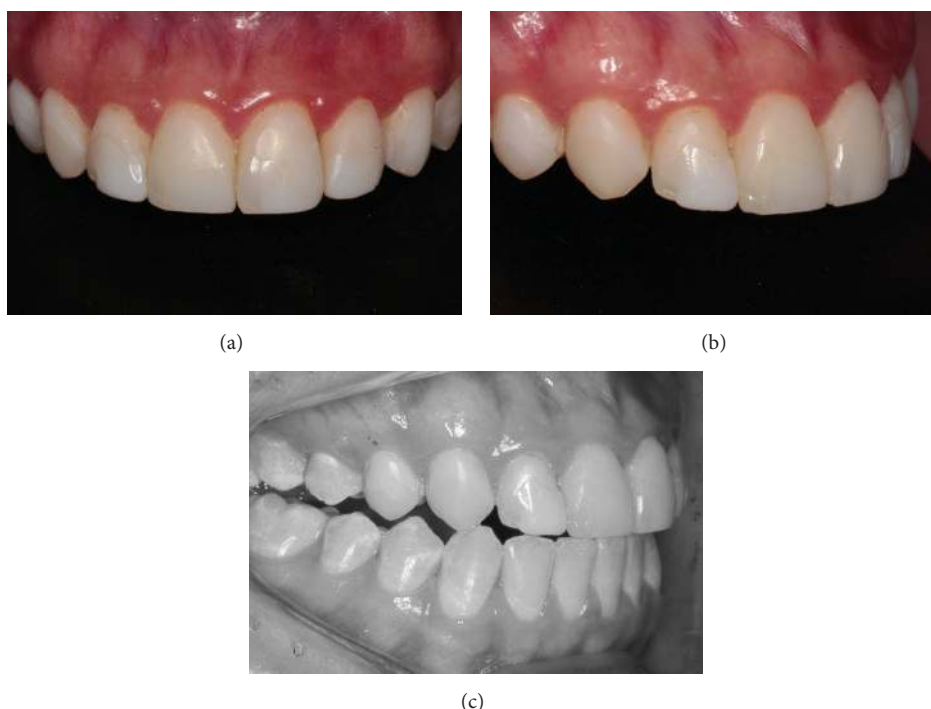
FIGURE 2: Close-up view of frontal (a) and lateral (b) anterior teeth showing worn and stained composite resins. (c) Image of right disclusion showing contact of canine as well as lateral and central incisors.

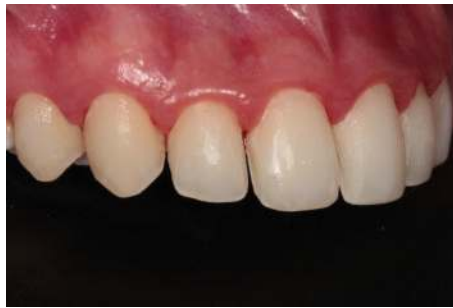
FIGURE 6: Teeth immediately after preparation. Note gum inflammation caused by the resins.

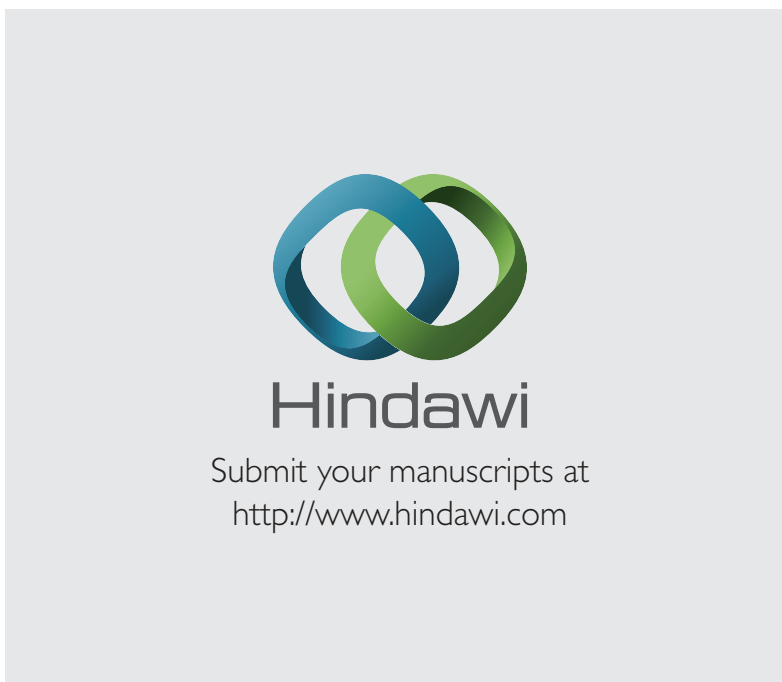
- [13] G. Gurel, N. Sesma, M. A. Calamita, C. Coachman, and S. Morimoto, "Influence of enamel preservation on failure rates of porcelain laminate veneers," *The International Journal of Periodontics & Restorative Dentistry*, vol. 33, no. 1, pp. 31–39, 2013.
