*Large Hadron Collider Project*

**LHC Project Report 1168**

**REPORT OF THE TASK FORCE ON THE INCIDENT  
OF 19 SEPTEMBER 2008 AT THE LHC**

This report summarizes the findings and recommendations of the Task Force established to investigate the 19th September 2008 incident which occurred in sector 3-4 of the LHC. It includes a number of annexes where specific analyses are detailed.

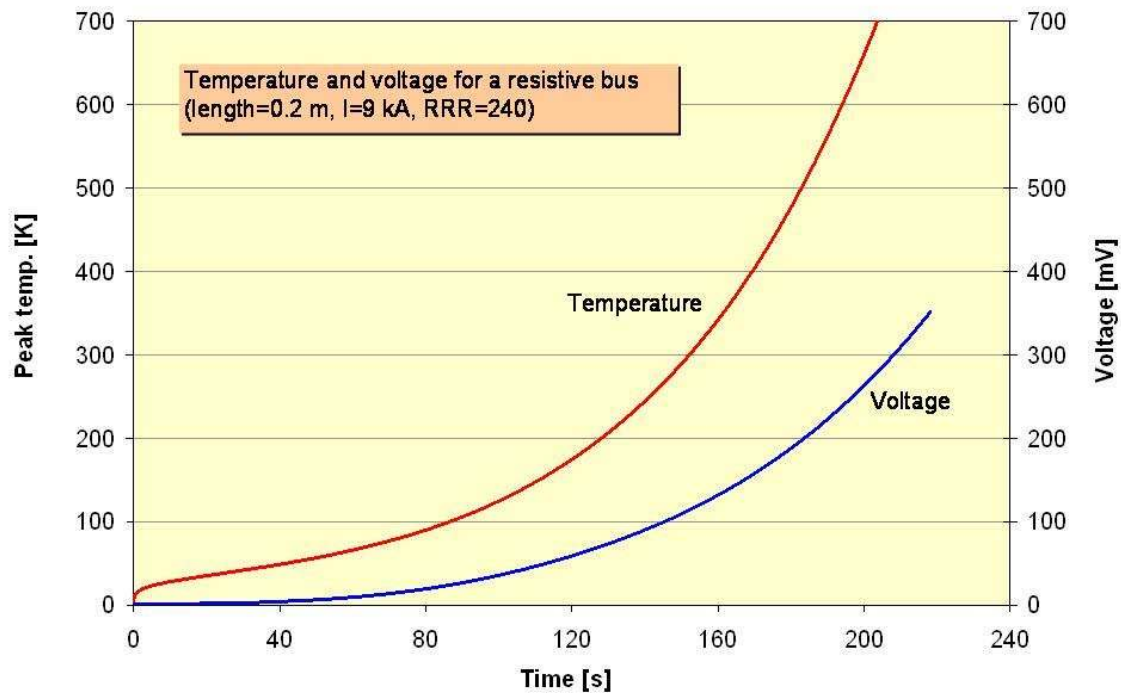
Figure 3: Calculated evolution of temperature and voltage for a localized resistive zone on dipole bus bar at 9 kA

This protection strategy, based on modelling [5, 6] and validated by model tests [7], correctly addressed non-localized, slow thermal runaway cases which critically depend on continuity of the stabilizer and good soldered contact with the superconducting cables. As the 19 September incident showed, it was however totally insufficient to detect in time a localized thermal runaway stemming from a thermally insulated joint resistance in a long, well-cooled bus bar acting as quench stopper: in this case (Figure 3), the melting temperature of the solder is exceeded and the circuit thus broken open well before the 1 V threshold is detected.

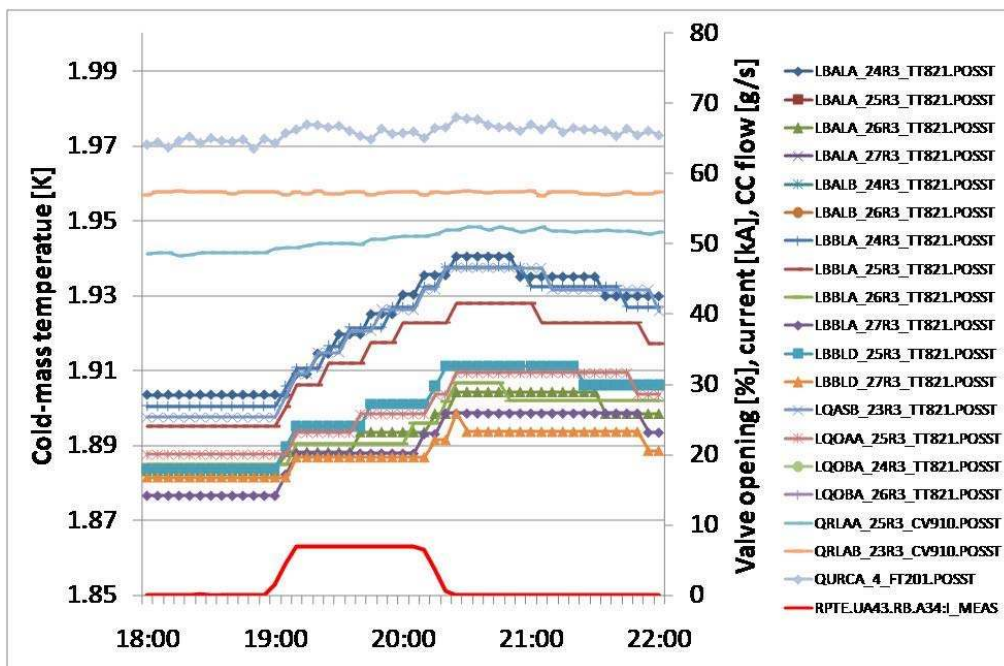
Figure 4: Evolution of temperatures in cold mass of sector 3-4 during 7 kA current cycle: temperatures in cell 24R3-25R3 increase faster than in other cells

Several attempts were made to reproduce, on test samples, a dipole bus bar joint with a resistance in the 200 n $\Omega$  range (Annex B). While it proved reasonably easy to get to a few n $\Omega$ , i.e. well away from specification, only absence of soldering could account for such a high value as observed in cell 24R3-25R3 of sector 3-4. This appears today as the most likely origin if the incident, as this type of defect was also observed – though leading to lower values of resistance – on internal splices in dipoles 2334 (100 n $\Omega$ ) and 2420 (28 n $\Omega$ ) which revealed lack of or insufficient soldering upon visual inspection after removal from the tunnel or from the test bench. The internal splices in dipoles however show a different configuration and were made by different teams than those in the magnet interconnections.

5.1.1. A first, straightforward recommendation is to analyse thoroughly the temperature evolution history of the magnet cold masses as recorded during past power tests, in order to identify doubtful regions which could be the seat of abnormal power dissipation: this has been done in all sectors, and has revealed a few other bad splices in the circuits.

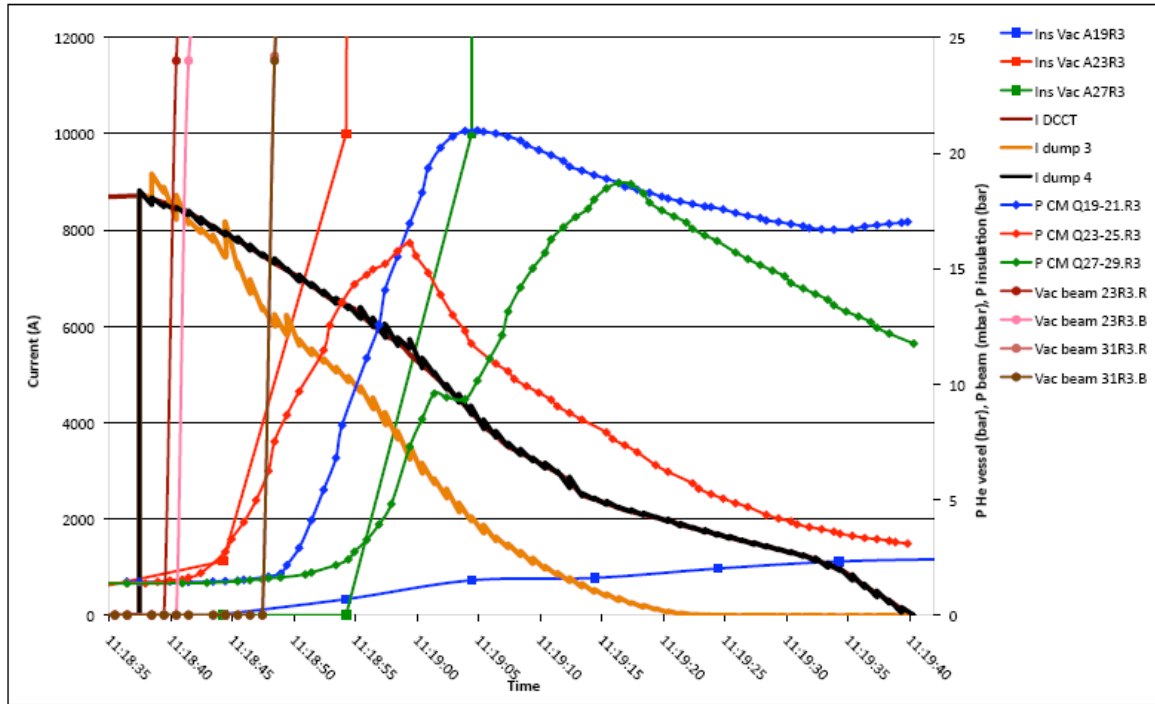
Figure 10: Development of pressure in helium, insulation vacuum and beam vacuum enclosures

The breaches of the helium enclosure and beam vacuum pipes, combined with the additional power reaching the cold mass from the arc and from the degraded insulation of the cryostat, led to the development of pressure in these volumes, over a time scale of several tens of seconds: this is schematically illustrated in Figure 10. The pressure rise in the helium enclosure was contained below the design pressure of 2.0 MPa by the opening of the self-actuated quench relief valves (set point 1.7 MPa), except in subsector 19-21, where it reached a maximum of 2.1 MPa, still within the regulatory allowance of 110 % of the design pressure.

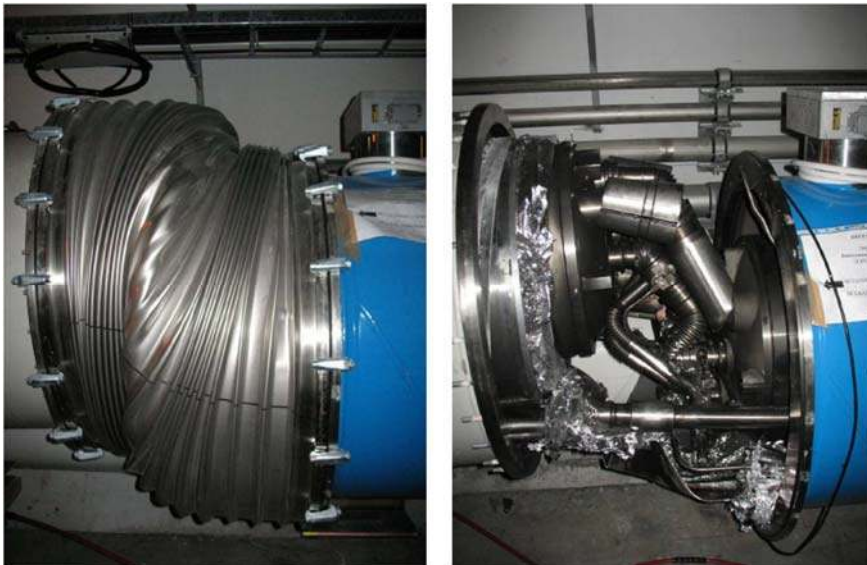
Figure 14: Damage to interconnection QQBI.27R3 by excess compression

The longitudinal displacements reached several tens of cm, either crushing interconnections in compression (Figure 14) or breaking open bellows and deforming bus bar expansion lyres by excessive extension (Figure 15). These produced secondary paths of helium discharge to the insulation vacuum of neighbouring sectors, as well as secondary electrical arcs when bus bar expansion lyres were extended beyond what they could absorb (Figure 16). The displacement of the Short Straight Section cryostats also damaged the “jumper” connections to the cryogenic distribution line (Figure 17), but without rupture of the transverse vacuum barriers equipping these jumper connections, so that the insulation vacuum in the cryogenic line did not degrade.

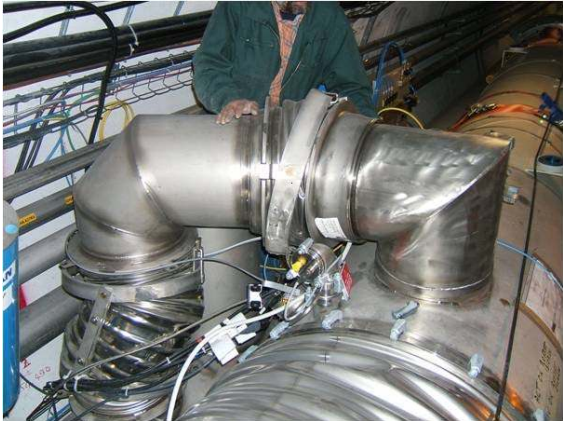
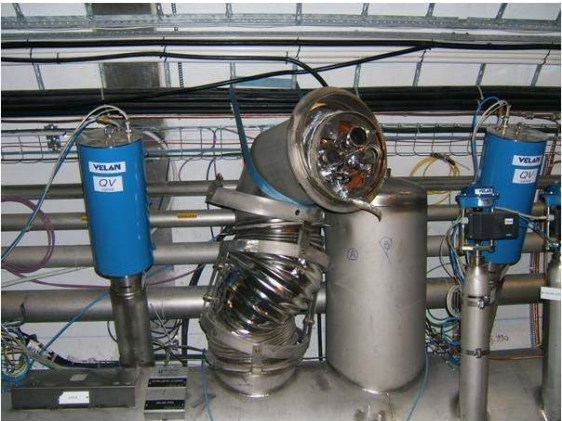
Figure 17: Damage to “jumper” connections of cryogenic distribution line

Four “jumper” connections between the cryogenic distribution line and the magnet string were mechanically damaged, in positions Q23R3, Q25R3, Q27R3 and Q31R3. After removal of the magnets granted access to the corresponding service modules of the cryogenic line, the jumpers were repaired.

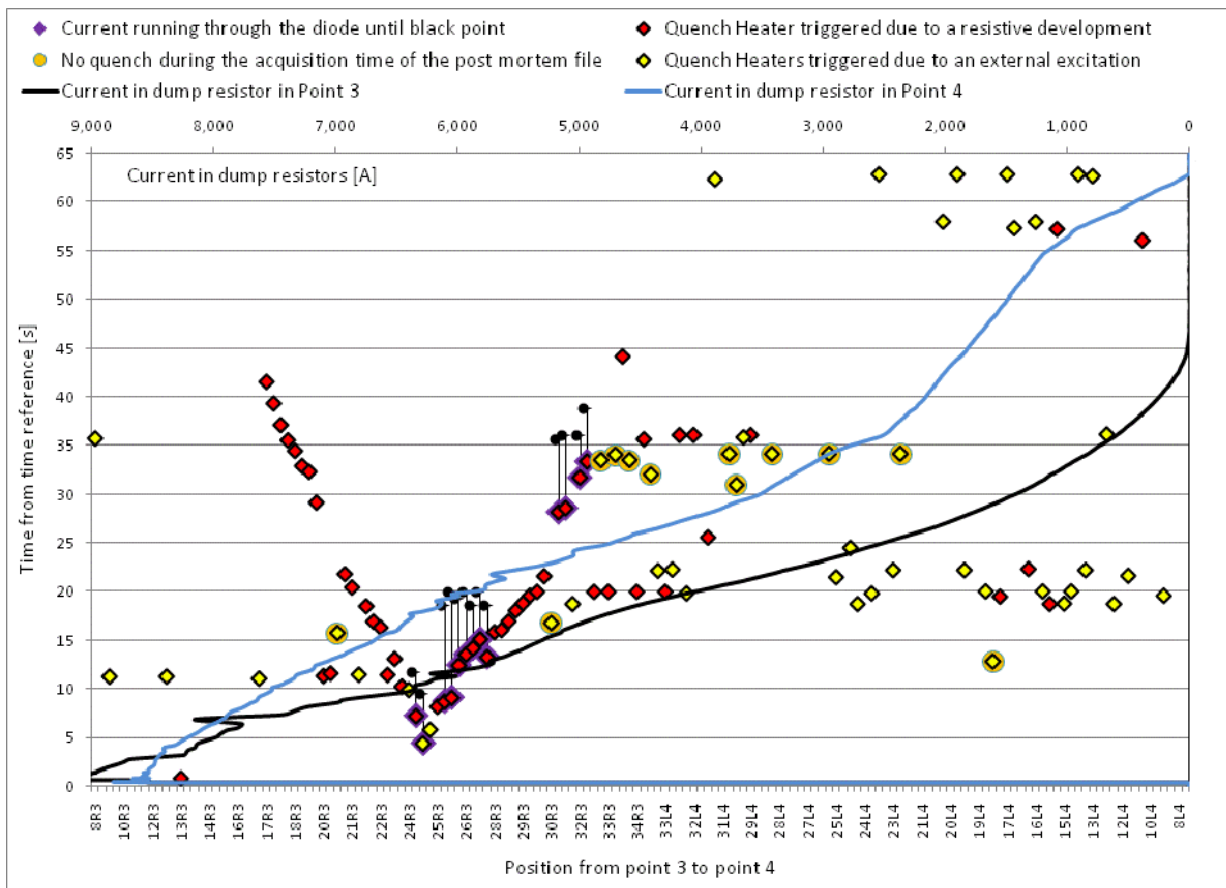
Figure 22: Propagation of quenches and quench triggers in sector 3-4

With the opening and further fragmentation of the circuits provoked by the electrical arcs and insulation faults, the magnets saw much higher rates of current discharge (in the 400 A/s to 500 A/s range) than the nominal 10 A/s (slow discharge) or 120 A/s (fast discharge) normally encountered. Although LHC series dipoles could not be ramped at these values due to limitations of the power converter equipping the tests station, early tests on model magnets showed their quench sensitivity to such high ramp rates. This effect is probably at the origin of the thermal propagation of resistive transitions at long distance in the sector, observed in Figure 22. Electrical noise induced in the quench detectors of many other magnets also triggered the firing of heaters at diverse locations, provoking quenches at other locations in the sector (Annex I). Annex I also presents the overall energy balance of the incident: out of the 595 MJ stored inductively in the dipole magnet circuit of sector 3-4 at the time of the incident, 46 % have been dissipated in an anomalous way, i.e. by electrical arcs. This is enough to heat and melt 375 kg of copper: it is therefore not surprising that the incident created heavy damage to sector 3-4.

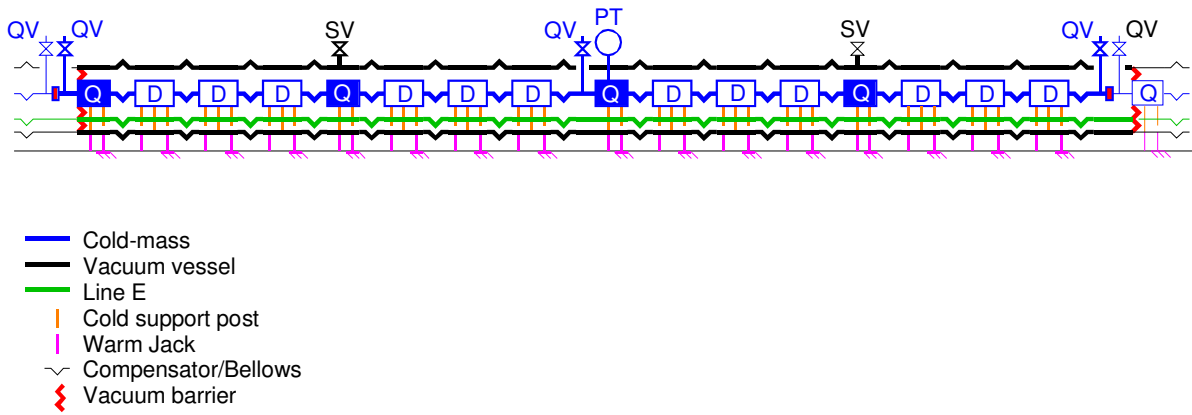
Figure A1: Schematic view of vacuum subsector in LHC arc

A schematic view of a LHC subsector is given in Figure A1. More details on the configuration and layout of the LHC can be found in reference A1. Naming and numbering conventions for LHC components are explained in reference A2.

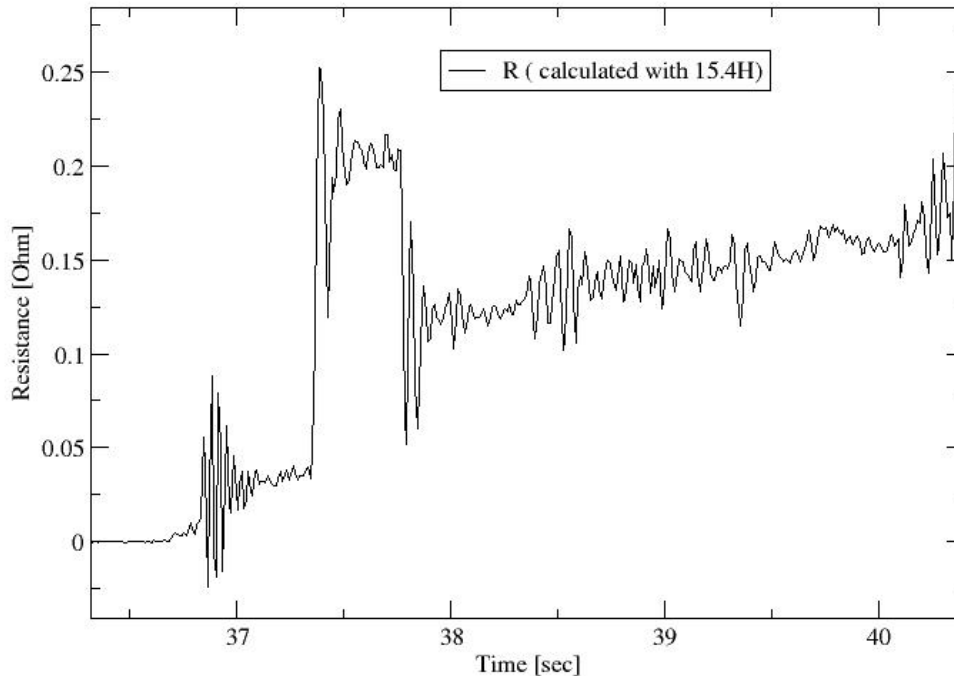
Based on the current decay curve one can estimate the resistance value of the circuit by assuming that the inductance of the string of magnets remains constant. Small effects like eddy current effects which would contribute to the process as an additional resistance were neglected since this effect is small compared to the observed resistance generated in the arc. In Figure E1 the resistance is plotted as a function of time. About 500 ms after the power converter tripped, the dump switch opened which can be observed on the resistance plot as a sudden increase of the resistance. The value of the dump resistance is well known as a function of time for several different current decays. In Figure E2 the value of the dump resistance is plotted as a function time for a 7 kA dump switch opening experiment. Subtracting the value of the dump resistance from the resistance curve, one can trace the evolution of resistance beyond the dump switch opening time stamp (see Figure E3). Unfortunately shortly after the dump switch opens, the arc splits the main circuit into two sub-circuits. Using the current decay curve it is not possible to estimate the total arc resistance any further. Up to this time, the evolution of resistance and current can be used to construct the development of power and energy dissipation in the original arc (see Figure E4).

Figure E1. Resistance was calculated using power converter voltage and current measurements, assuming that the circuit is in one piece (inductance 15.4 H). The latter assumption is no longer valid after 37.8 s

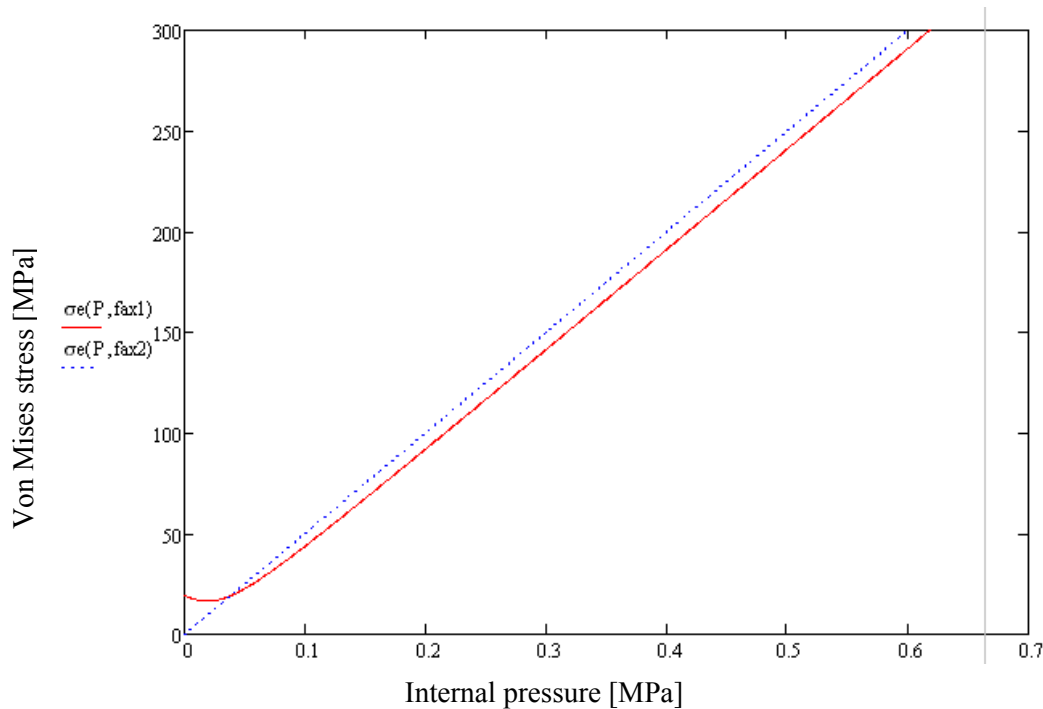
Figure G3: Von Mises stress vs. internal pressure

The Von Mises stress has been plotted for two values of axial force ( $f_{ax1} = 60'000$  N that corresponds a bellows elongation of 500 mm and  $f_{ax2} = 0$ ) (Figure G3). It turns out that the axial force does not have a strong influence on the result and that the minimum internal differential pressure needed to initiate plastic deformation is around 5.5 bar.

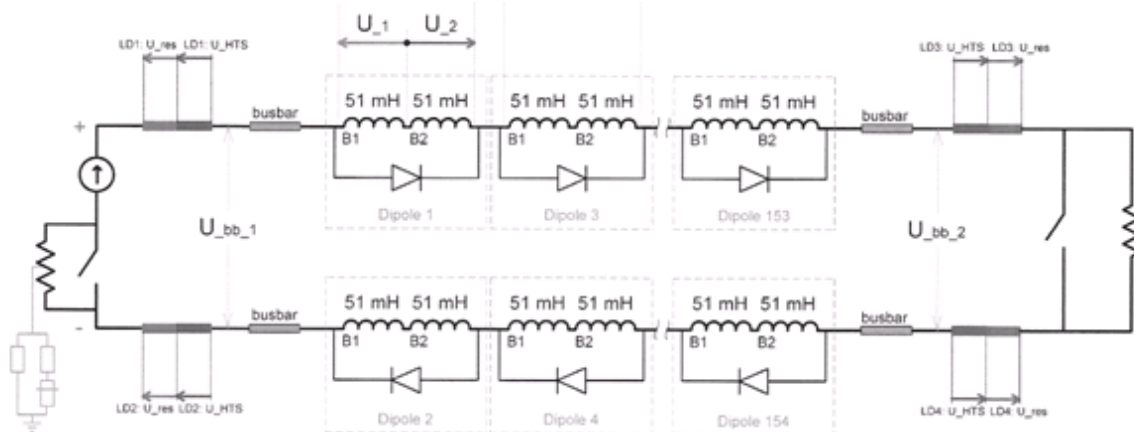
Figure I1: RB circuit configuration

In case of a resistive transition detected in a magnet, the quench heaters mounted on the magnet coils are fired, developing a large resistance. The quenching magnet is then decoupled from the other magnets in the circuit thanks to a diode installed in parallel to the magnet. The breakers of the energy extraction systems are immediately opened, discharging the current through the dump resistors in several minutes. The energy of the quenched magnet is dissipated into its now resistive coil, while the energy of the remaining circuit is dissipated into the dump resistors.

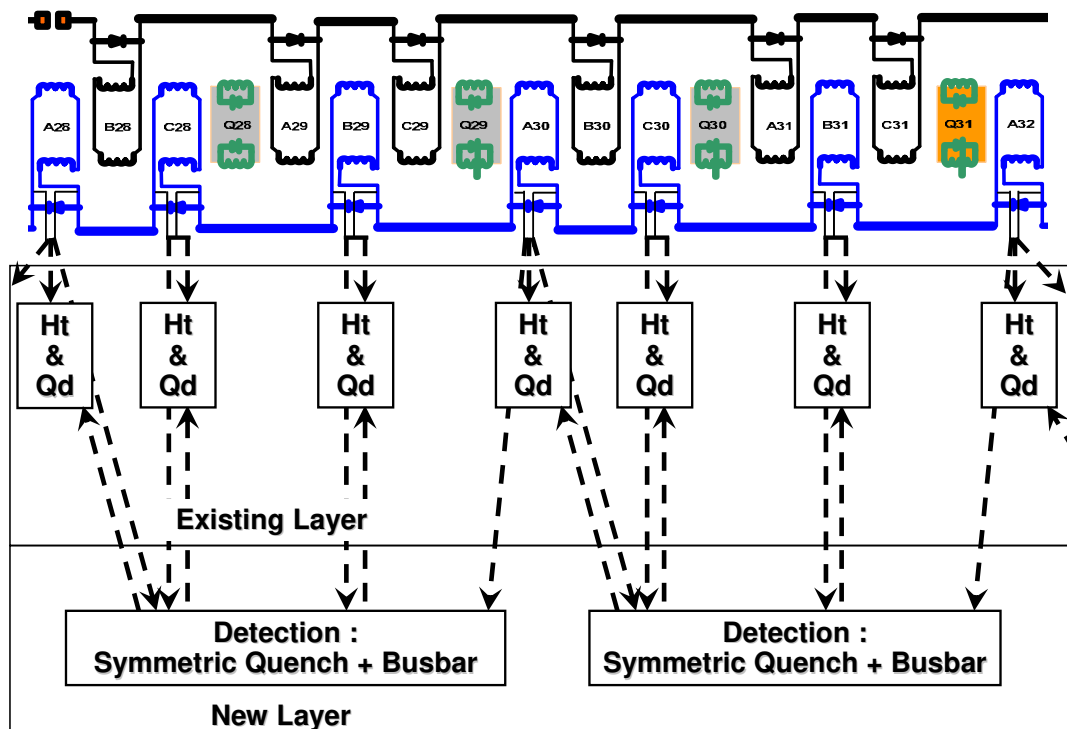
Figure J1: Existing layer of Heater Units and Quench Detection (Ht & Qd) and the new layer, sketched for only one line of dipole magnets. Quenches occurring in the magnets are detected by the existing layer. Quenches occurring in the bus bars linking the magnets are detected by the new layer with a threshold of 0.3 mV. Four electrically adjacent dipoles are compared for symmetric quenches and the Heater Power Supply are fired accordingly. The dotted lines represent the instrumentation and control cables. Similar cables have to be pulled for the return dipole line (top of the figure) and for both quadrupole lines (not drawn).
