# Residual Stiffness Assessment of Failed RC Beam Structure by FE Model Updating

J. M. W. Brownjohn<sup>1</sup> and P. Q. Xia<sup>2</sup>

For a reinforced concrete (RC) beam structure subject to a mid-span point load, failure in tension is deemed to occur when steel reinforcement on the tension side has yielded. When unloaded from this post-serviceability cracking stage, the residual stiffness of the failed structure is difficult to estimate. This paper presents a new method for the residual stiffness assessment of a failed RC member such as a beam or one way narrow slab at the post-serviceability cracking stage based on dynamic testing and finite element (FE) model updating. The failed zones are simulated using damaged beam elements in an FE model of the structure and the measured modal properties i.e. frequencies and mode shapes are used as the reference data for model updating. Through a procedure of sensitivity-based updating, the stiffness distribution along the member can be obtained, leading to identification of location and extent of the damaged (failed) region.

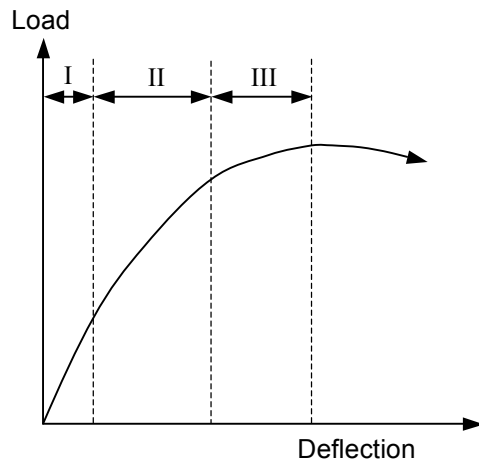
Fig. 1 Load-Deflection Relationship of Beam  
Region I, Pre-cracking Stage;  
Region II, Post-cracking Stage;  
Region III, Post-serviceability Stage

The deflection, as a measure of stiffness, of a reinforced concrete (RC) member determines an operating range for serviceability and post-serviceability before rupture. The load-deflection relationship of a RC beam, shown in Fig. 1 (Nawy, 1990), is essentially composed of three regions prior to rupture:

- (1) a very limited or even non-existent pre-cracking stage where a structural member is crack-free;
- (2) post-cracking stage where the structural member develops acceptable controlled cracking both in distribution and width (most beams lie in this region at service loads); and
- (3) post-serviceability cracking stage where the stress in tension reinforcement reaches the limit state of yielding, the beam is considered at this stage to have structurally failed by initial yielding of tension steel.

At the first stage in region I shown in Fig. 1, the flexural stiffness of the bridge deck  $EI$  can be estimated using Young's modulus of concrete  $E_c$  multiplied by the moment of inertia of the uncracked RC cross section which is transformed to the same material. The value of  $E_c$  for normal-weight concrete can be estimated using the ACI empirical expression (Nawy, 1990),  $E_c = 4730\sqrt{\sigma_c}$  ( $N/mm^2$ ) where  $\sigma_c$  is compressive strength of concrete measured at 28 days after casting. Based on sample cube tests,  $E_c = 2.99 \times 10^4$  ( $N/mm^2$ ). The area of steel reinforcement  $A_s$  is replaced by an equivalent concrete area  $(E_s/E_c)A_s$  in which  $E_s$  is the modulus of the reinforcing steel. The transformed moment of inertia of one edge beam  $I_{bt}$  and of slab component  $I_{st}$  with rectangular cross-section shown in Fig. 2 and their center of gravity of the transformed section  $\bar{y}_{bt}$  and  $\bar{y}_{st}$  are given as follows,

At the second stage of load-deflection relationship (region II shown in Fig. 1), the edge beams underwent varying degrees of cracking along the span, corresponding to the stress and deflection levels at each section. Hence cracks were wider and deeper at midspan. When flexural cracking developed, the flexural rigidity of the section was reduced as the contribution of the concrete along the beams in the tension zone reduced substantially and the depth of the compression zone reduced. As the cracked zone expanded, stiffness continued to decrease, reaching a lower-bound value corresponding to the reduced moment of inertia of the completely cracked section. At this state the contribution of tension-zone concrete to the stiffness was neglected. The strain and stress distributions through the depth of the cracked rectangular concrete beam section at this stage are shown in Fig.3. Based on extensive testing verification (Spiegel and Limbrunner, 1998), the following assumptions were made:

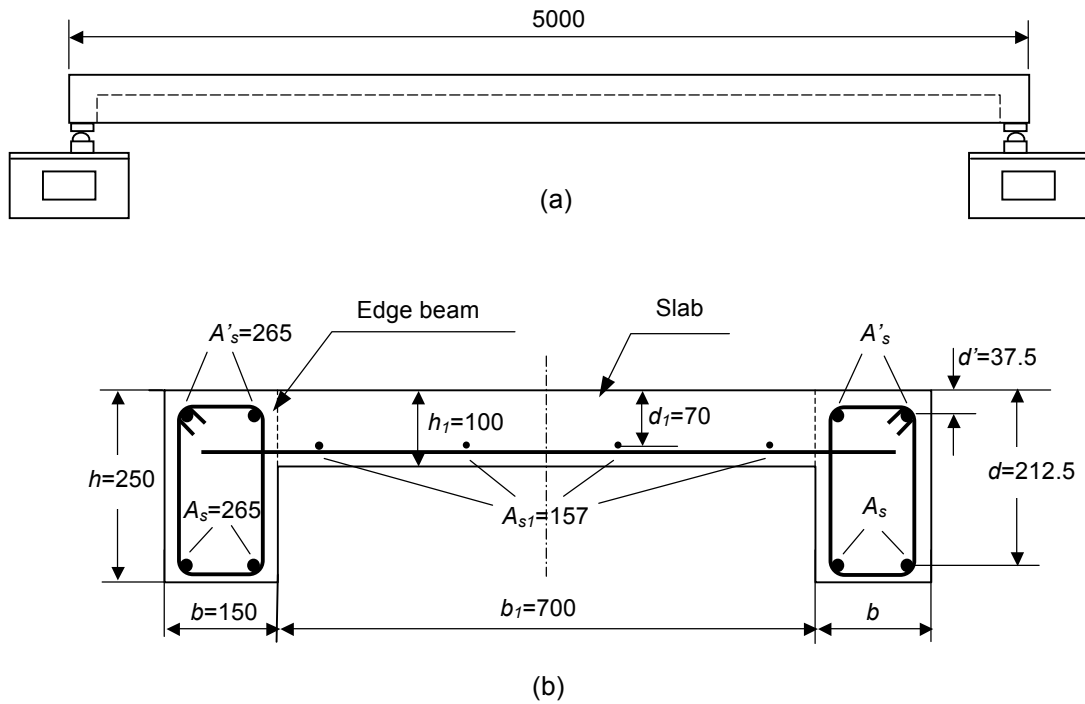
Fig. 2 Schematic of Reinforced Concrete Bridge Deck  
 (a) Span Unit with Simple Supports;  
 (b) Cross-section, Unit: Length(mm), Area(mm<sup>2</sup>)

The detailed geometry of investigated RC bridge structure is shown in Fig. 2. It comprised a shallow lightly reinforced slab component with two deep reinforced edge beams. The edge beams were nominally 250mm deep by 150mm wide. The bridge deck

had overall 1m width and 5m length and was simply supported at the ends on two concrete blocks as shown in Fig. 2.

where,  $n = E_s/E_c$  is the modulus ratio.  $A_s$  and  $A'_s$  are the areas of top and bottom steels in one edge beam respectively.  $A_{s1}$  is the total areas of steels in the slab. The values of dimensions and areas are given in Fig. 2. After substitution of relevant values into

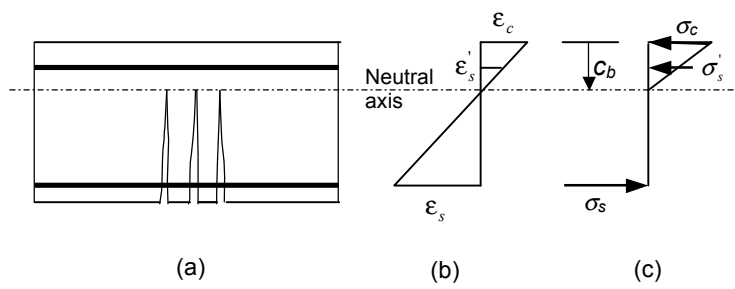
Fig. 3 Stress and Strain Distribution of Cracked Reinforced Concrete Beam: (a) Geometry; (b) Strain; (c) Stress

In terms of the assumptions and the horizontal force equilibrium in cross section, the moment of inertia of the cracked beam section  $I_{bcr}$  can be determined as follows,

In equation (5), the first term denotes the moment of inertia of the compressive area  $bc_b$  about the neutral axis, namely, the base of the compression rectangle, neglecting the section area in tension below the neutral axis. The reinforcing area was scaled by  $n$  to transform to an equivalent concrete area for contribution to the section stiffness. The moment of inertia of the steel about its own axis was disregarded as negligible.

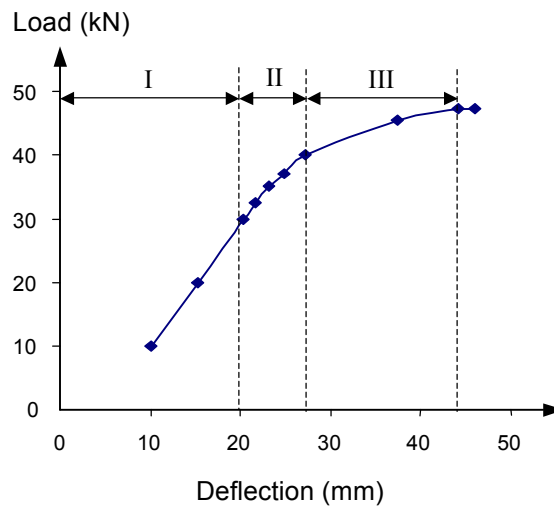
Fig. 4 Measured Load-Deflection Relationship of Deck

In the static load testing, midspan loads were applied in increments of 2~5kN by a hydraulic jack as shown in Fig. 7 until the maximum load of 47.3 kN was sustained, (compared to the design value of 40 kN). Beam deflections obtained by LVDTs and steel reinforcement strains from electrical resistance strain gauges were recorded. Fig. 4 shows

the measured load-deflection relationship showing regions I, II and III. The cracking developed at midspan is shown highlighted by marker pen in Fig. 5.

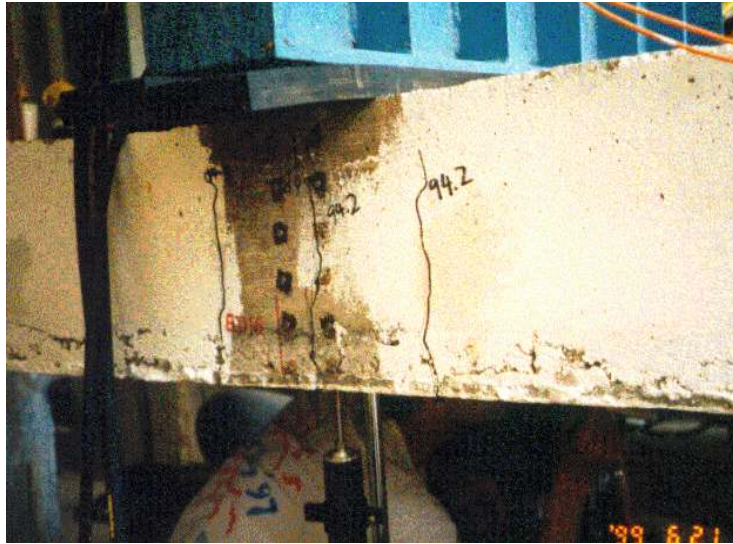
Fig. 5 Cracks at Midspan of Beam

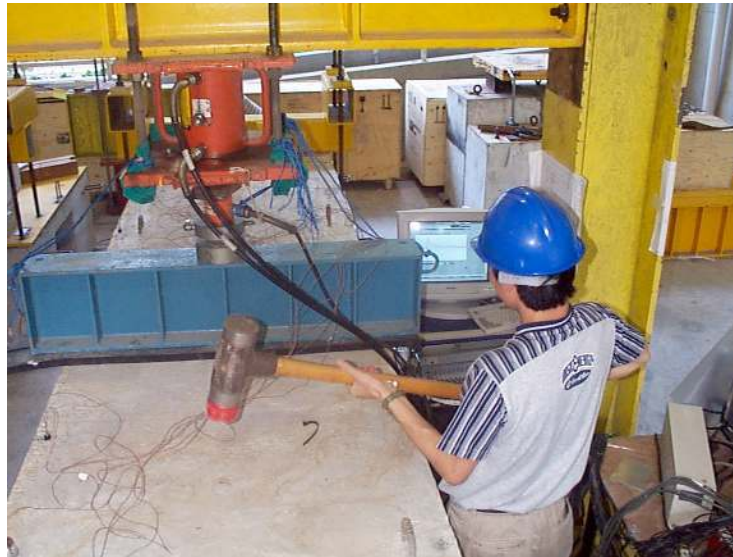
Fig. 7 Vibration Testing Using Instrumented Hammer and Experimental Set-up

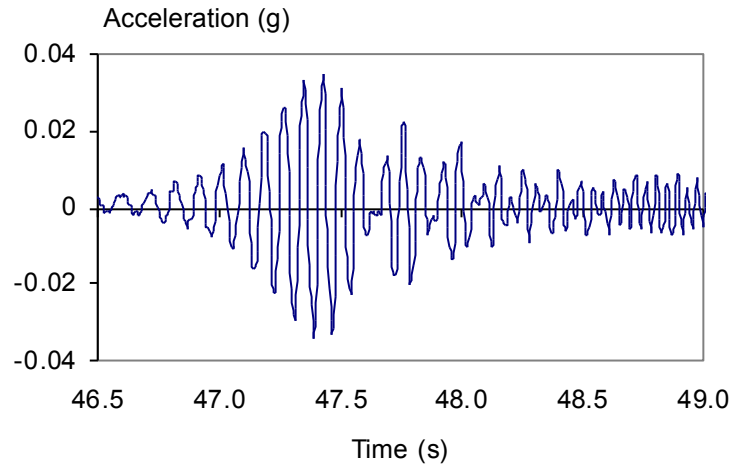
Fig. 8 Time History of Acceleration Response due to Chirp Excitation

An example acceleration response time history from an accelerometer at a measurement point by shaker excitation and an FRF curve are shown in Fig. 8 and Fig.9 respectively. From the FRFs, the measured frequencies and corresponding mode shapes of the structure were obtained by using modal analysis technique (Ewins, 1984). The measured frequencies  $f_m$  are listed in the second column in Table 1. The measured mode

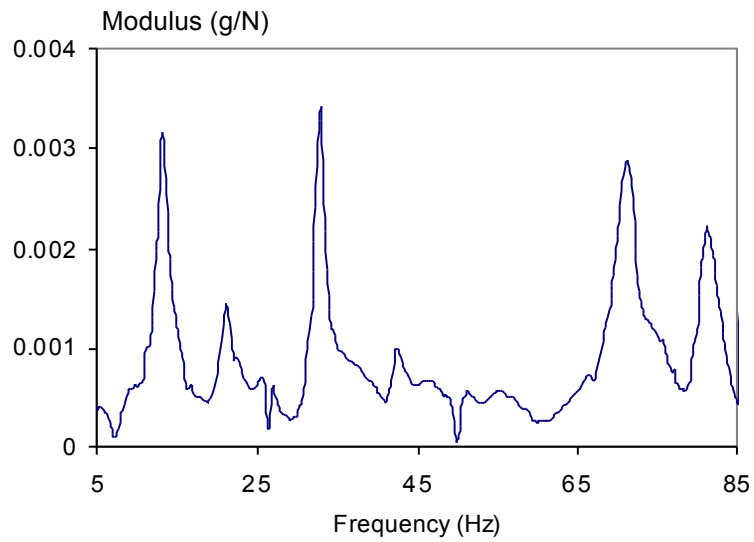
Fig.9 Measured FRF Magnitude at One Point

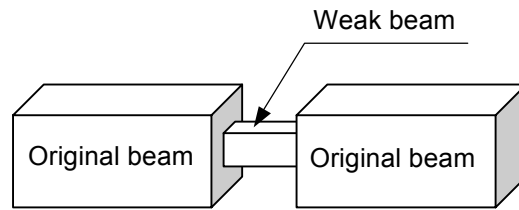
Fig. 11 A 'Damaged' Beam Model

will not be generally contained in a FE model unless some special considerations are incorporated. In this case, a kind of ‘damaged’ or ‘weakened’ beam model (Brownjohn and Xia, 1999) was used to simulate the cracked zone at midspan of the edge beam components. A ‘damaged’ beam model is shown in Fig. 11. The physical and geometrical parameters of the ‘damaged’ element depend on the damage extent.

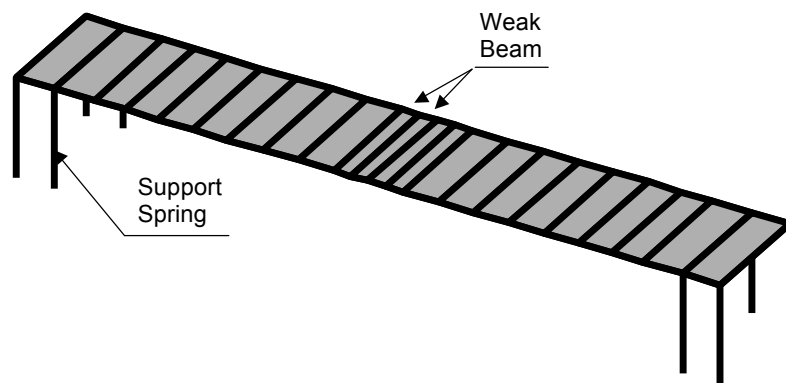
Fig. 12 FE Model of Bridge Structure

To represent the large responses at the supports of the structure (Fig. 10), the boundary conditions were taken as elastic supports in the form of eight linear springs in the FE model. Two side edge beam components were modeled using 3D beam elements and four ‘weak’ beam elements were located around midspan. The top slab component of the deck was modeled using shell elements. The resulting FE model is shown in Fig. 12. It should be pointed out that if the parameters of ‘weak’ beam elements take the real values for the damage zones, then the FE model is taken to represent the damaged structure, but if the parameters match those for the rest of the beam the FE model represents the undamaged structure.

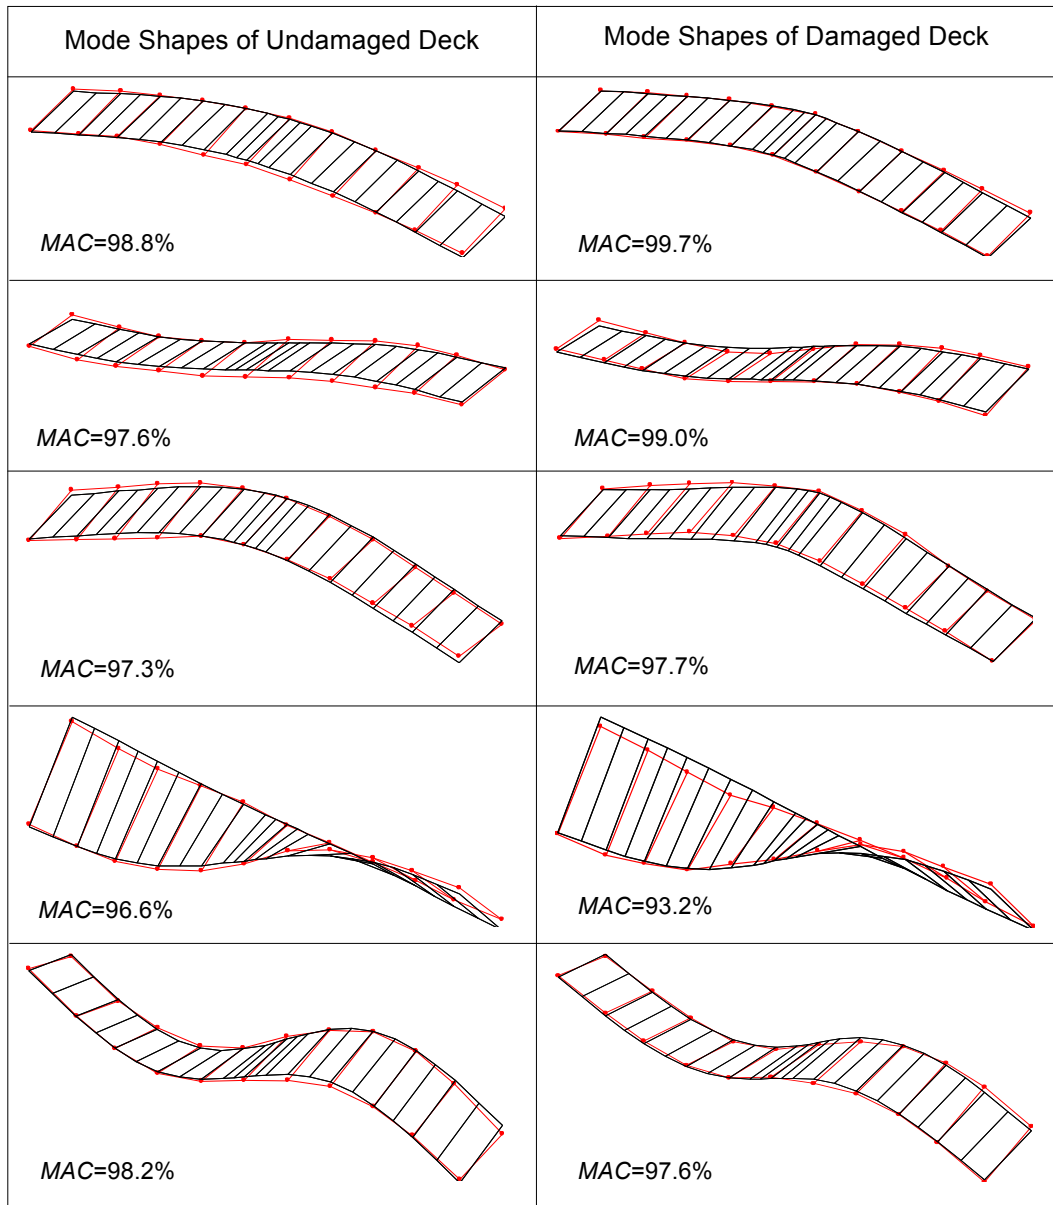
Fig. 13 Pair of Mode Shapes between FE Updated and Measured  
 — FE Updated —●— Measured

After the tuning procedure, the updated frequencies  $f_u$  and the differences  $\Delta_f$  are listed in the fifth and seventh column in Table 1, respectively. The *MAC* values are listed in the eighth column in Table 1. The  $\Delta_f$  values were very small and the *MAC* values were very high. The pairing of mode shapes of the failed structure with those from the updated ‘damaged’ FE model is shown in the second column in Fig. 13 in which the consistency of the updated model with the measured model can be seen.

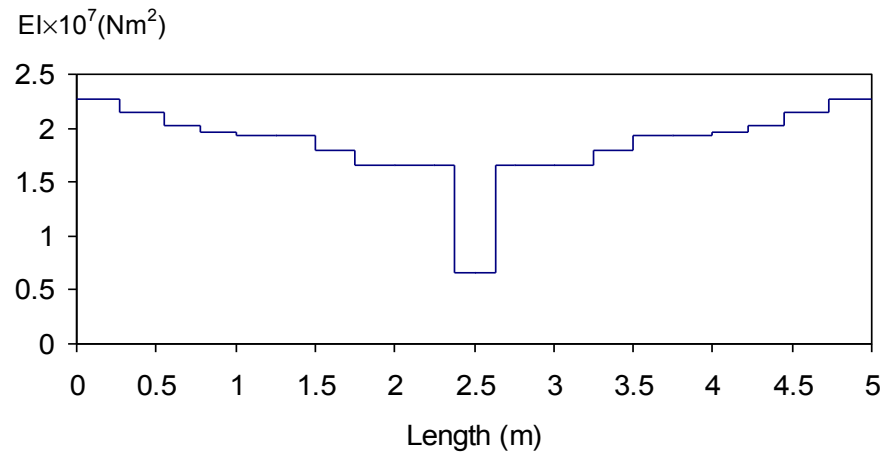
Fig. 14 Distribution of Stiffness of Failed Beam

At midspan, the updated value of Young’s modulus and moment of inertia were  $E_{bm}^f = 2.15 \times 10^3 N/mm^2$  and  $I_{bm}^f = 3.14 \times 10^7 mm^4$  respectively (all values of moment of inertia at midspan beam are listed in Table 2 for convenient look). Thus, The residual stiffness of the failed bridge deck at midspan at the post-serviceability cracking stage III was estimated as  $2E_{bm}^f I_{bm}^f + E_c^u I_{pt} = 4.91 \times 10^{12} Nmm^2$ , smaller than the estimated value  $E_c^u I_{cr} = 7.72 \times 10^{12} Nmm^2$  at the post-cracking stage II. According to the updated values of moment of inertia along the beam, the distribution of stiffness  $EI$  along the failed deck at the post-serviceability cracking stage III can be obtained and is shown in Fig. 14. It is obvious that the smallest stiffness was at midspan of the failed deck and the stiffness increased gradually towards the supports.

It should be pointed out that the moment of inertia of RC beam depends on the square of depth of neutral axis through equation (5), so the distribution of stiffness along a beam will be similar to the distribution of depth of neutral axis along the beam. Fig. 15 shows the measured distribution of depth of neutral axis of the beam under the ultimate limit state during the static testing. The neutral axis depth for the beam was obtained by linear interpolation of strain values from the top and bottom steels in the edge beam and is defined as  $c_b$  in Fig. 3. The negative neutral axis depth at the midspan means that the up and down steels in the edge beam were all in tension at the ultimate limit state. Values above the beam are possible due to the contribution of the slab element with uneven surface. The distributions in Fig. 14 and Fig. 15 are remarkably similar.

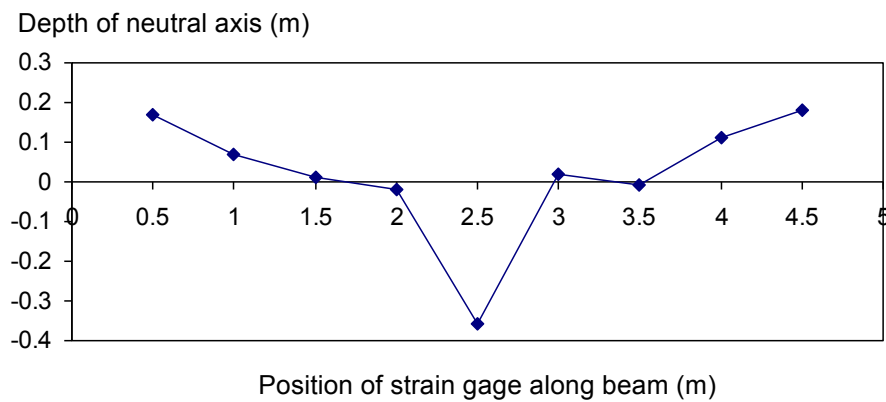
Fig. 15 Measured Neutral Axis of Beam under Ultimate Limit State

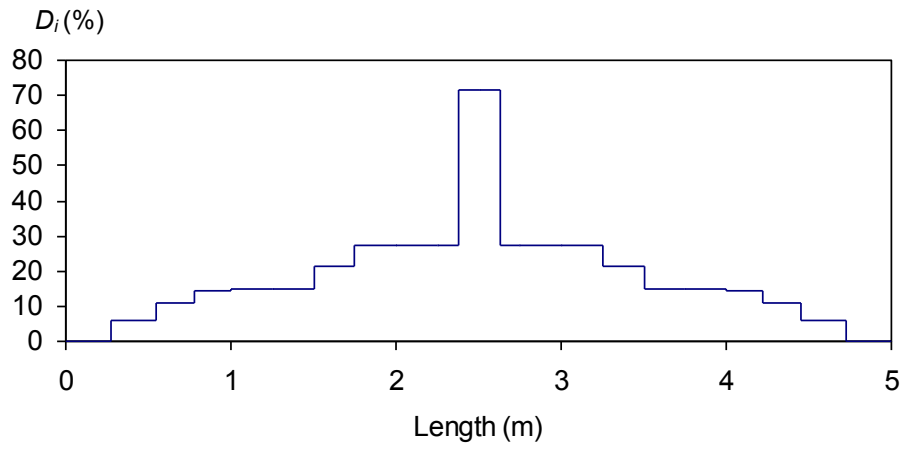
Fig. 16 Distribution of Damage Index along Beam

where  $\Delta(EI)$  denotes the change in stiffness between undamaged and damaged cross-section of the deck and  $(EI)_o$  denotes the original stiffness of the undamaged cross section of the deck. Fig. 16 shows the damage index  $D_i$  along the deck. Obviously, the extent of damage at midspan of the failed deck was most serious, at 71.4%.
