Salt Freeze-Thaw Damage Characteristics of Concrete based on Computed Tomography

Shaojie CHEN, Jianxi REN, Yongjun SONG, Qiang LI, Jielong Sun, Yongxin CHE, Jiaying CHEN

Keywords: CT technology; concrete; damage characteristics; salt freeze–thaw cycles

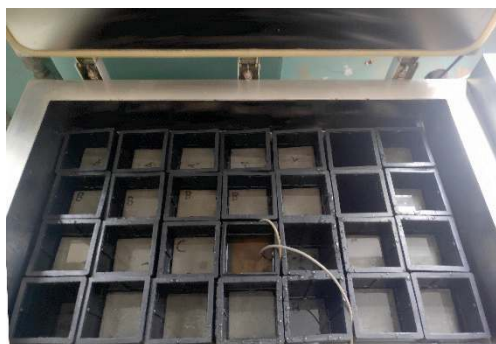
Figure 1 Freeze–thaw test

The fast KDR-V9 concrete freeze-thaw machine made by Beijing Digital Intelligence Yilong Instrument Company was utilized. The freeze-thaw experiment was performed through the fast-freezing method in the Test Standards for Long-term Performance and Durability of Ordinary Concrete GB/T50082-2009 [30] (Fig. 1). Prior to the experiment, concrete samples were immersed in 5% $NaCl$ solution for 4 days. Then, the freeze-thaw experiment was conducted after the saturation of all samples. The lowest and highest temperatures in the center

of the samples were controlled at $(-18 \pm 2) ^\circ\text{C}$ and $(5 \pm 2) ^\circ\text{C}$, correspondingly. Each freeze–thaw cycle was accomplished in 2–4 h, and a group of 3 concrete samples was collected every 25 freeze–thaw cycles to test the

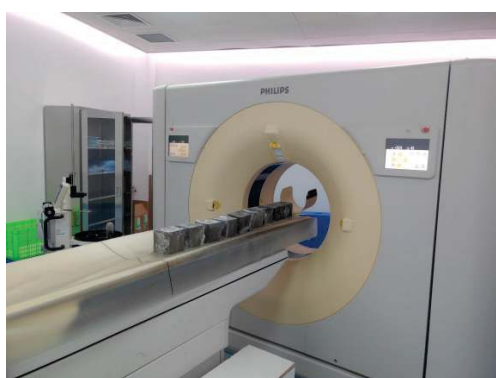
Figure 2 CT scan test

The Brilliance iCT 256-layer spiral top-speed CT machine made by Philips was used in the CT scan test. The following scanning parameters were set: 120 kV of voltage and 117 mA of current. The slice thickness was set to 1 mm. The cubic concrete samples were scanned continuously under saturation conditions along the cross section, and the display matrix was 512×512 . All concrete samples were wrapped using a thin film to prevent the liquid evaporation of samples. The scanning test is depicted in Fig. 2.

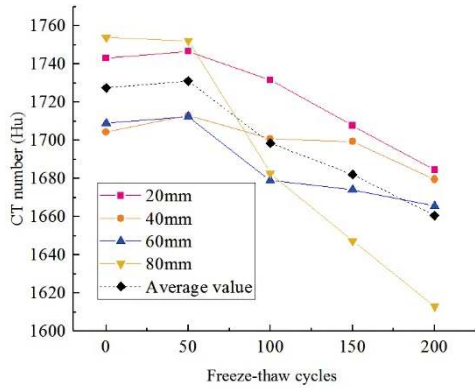
Figure 5 Relation between relative CT values of different scanning sections and salt freeze–thaw cycles

Figs. 5 and 6 exhibit that the relative CT value of the sections of the samples increases initially and then decreases with the increase in salt freeze–thaw cycles. The 80 mm scanning section shows the largest area losses, followed by the 20, 60, and 40 mm scanning sections successively. This result reflects that the peeling loss of the samples at the two ends is higher in the salt freeze–thaw environment than in the middle region. Micropores and fine aggregates develop volume expansion given frost heaving in the early stage of the salt freeze–thaw cycles. The internal structure is loose, and the sample volume increases. Equation (4) expresses that the surrounding solution fills in cracks in concrete materials during melting. The CT value of the solution is approximately 71 Hu, which is smaller than that of concrete materials but higher than that of air (-1000 Hu). Thus, the relative CT value in the chosen region increased. The concrete surface material peeled off after 100 freeze–thaw cycles, accompanied by the reduction of the surface area. In the selected $105 \text{ mm} \times 105 \text{ mm}$ space, the original concrete material was replaced by air. The relative CT value declined because the CT value was far lower in air than in the materials.

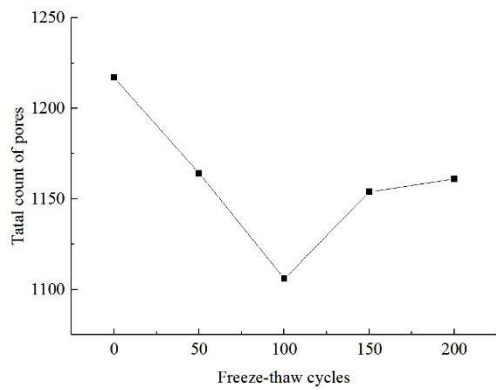
Figure 12 Changes in the total number of pores with the salt freeze–thaw cycles

and then increased with the salt freeze–thaw cycles but presents a generally decreasing trend. The reduction in the total number of pores in the early stage of the salt freeze–thaw cycles was due to two phenomena. On the one hand, the concrete surface peeled off, and external pores decreased due to frost heaving. On the other hand, some pores were connected given the salt freeze–thaw cycles,

thus decreasing the total number of pores. The total number of pores in the late stage of the salt freeze–thaw cycles increased slightly in response to the loose aggregate structure of concrete and increased the number of pores. Given that peeling damage takes a dominant role, the total number of pores decreased gradually.

(2) The changes in the number of pores in concrete are closely related to the salt freeze–thaw cycles. With the increase in salt freeze–thaw, the total number of pores decreases initially and then increases. The reduction in pores in the early stage of salt freeze–thaw cycles is mainly due to two aspects. On the one hand, concrete surface peels off due to frost heaving, and the pores at the outer side decrease. On the other hand, some pores are connected given the salt freeze–thaw cycles, and the total number of pores decreases accordingly. The increased total number of pores in the late stage is due to the initiation of new pores in the loose concrete aggregate.

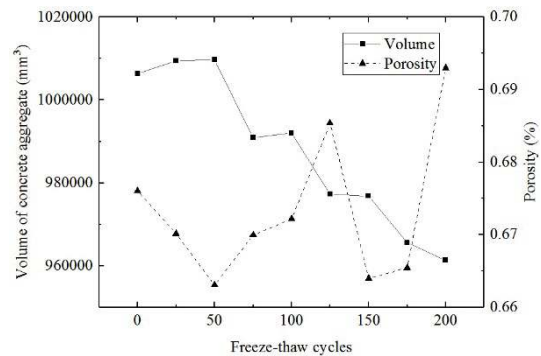
Figure 14 Changes in the concrete aggregate volume and porosity of the samples with the salt freeze–thaw cycles

The changes in the concrete aggregate volume and porosity of the samples with the salt freeze–thaw cycles are presented in Fig. 14. In the early stage of the salt freeze–thaw cycles, the aggregate volume increased. This result is the collaborative consequence of the internal structural expansion given frost heaving and few surface peeling damages. The peeling of surface aggregates accelerated after 50 salt freeze–thaw cycles, and volume decreased accordingly. The volume loss rate at 200 salt freeze–thaw cycles was approximately 4.5%. The porosity of the concrete samples was between 0.66% and 0.69%. It fluctuated with the increase in salt freeze–thaw cycles and increased slightly in the late stage. However, the overall change was small, thus indicating that salt freeze–thaw cycles are mainly caused by the peeling of concrete aggregates.

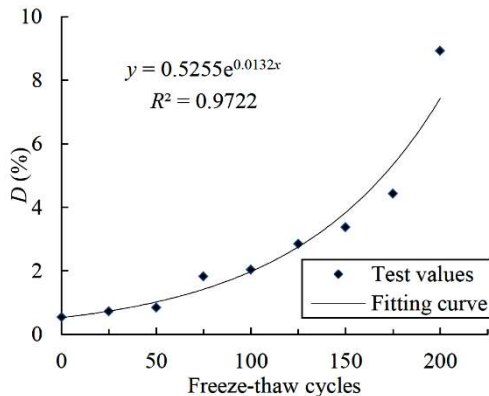
Figure 17 Relationship between salt freeze–thaw cycles and degree of damages

Table 2 displays that concrete damages are intensified with the increase in salt freeze–thaw cycles, whereas the uniaxial compressive strength decreases. The fitting map of freeze–thaw cycles and the degree of damages are exhibited in Fig. 17. The fitting results show an exponential

distribution of the degree of concrete damage with the freeze–thaw cycles.

$$D = 0.5255e^{0.0132i} \quad (10)$$

According to the fitting results, the slope of the concrete damage curve in the early stage increases slowly, thus indicating a small degree of concrete damages. However, the slope increases quickly after 100 freeze–thaw cycles, thereby implying that the concrete aggregate peels significantly in this stage. Crack development accelerates, and the degree of damages increases.

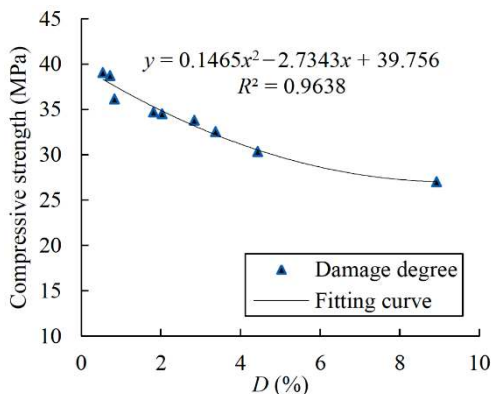
Figure 18 Relationship between degree of damages and uniaxial compressive strength

The fitting results of the degree of concrete damage and uniaxial compressive strength are illustrated in Fig. 18.

where σ is the uniaxial compressive strength of concrete (MPa). In accordance with the fitting curve, the uniaxial compressive strength of concrete decreases gradually with the increase in the degree of damages, and the fitting degree of the trend line (R^2) is 0.9638.

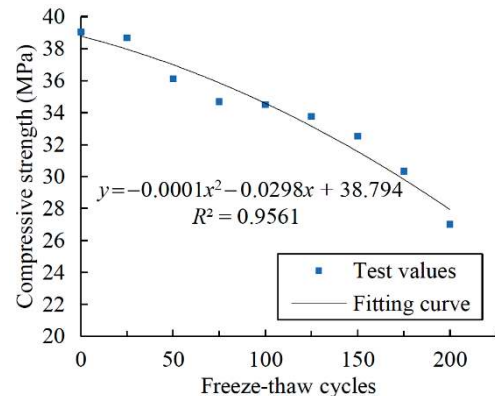
Figure 19 Relationship between salt freeze–thaw cycles and uniaxial compressive strength

In accordance with the fitting curve, the uniaxial compressive strength of concrete decreases gradually with

the increase in the freeze–thaw cycles, and the fitting degree of the trend line (R^2) is 0.9561, thereby indicating that the fitting formula can reflect the relationship between the salt freeze–thaw cycles and compressive strength.
