Satellite-based assessment of the August 2018 flood in parts of Kerala, India

Kerala flood; August 2018 flood; Sentinel-1A; Flood Inundation Mapping; Modified Normalized Difference Water Index

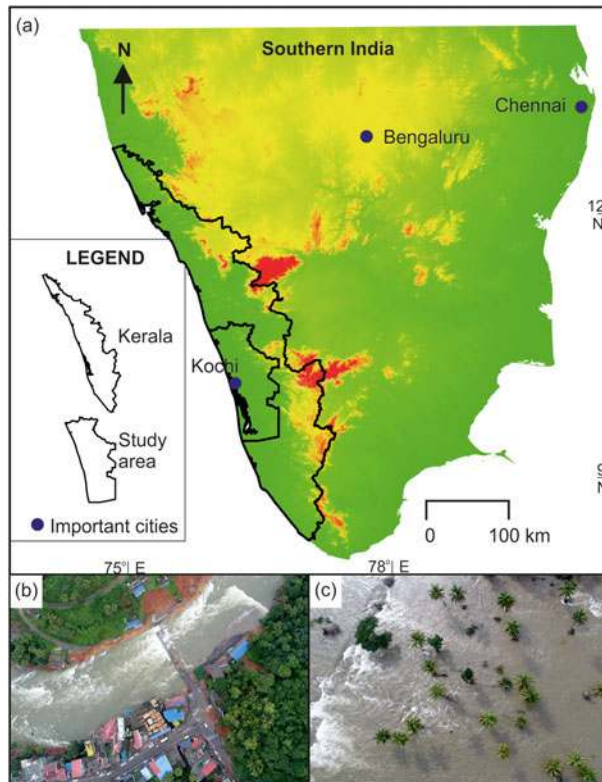
Figure 1. (a) South India showing the state of Kerala (mosaic of SRTM 90 m resolution DEM) (b) and (c) UAV images of flooding event along Periyar river course (Source: I&PRD, Govt of Kerala).

Kerala, a relatively small state with an area of 38,863 km² area, located in the southwestern part of the Indian Peninsula (Figure 1a), typically experiences rainfall for nearly 6 months in any given year in the form of monsoon rain and thunder-showers. The variation in the annual rainfall in Kerala is small when compared with other parts of the Indian sub-continent. However, there had been at least one, uncharacteristically wet years when the historians have noted that a total of 3368 mm of rain was recorded during a period of three weeks in 1924. Specifically, this rainfall event in 1924 occurred during the southwest monsoon (SWM) season. During the present SWM rainfall events, between 1 June and 26 August 2018, the amount of rainfall was 50% less than the 1924 event but was still 36% more than the normal rainfall for that period (IMD 2018).

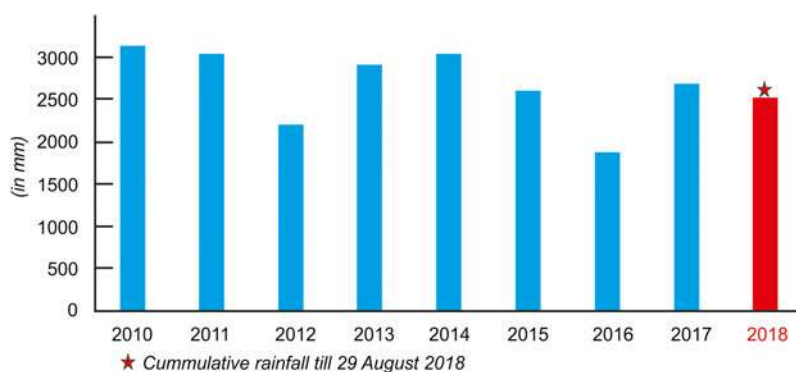
Figure 2. Hyetograph of Kerala from 2010 to 2018 (up to 29 August).

The state of Kerala experiences two monsoon seasons characterized by southwest (June to September) and northeast (October to December) monsoons. The spatio-temporal distribution of rainfall here is significantly influenced by the overall physiography of the state (Simon and Mohankumar 2004). Located in the western slopes of the Western Ghats, Kerala experiences heavy rainfall (roughly 3000 mm annually), of which, majority occur during the monsoon (Thomas and Prasannakumar 2016). The year 2018 experienced larger than normal rainfall with the southwest monsoon bringing an excess of 36% till the 29 August itself (Figure 2: Source IMD 2018) causing this deluge.

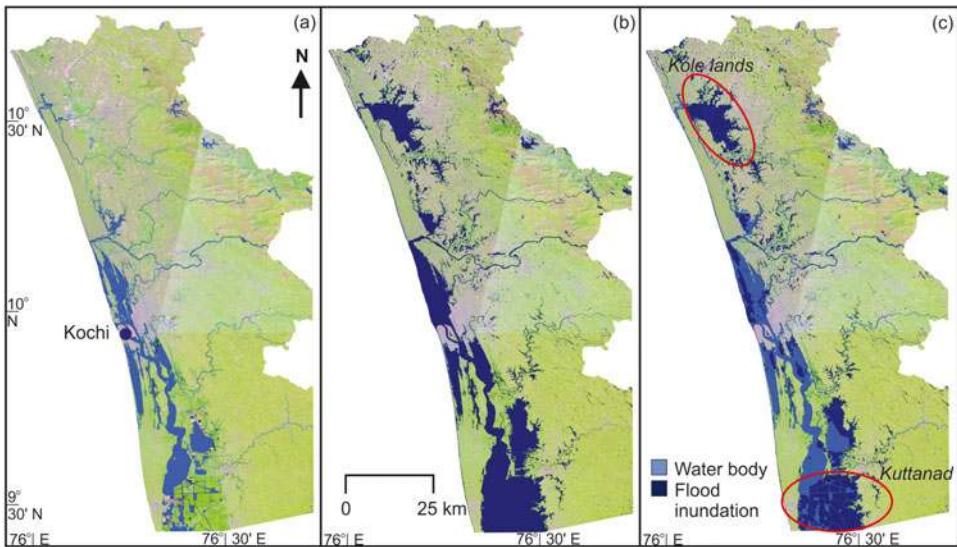
Figure 3. (a) Sentinel 2 image showing the water bodies of the study area before the flood event (b) Flood inundation map prepared from the water pixels of Sentinel 1 image of 21 August 2018 (c) Changes between the pre-event and the flood inundation map of the study area.

Though the flood waters in most of the inundated land in the river basins had already begun to recede by 21 August 2018, the water levels in the Kuttanad and Kole wetlands were slow to decline. As observed in Figure 3(b,c), the Kuttanad region in the south and the Kole wetlands in the north remained inundated in the 21 August, 2018, imagery. Furthermore, satellite image analysis showed a clear 89.6% increase in the area covered by water. The nearly twice as much area was covered with water when compared with any normal year is unequivocally a matter of grave concern.

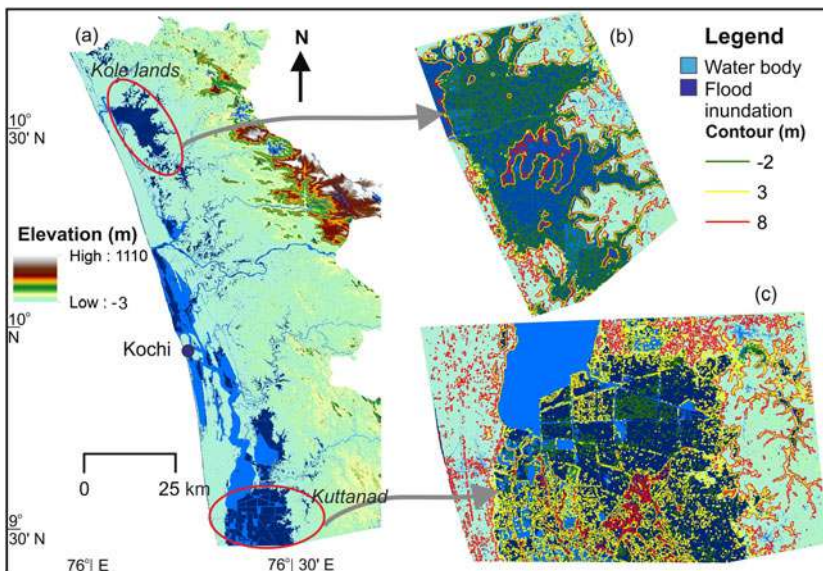
Figure 4. (a) DEM of the area showing pre-flood and flood, (b) flood inundation at Kole lands of Thrissur. Note the 10 m rise in water level during flooding and (c) flood inundation at Kuttanad. Note the 5 m rise in water level during flooding.

Figure 4a is an overlay of DEM derived contours over the flood inundation vectors of Kuttanad and Kole wetlands. The rise in water levels in the Kole wetlands was up to ~10 m (Figure 4b); while in the Kuttanad region it was up to ~5 m (Figure 4c). Such a difference in the flood level is due to the geomorphology. Kuttanad is a vast

basin with its floor lying below mean sea level, in contrast to physiographic highs surrounded Kole lands. This water level rise of 5–10 m is to be considered as a substantial rise and this rise is indicative of the disastrous and disruptive nature of the flood.

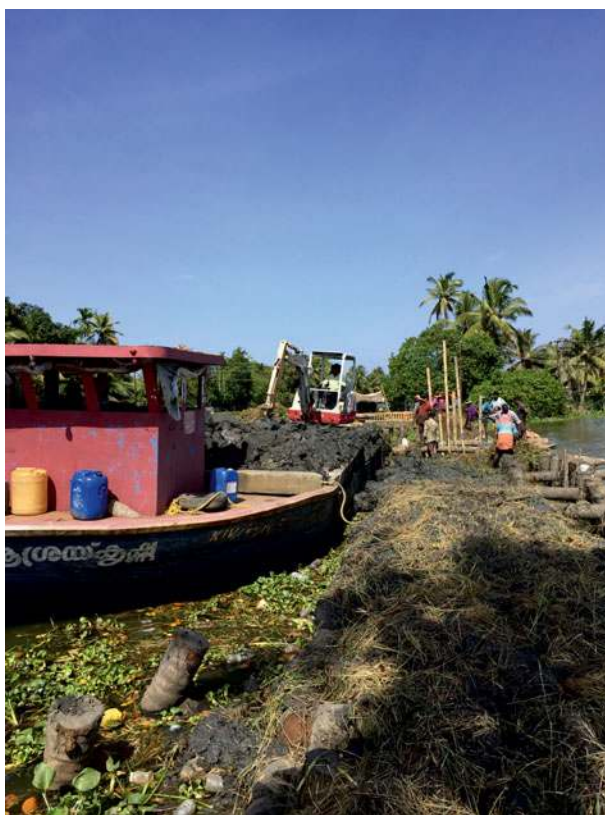
Figure 5. View of the bund reconstruction efforts that secures Kanakassery, Valiyakari, and Meenapally paddy polders from the Vembanad Lake in Kuttanad. The left of the bund is the Vembanad Lake and the right of the bund is the paddy polders that span over 750 acres.

In Kuttanad, in addition to the extreme rainfall and opening of shutters of almost all the major dams, it was high tide time in the Arabian Sea and that further delayed the discharge of the flood waters. It was also observed by the authors in the field visit to Kuttanad that several bunds/embankments that secured the paddy polders and residential areas from the Vembanad Lake had experienced minor to major damages (Figure 5). These damages aggravated the flood effects as water from the Vembanad Lake started filling up the low lying paddy polders and residential areas.
