Seismic behaviour of traditional timber frame walls: experimental results on unreinforced walls

Elisa Poletti¹, Graça Vasconcelos

ISISE, Department of Civil Engineering, University of Minho, Campus de Azurém, 4800-058
Guimarães, Portugal

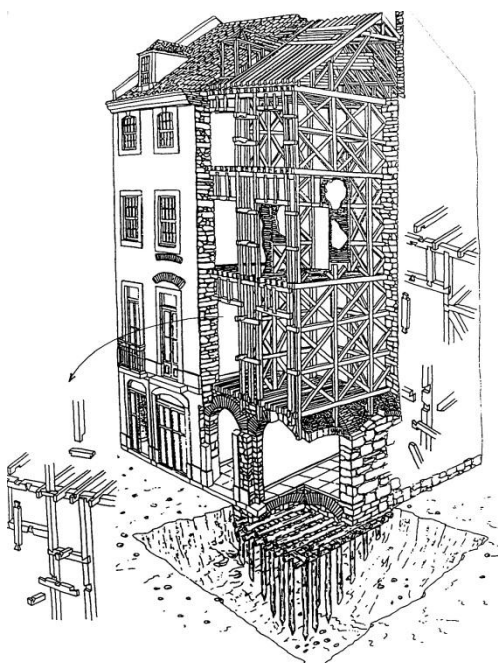
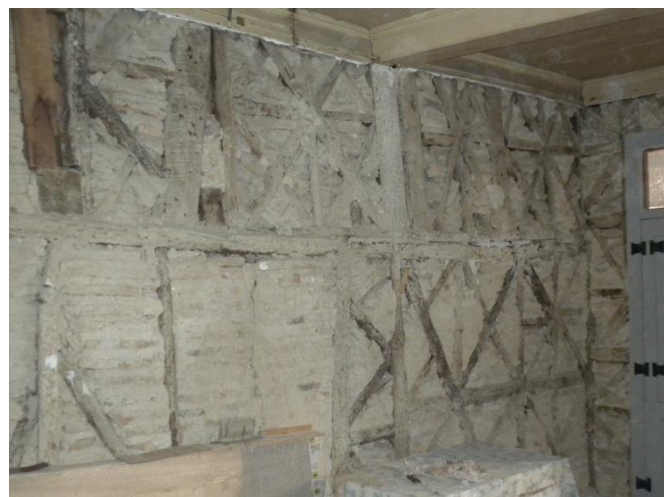
Fig. 2 Timber frame structures in Portugal: (a) typical Pombalino construction (Mascarenhas 2004); (b) timber frame building in Guimarães

Though this constructive system is typical of the city of Lisbon, timber frame structures can also be found in historic city centres in the north of the country, for example in Porto, Vila Real, Braga and Guimarães (Fig. 2b), even if the seismic hazard is very low in these locations. Their use is attributed to the generalization of the Pombalino construction technology all over the country due its popularity as a lighter and less expensive construction system (Salavessa 2011). In these cities, only the ground floor is comprised of masonry walls, while in all other storeys, each wall is either a *frontal* wall, even the external ones (called *taipa de rodizio*), or a wooden partition wall (called *taipa de fasquio*).

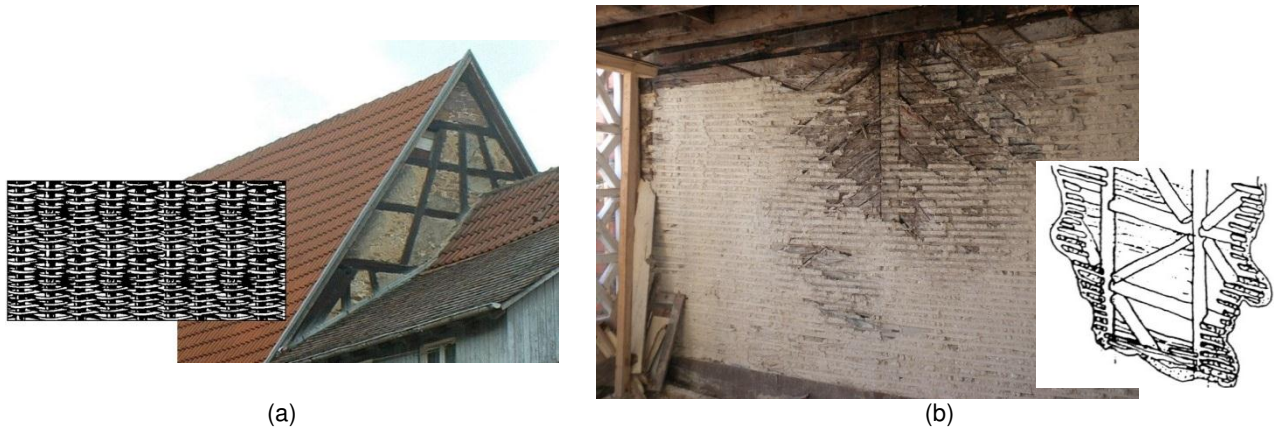
Fig. 3 Types of infill: (a) willow basketry in Germany (Bostenaru 2004); (b) *taipa de fasquio* in Guimarães and adoption of same infill for *frontal* wall (Mascarenhas 2004)

in the Peruvian *quincha*, or adobe on willow basketry (Fig. 3a) or wooden planks (Bostenaru 2004) in Germany. These types of walls are lath and plaster walls and are a common in Turkey (*bagdadi*) and the USA (in balloon frame constructions).

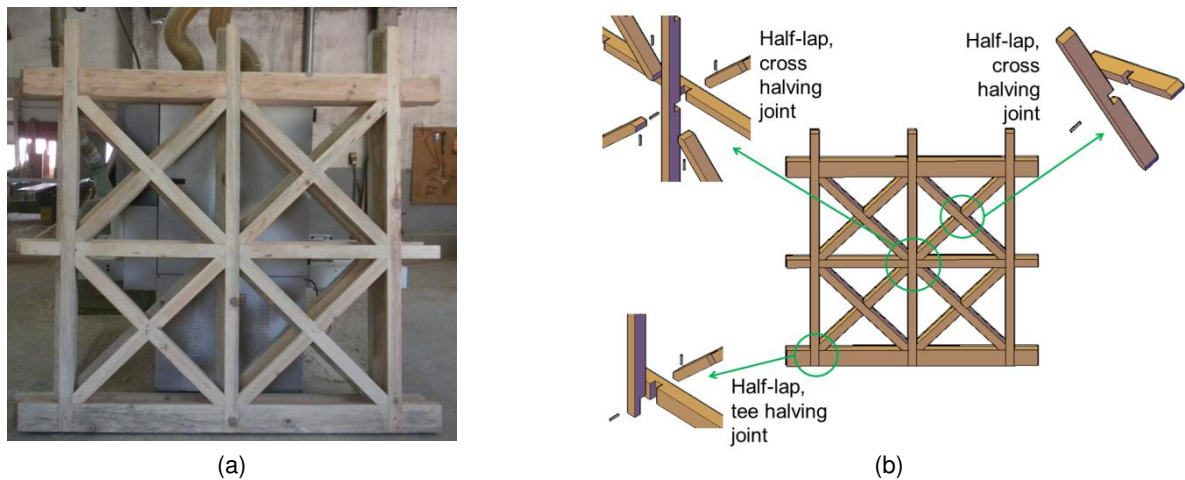
Fig. 4 Walls construction: (a) Completed timber frame; (b) detail of the type of connections adopted

The connections of the main frame are all half-lap connections, as well as the connections between each two diagonals, whereas the connection between the main frame and the diagonals is made by contact (Fig. 4). In all of the connections a nail was inserted. The nails were modern and it has to be pointed out that their length and section is smaller than the ones found in existing buildings. As it should be expected in a manual job, the connections presented some clearances, which can have some influence on the results of the shear tests. Moreover, the timber used was already dry and drying fissures were present in the timber elements, which can, in certain extent, promote the onset of cracking propagation and failure in the walls during testing.

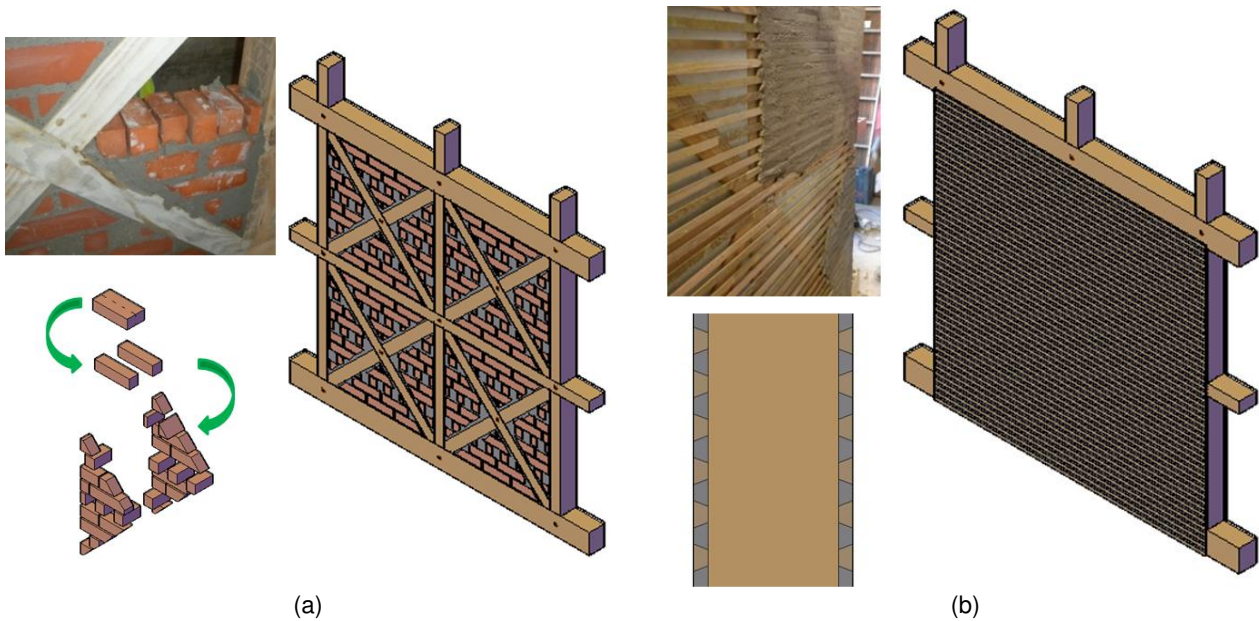
Fig. 5 Timber frame walls: (a) masonry pattern of infill walls; (b) lath and plaster wall

The first type of infill of the walls was in brick masonry and was carried out in the laboratory by a specialized mason. The masonry pattern was suggested by a Portuguese company from Lisbon which specializes in the rehabilitation of Pombalino buildings. The masonry pattern consists of double leaf masonry with transversal series of bricks every two rows of horizontal double leaf masonry, as detailed in Fig. 5. It was decided to use modern materials available in the market mainly to represent what it is being done nowadays in rehabilitation works, in order to reduce rehabilitation costs. The bricks with modern dimensions ($22 \times 6 \times 11 \text{ cm}^3$) were cut in half along the thickness (Fig. 5a) and then other cuts were made in order to accomplish with the adopted masonry bond. The masonry pattern adopted and the cut of the modern bricks intended to attain representative masonry existing in historic constructions. Notice that in historic buildings, bricks were usually smaller and moreover, rubble masonry could be used, thus having a more uniform distribution of materials even in the corners. It has to be pointed out that the bricks had a higher strength than those used in the original buildings, so they would confine more the connections. Additionally, two lath and plaster walls were built, using wood strips with a trapezoidal section (Fig. 5b) spaced of 2cm. As mentioned above, this type of infill is typical of the north of Portugal, but they can be found even in *frontal* walls, creating a lighter and more elastic wall (Mascarenhas 2004). The wooden strips have a tendency to confine the wall more, since they link together the posts and the beams, preventing deformations of the walls.

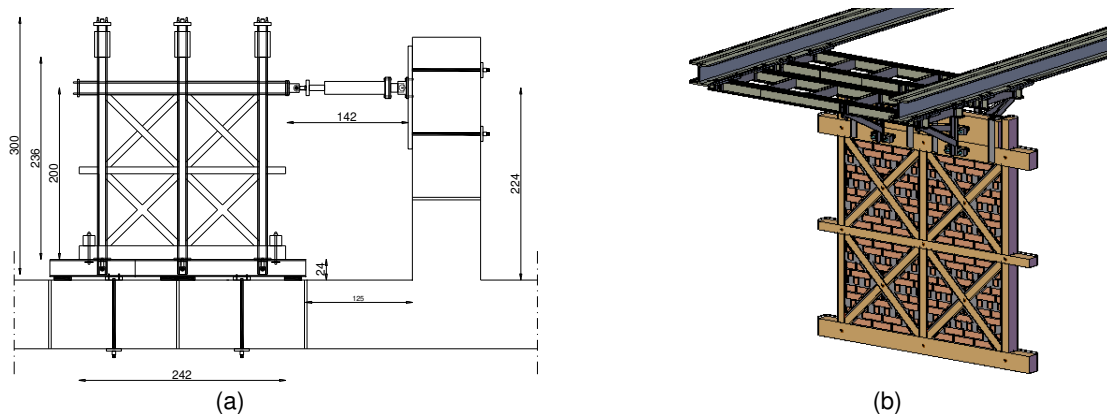
Fig. 6 Test setup: (a) in-plane setup; (b) out-of-plane setup

The out-of-plane displacements, which proved to be a delicate problem for these slender walls, were prevented by a guide created in the upper beam through means of punctual steel rollers distributed along the length on the beam on the two sides of the wall (Fig. 6b). For a detailed description see Poletti (2013).

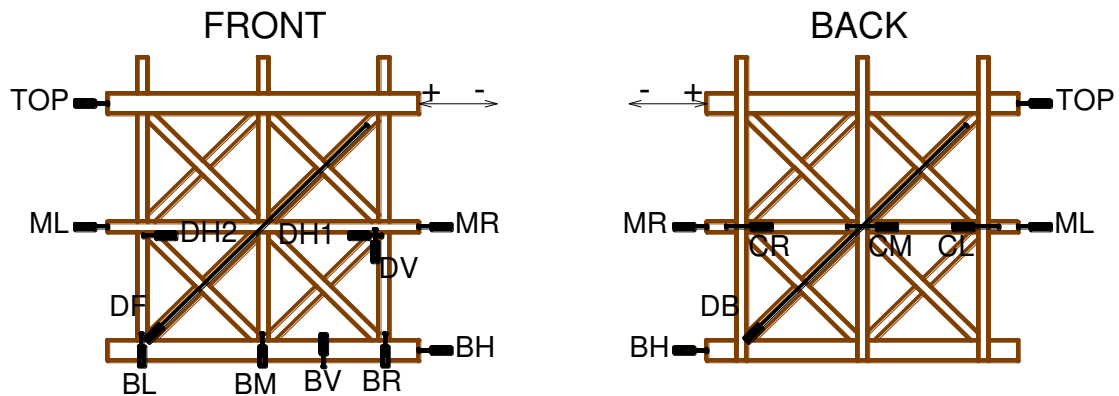
general position of the LVDTs. The horizontal displacements at the top and mid height beam are measured on both sides of the wall. The control displacement is applied to the top beam on the right side of the wall (front view) and LVDT TOP measures the corresponding displacement on the other side of the wall (TOP). Two LVDTs (ML and MR) are placed on the two sides of the walls at mid height and measure the horizontal displacement of the central beam on the two sides. The vertical uplift of the three bottom connections are monitored through LVDTs BR, BM and BL.

Fig. 7 Instrumentation in walls tested

All of the walls were instrumented with linear voltage displacement transducers (LVDTs), placed in strategic positions to capture the global and local behaviour of the walls. Fig. 7 illustrates the

The displacement in the diagonals is measured with LDVTS DF and DB at the front and back of the wall, measuring the displacements of the different diagonals in order to appreciate the effect of the compressive and tensile cycles as well as differences on the two sides of the wall.

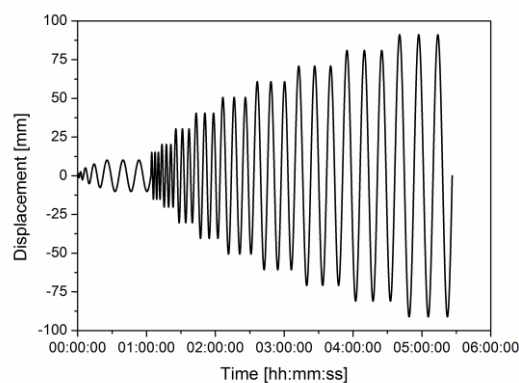
Fig. 8 Test procedure used in the experimental campaign of timber shear walls

The displacements applied were derived from a previous monotonic test performed on the wall in order to evaluate its displacement capacity (**Poletti 2013**). From the displacement of 10% of the maximum load and higher, each loading step was repeated three times. After the initial cycle, two stabilization cycles were introduced. In this way, the reduction in strength and stiffness can stabilize before increasing the applied displacement in the next loading step. Stabilization cycles allow the wall to achieve the maximum damage for a given displacement. For further details, see Poletti (2013).

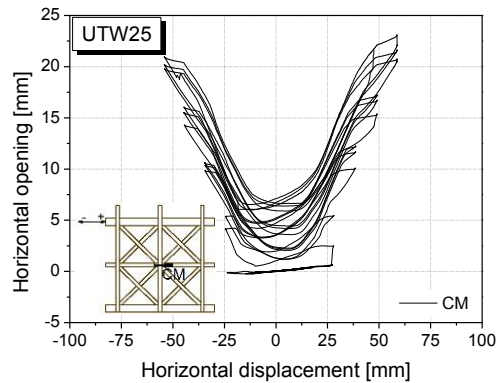
Fig. 12 Opening of the half-lap connections at central mid height for unfilled timber walls – intermediated half-lap connection CM

Notice that crack opening at the central connection increases considerably as the lateral displacement increases, see Fig. 12, causing the differential opening on the two sides of the wall. It

is clear that, after failure, the connection was opening progressively, until it was not possible anymore to register its opening, due to reaching the end of the linear range of the transducers.

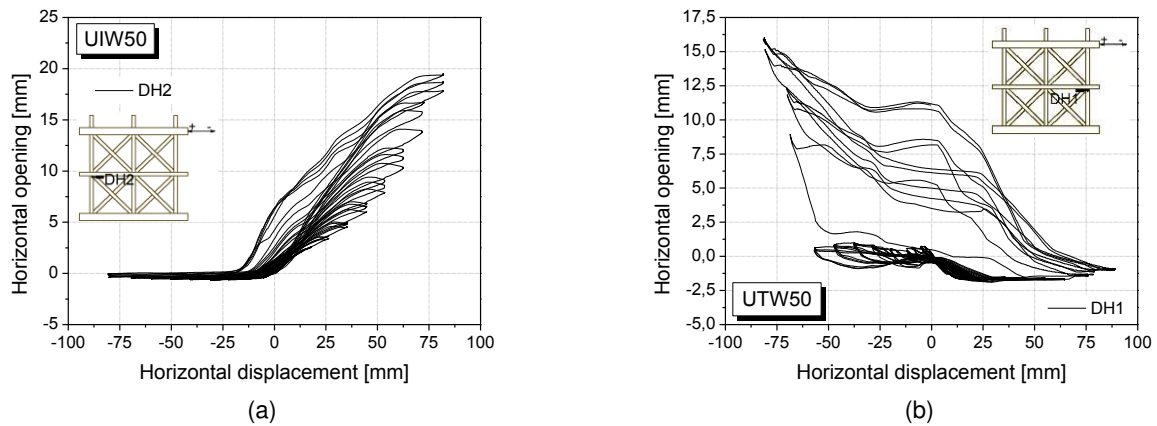
Fig. 13 Opening of nailed connections for walls tested with higher vertical load: (a) horizontal opening of diagonal nailed connection in timber frame wall with masonry infill; (b) horizontal opening of diagonal nailed connection in timber wall with no infill

The movement of the diagonals could also be observed in the single connections, where the nailed connections between the diagonals and the main frame were opening various millimetres during the test. From Fig. 13a,b, where the horizontal component of the displacement (DH1 and DH2) of the diagonal bars are displayed for the infill and unfilled timber frame walls, it is seen that the diagonals were detaching in one direction, while in the other direction they were cutting the connections. This means that the posts separate from the diagonals when tensile forces are applied along the diagonals. The separation is increasing continuously in the case of infill timber frame walls, while for timber frame walls there is a significant increase in the detachment near failure. In the case of lath and plaster walls (not pictured), the wooden strips, connecting the diagonals to the main frame, contribute to the limitation of the separation between the diagonal and the main frame due to the lateral confining effect. A similar opening was observed even in the vertical direction, reaching openings of 9mm for displacement values of 80mm. It has to be pointed out that in case of filled walls diagonals exhibited equal uplifting of the vertical posts, given that both masonry blocks and wooden were preventing an independent behaviour of the two elements. In case of unfilled timber framed walls, the diagonal elements can move independently. This is also an indication of the fact that the strong flexural behaviour of infill walls was mainly associated to the presence of the infill material. In fact, in timber frame walls without infill, the movement of the

diagonals reached values of 30mm for displacement values of 80mm, measured manually during the tests due to lack of transducers in those connections.

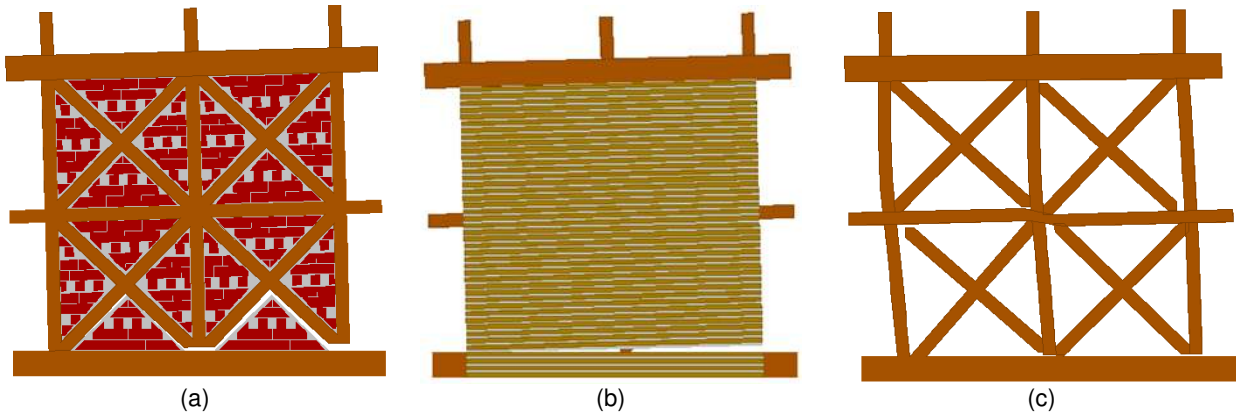
Fig. 15 Behaviour of the wall during the test: rocking of walls for lower vertical load level: (a) timber frame wall with masonry infill; (b) lath and plaster wall; (c) timber frame wall

The predominant resisting mechanism exhibited by infill timber frame walls was rocking, particularly in case of the lower vertical pre-compression load level, see Fig. 15a. As mentioned above, when a wall rocks, it can achieve large displacements without a significant loss in strength and thus with low damage. In the case of the infill walls here analysed, the damages found were not great and thus it was generally simple to reassemble the walls for retrofitting.

In case of brick masonry timber frame walls, the detaching of brick masonry from the timber frame was evident due to the rocking movement. As the confinement of the frame was loosening during the test, masonry tended to move out-of-plane, moving out as much as 2cm. The vertical posts and

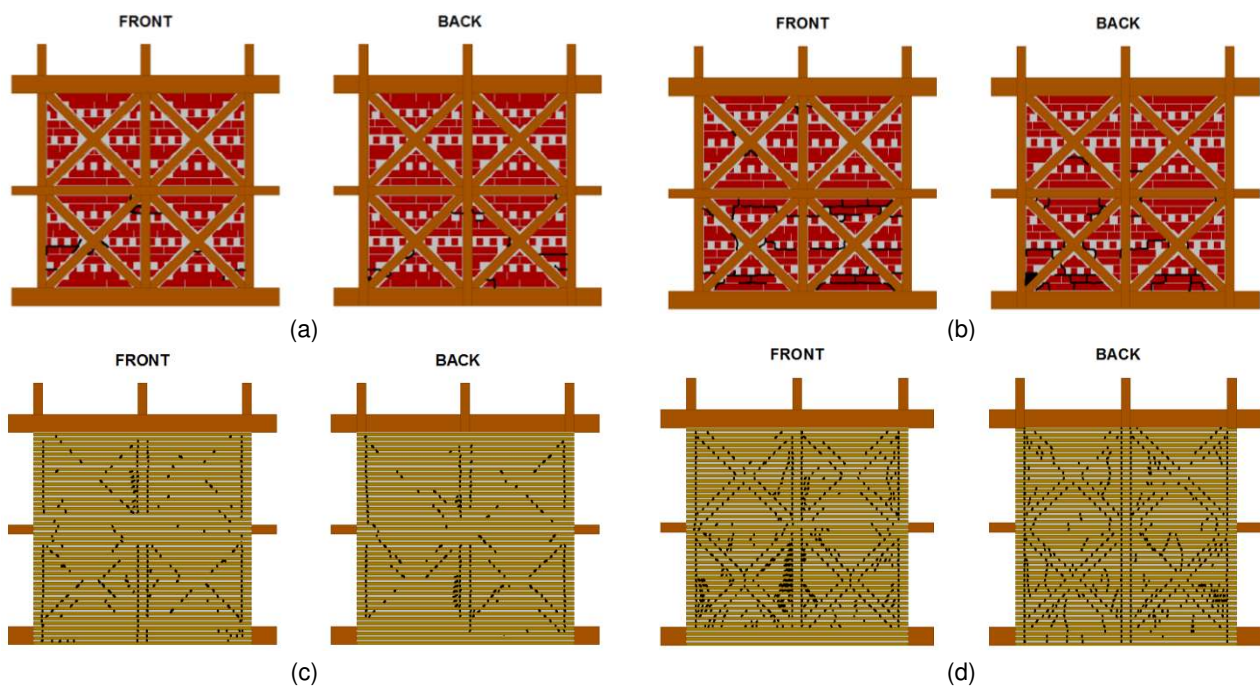
Fig. 16 Typical crack patterns in infill walls: (a) masonry infill lower load; (b) masonry infill higher load; (c) lath and plaster wall lower load; (d) lath and plaster wall higher load

In lath and plaster walls the damages on timber connections were similar to the ones observed in masonry infill walls. The walls exhibited rocking mechanism, particularly for the lower level of pre-compression, see Fig. 15b, and the damages were higher for the higher vertical load. It was clearly visible that no timber strips broke but bent where the post was uplifting. Besides, in UFW50 wall, the left post failed at the base, due to the stress concentration associated to rocking, inducing also crushing of the bottom beam. This led also to remarkable out-of-plane deformation due to the lack of support. The damages in the mortar were more noticeable in the lower part of the wall for the lower vertical load level (Fig. 16c), as happened for masonry infill walls. For the higher vertical load, the cracking density was higher, developing both at the timber elements borders, as in the wall submitted to the lowest pre-compression, and in the triangle cells, see Fig. 16d.

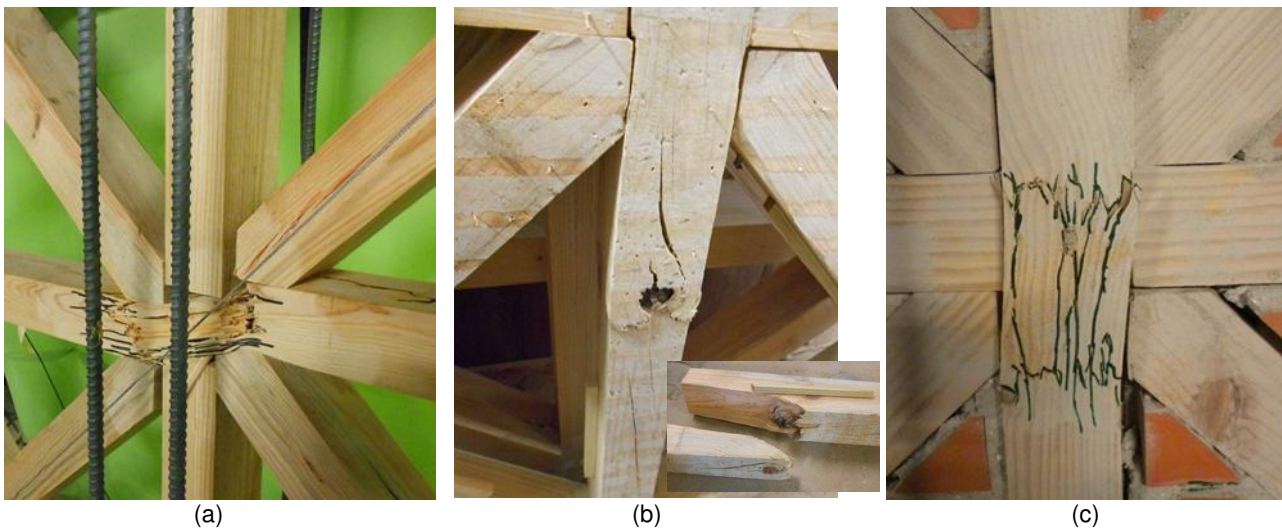
Fig. 17 Damages in central connection: (a) timber frame walls; (b) lath and plaster walls; (c) timber frame walls with masonry infill

The differences in terms of damage the central half-lap connection according to the distinct types of walls can be seen by comparing the damage patterns shown in Fig. 17, obtained for the highest level of pre-compression. In both filled walls, some deformation of the central connection was observed but it was not enough to result in severe damage as in the timber walls. In case of lath and plaster walls (Fig. 17b), the central middle connection did not crush, because the damage was moved to a weak point in the central post, i.e. a knot from which cracking propagated causing the

failure of the central post. For infill walls (Fig. 17c), the crushing of the central connection was concentrated on the post, and not on the beam as for timber frame walls. The confining effect given by the infill guaranteed that the connection did not open at the same levels of those of timber walls. Moreover, the damage and relative opening were more progressive.

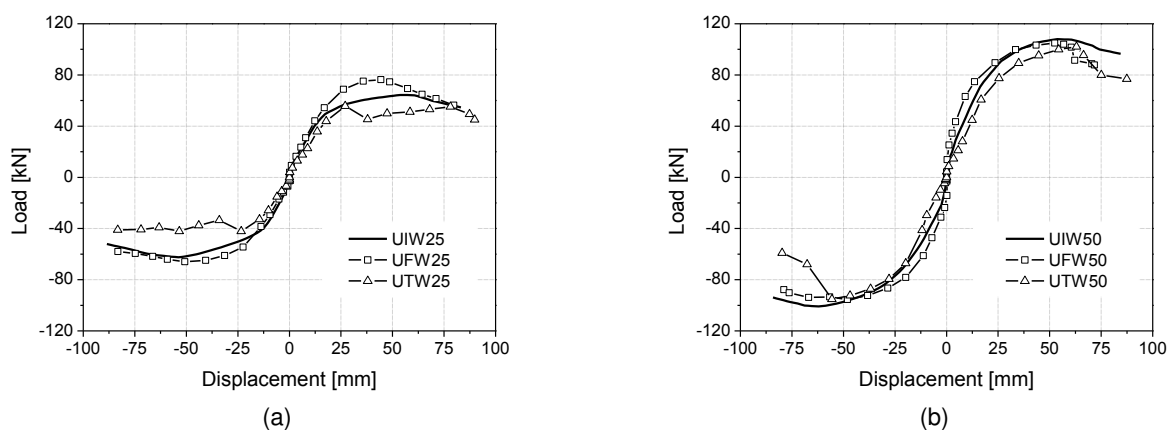
Fig. 18 Envelope curves of tested walls, mean values: (a) lower vertical load level; (b) higher vertical load level

All timber frame walls present similar results for each load level. The variation in terms of lateral resistance was of 7% for walls submitted to 25kN/post, while it was of 5% for walls submitted to 50kN/post. In terms of ultimate displacement, the variation was even lower: 0.99% in the positive direction and 2.34% in the negative one for walls submitted to 25kN/post and 2.11% in the positive direction and 2.92% in the negative direction for walls submitted to 50kN/post (Poletti 2013).

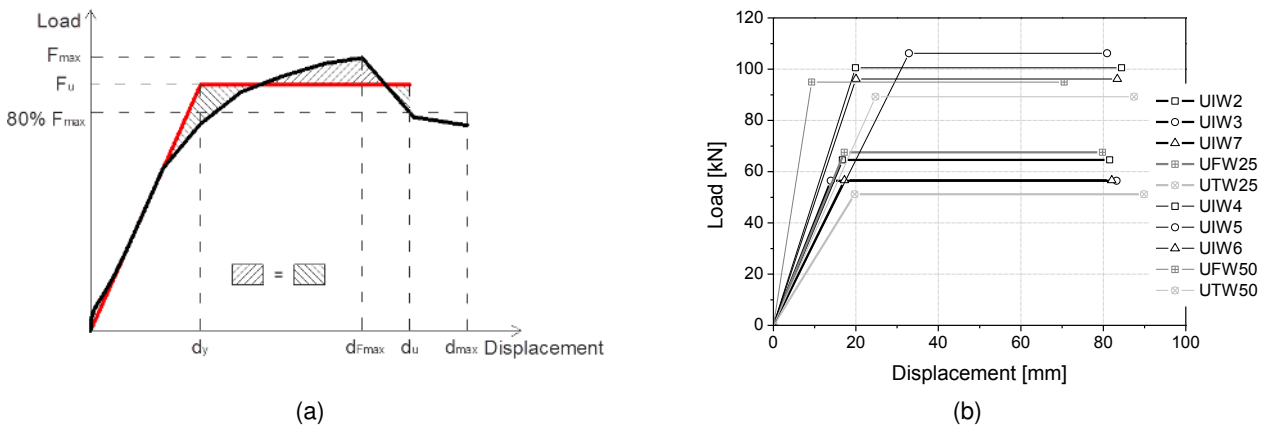
Fig. 19 Bilinear curves of walls tested: (a) method used to obtain bilinear; (b) bilinear idealizations

In order to obtain the bi-linear diagram, the yield displacement was defined according to the approach proposed by Tomažević (1999), i.e. considering the failure load as 80% of the maximum load and calculate the yield displacement from the equivalence of the areas (Fig. 19a). It

Fig. 19b presents the bilinear curves used to obtain the values of ductility for all walls. Only positive values are shown, since it was decided to take the positive displacements of the envelope for the calculation of seismic parameters.

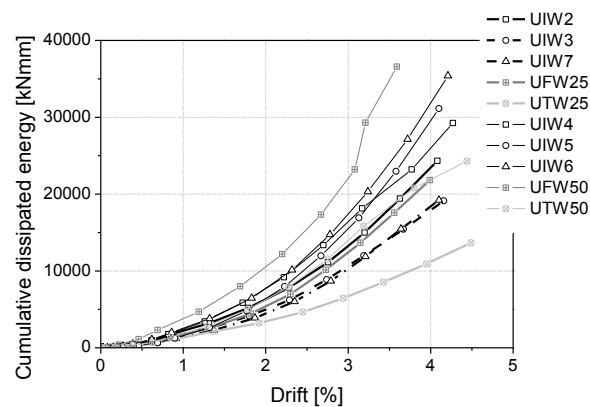
Fig. 21 Energy dissipated in walls, cumulative values

Fig. 21 reports the graphs of the variation of the cumulative dissipated energy for all walls tested with the two vertical load conditions with the increasing lateral drift. It is observed that the vertical load has an important role on the amount of energy dissipated. The dissipated energy increases with the drift, with a higher trend for the higher vertical load level. This can be related to the higher amount of damage found for this level of vertical pre-compression. In fact, the energy dissipation is always associated to the propagation of damage on a structure.

The low values of dissipated energy for timber frame walls (Fig. 21), compared to filled walls, can be attributed to the strong pinching present in this walls, that clearly diminishes the dissipative capacity of the walls. In fact, when comparing the different shape of the hysteretic loops for each wall type (Fig. 22a,b) the strong pinching in timber frame walls is evident, as well as the plateau in the unloading branch of filled walls, which reduces the dissipative capacity of the walls.

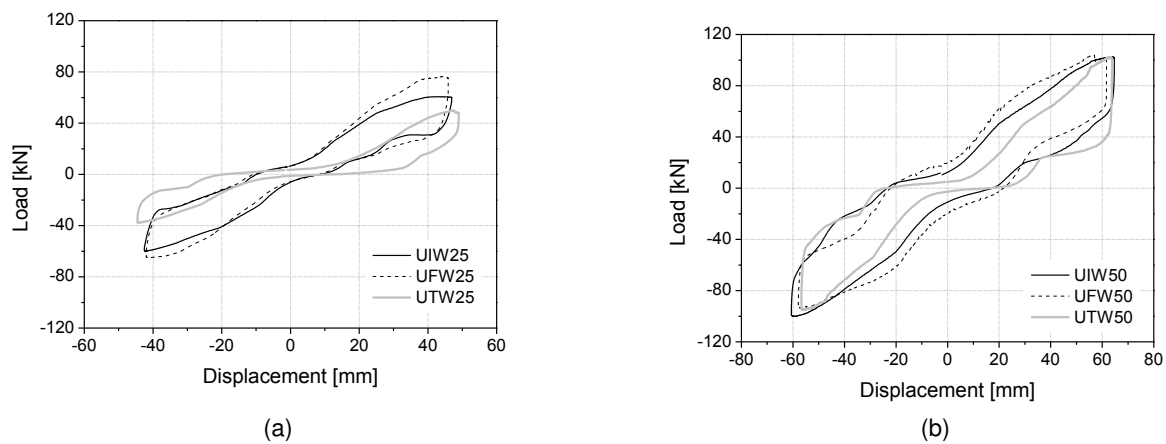
Fig. 22 Typical hysteretic loops: (a) lower vertical load level at 50.61mm; (b) higher vertical load level at 70.85mm

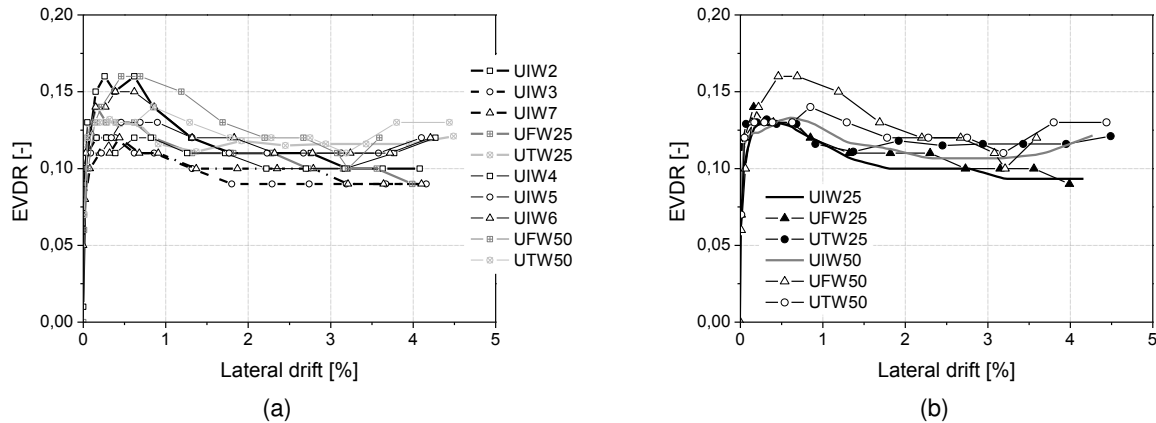
Fig. 23 Values of EVDR: (a) all walls; (b) average values according to wall typology

decrease and become comparable to those of timber frame walls. This means that, although timber walls present lower values of maximum load, stiffness and ductility, they have a comparable damping capacity for high values of drift due to the shear behaviour. In fact, only analysing the loops of infill walls vs. timber frame walls it is possible to observe how the loops in timber frame walls are more curved, so the damping for these walls is higher.
