SEISMIC RETROFIT OF COLUMNS IN BUILDINGS FOR FLEXURE USING CONCRETE JACKET

Gnanasekaran Kaliyaperumal* and Amlan Kumar Sengupta**

Indian Institute of Technology Madras, Chennai-600036

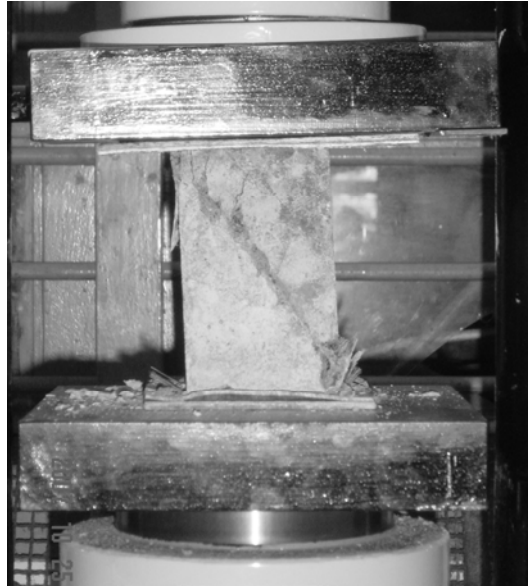
Fig. 3 Failure pattern of a specimen with roughened surface

The typical failure pattern of a specimen with roughened surface is shown in Figure 3. The failure loads are given in Table 1. Figure 4 shows the corresponding values of average failure stress. From the results, it was found that the specimens with roughened surface of the old concrete and without any bonding agent failed at higher loads compared to the other specimens. Thus, it was decided that for the retrofitted column and sub-assembly specimens, the faces of the old concrete would be roughened and bonding agent would not be used.

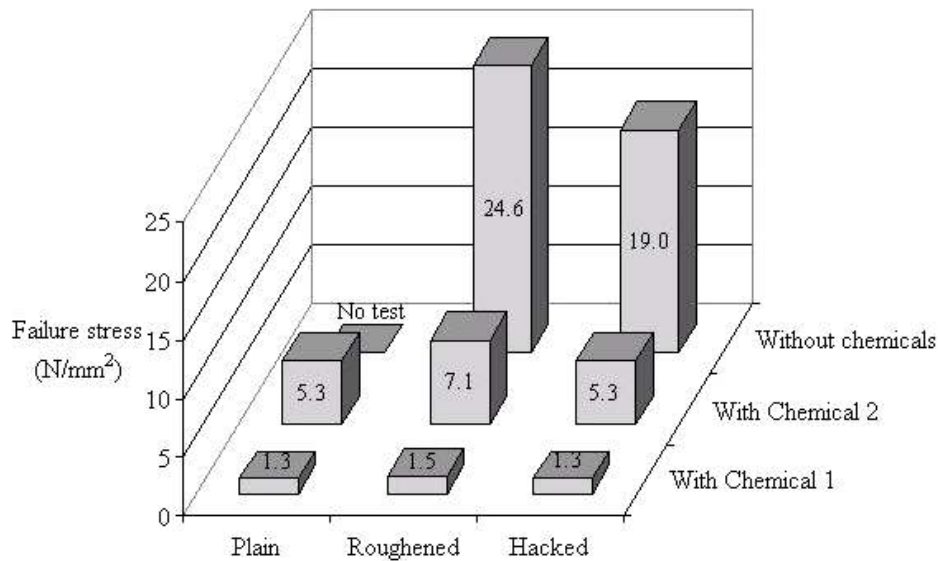
Fig. 4 Average failure stress for the specimens of slant shear tests

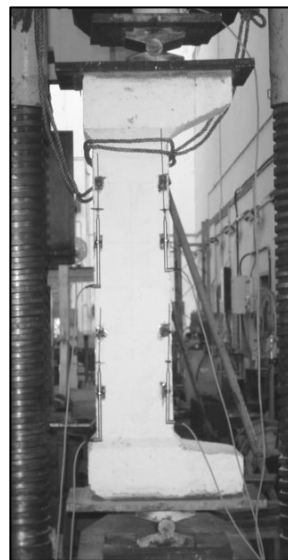
B = Spreader beam, e = eccentricity, L = Load cell, G = LVDT gage, P = Applied load, S = Specimen
 $e = 50$ mm for reference specimens and 100 mm for retrofitted specimens.

(i) Pure Compression

(ii) Eccentric Compression

(iii) Pure Bending

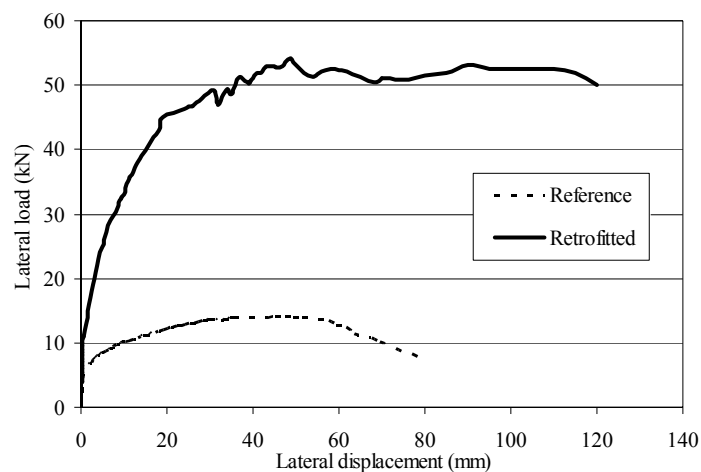
Fig. 22 Comparison of the lateral load versus displacement curves under monotonic loading

The measured lateral load versus displacement curves for the reference and retrofitted specimens tested under the monotonic lateral loading are compared in Figure 22. It may be observed that the lateral strength (equal to the maximum lateral load sustained) and the displacement ductility of the retrofitted specimen have improved substantially as compared to the reference specimen. The corresponding measured moment versus curvature curves for the hinges are shown in Figure 23.

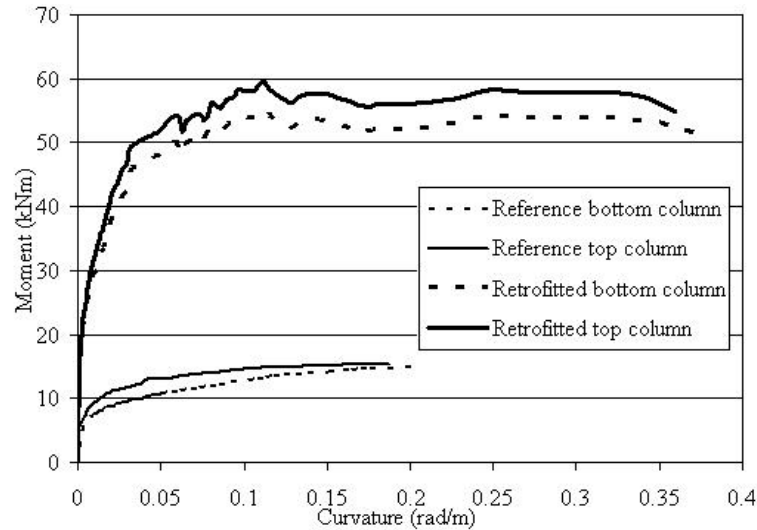
Fig. 23 Comparison of the moment versus curvature curves under monotonic loading

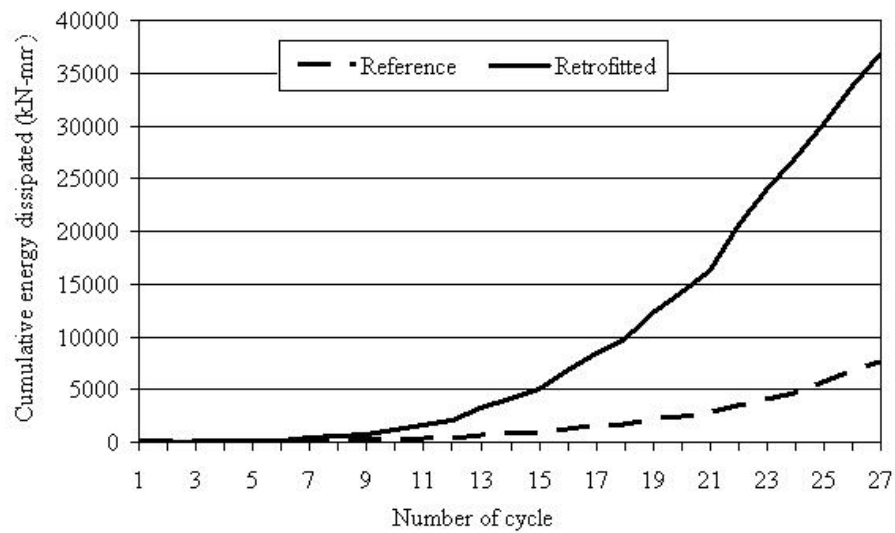
Fig. 25 Comparison of the curves for energy dissipated under cyclic loading

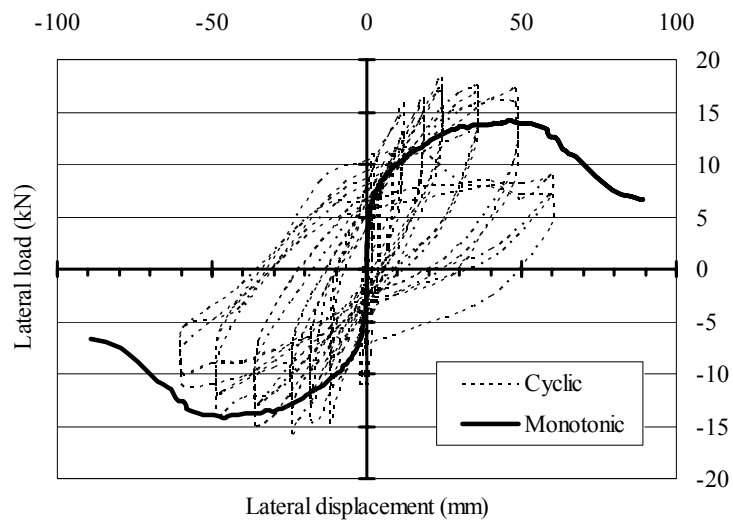
Fig. 26 Comparison of the lateral load versus displacement curves under monotonic and cyclic loadings for reference specimens
