**Seismic Strengthening and Repair of
Reinforced Concrete Shear walls using Externally Bonded
Carbon Fibre Tow Sheets**

Josh Christopher Lombard

Master of Engineering*

September 1999

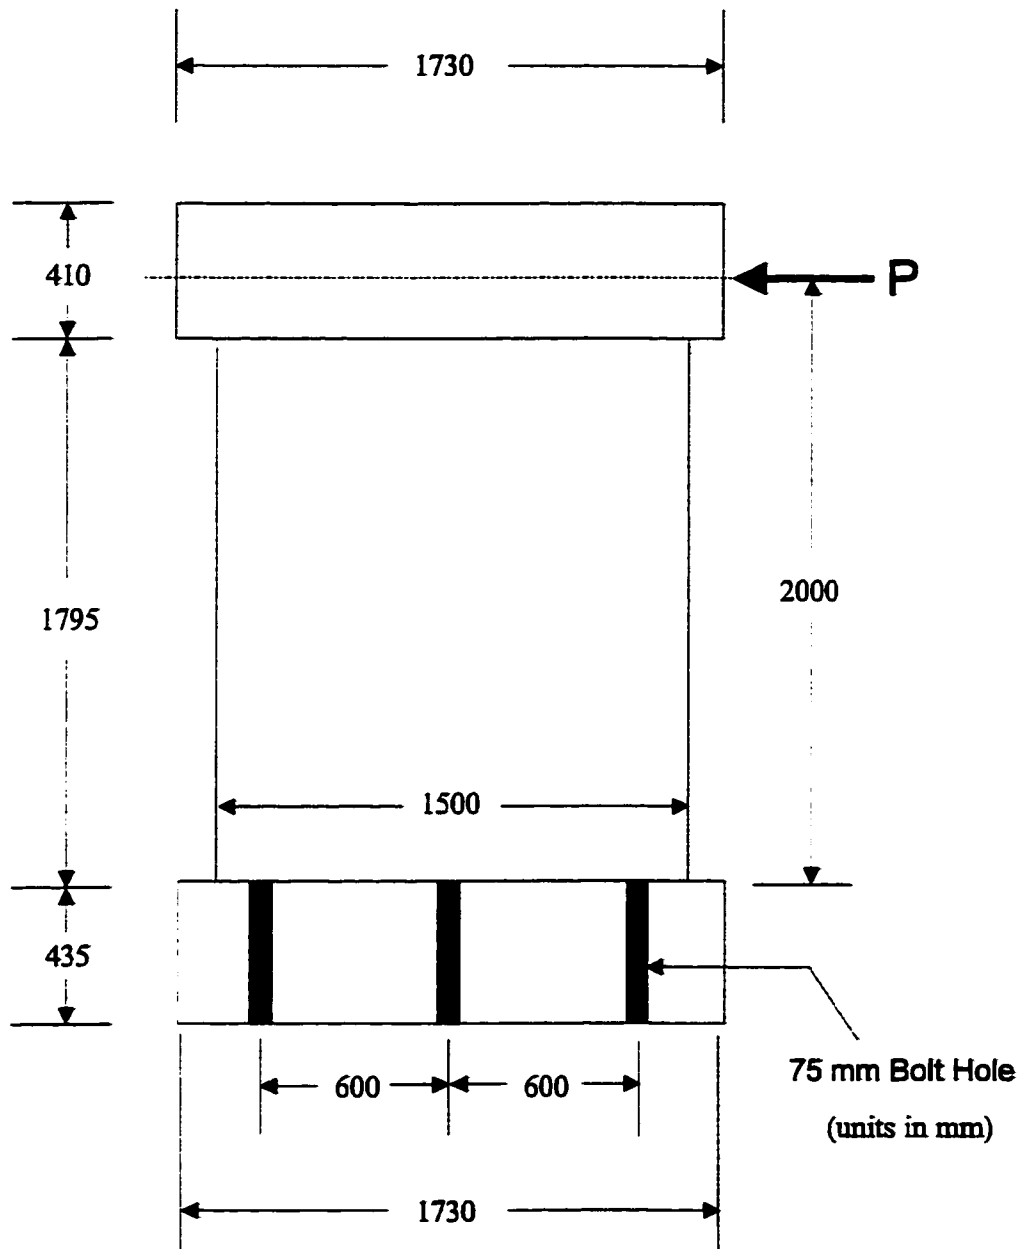
Figure 4.1 Side view of a reinforced concrete shear wall test specimen

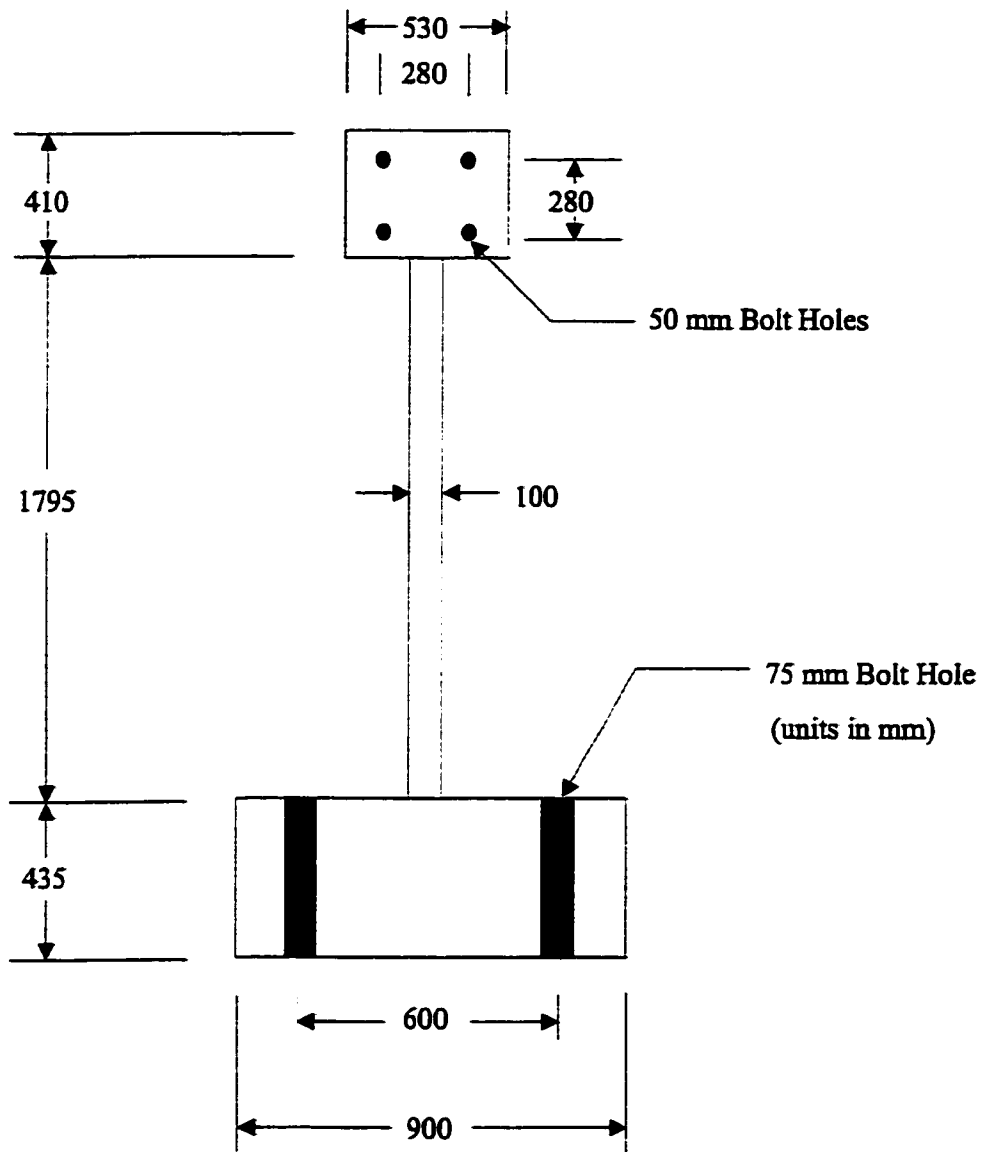
Figure 4.2 End view of a reinforced concrete shear wall test specimen

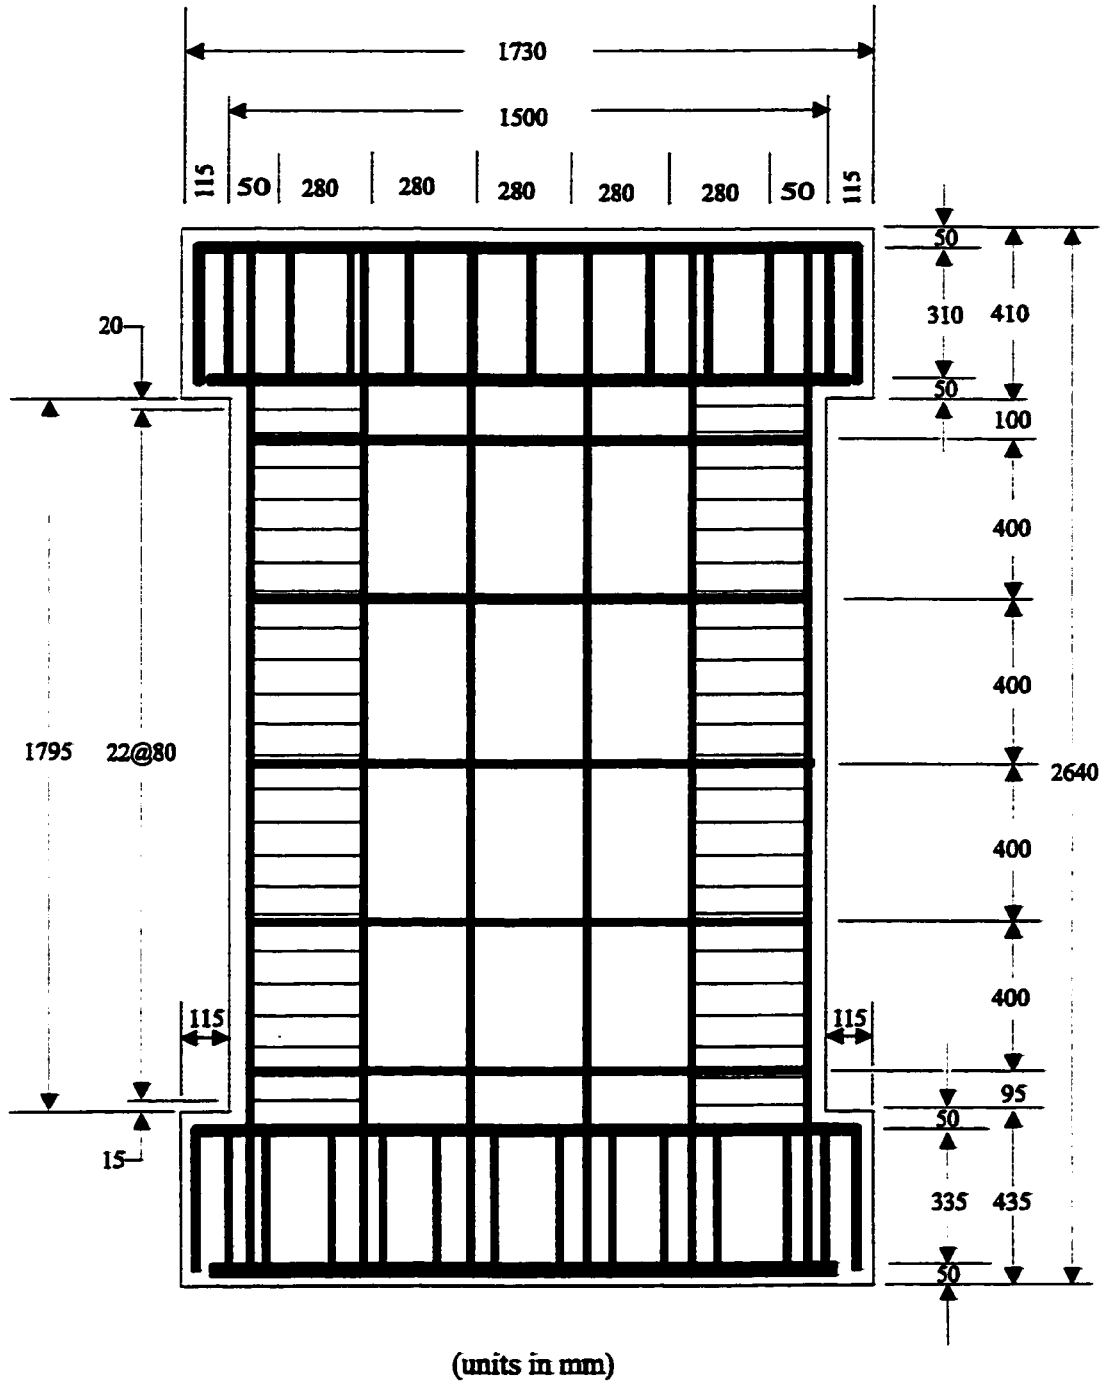
Figure 4.3 Reinforcement details of a shear wall test specimen

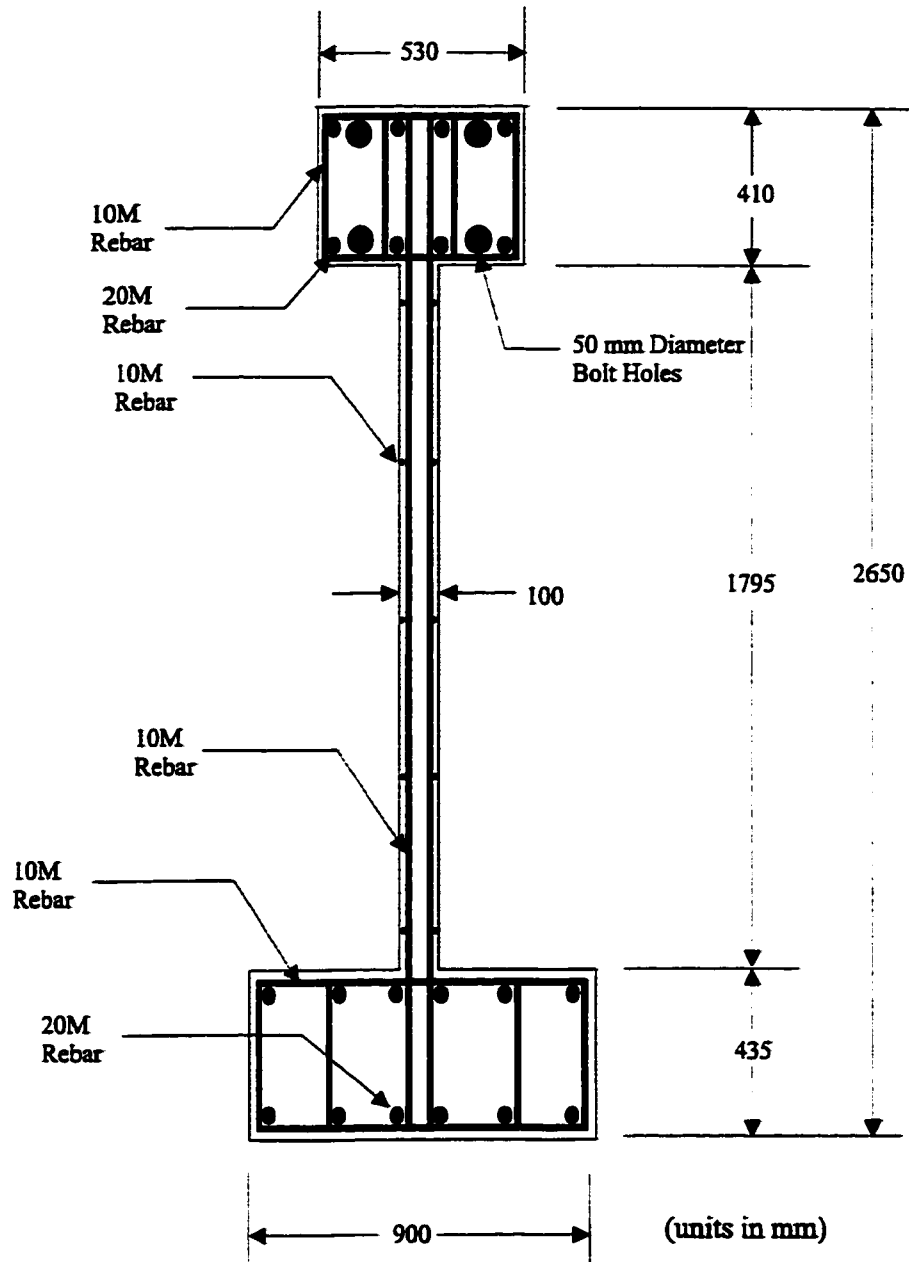
Figure 4.4 End view of the reinforcement layout

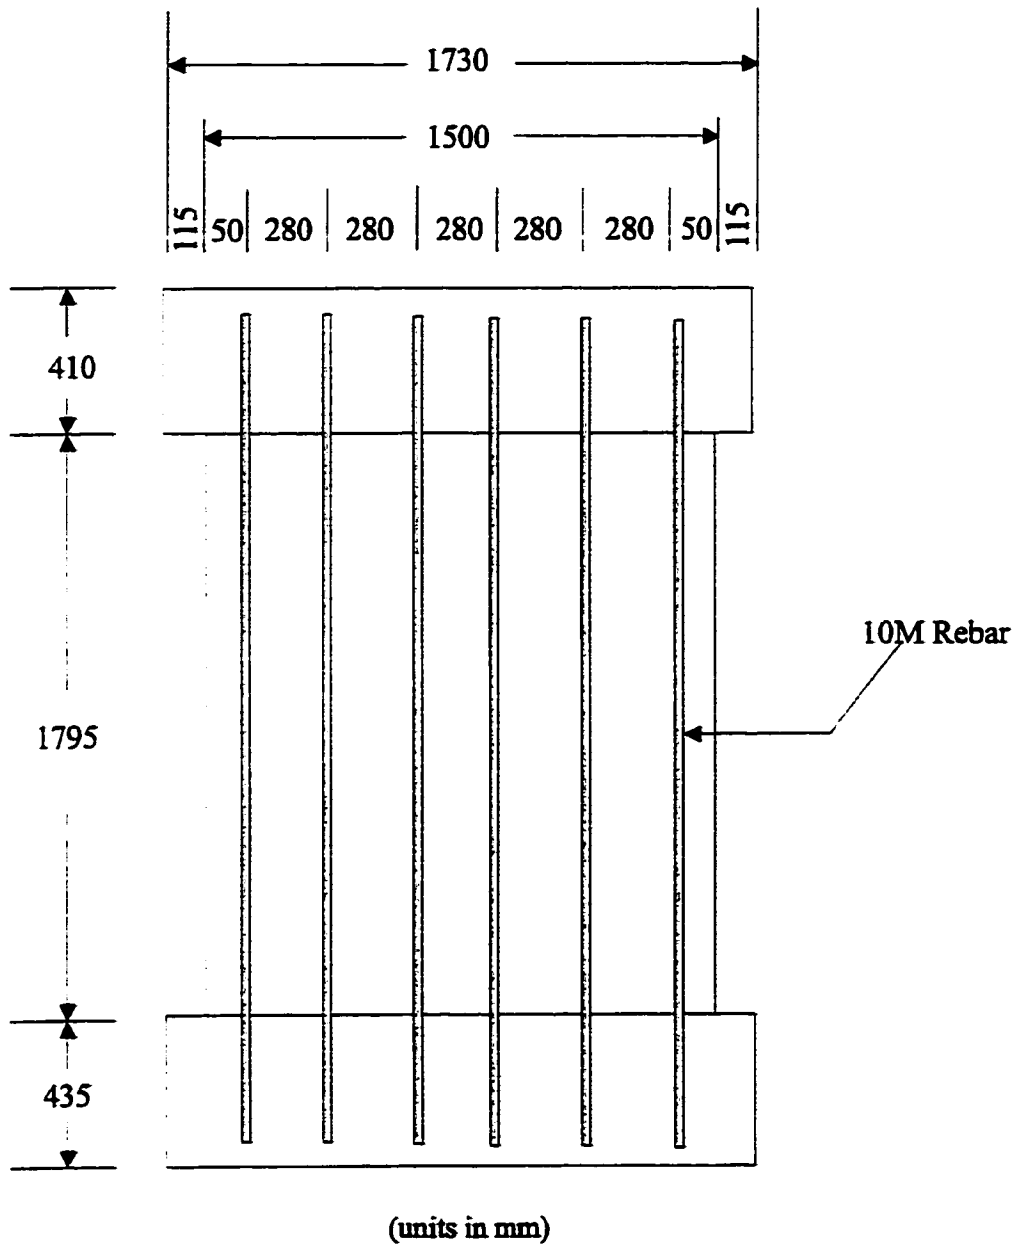
Figure 4.5 Flexural reinforcement layout

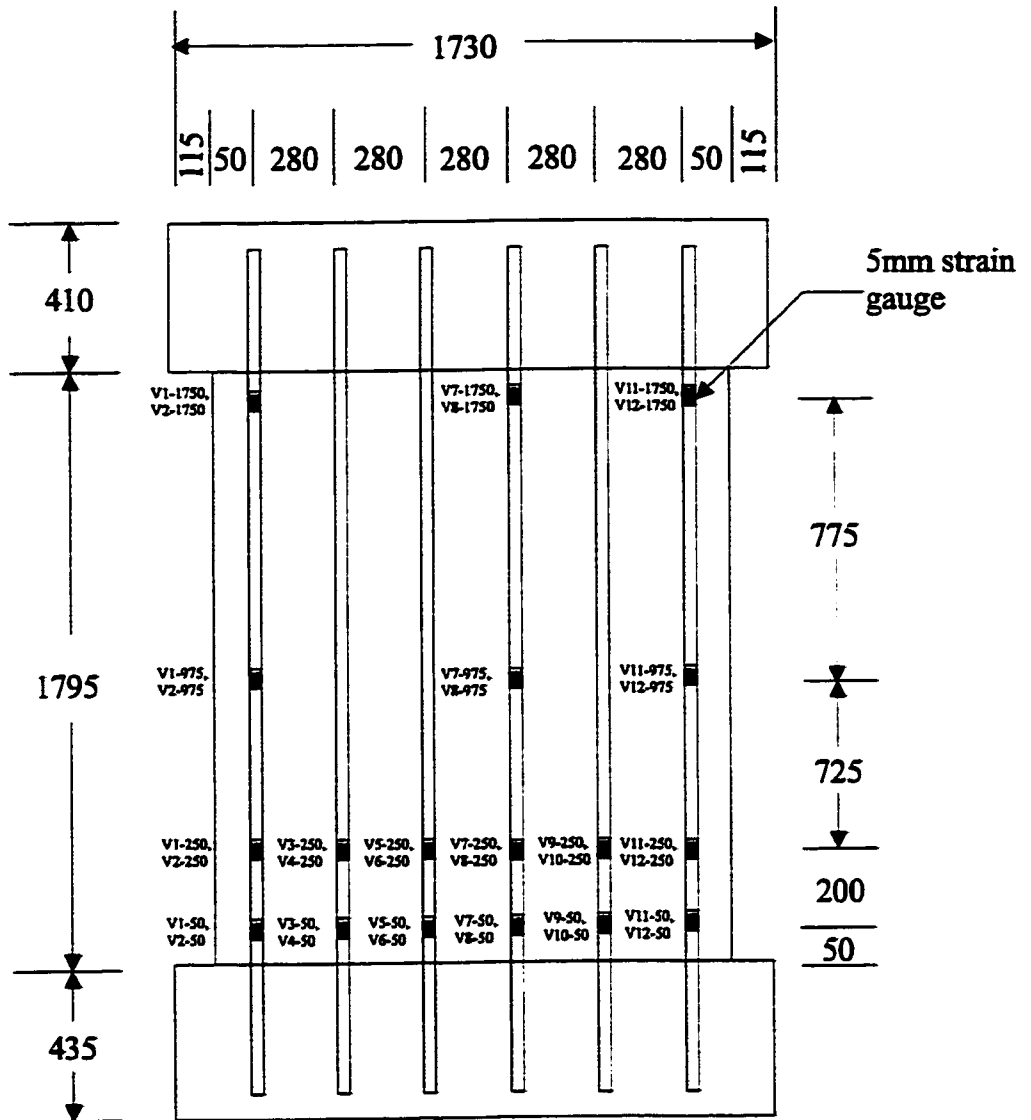
Figure 4.16 Location of strain gauges on vertical reinforcement

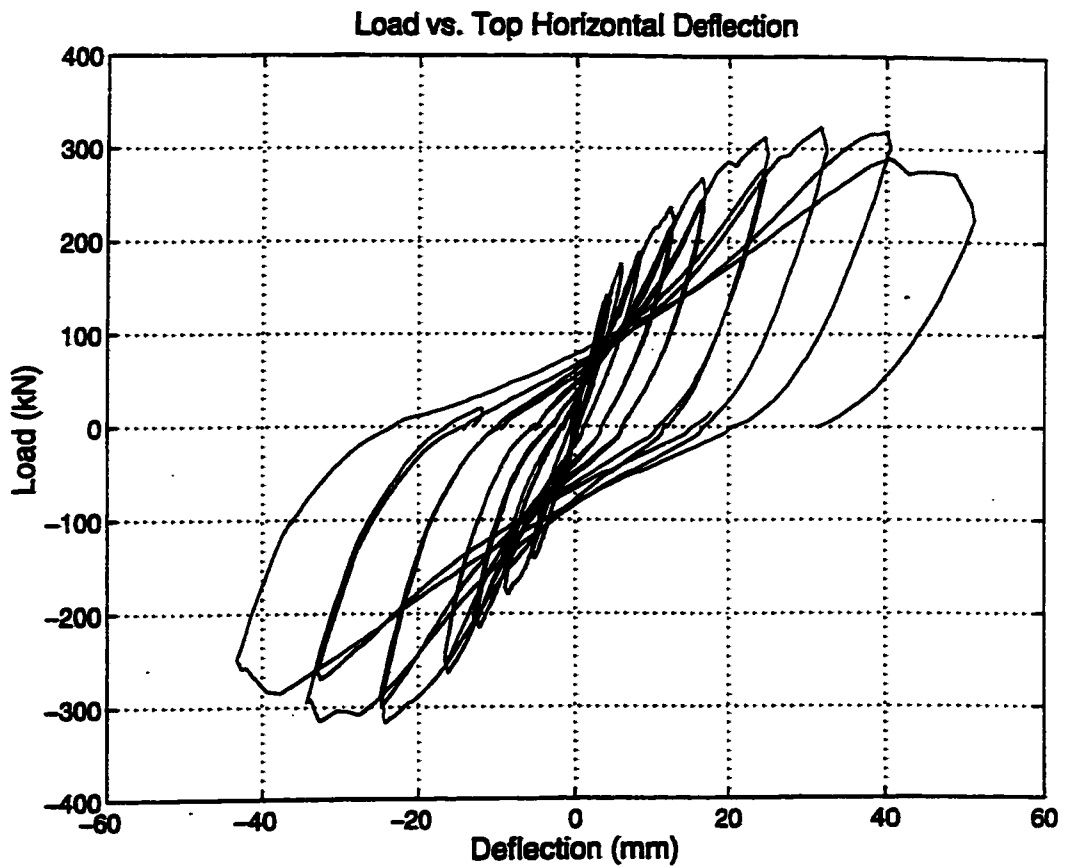
Figure 6.22 Average measured lateral load-total top horizontal deflection curve of the repaired wall

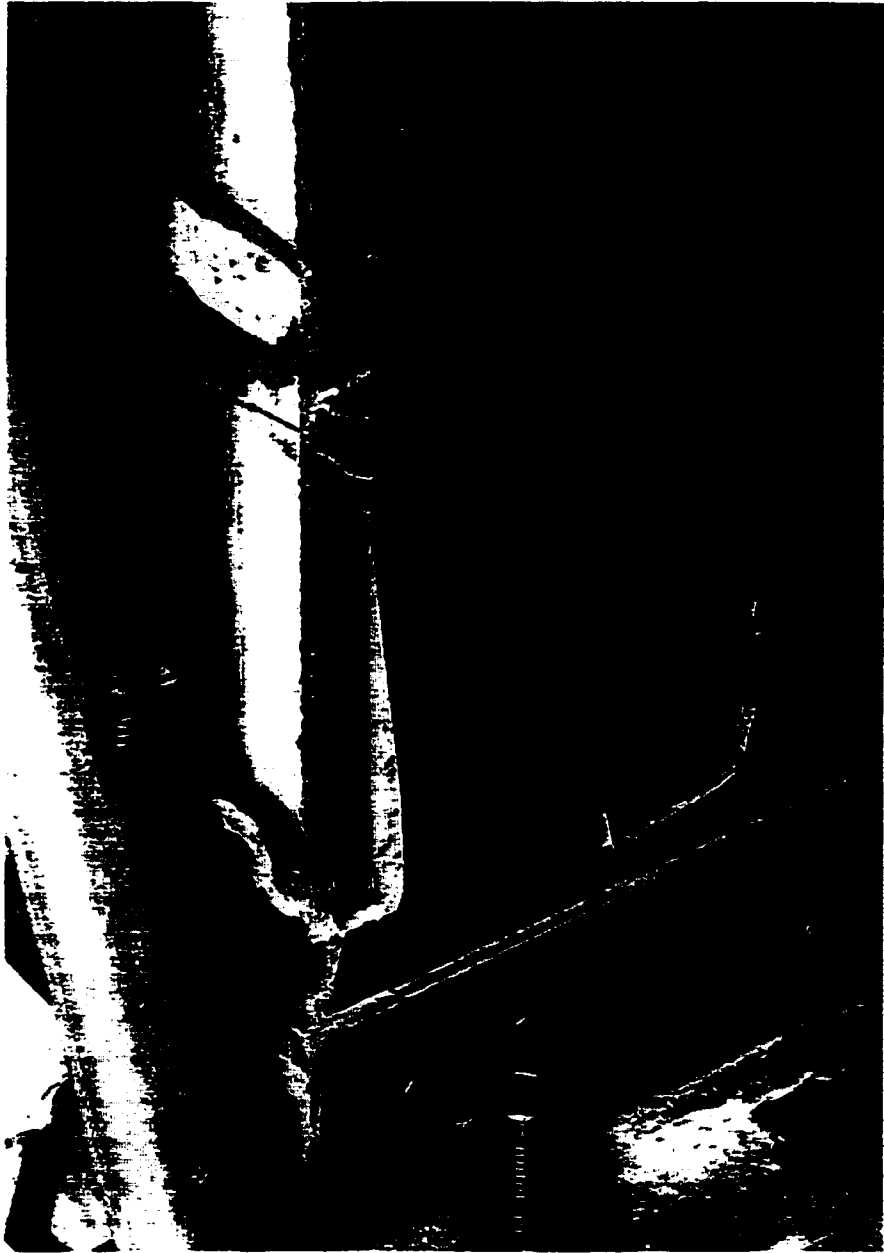
Figure 6.31 Vertical splitting and compression buckling of the CFRP sheets

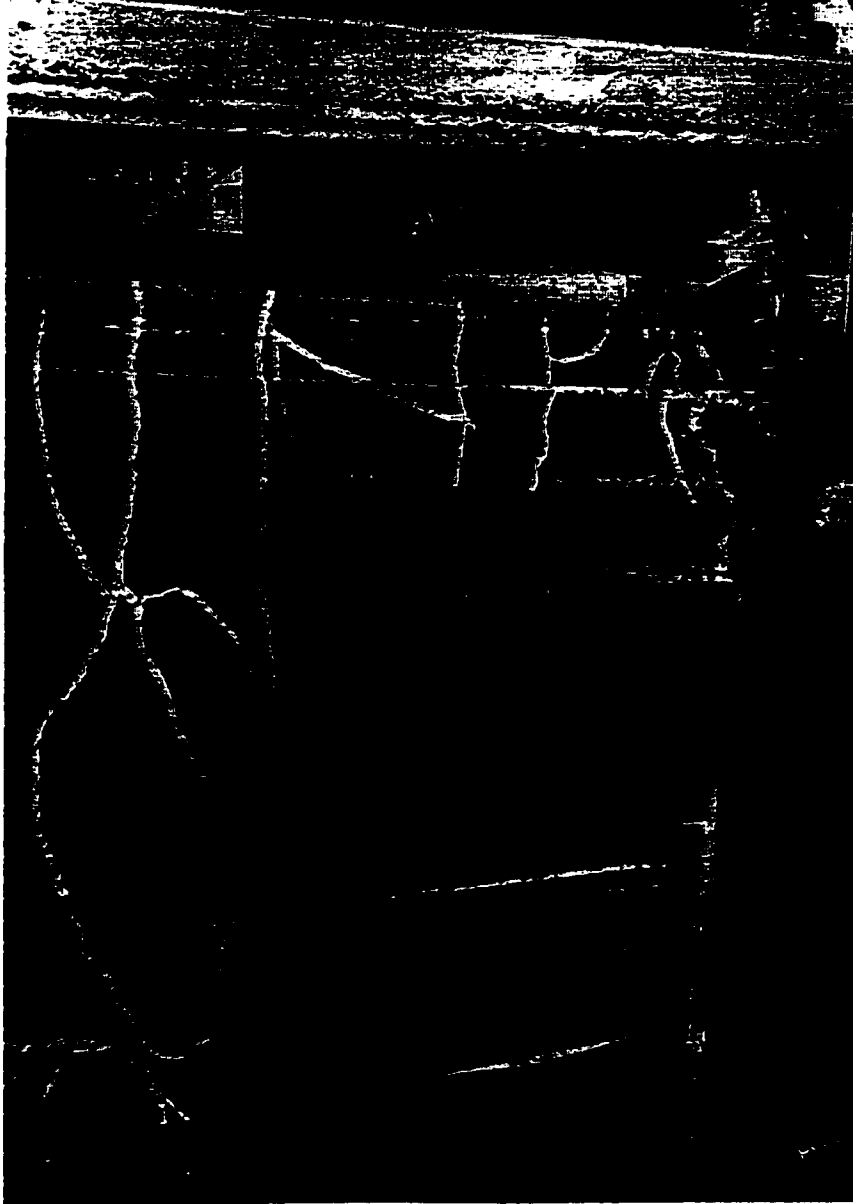
Figure 6.33 Tensile failure of a 275 mm wide CFRP strip

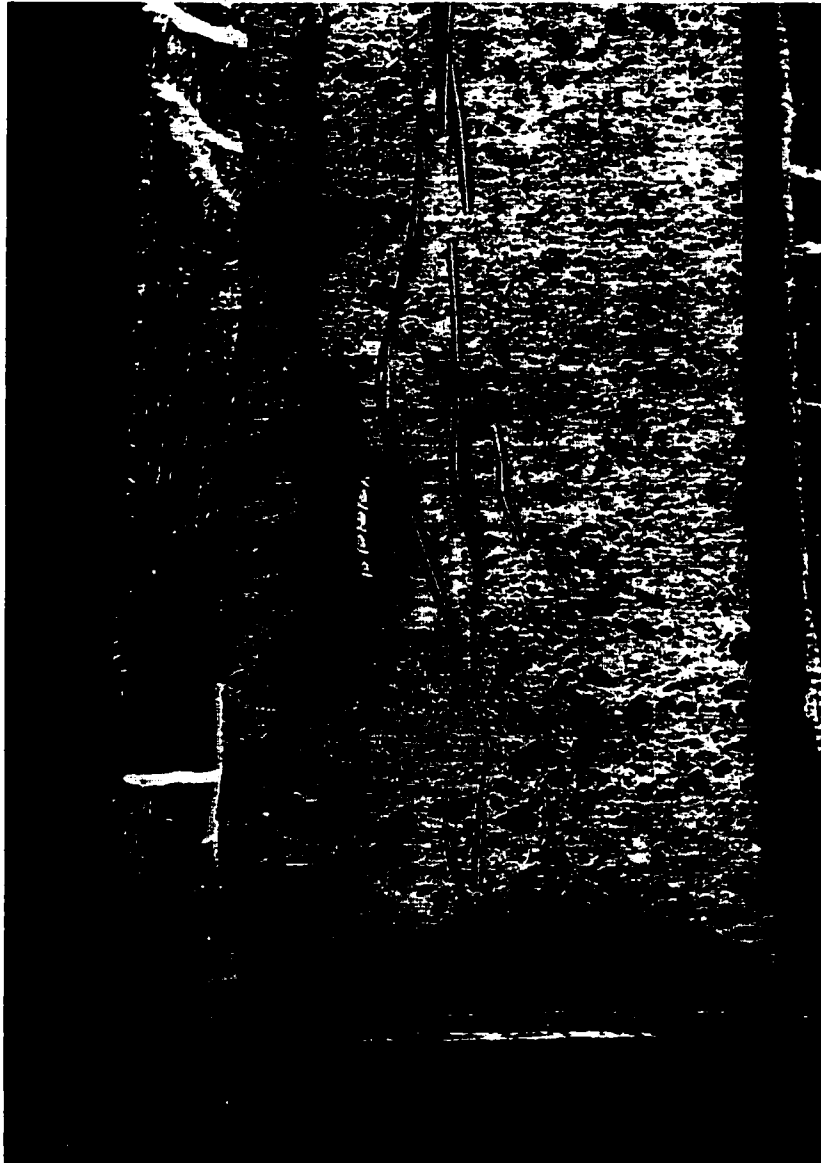
Figure 6.38 Buckling of the extreme layer of vertical steel reinforcement

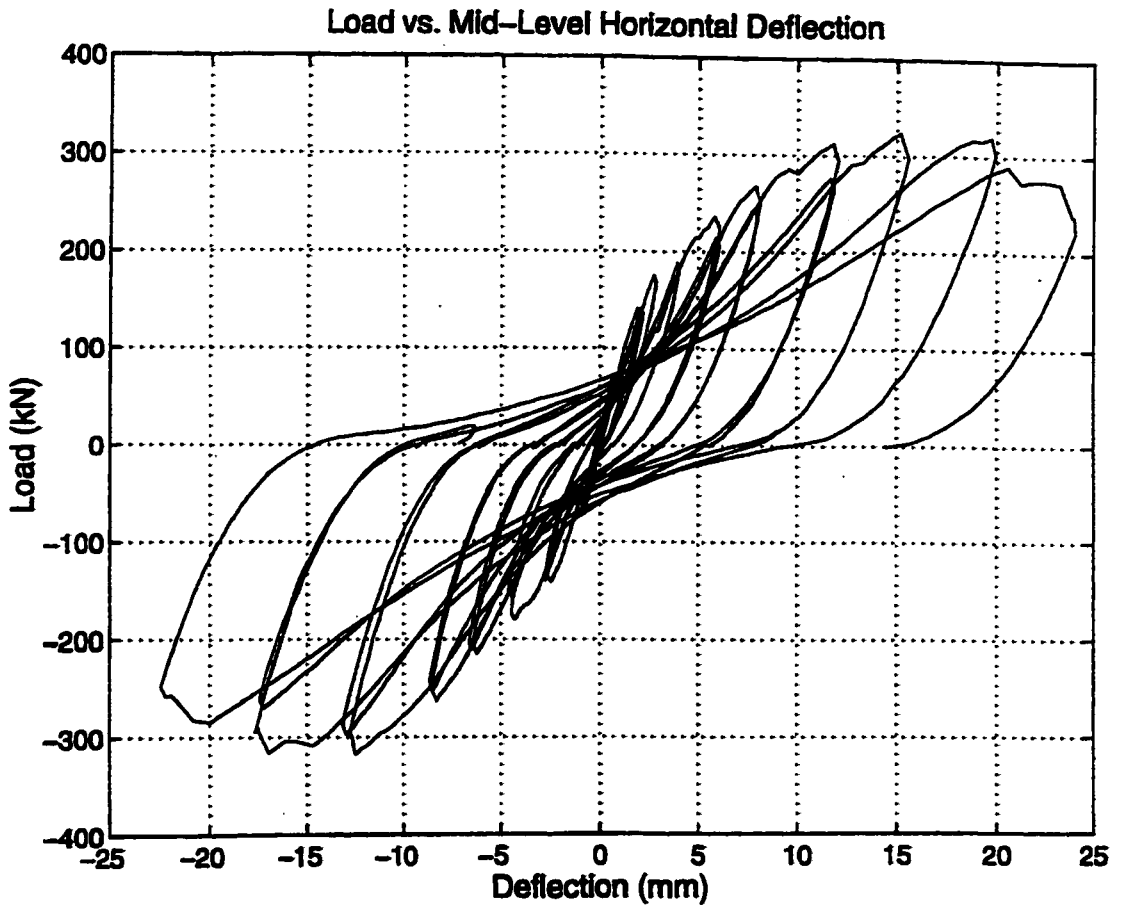
Figure 6.40 Average measured lateral load-mid-level deflection curve of the repaired wall

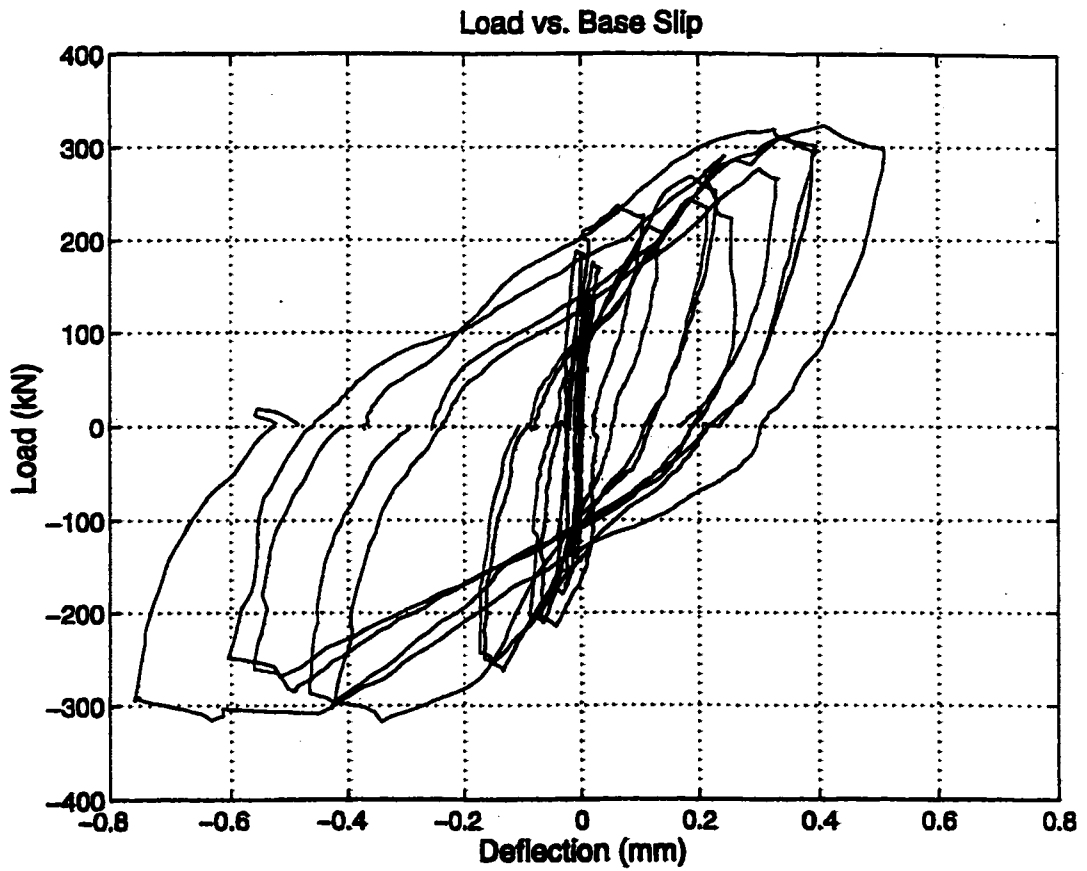
Figure 6.41 Average measured lateral load-base slip deflection curve of the repaired wall

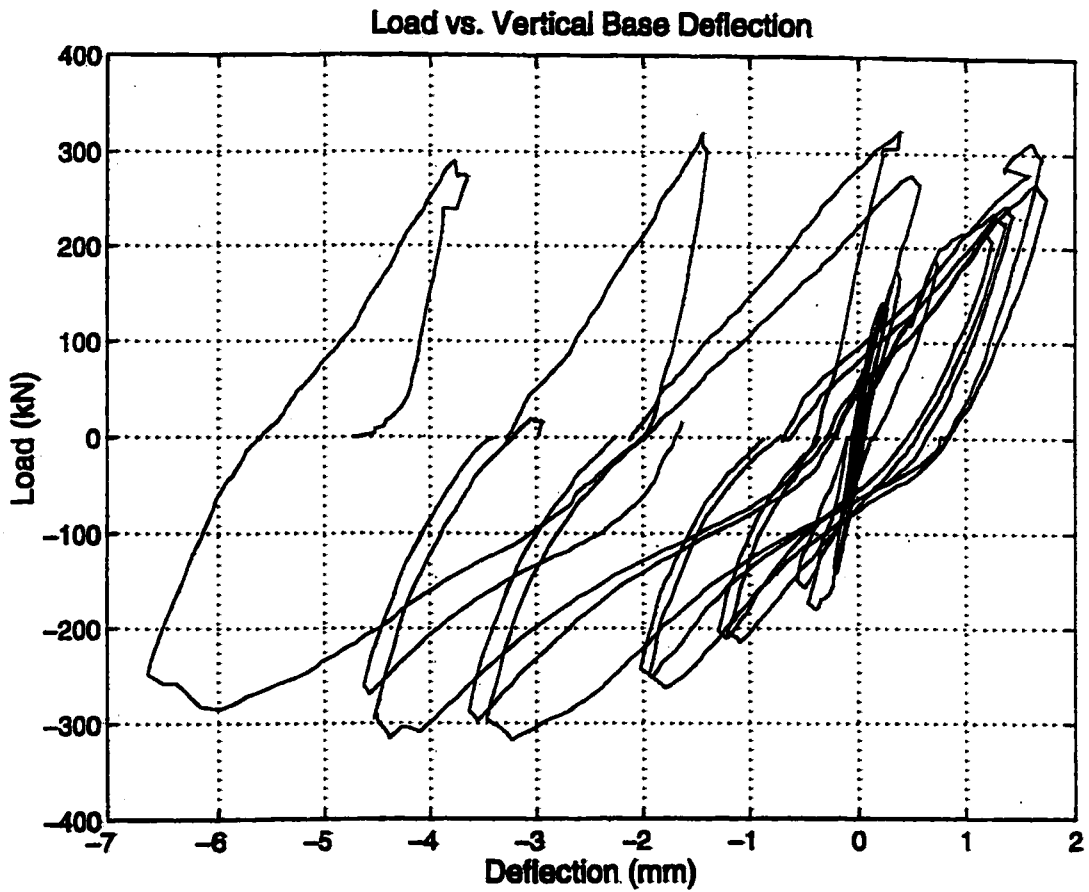
Figure 6.42 Lateral load-vertical base displacement curve of the repaired wall as measured by LVDT # 9

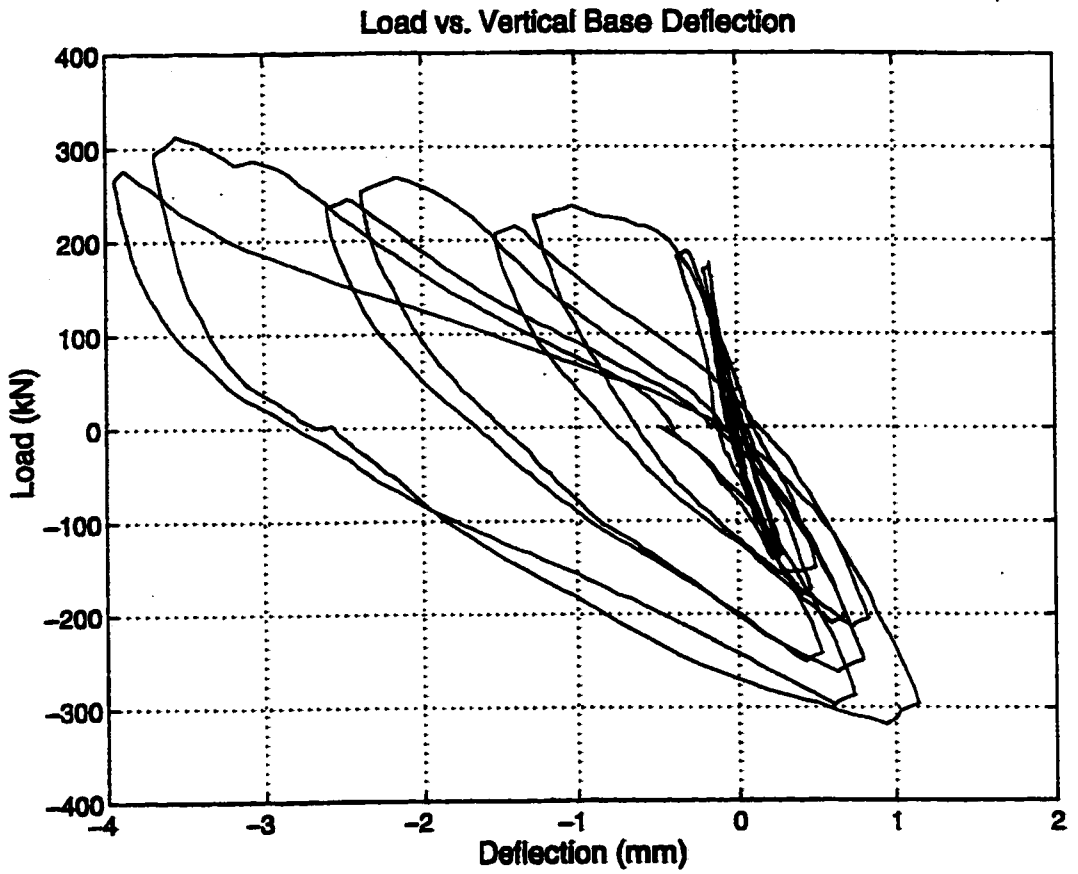
Figure 6.43 Lateral load-vertical base displacement curve of the repaired wall as measured by LVDT # 10

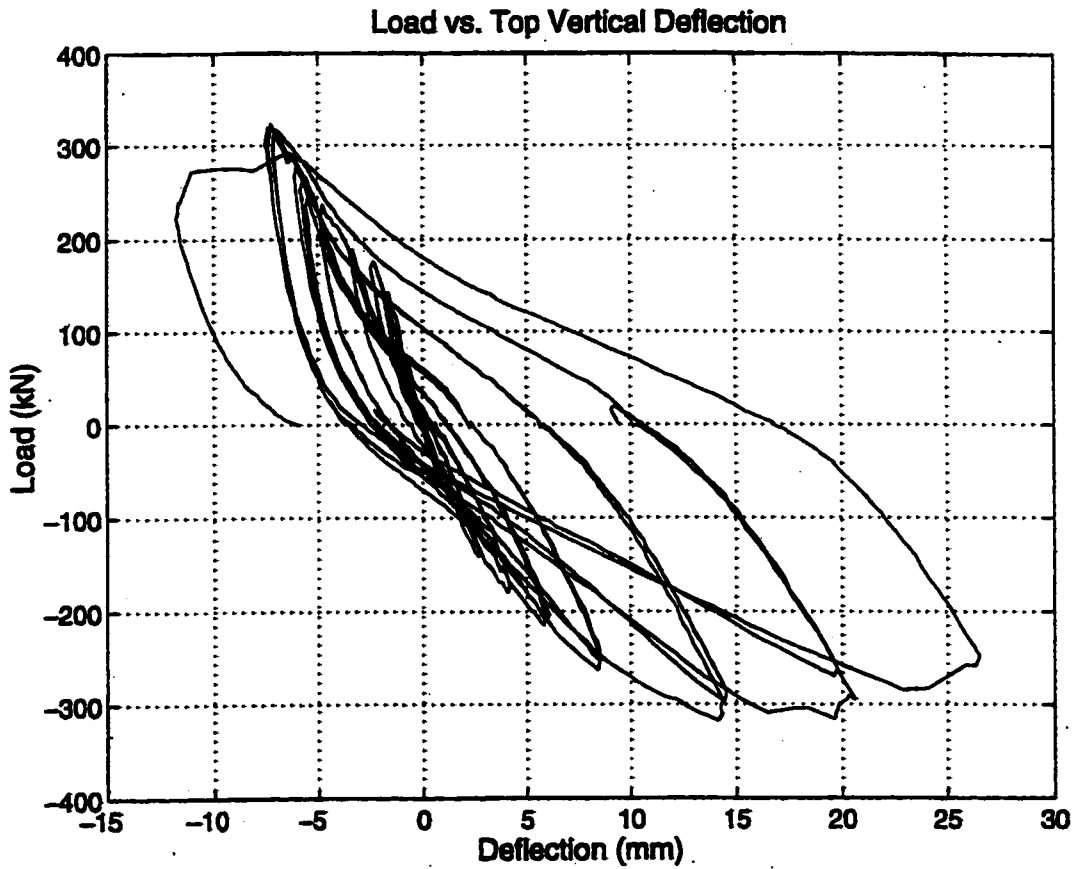
Figure 6.45 Lateral load-top vertical displacement curve of the repaired wall as measured by LVDT # 12

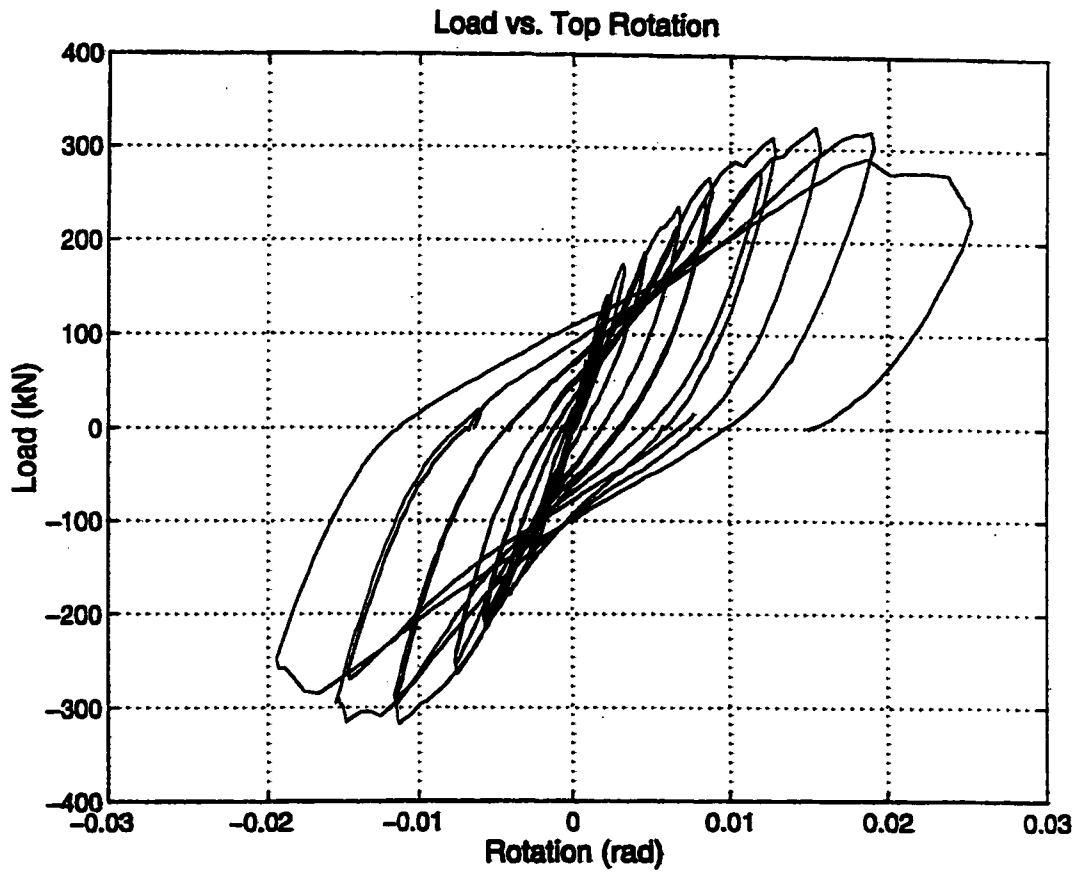
Figure 6.46 Lateral load-top rotation curve of the repaired wall

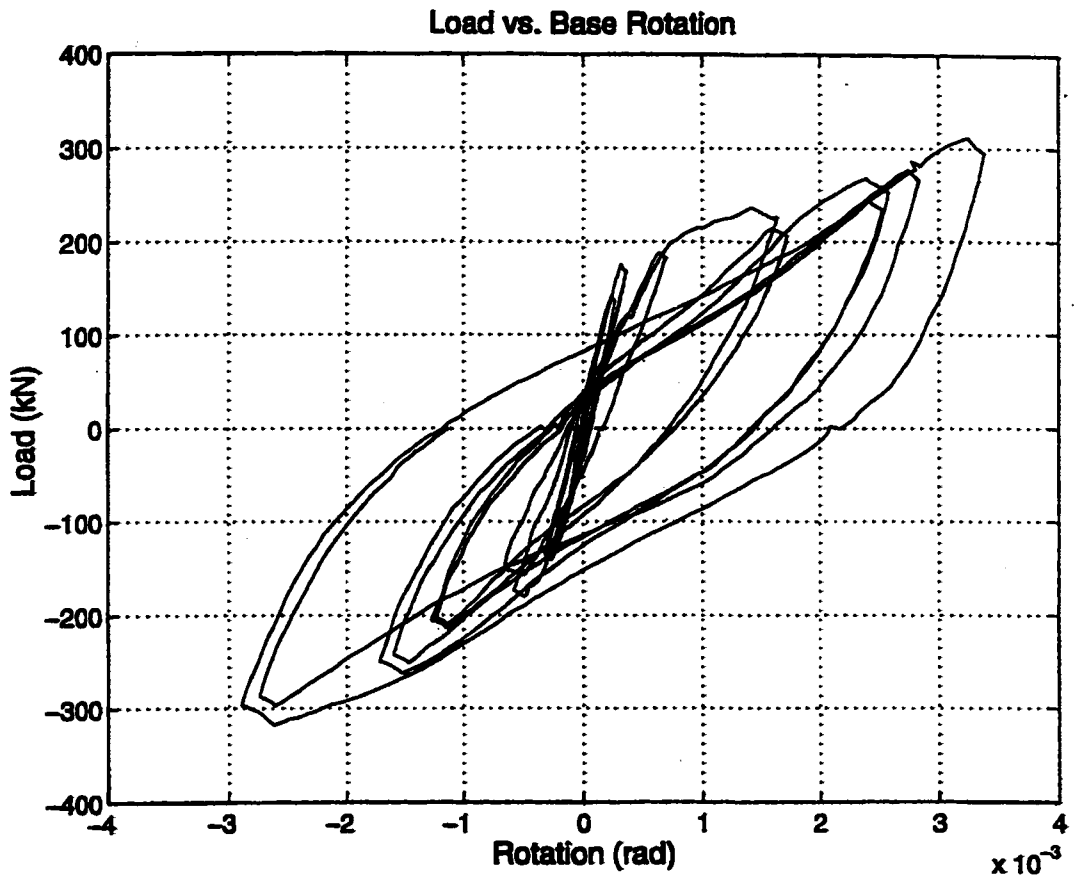
Figure 6.47 Lateral load-base rotation curve of the repaired wall

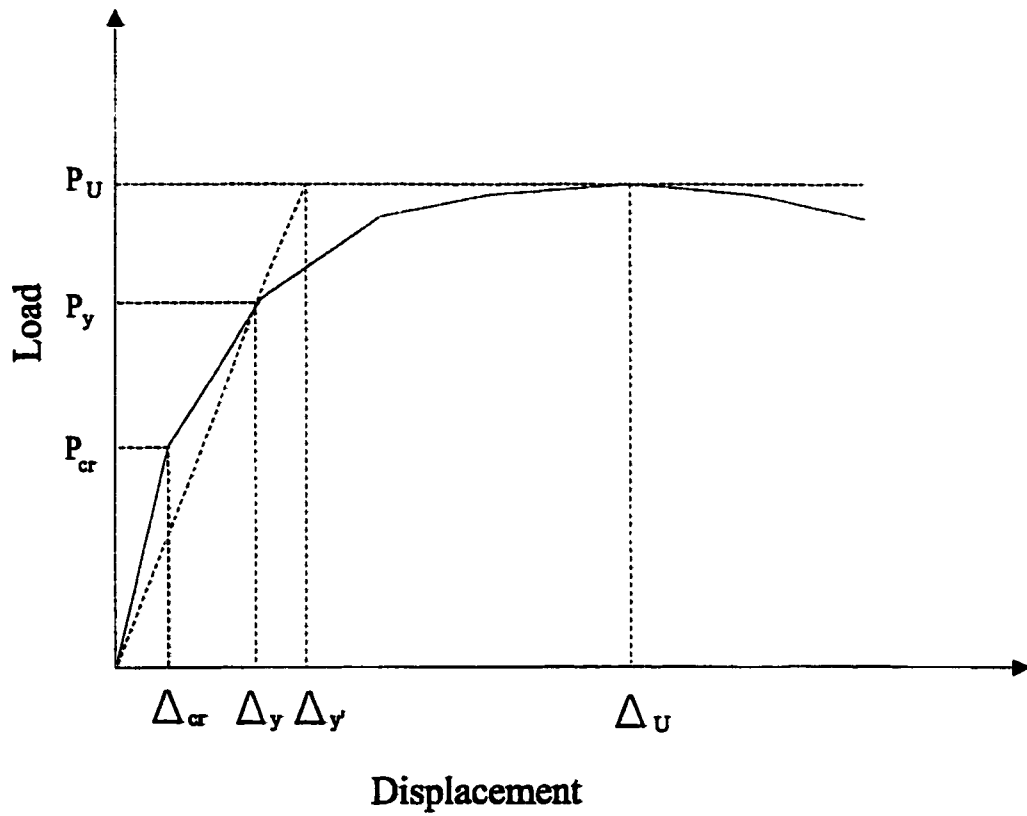
Figure 6.48 Load deflection parameters used for evaluation of the repair and strengthening procedures

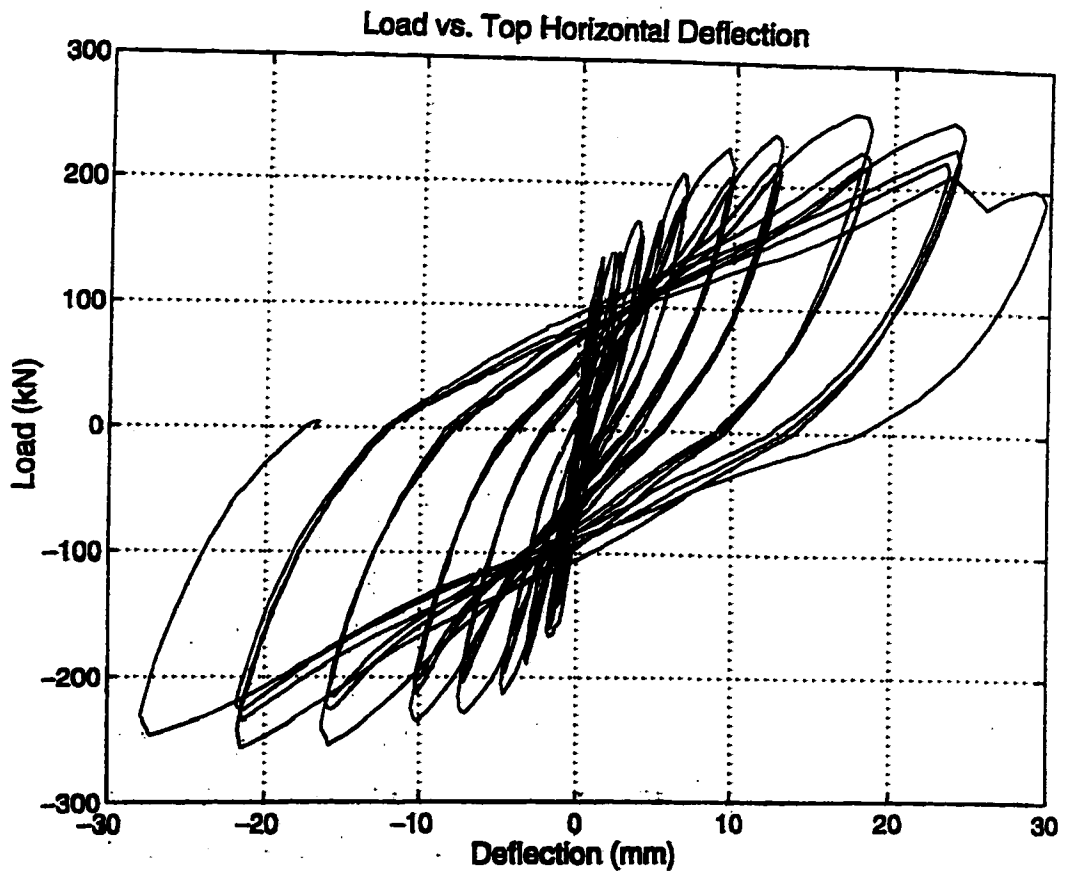
Figure 6.49 Average measured lateral load-total top horizontal deflection curve of strengthened shear wall #1

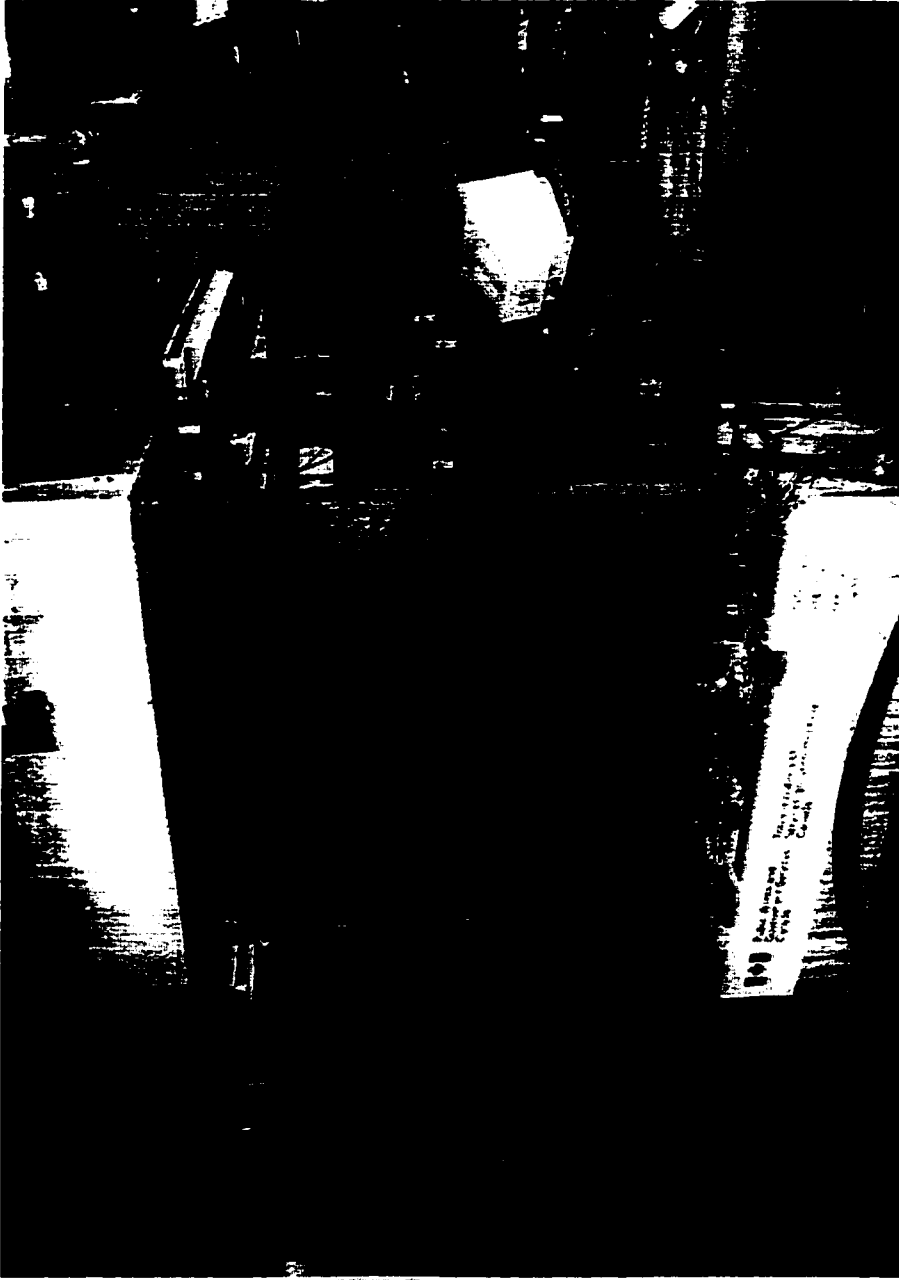
Figure 6.69 Strengthened wall #2 following load step #9

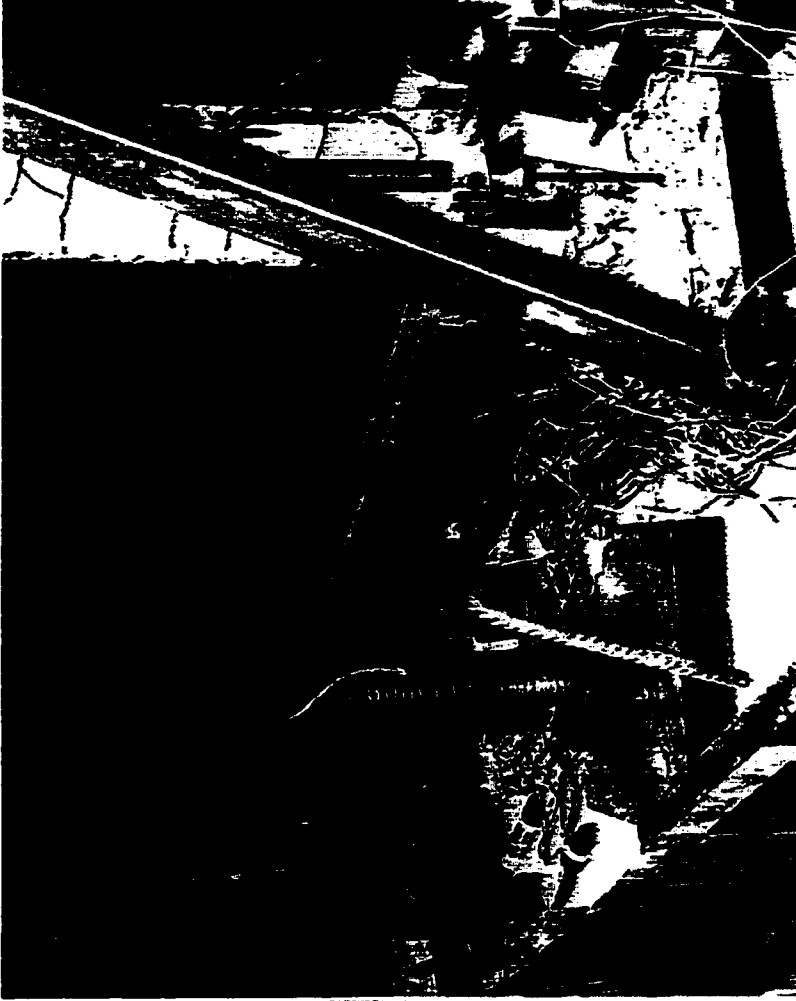
Figure 6.76 Damaged sustained following load step #13
