**Seismic Strengthening and Repair of
Reinforced Concrete Shear walls using Externally Bonded
Carbon Fibre Tow Sheets**

Josh Christopher Lombard

Master of Engineering*

September 1999

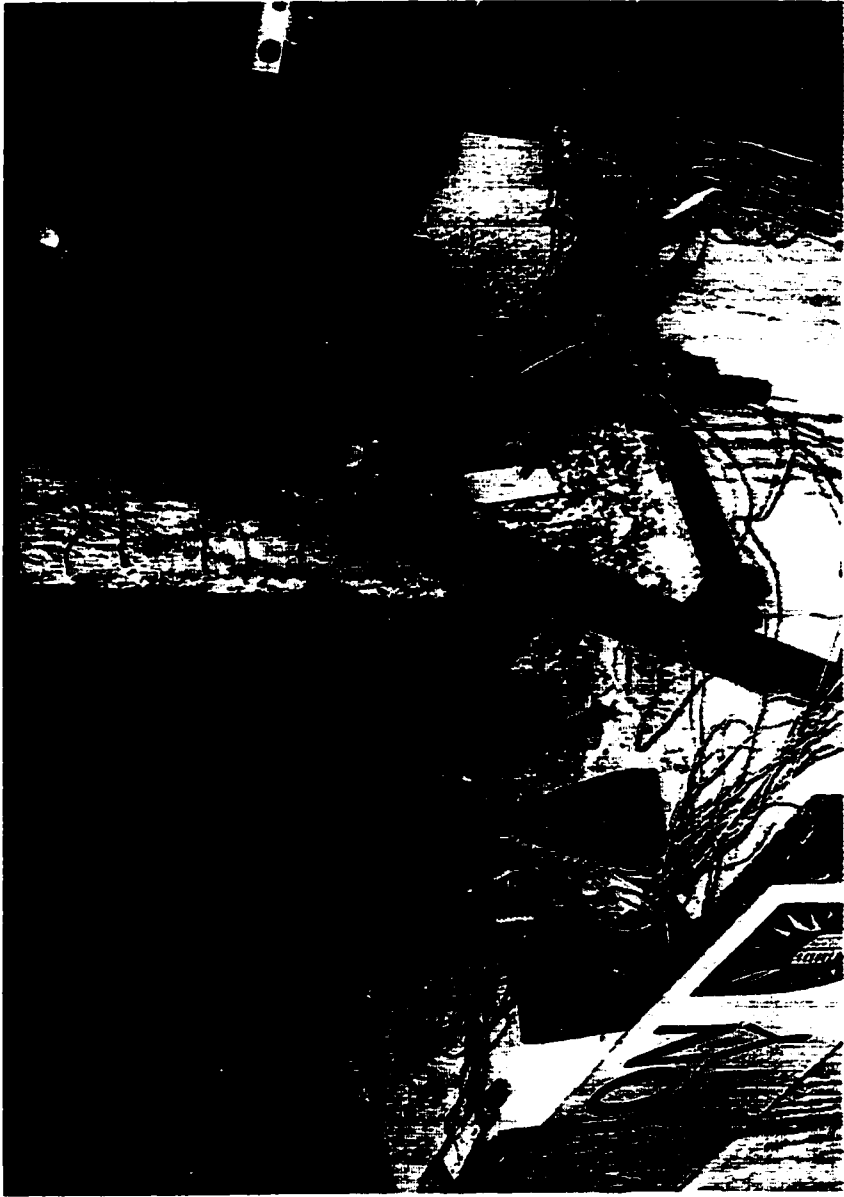
Figure 6.77 Damaged sustained following load step #14

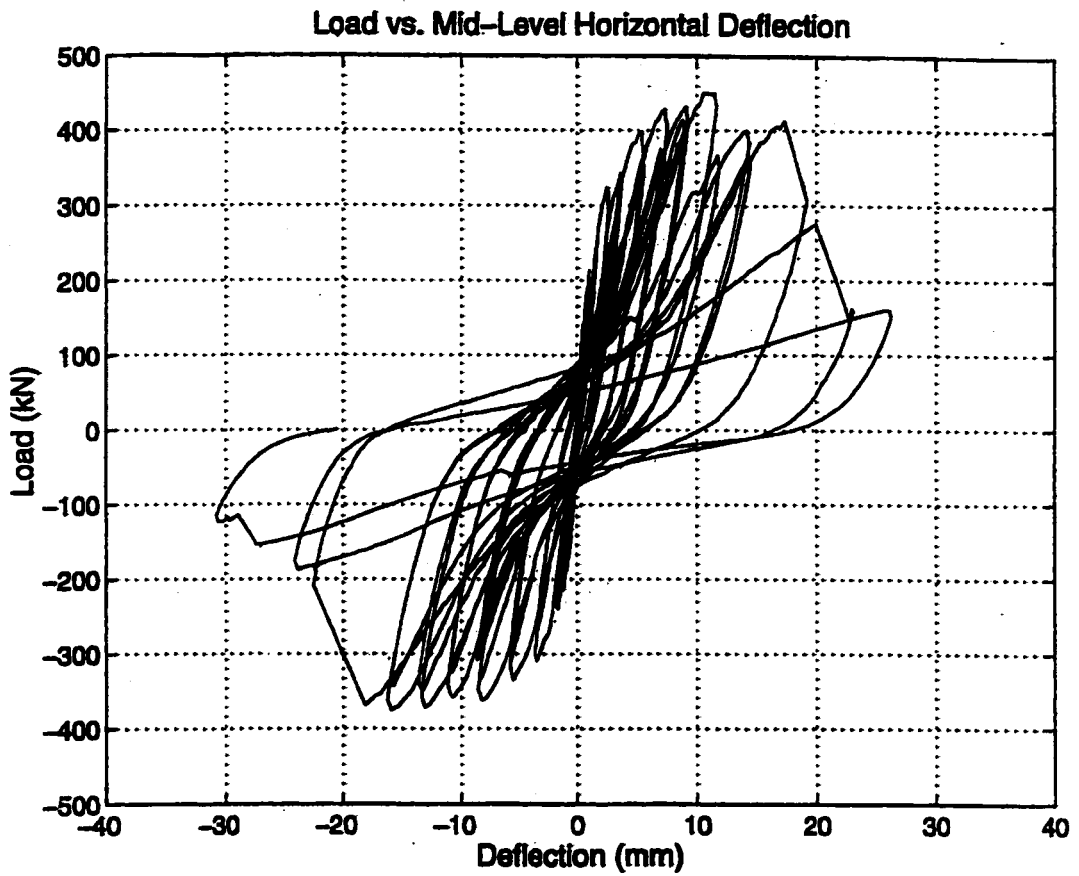
Figure 6.82 Average measured lateral load-mid-level deflection curve of strengthened shear wall #2

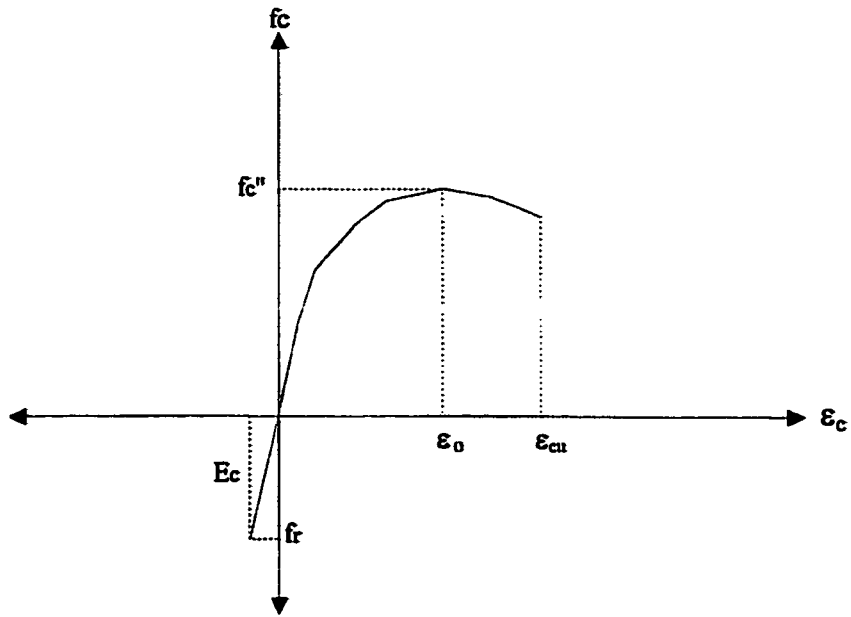
Figure 8.1 Concrete stress-strain model

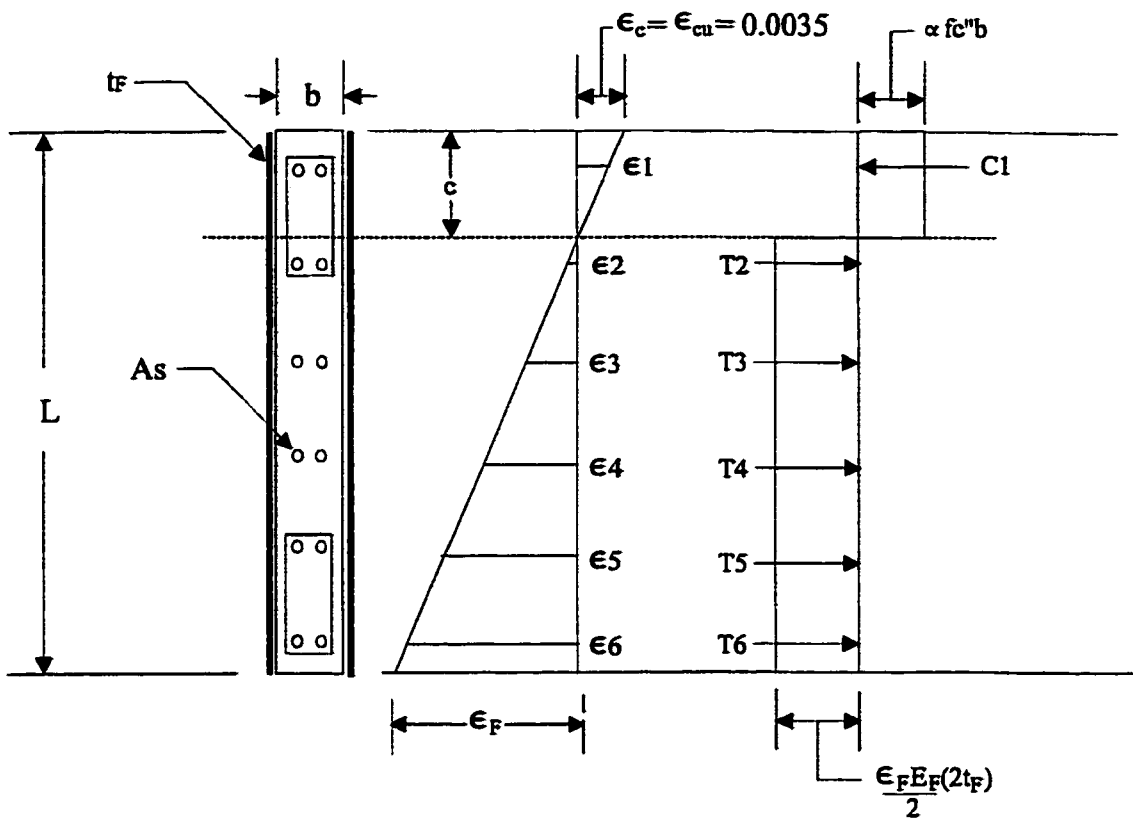
Figure 8.7 Strain distribution at ultimate state of a retrofitted wall whose governing failure mode is crushing of the concrete

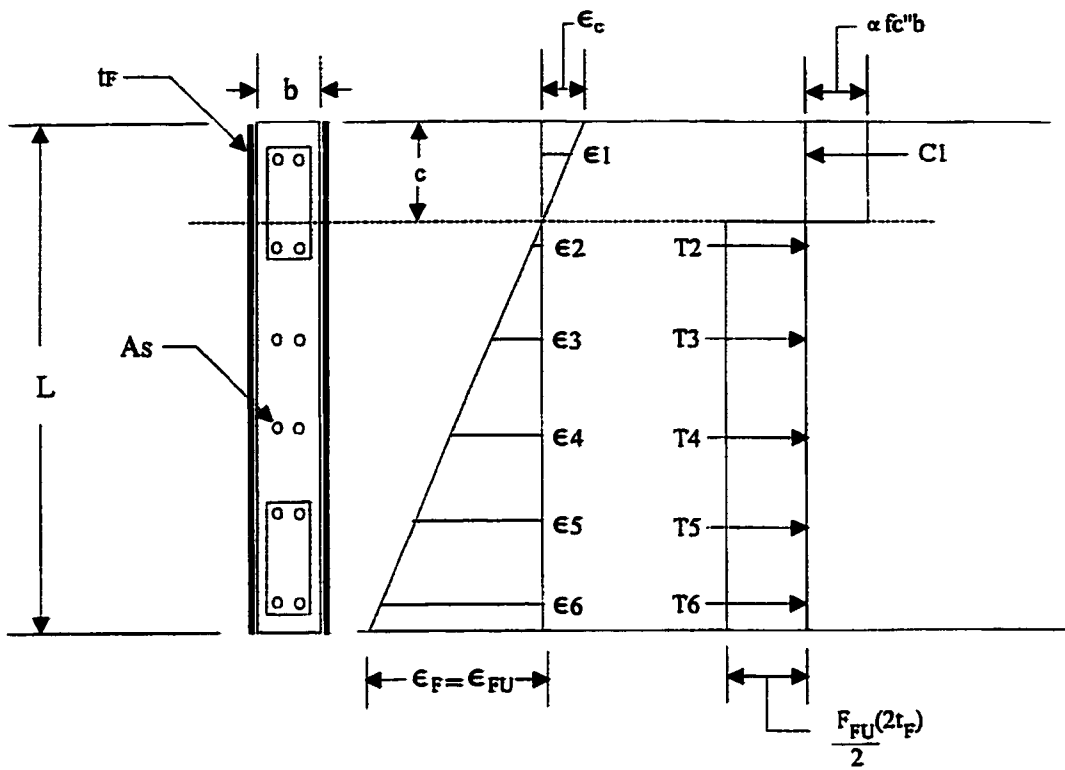
Figure 8.8 Strain distribution at ultimate state of a retrofitted wall whose governing failure mode is tearing of the CFRP sheets

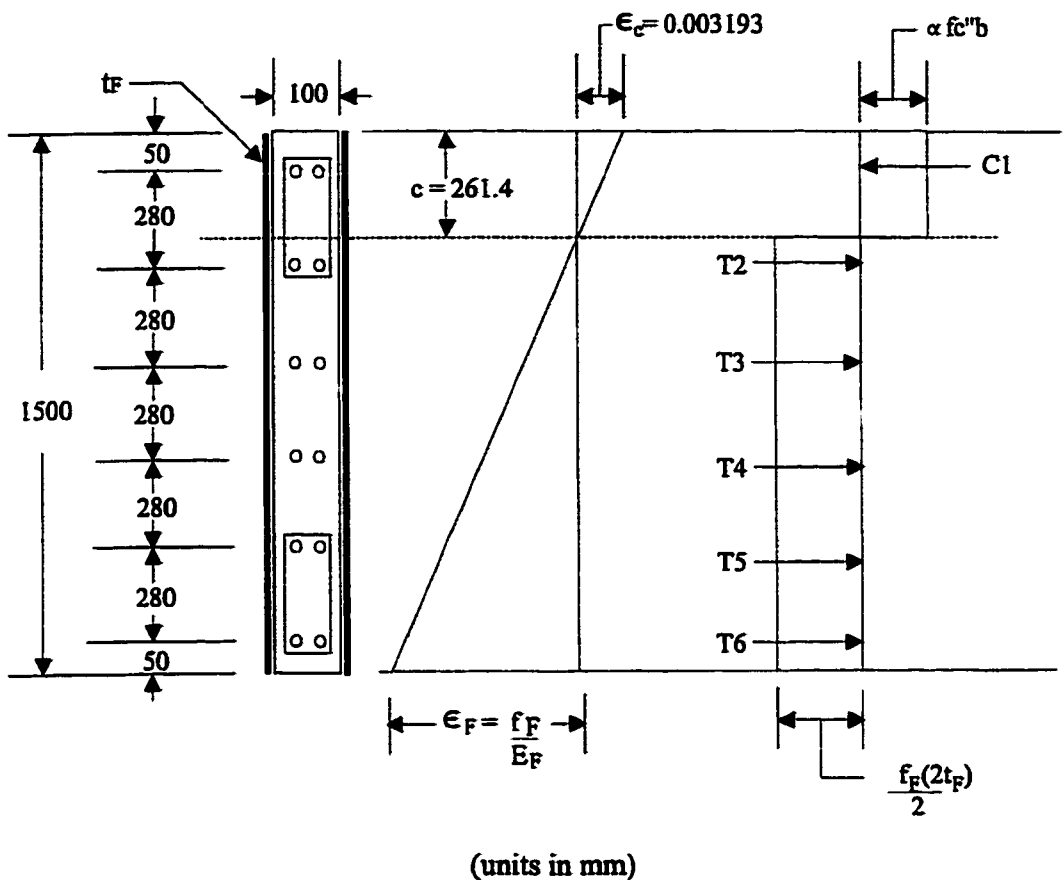
Figure G.1 Strain distribution used to calculate the flexural strength of the repaired wall and strengthened wall #1.

$$M_r = 671.9 \text{ kN}\cdot\text{m}$$

$$P_r = M_r/h = 671.9/2 = 335.96 \text{ kN}$$
