SLOW-STRAIN-RATE-HYDROGEN EMBRITTLEMENT AND STRESS-CORROSION CRACKING
IN Ti-Al BINARY ALLOYS

A THESIS

David Alexander Mauney

Georgia Institute of Technology

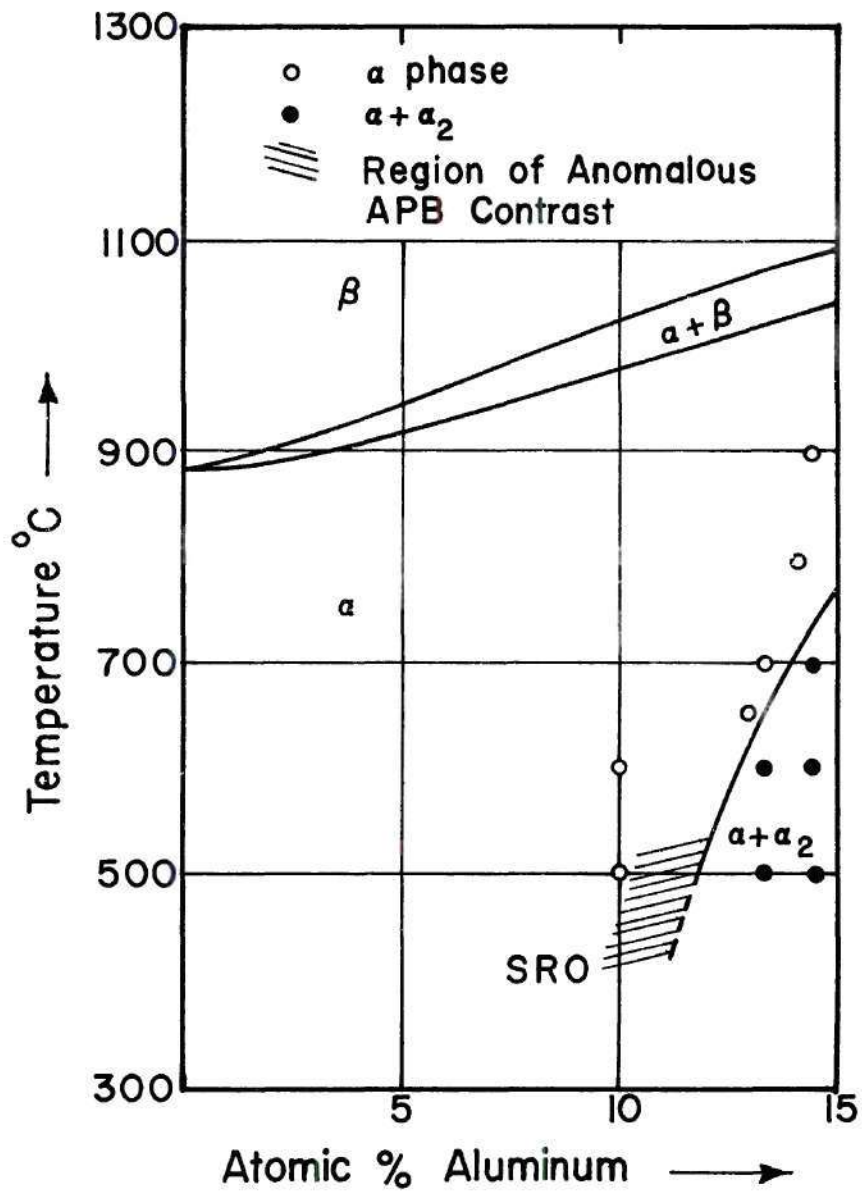
Figure 1. The Titanium-Aluminum Phase Diagram from 0 to 15 Atomic Percent Al (after Blackburn¹⁹)

Blackburn¹⁹, using thin foil transmission electron microscopy and X-ray diffraction, has been able to circumvent the above mentioned difficulties. The phase diagram determined by him, Figure 1, shows good agreement with those of several other workers^{9,23-25} for 0 to 15 atomic percent Al content. Blackburn's phase diagram for the Ti-rich end of the Ti-Al system has the general form found in systems having solid state order-disorder transformations. On this diagram α is the disordered hcp phase and α_2 the ordered phase. From 0 to 15 atomic percent Al, the structure goes from the disordered α -phase through short-range order, to small ordered domains in a disordered α -matrix¹⁹. For purposes of this investigation, Blackburn's phase diagram will be used for this region.

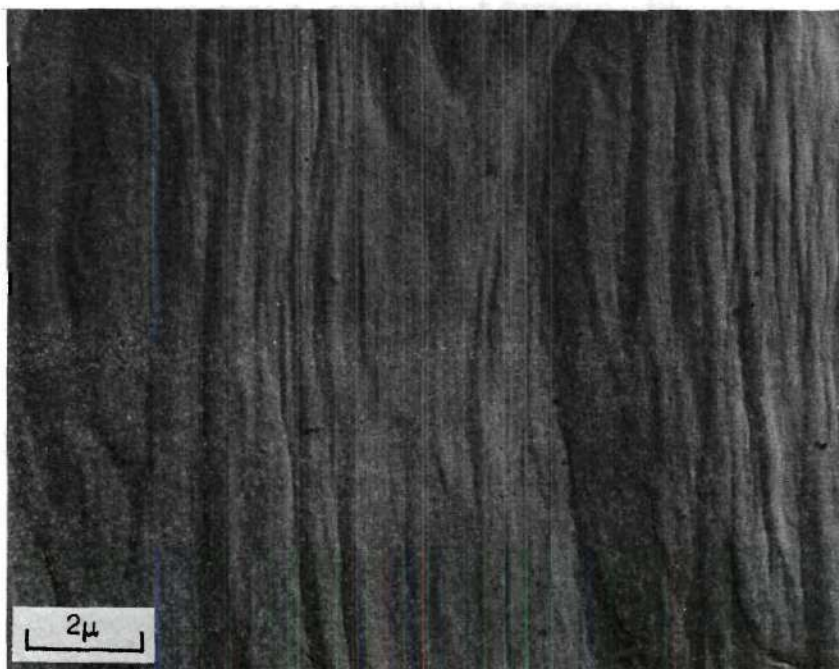
Figure 8. Electron Fractographs of a Ductile Area of the Ti-2.5 Weight Percent Al Alloy, 3.5 Percent NaCl Solution, Low-Hydrogen Failure: (a) Dimples, (b) Serpentine Glide

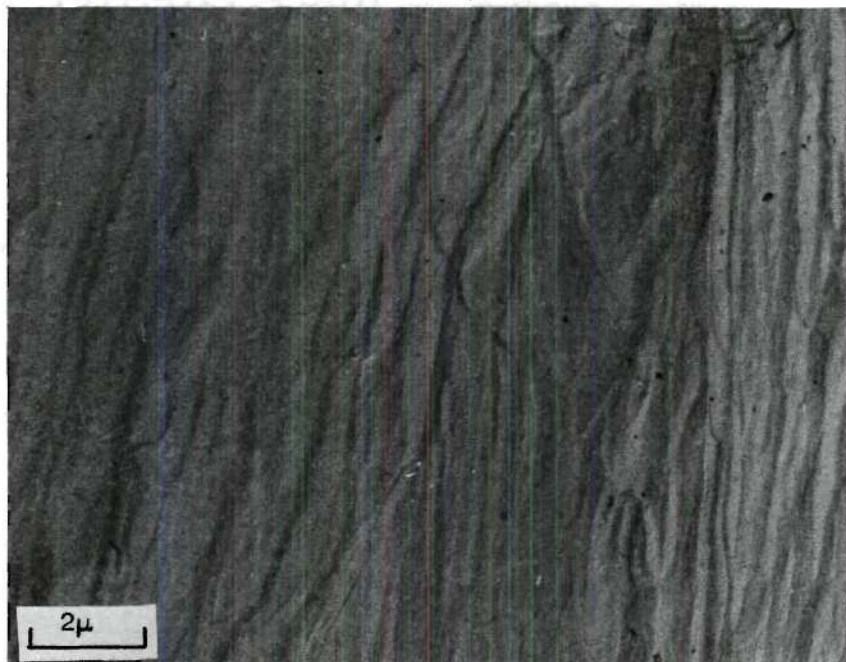
Figure 15. Electron Fractographs of the Ti-8 Weight Percent Al Alloy, Laboratory-Air, Low-Hydrogen Failure: (a) Serpentine Glide, (b) Nonclassic Cleavage

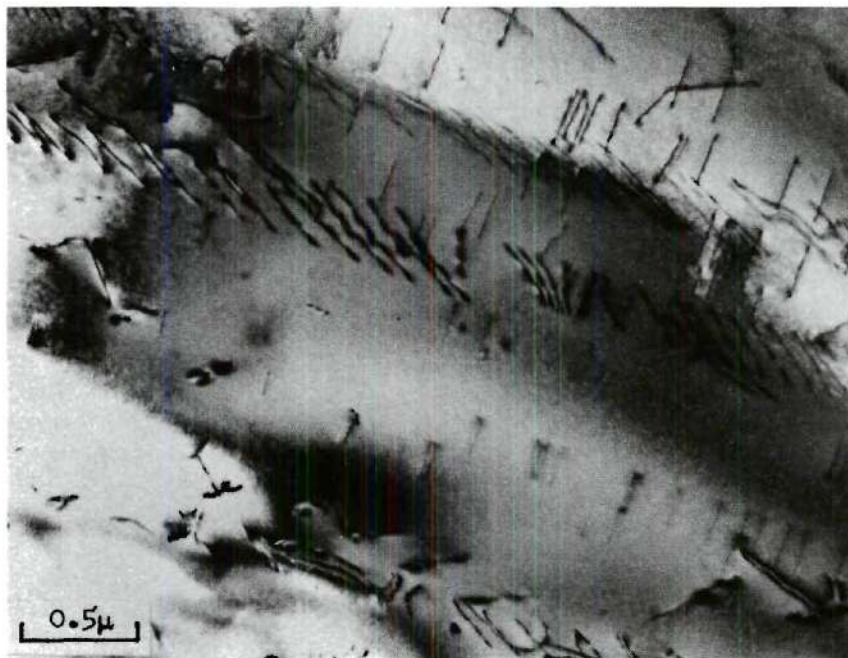
Figure 21. Transmission Electron Micrographs of Strained Ti-8 Weight Percent Al Alloy: (a) Dislocation Coplanar Arrays in Low-Hydrogen Content Alloy, (b) Dislocation Coplanar Arrays in High-Hydrogen Content Alloy

Slip was the only deformation mode observed in the present investigation. The Ti-2.5 weight percent Al samples showed dislocation tangles typical of this alloy⁴ in both the low- and high-hydrogen content specimens, Figure 19a and 19b. The Ti-5 weight percent Al alloy specimens showed coplanar arrays in the low-hydrogen content specimen, Figure 20a, and coplanar arrays containing hydrides in the high-hydrogen content specimen, Figure 20b. Coplanar arrays of dislocations were seen in both the low- and high-hydrogen content, Ti-8 weight percent Al alloy specimens, Figure 21a and 21b, respectively. No hydrides were observed in either specimen.
