## **Soil bioengineering in northeastern Brazil: An Overview**

**ARTICLES** doi:10.4136/ambi-agua.2650

This article presents an overview of the application of soil bioengineering techniques, also modeled as natural engineering, in the state of Sergipe, northeastern Brazil, showing the importance of integrating living and inert elements to protect river banks from erosion. The employed techniques are different, ranging from the characterization of susceptibility to erosion to the use of biotechniques, considering knowledge in the areas of agronomic engineering, forestry engineering, civil engineering, biology, pedology, geology, geomorphology and geotechnics. It is an approach that uses techniques and methodologies in a multidisciplinary way, seeking to maximize synergies (for example, natural engineering techniques to combine inert materials in ways that help plants to develop increasingly efficient systems). This approach also considers maintenance-cost optimization in the conduction of the works, using different materials, differing from traditional engineering, which uses predominantly inert materials. The research work carried out in different locations sought the availabilit

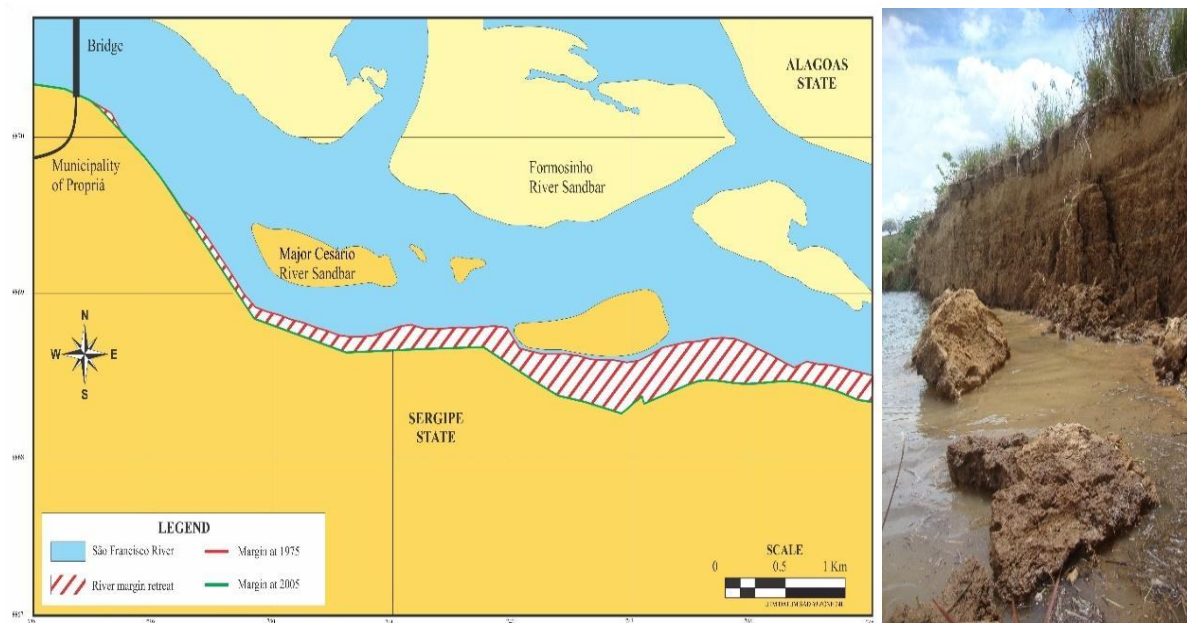
**Figure 2.** Margin retreat of the Lower São Francisco River from 1975 to 2005, resulting from river bank erosion.

The triggering of erosion and sedimentation are evidence of the complex readjustments taking place in the channel morphology, as a new dynamic equilibrium is sought. The mechanisms of slope destabilization at the margin of the Lower São Francisco have been studied by Holanda *et al.* (2007) (Figure 2) through observation of the differences in behavior between the soil layers of slopes and erosion on the river bank. The authors stated that, over 30 years, in some stretches the margin retreats ranged from a maximum distance of 309.15 m to a minimum distance of 12.26 m.

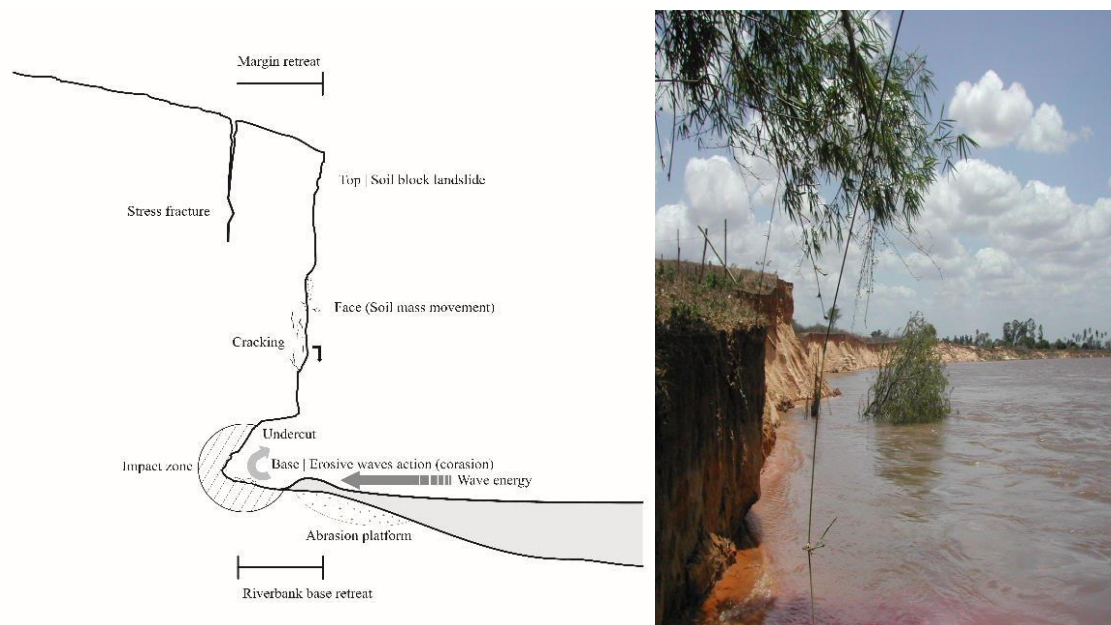
**Figure 4.** Undercutting and failure of river banks along the Lower São Francisco (36°47'28.6" W and 10°13'40.8" S).

mainly on the concave bank. The cohesive sediments, having low permeability, are more resistant to surface erosion which also reduces the negative effects of subsurface aqueous flows on the slope stability. However, when slopes are undercut and/or become saturated, mass movements of soil such as landslides and falling blocks occur frequently (Figure 4). The undercutting is caused by the action of waves at the overlap between the basal level and loamy sands, giving rise to failure in this layer of loamy sands; blocks that fall break down into smaller ones that slide to the bottom of the bank.

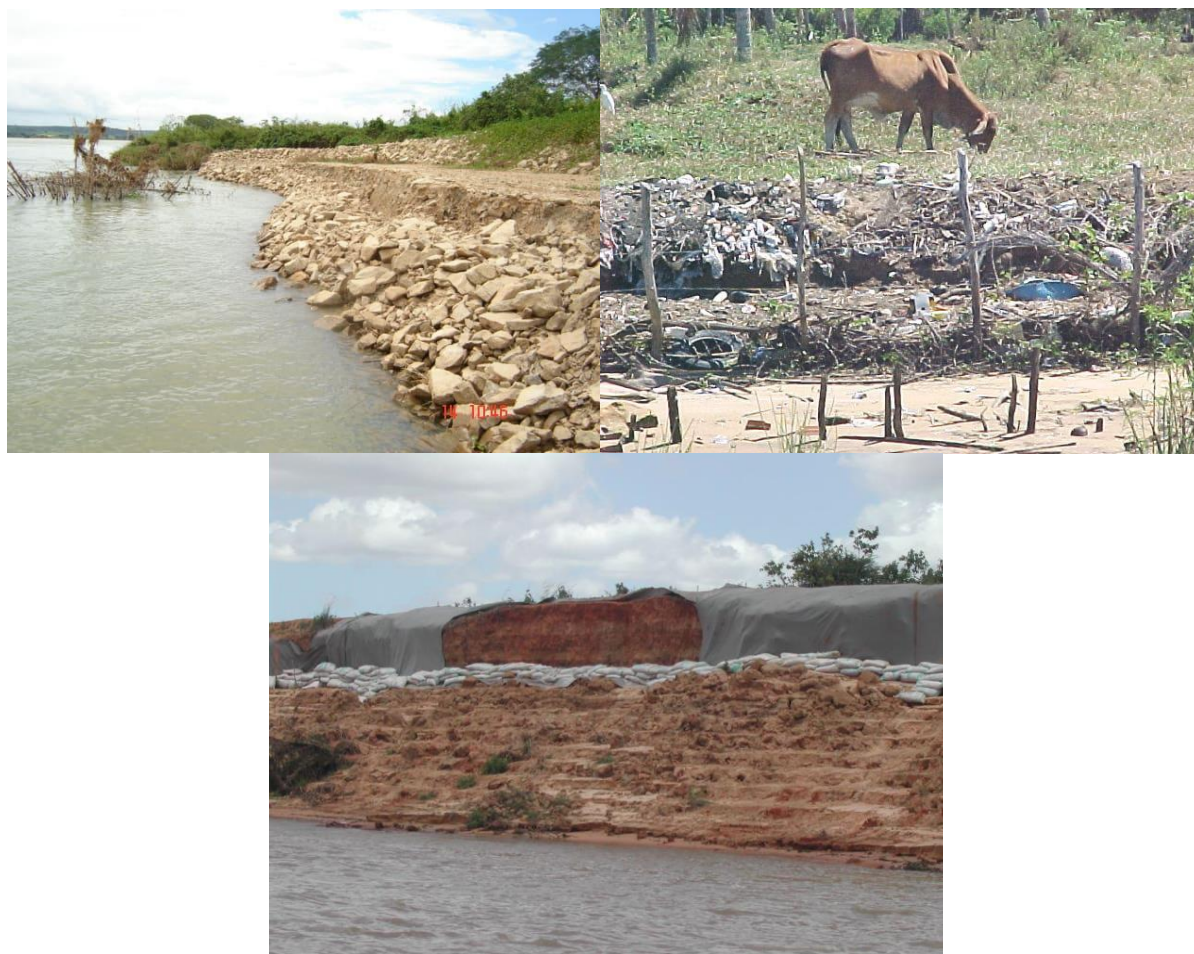
**Figure 5.** Riprap and other erosion-control methods used by the riverine population.

As an example of remedial measures implemented for large rivers, since the 1980s riprap (massive stones) has been used to control erosion along the banks of the São Francisco River (Figure 5). Riverine population living along the river, concerned with flooding of their lands, have struggled to mitigate the degradation of the river banks using low-cost materials such as coconut (*Coccus nucifera* L.) straw, sandbags, and old rubber tires and inner tubes, with or without the assistance of public agencies in controlling the erosion. Although intended as an immediate solution to a genuine problem, it is important to note that such solutions carry their own environmental risks.

To overcome the problem of low cohesion of alluvial soils, riverbanks, normally entisols, rock material with an average diameter of 70 cm has been used on the local banks. This material not only retains the soil particles that were dragged by the underground erosion but also absorbs the impact of the waves on the face of the bank, avoiding the undercutting (Hiller *et al.*, 2018; Holanda, *et al.*, 2009b). The installation of riprap involves operations to smooth the river bank, followed by coating with rocky materials having a particle size scaled to absorb the impact of waves. The stability of loose (dumped) rock riprap against erosive forces due to flowing water was also studied by Jafarnejad *et al.* (2019), who agree that riprap is typically employed in locations where portions of the slope have been cut away and is considered an emergency measure to contain the river-bank erosion. This technique, however, even if implemented by engineering specialists, may not be a lasting solution, since the structure could eventually collapse as the erosion proceeds in the bank-toe.

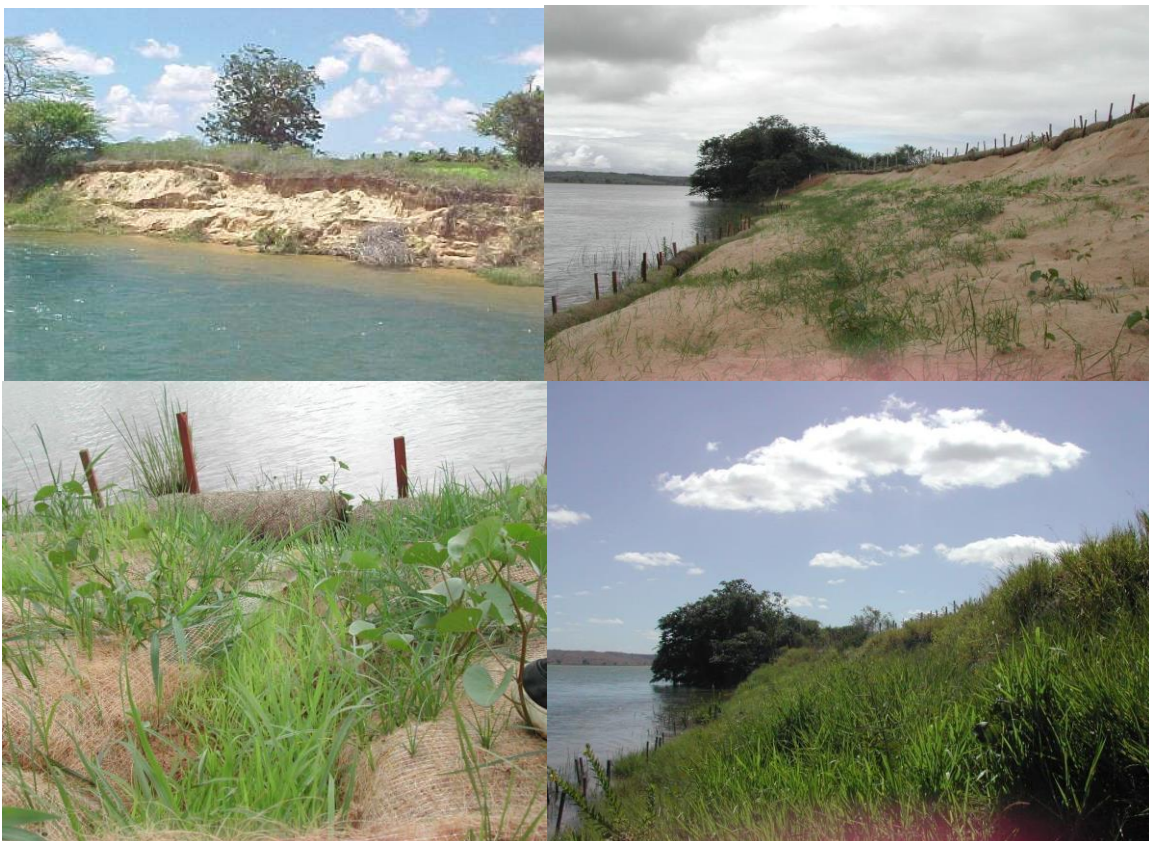
**Figure 6.** The use of soil bioengineering techniques to control erosion (Holanda *et al.*, 2005).

The soil bioengineering materials primarily used were geotextiles of 100% coconut fiber with photodegradable polypropylene (Figure 6). These were used as an erosion blanket protection on the alluvial soil of one of the slopes. The slope that was not treated with soil bioengineering techniques continued to erode severely. As shown in Figure 7, its transverse profile was significantly altered, mainly from the action of shock waves at the base of the slope, which led to the verticalization of the margin. This change in profile took place in less than a year, between September 2004 and March 2005 (Holanda *et al.*, 2008), and in turn gave rise to frequent shear-induced mass movements of soil, with large blocks falling from the bank toe. In the treatment with soil bioengineering, the importance of living and inert elements in the physical protection of the slope against the effects of marginal erosion is perceptible. A combination of coconut (*Coccus nucifera* L) geotextile with coir roll with biodegradable mesh and native species seeds cocktail was tested. The geotextile contributed to the stabilization of the slope and showed efficiency in the control of the erosion of the margins in the evaluated period.

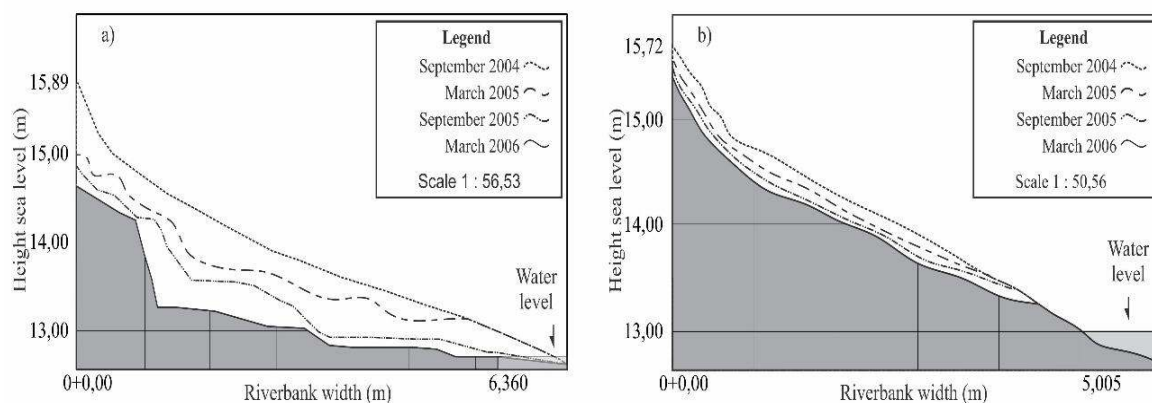
**Figure 7.** Comparison of river bank profiles: left panel untreated river bank; right panel riverbank treated with soil bioengineering techniques.

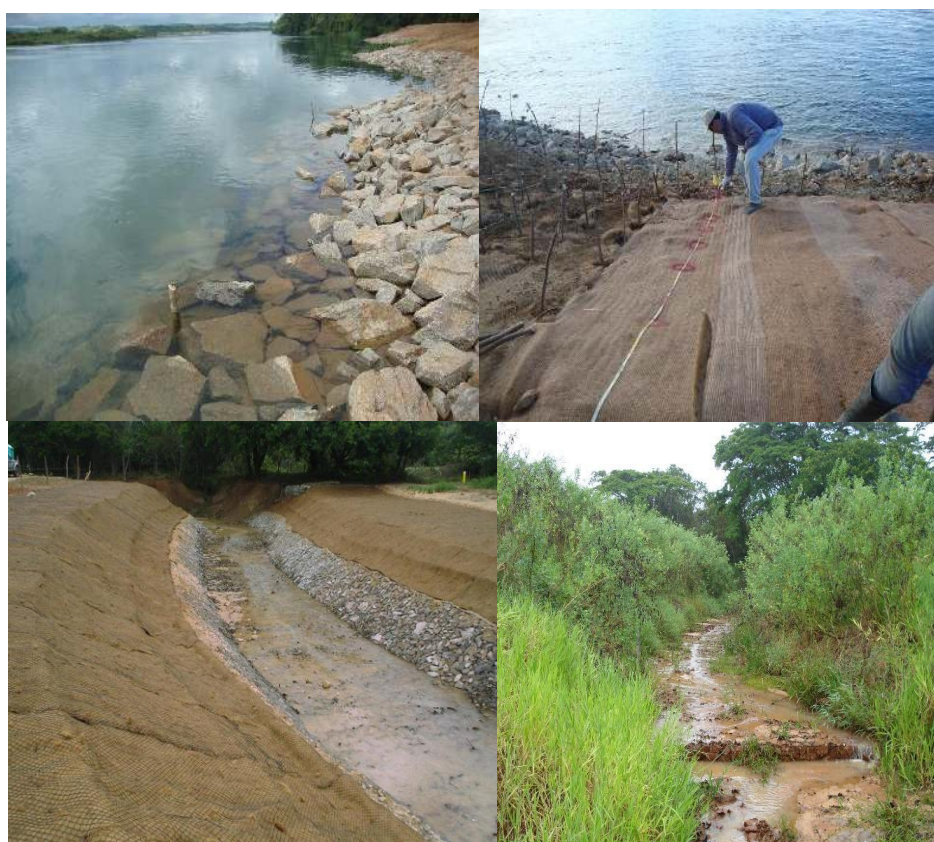
**Figure 8.** Use of geotextiles, with riprap and gabion as toe protection, on the banks of the São Francisco and Paramopama Rivers.

A variety of studies have been done to investigate the usefulness of soil bioengineering techniques. All of them have used a combination of geotextiles and other devices designed to protect the slope toe, such as the gabion, a rectangular structure having a hexagonal mesh exterior of reinforced, galvanized wire. These structures range in width from 0.17 m to 0.30 m and are filled with non-friable stone. Plastic materials and natural or synthetic fibers are applied to the soil surface to supplement the protective effect of the vegetation. These materials reinforce the soil laterally and form a layer that acts as a surface blanket. Soil bioengineering protection of this kind was used for the bank restoration of both São Francisco and Paramopama Rivers (Ribeiro *et al.*, 2011) (Figure 8).

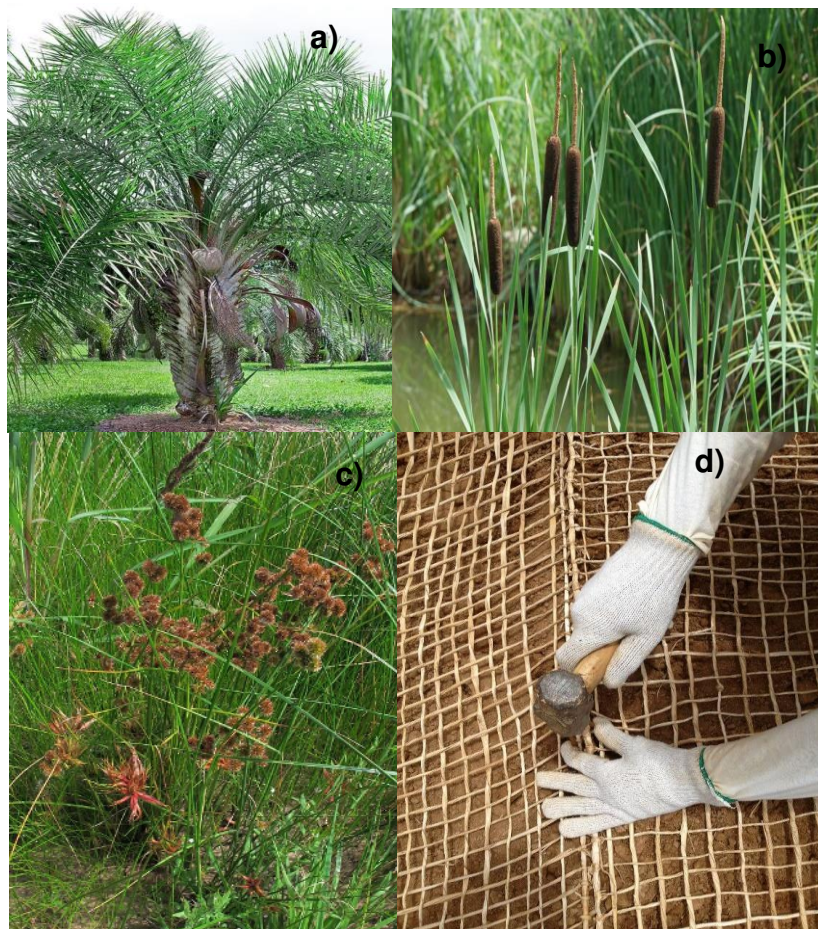
**Figure 9.** a) Plant of *Syagrus coronata* (Mart.) Becc., b) Plant of *Typha latifolia*, Linn., c) Plant of *Juncus spp* Vahl. (d) Use of *Typha latifolia* geotextile on the riverbank erosion control.

The use of social technologies that enable possible innovation using local knowledge has been conducted to make geotextiles from the use of natural fibers routinely used for handicraft making in the Lower São Francisco of Sergipe state. The production of these geotextiles, using abundant natural resources at the collection sites, leads to the possibility of an additional source of income, as well as the contribution to erosion control, since the geotextiles offer support against soil mass transport and conditions favorable for the development of vegetative cover. We have been working on the manufacture of an efficient braid for erosion control in riverbanks or slopes, through its manufacture using fiber of the species *Typha latifolia*, Linn, *Juncus spp* Vahl. and *Syagrus coronata* (Mart.) Becc (Figure 9). This work has tried to get the real efficiency of the geotextiles made from the natural fibers in erosion control as part of the soil bioengineering techniques. At the same time, it is unknown whether the use of fibers produced from species found in the vicinity of riparian communities is sustainable, or whether the fibers used in the production of handicrafts in the studied communities for the production of geotextiles is suitable.

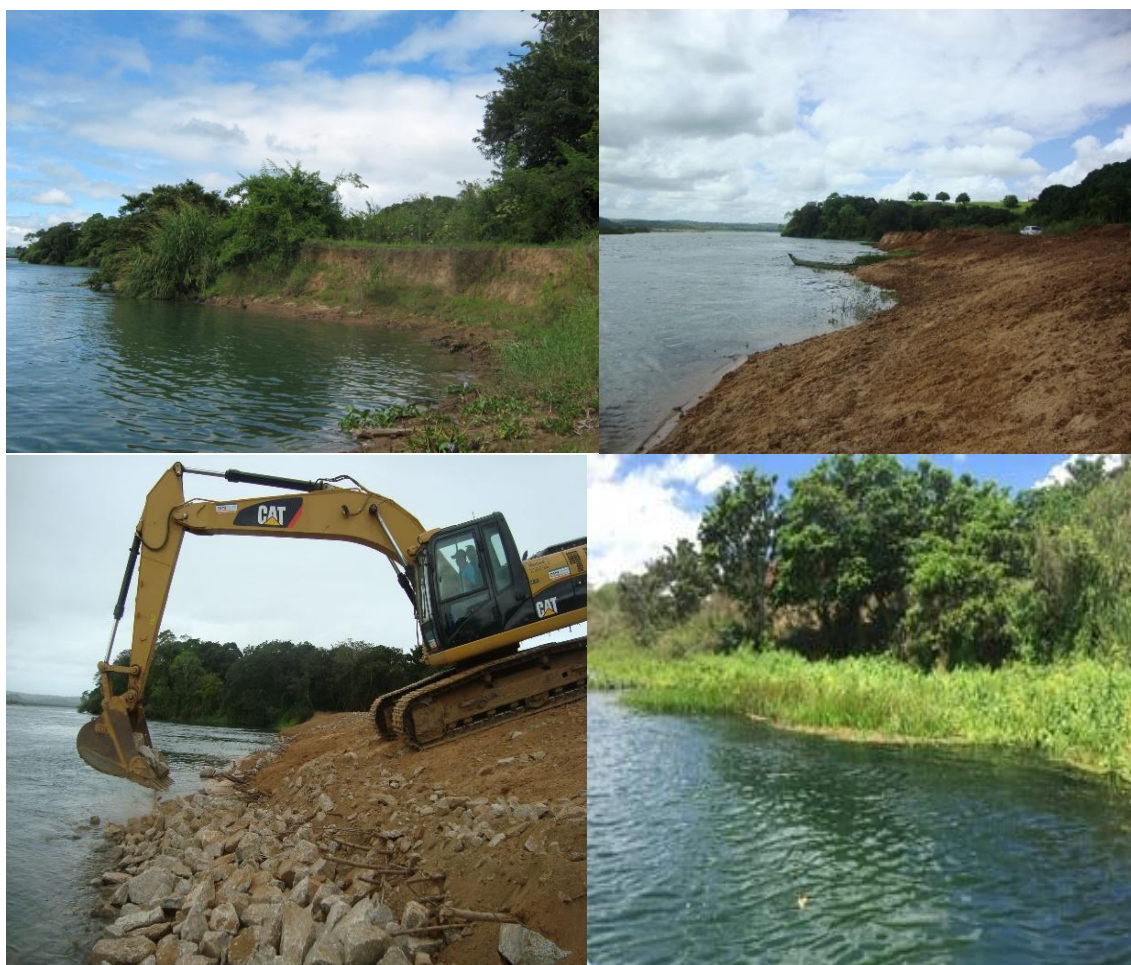
**Figure 10.** Lower São Francisco Riverbank recovery, Northeastern Brazil, through soil bioengineering technique called Vegetated riprap, from 2010 to 2018.

Vegetated Riprap is one of the most widespread soil bioengineering techniques, characterized by the use of rocks to protect the base of unstable slopes. It is commonly associated with other techniques that use live stakes or geotextiles in the middle and upper slope (Figure 10). This comprises one of the soil bioengineering techniques used at the slope toe of the São Francisco riverbanks in 2011, with rock materials with different diameters, and vegetated with species of local flora, as listed in Table 2, and also populated with other species resulting from seed dispersal by fauna and the wind. Live fascines and brush layer were used with vegetated riprap, composed of species previously tested in assays, such as *Schinus terebinthifolius* Raddi, *Erythrina velutina*, *Caesalpinia leiostachya* e *Enterolobium contorsiliquum*, *Spondias lutea* L., *Inga marginata* Wild, *Tapirira guianensis* Aubl, *Lonchocarpus sericeus* (Poir.), and *Mimosa caesalpiniaefolia* Benth L with very satisfactory results, especially *S. terebinthifolius*., *M. caesalpiniaefolia*, and *Mimosa pigra* (Holanda *et al.*, 2010; 2012a).

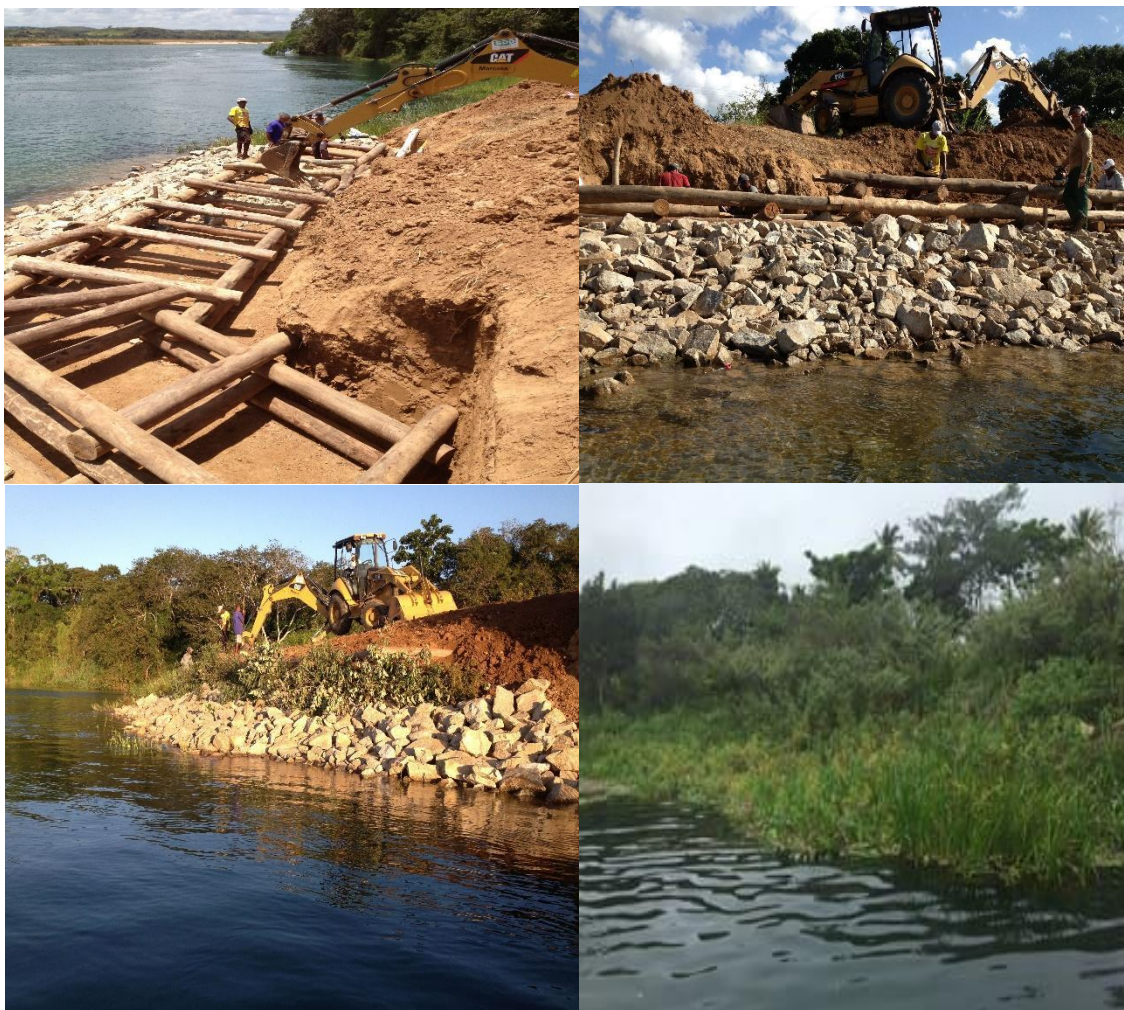
**Figure 11.** Lower São Francisco Riverbank recovery, Northeastern Brazil, through soil bioengineering techniques called Crib-wall, from 2013 to 2018.

Live Cribwall is the most recent implanted technique, implanted in September 2013, which used inert materials, such as rocks as riprap (at the slope toe), wooden logs and clamps, together with biological materials also associated with brush layer for slope stabilization (Figure 11). This creates a favorable environment at the slope toe exposed to the ebb and flow of water, with the presence of aquatic macrophytes that cover and protect the slope, as time passes. The Vetiver grass Contour Line consists of seedlings of Vetiver grass planted in contour lines, mostly used in road slopes.
