**SOME OBSERVATIONS AT LE COTEAU LANDSLIDE,
GATINEAU, QUEBEC**

BY
W. J. EDEN

Reprinted from
CANADIAN GEOTECHNICAL JOURNAL
Vol. 9, No. 4, November 1972
p. 508

In April 1971, landslide activity developed in a 100-ft (30.5-m) high clay slope in a housing development. This note describes the landslide and discusses the pore-water pressure measurements made at the site.

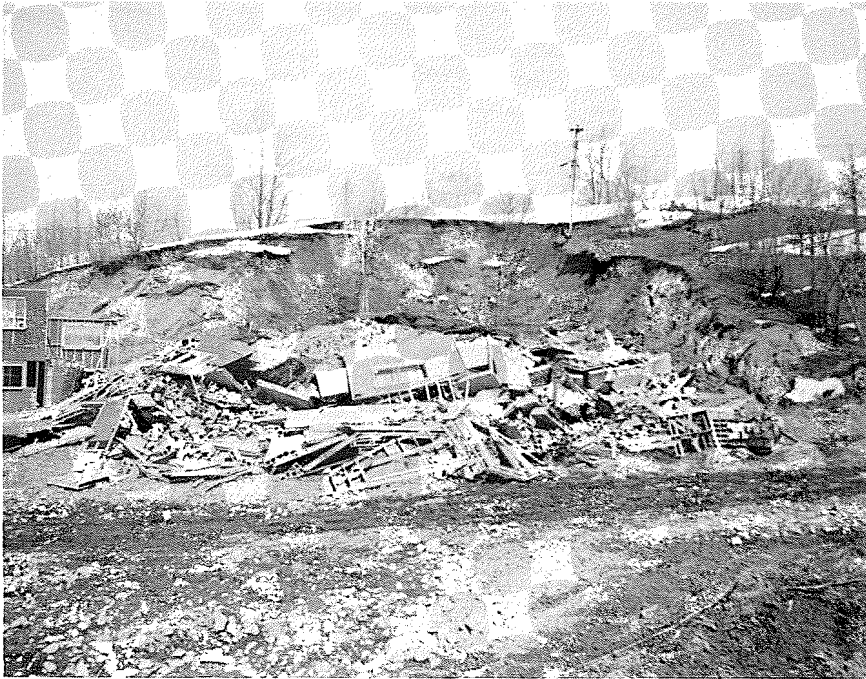
FIG. 2. Slide No. 2 and wreckage of partially completed row house.

area and several families were advised to evacuate their homes temporarily on 7 April. During the night of 7 April a second landslide occurred west of the first occurrence, destroying a partially completed row house. Figure 2 shows this slide. On 8 April, four vibrating wire piezometers were installed at locations shown on Fig. 1 in an attempt to obtain information on the changes in pore water pressure in the slope at the point of critical equilibrium. The readings would also assist officials in deciding when the dangerous period had passed for the slopes.

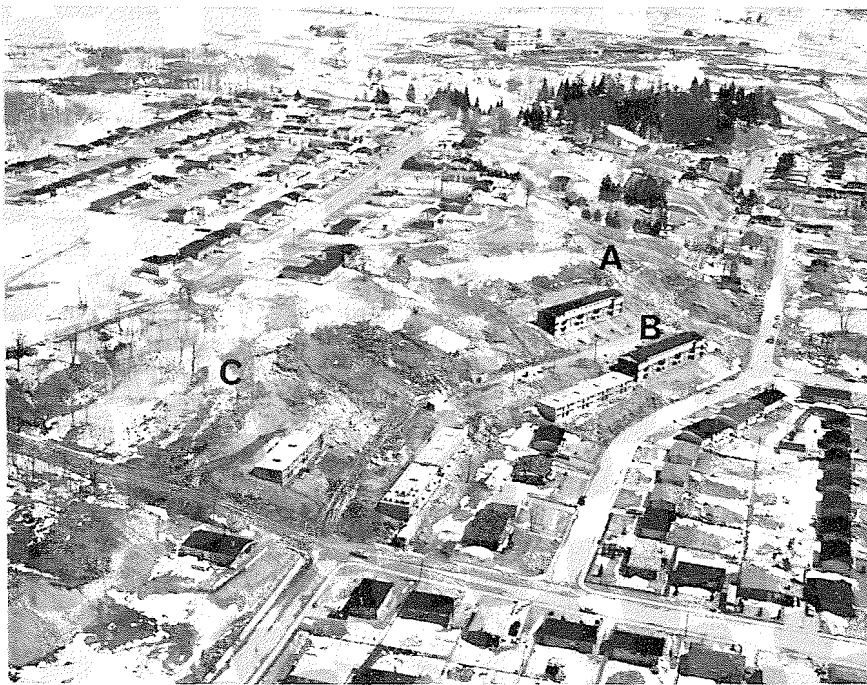
FIG. 3. Aerial view of landslide site. A. Slides 1, 3, 4, and 5. B. Le Coteau St. C. Slide 2.

The slopes remained stable until 12 April, when a significant rainfall began. The fourth slide occurred about 10:30 a.m. and was the largest of the series. It occurred at the same location as the first slide and pushed debris from there almost to the house situated at No. 209 Hillside. Rain continued during the night of 12 April. About midnight, the fifth and final slide of the series occurred, immediately west of the first occurrence, covering Le Coteau St. with debris. The locations of all the slides are shown on Fig. 1; Fig. 3 is an aerial view. Figure 4 shows four of the five occurrences.

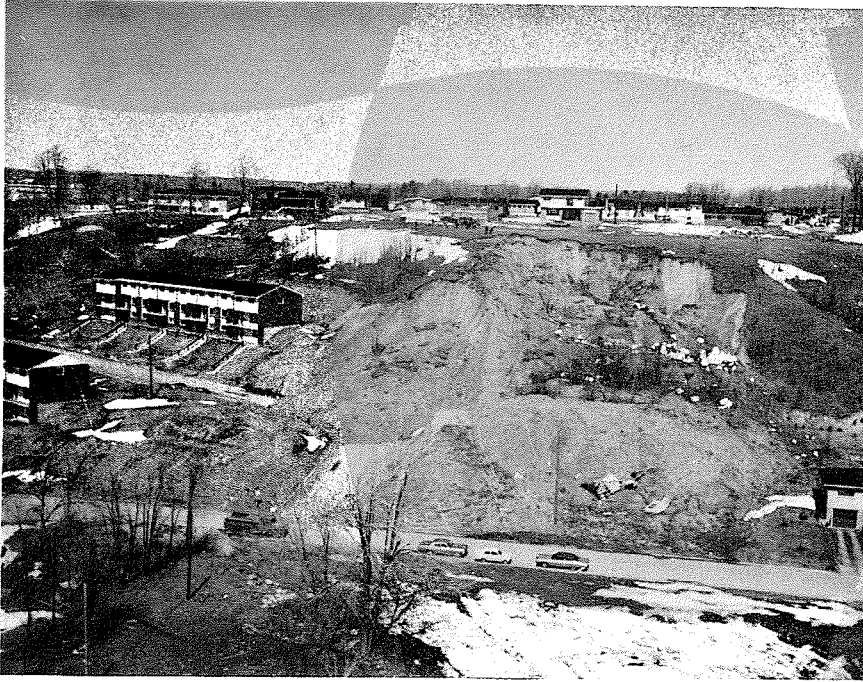
FIG. 4. View of Slides 1, 3, 4 and 5.

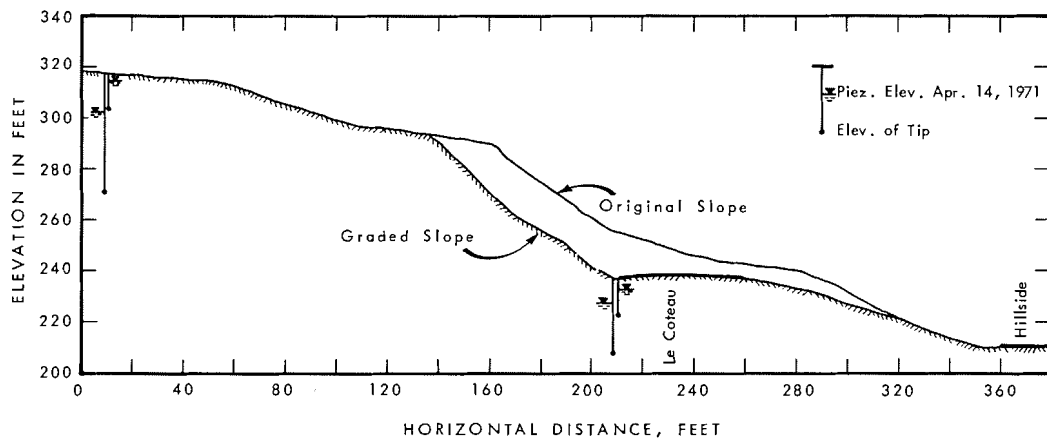
FIG. 6. Slope profile A-A through piezometers.

Readings began immediately after installation and were continued on a more or less daily basis for the month of April. They were taken initially using a portable generator set. Some difficulties were encountered with the stability of this power source and later readings were taken with a 6-V battery powering a D.C.–A.C. converter. The piezometer readings, which have been converted to piezometer elevations, are presented in Fig. 5. Figure 6 is an approximate profile of the slope indicating the relative vertical positions of the piezometers and the groundwater levels.

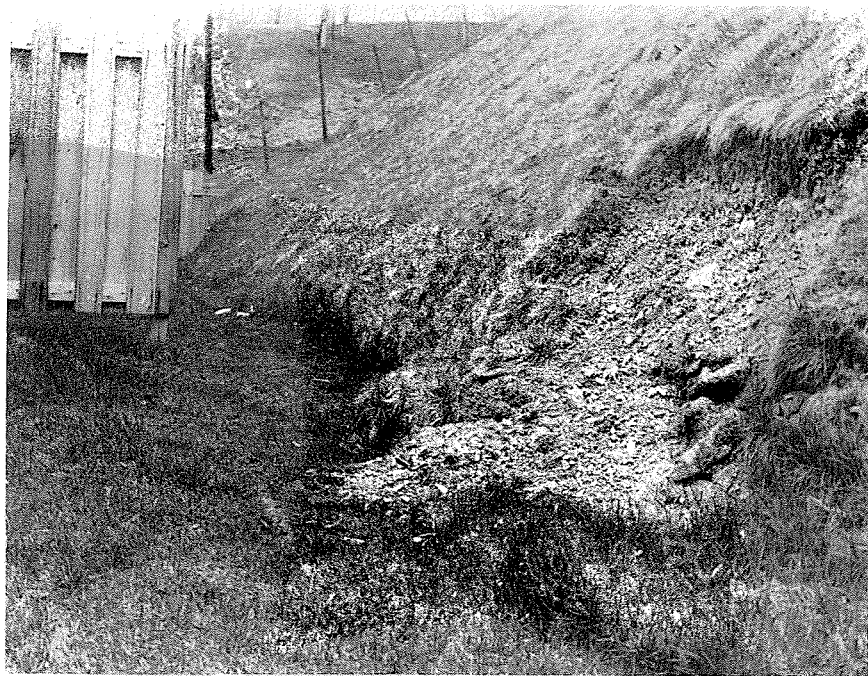
FIG. 8. Bulge at toe of slope behind row house 227 at 241 Le Coteau.

(3) Numerous tension cracks and one instance of bulge of the toe of the slope were observed. Figure 7 shows the tension crack that preceded the fourth landslide. Figure 8 indicates the bulging that occurred at the toe of a steeply graded slope immediately behind row house 227 at 241 Le Coteau St., which was not affected. These movements indicate active shear in the slope which did not result in full failure.
