# Spectroscopic Approach for the On-Line Monitoring of Welding of Tanker Trucks

**Abstract:** The appearance of defects during the manufacture of tanker trucks via arc-welding is a significant problem in the industry. A reliable low-cost and non-destructive on-line method could aid the discovery of solutions to overcome productivity problems. Plasma optical spectroscopy was employed in this study to correlate the presence of several elemental emission lines with certain quality-related events, such as the appearance of porosities. Results obtained through field trials and also during in-line production show that the convenient processing of acquired process signals facilitates not only the detection of defects, but also the identification of their causes. Output monitoring signals have been compared with X-ray inspections of the seam welds performed. It has been demonstrated that the spectroscopic monitoring variables obtained are good indicators for evaluating contamination in the process and therefore the occurrence of welding defects.

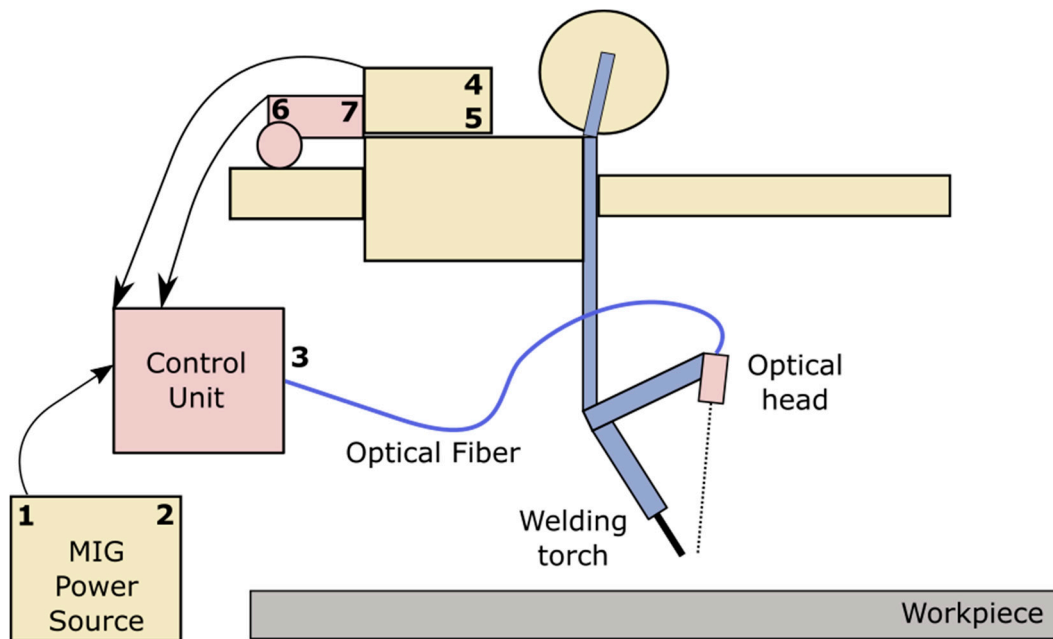
**Figure 1.** Schematic representation of the designed welding monitoring system incorporating the following sensors: (1) welding voltage, (2) welding current, (3) plasma optical spectroscopy-based, (4) protection gas flow rate, (5) wire feed speed, (6) welding speed and position and (7) temperature and humidity sensors.

The main sensor of the system is based on plasma optical spectroscopy and is complemented with traditional sensors to monitor the electrical, mechanical or environmental parameters of the process. Figure 1 is a scheme of the monitoring system, including the plasma optical spectroscopy-based system, as well as the welding voltage and current (closed loop Hall effect), wire feed speed (encoder-based, 800 pulses per revolution), protection gas flow rate (with temperature compensation), welding speed and position (encoder-based, 800 pulses per revolution) and ambient temperature and humidity sensors. The welding process has been illustrated in Figure 2.

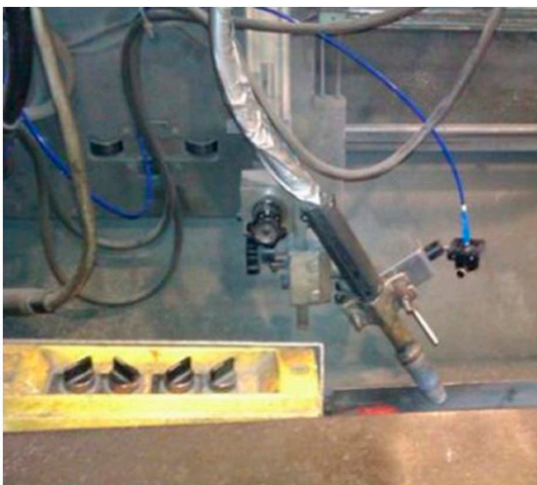
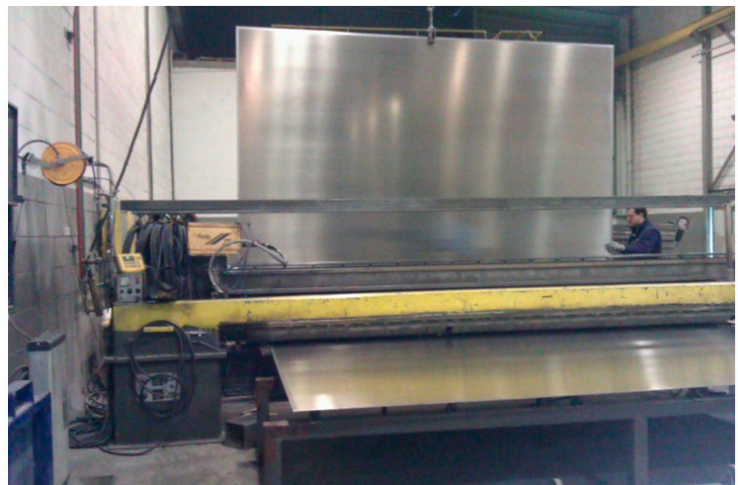
**Figure 2.** Images of the MIG welding process of Al-Mg alloy sheets. (a) Detail of the welding torch and the optical fiber used during the trials. (b) Preparation of the sheets before the welding process.

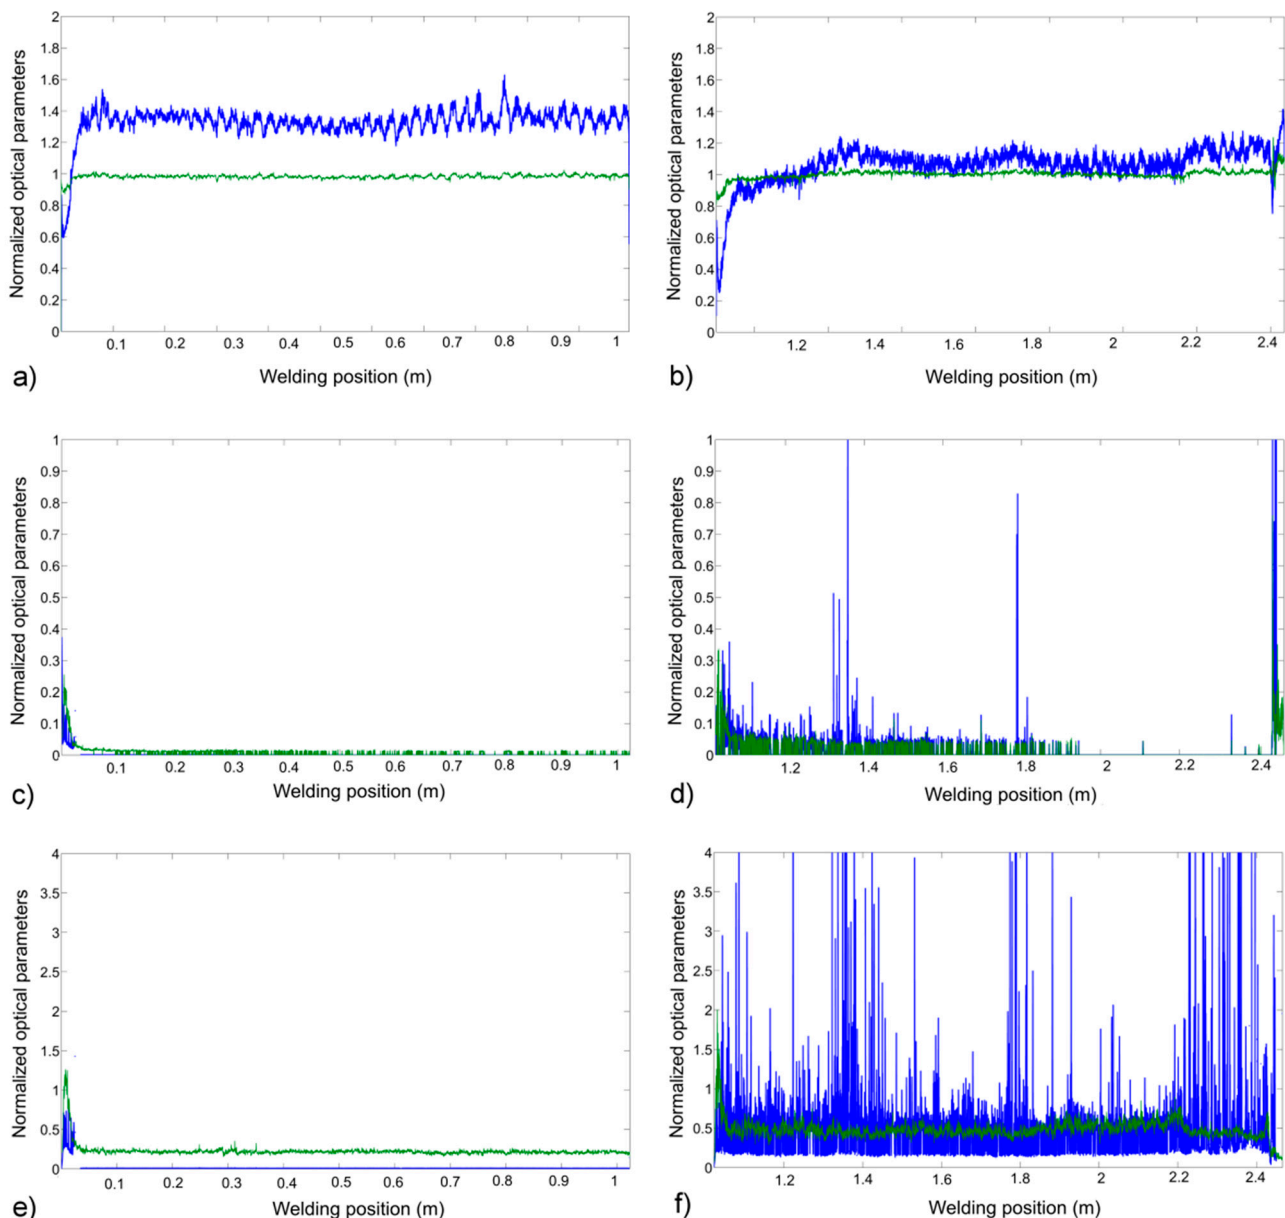
**Figure 3.** Output monitoring profiles for Weld Trials #1 and #2 using different spectroscopic parameters. Plasma RMS signal (thick blue line) and color temperature (thin green line) associated with (a) Trial #1 and (b) Trial #2. Ratio of H I line (656 nm) to Al I line (396 nm) (thick blue line) and 670 nm (thin green line) associated with (c) Trial #1 and (d) Trial #2. Ratio of Na I line (589 nm) to Al I line (396 nm) (thick blue line) and 670 nm (thin green line) associated with (e) Trial #1 and (f) Trial #2.

Figure 3a depicts the plasma RMS and color temperature profiles associated with both seams. It can be observed that, although there are some subtle variations, especially in Trial #2, the presence of defects is not clearly indicated by perturbations in these signals. This situation changes when H lines are employed to generate the output profiles. In Figure 3c,d, the ratio of the H I (hydrogen neutral atom) (656 nm) line to the Al I line at 396 nm is used. It is worth noting that, in this case, a clear difference appears between the results derived from weld Trials #1 and #2. The higher contribution of the H I line in Trial #2 seems to be correlated with the appearance of porosities in the seam detected by the X-ray inspection. Finally, Figure 3e,f show similar analyses, though using the ratio of Na I (589 nm) to Al I (670 nm). Again, the higher Na I contribution can be correlated with the detected porosities.

In terms of the study derived from Figure 3, an interesting analysis can be performed with Trials #7 and #9 and the results shown in Figure 4. The former trial was performed with a lower protection gas flow rate (reduced from 22 to 20 L/min), and a dry compressed air torch was employed at the end of the seam to simulate a greater perturbation in the process. Trial #9 was designed to study the influence of process speed in the process dynamics: a higher speed was applied at the beginning, then it was reduced, and in the last half of the seam both water and oil were applied in the seam backing. Figure 4 presents the results derived from the analysis of Trial #7 and the final section of Trial #9, associated with contaminants in the weld backing. Regarding Trial #7, it might be expected that the H I contribution should be significant, considering the gas flow rate reduction. However, it seems that 20 L/min, although 2 L/min under the standard gas flow rate, is a sufficient

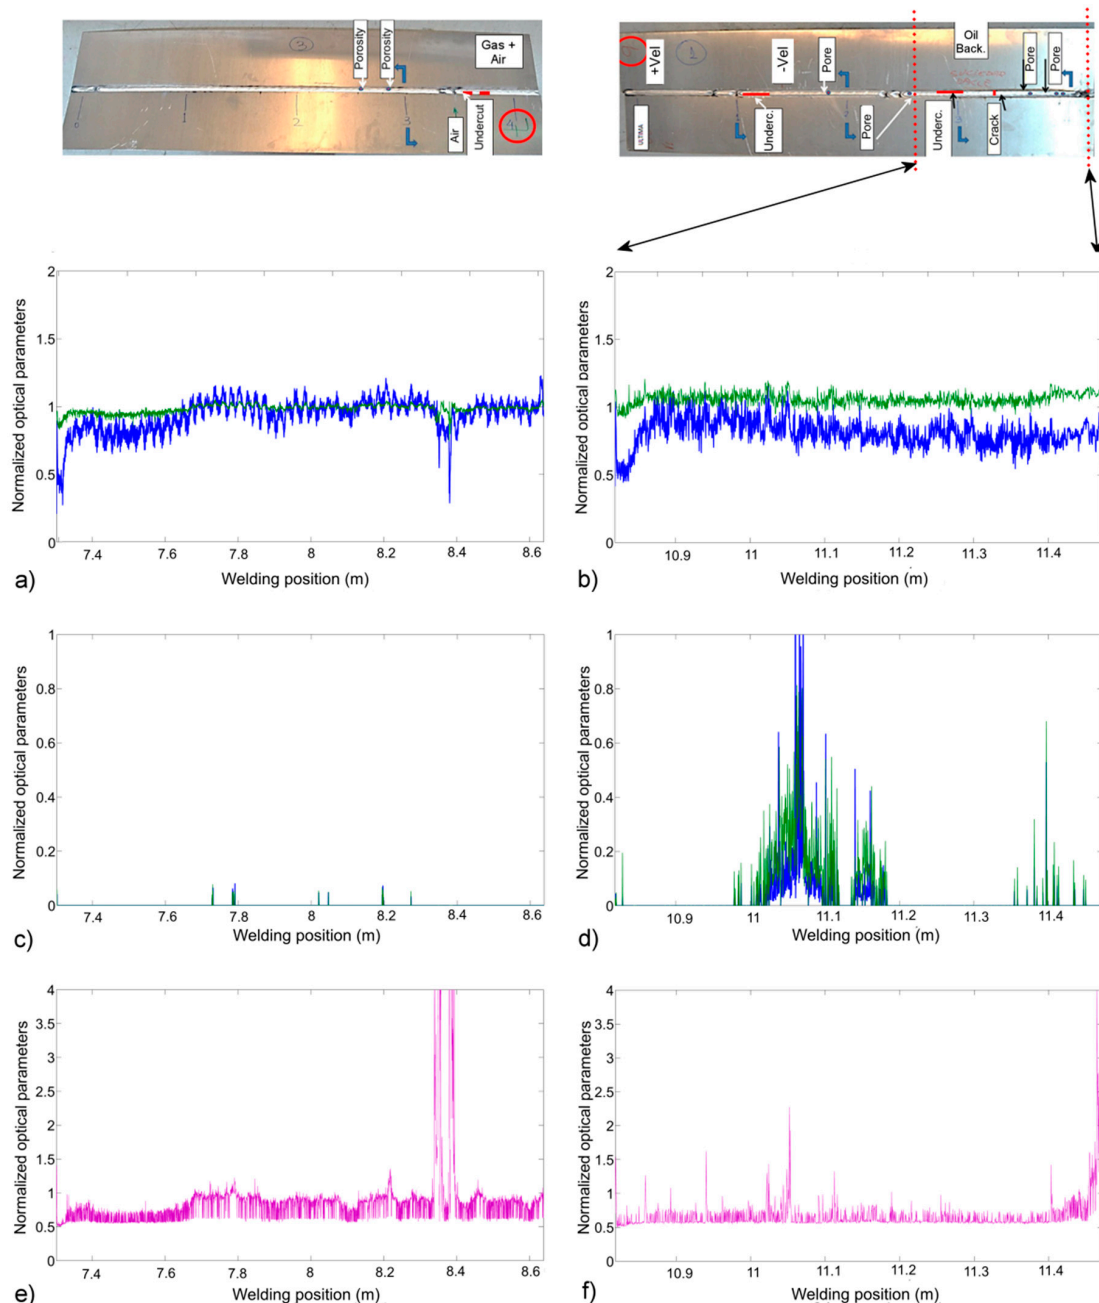
**Figure 4.** Output monitoring profiles for Weld Trials #7 and #9 (final part) using different spectroscopic parameters. Plasma RMS signal (thick blue line) and color temperature (thin green line) associated with (a) Trial #7 and (b) Trial #9. Ratio of H I line (656 nm) to Al I lines at 396 nm (thick blue line) and 670 nm (thin green line) associated with (c) Trial #7 and (d) Trial #9. Ratio of Ar I line (738 nm) to Ar I (763 nm) lines associated with (e) Trial #7 and (f) Trial #9.

level to ensure the protection of the pool, and the H I participation depicted in Figure 4c is significantly lower than the one discussed in Figure 3d. However, the H I profile does not indicate the occurrence of the defect provoked by the use of the dry compressed air at the end of Seam #7. On the contrary, the plasma RMS and color temperature (Figure 4a) and the ratio of the Ar I line (738 nm) to the Ar I line (763 nm) profiles give rise to the identification of a clear event at  $x \approx 8400$  mm. (It is worth mentioning that the x-axis has been sequentially generated for all the weld trials, i.e., Trial #1 goes from 0 to 1000 mm, #2 from 1000 to 2400 mm, and so on.)

This result is backed by the X-ray inspection (Figure 4, top-right), where the undercut close to the end of the seam is associated with the use of compressed air. Note that defects indicated by the radiographic analysis and their locations have been indicated over the seam under analysis. There are also two isolated porosities around  $x \approx 8200$  mm whose identification is not so clear (although there is a peak in Figure 4e), but in this case the H I profile does not indicate contamination of the process. Figure 4d, however, shows high levels of H participation in the process, thus supporting the X-ray detection of several defects in the associated seam, leading to the conclusion that the employment of oil and water in the process backing gave rise to clear contamination and, consequently, a defective seam. In this case, the Ar profile (Figure 4f) also exhibits some peaks that can be correlated with the quality-related events presented in Figure 4d.

Please note that the images of the seams at the top of Figure 4 (and also Figure 6) are presented at a scale that does not correspond to the associated graphs. These images, with the indications of the welding quality-related events, are intended to provide a better understanding of the trials and the associated results.

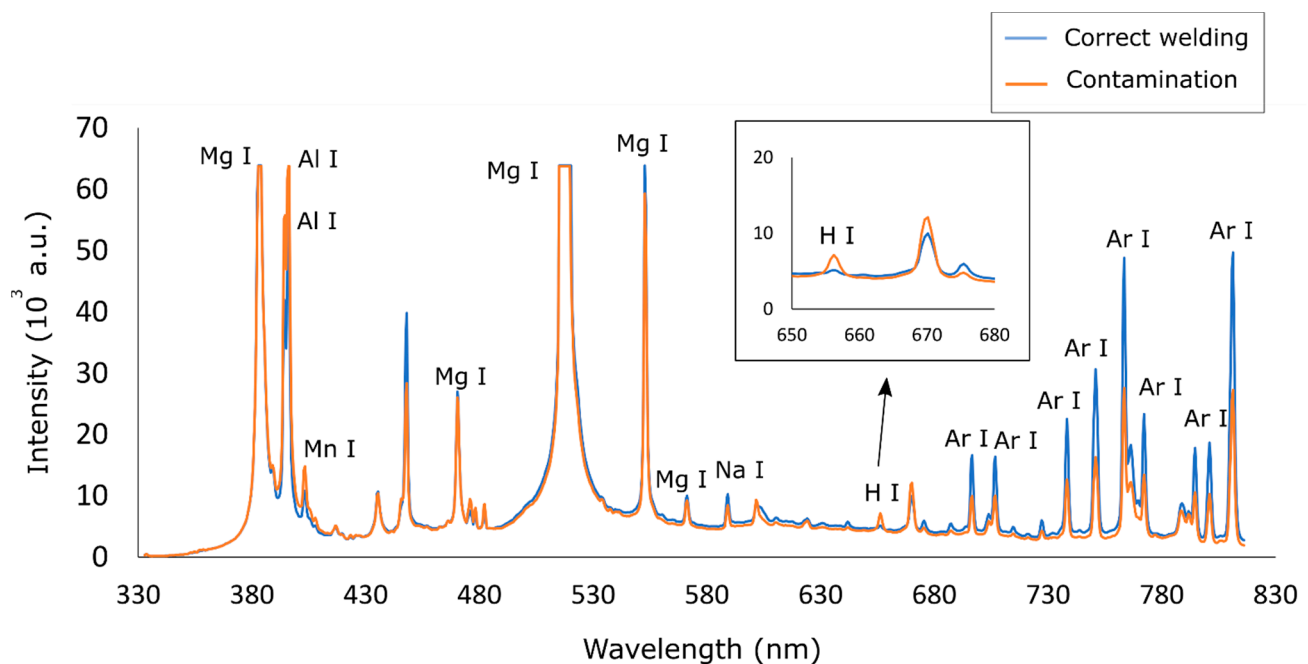
**Figure 5.** Welding spectra captured during Weld Trial #9: spectra associated with correct welding (blue line) and process contamination (orange line). Inlay: detail of the variation in the intensity of the H I line at 656.2 nm.

Spectra captured during Weld Trial #9 are shown in Figure 5. In particular, a comparison is shown between a spectrum associated with a section of correct welding and a spectrum from a section where contamination occurred. It can be observed that the contamination gave rise to an increase in the H I line at 656.2 nm (see detail in the inlay), while clear decreases are shown in the intensities of the Ar I lines located between 695 and 811 nm. This behavior agrees with the results provided in Figure 4. It can be observed how some of the emission lines overlapped due to the limited resolution of the low-cost spectrometer chosen. However, this resolution does not compromise a suitable spectroscopic analysis for the required monitoring purposes.

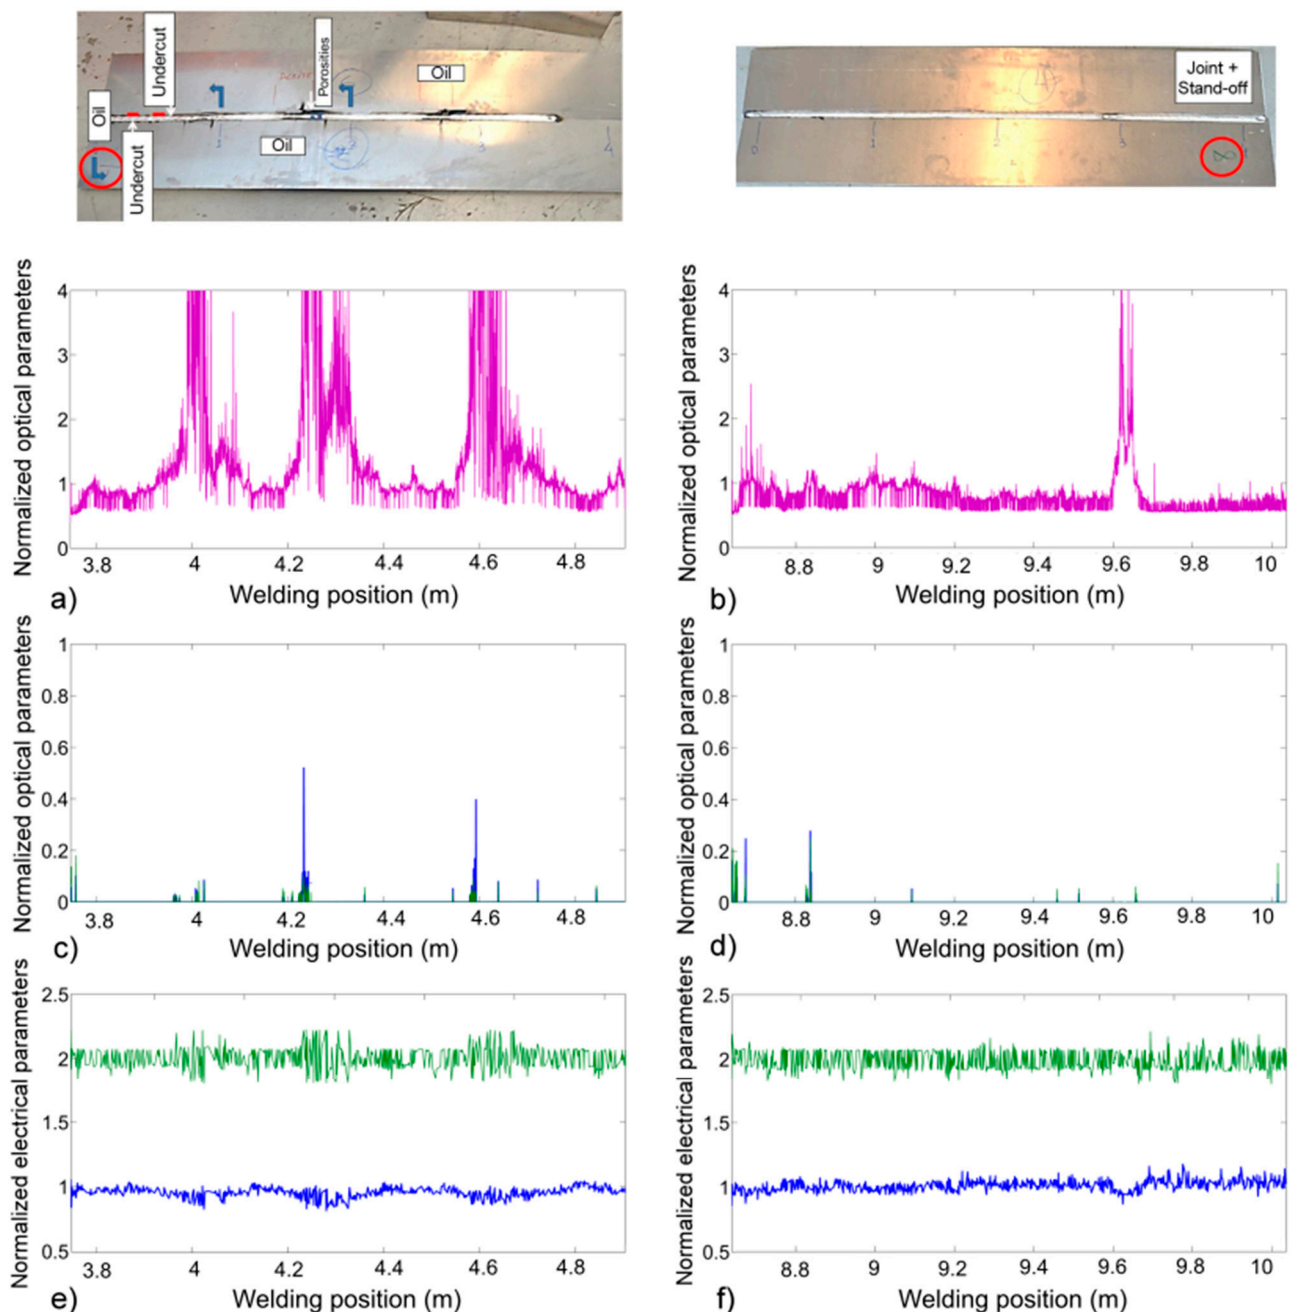
**Figure 6.** Output monitoring profiles for Weld Trials #4 and #8 using different spectroscopic and electrical parameters. Ratio of Ar I line (738 nm) to Ar I (763 nm) line associated with (a) Trial #4 and (b) Trial #8. Ratio of H I line (656 nm) to Al I lines at 396 nm (thick blue line) and 670 nm (thin green line) associated with (c) Trial #4 and (d) Trial #8. Welding voltage (thick blue line) and current (thin green line) associated with (e) Trial #4 and (f) Trial #8.

with quality-related events. For example, Figure 6e presents the welding voltage and current profiles for Weld Trial #4, where oil was used at the top of the joint to simulate a lack of cleanliness. A visual inspection of the seam (Figure 6, top-left) clearly revealed the effects of the oil during the process. Specifically, the Ar I profile depicted in Figure 6a exhibited a trend with a good correlation with the visual defects to be found in the seam. Both the welding voltage and current also exhibited some perturbations matching these events (Figure 6e).

A less clear situation can be studied in Figure 6b,d,f. In this case, the trial was designed to analyse the effects of joint preparation and variations in the stand-off distance employed in the process. Curiously, the X-ray inspection did not detect any defect, but a “burnt” is clearly visible at  $x \approx 9600$  mm. Both the Ar I (Figure 6b) and the voltage (Figure 6d) profiles show perturbations at this location—more evident in the optical analysis. It is worth mentioning that, in this case, the HI profile did not exhibit any correlation with this event.

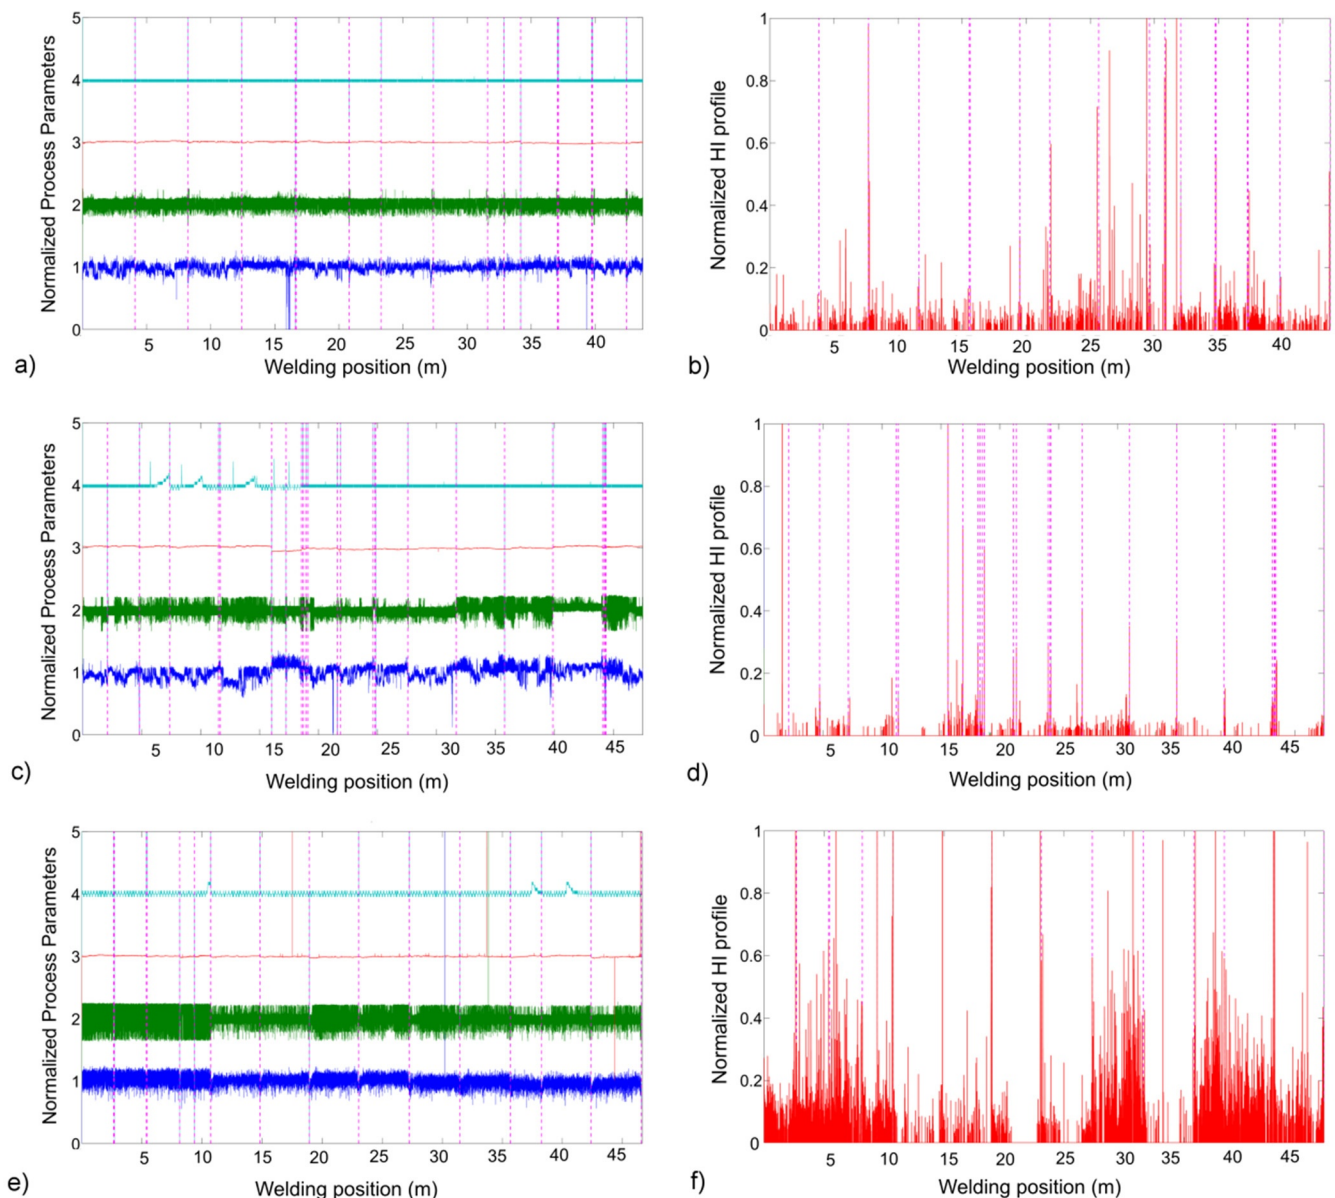
**Figure 7.** Output monitoring profiles for Tankers #1, #2 and #3. (a) Welding voltage (blue), current (green), gas flow rate (red) and wire feed speed (light blue) for Tanker #1. (b) Ratio of H I line (656 nm) to an average of the Al I lines profile for Tanker #1. (c) Welding voltage (blue), current (green), gas flow rate (red) and wire feed speed (light blue) for Tanker #2. (d) Ratio of H I line (656 nm) to an average of the Al I lines profile for Tanker #2. (e) Welding voltage (blue), current (green), gas flow rate (red) and wire feed speed (light blue) for Tanker #3. (f) Ratio of H I line (656 nm) to an average of the Al I lines profile for Tanker #3.

Figure 7 depicts the results derived from the analysis of the seams associated with three different tankers developed on different days. Each tanker is formed by up to 14 different seams, with a total welding length of more than 45 m. The vertical dotted lines in the graphs indicate the separations between different seams, depicted sequentially. Figure 7b,d,f show the corresponding HI profiles which serve as indications of the occurrence of atmospheric contamination or porosities derived therefrom. It can be appreciated that the level of HI participation, calculated as the ratio of the integration of the HI line at 656 nm to an average of the Al lines identified in the spectra, increases from Tanker #2 to #1, and becomes quite significant for Tanker #3. Analysis of the X-ray inspections of these seams revealed a very good correlation, detecting several porosities for Tankers #2 and #3. In fact, an analysis performed a posteriori on the data acquired for the system indicated that the welding for Tanker #3 had been performed with a protection gas flow rate of 16 L/min, inferior to the standard value of around 20 L/min, which explains the high contamination that can be seen in Figure 7f. It is also interesting to point out how in this case (Figure 7e) the electrical parameters, both the welding current and voltage, exhibit a noisier profile in comparison to the rest of the seams. Figure 7a,c,d present the welding voltage ( $y \approx 1$ ), current ( $y \approx 2$ ), gas flow rate ( $y \approx 3$ ) and wire feed speed ( $y \approx 4$ ) for these three tankers, with their corresponding values normalised to allow a suitable representation.

It is also remarkable how, in spite of the low contamination detected, the voltage and current profiles are quite unstable in Figure 7c for Tanker #2. This might be explained by reference to other defects, such as lack of penetration, that were detected in this case by the X-ray inspection.

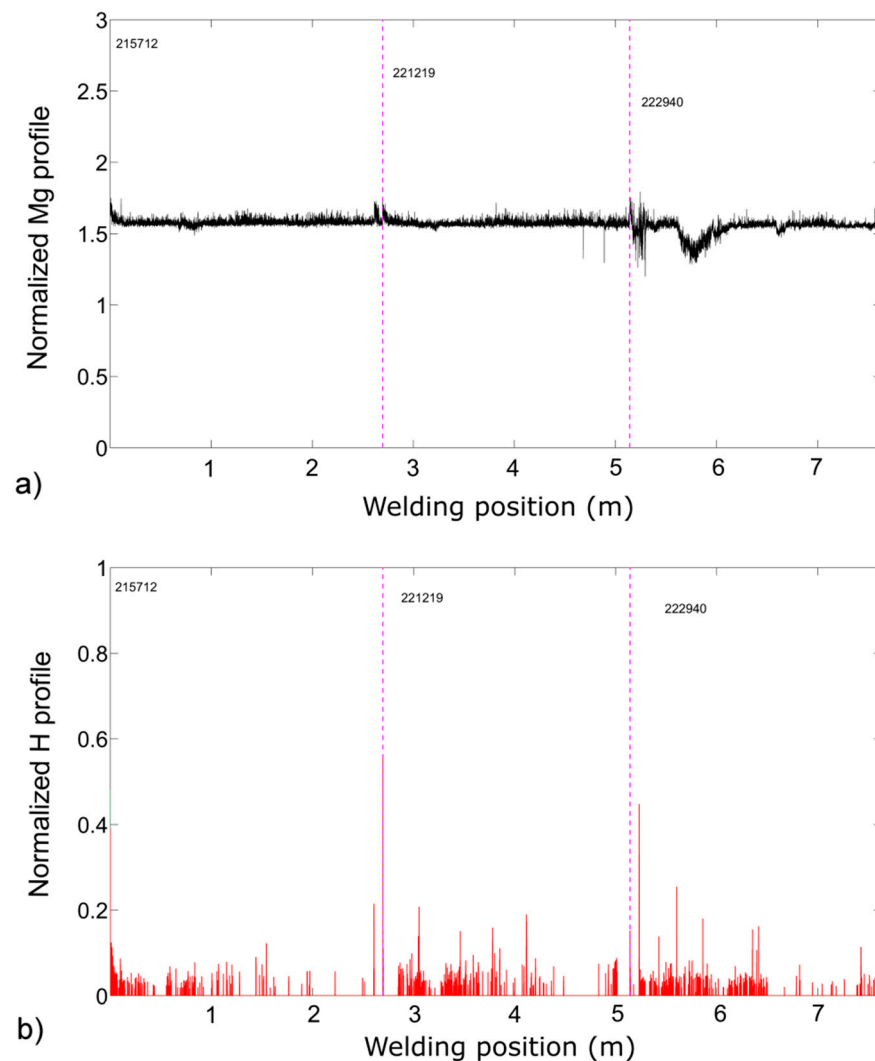
**Figure 8.** Output monitoring profiles for Tanker #2, seams 215712, 221219 and 222940. (a) Ratio of Mg I (553 nm) to an average of the Mg lines profile for the three seams. (b) Ratio of H I (656 nm) to an average of the Al I lines profile for the three seams.

Although the occurrence of defects apart from porosities is low, Figure 8 presents an example of a crack detected via X-ray in Seam #222940 (Tanker #2). As already discussed, while H profiles are suitable to detect the appearance of porosities, other defects might not be reflected in them. In this example, the level of H participation is quite similar in these seams, but there is no clear indication of the mentioned crack. The Mg profile, calculated as the ratio of the integrated value of the Mg I line at 553 nm to an average of the detected Mg lines, shows a clear dip associated with the location of the crack detected by means of the X-ray inspection.
