State of Maintenance in Relation to Property Regime, Tenancy and Uses of a Large Sample of Residential Buildings Located in the Most Vulnerable Areas of the City of Barcelona

Sara Vima-Grau¹, Còssima Cornadó² and Pilar Garcia-Almirall³

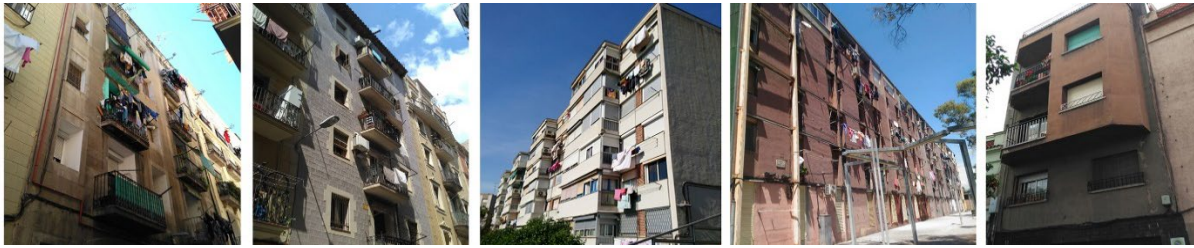
Figure 1. Different type of buildings of the five analysed neighbourhoods. From left to right: El Raval, La Barceloneta, Ciutat Meridiana, El Besòs and Trinitat Vella.

This paper presents a cross-analysis of data of a total sample of 2434 buildings located in five of the previously studied vulnerable neighbourhoods that are selected for their very diverse characteristics. El Raval (1119/1685 analysed buildings) and La Barceloneta (737/1074 buildings) are central neighbourhoods with a historic urban tissue with mainly constructions of the XIX century. Ciutat Meridiana (54/78 buildings) and El Besòs (188/281 buildings) are peripheric neighbourhoods in the north and south of river Besòs and consist of a modern urban tissue with mainly open block and tower constructions built between 1950 and 1975. Trinitat Vella (345/592 buildings) is also a peripheric neighbourhood built in the same period, but its urban tissue consists of attached constructions between party walls conforming a closed urban block (Figure 1).

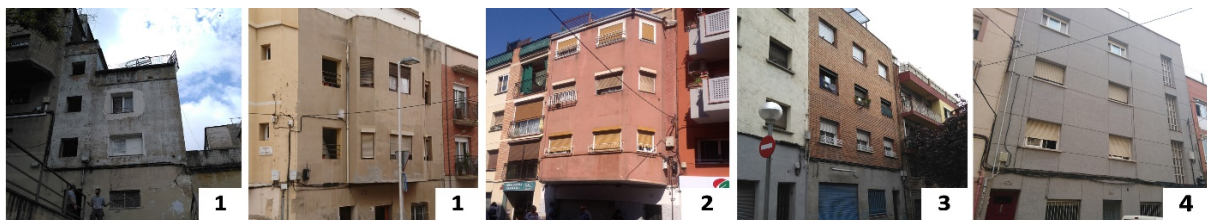
Figure 3. Fieldwork images of buildings with different results the need of rehabilitation indicator.

Secondly, this paper presents qualitative and quantitative indicators to statistically analyse the state of maintenance and conservation of the building stock: a qualitative indicator that describes the need of rehabilitation of the building stock obtained in a campaign of fieldwork (Cornadó *et al.*, 2017) (Figure 3), a quantitative indicator of the superposition of the previously described damages within one single building (Cornadó *et al.*, 2017), and finally a quantitative indicator of the existence of administrative requirements and orders of conservation provided by the Council of Barcelona (Garcia-Almirall *et al.*, 2017).

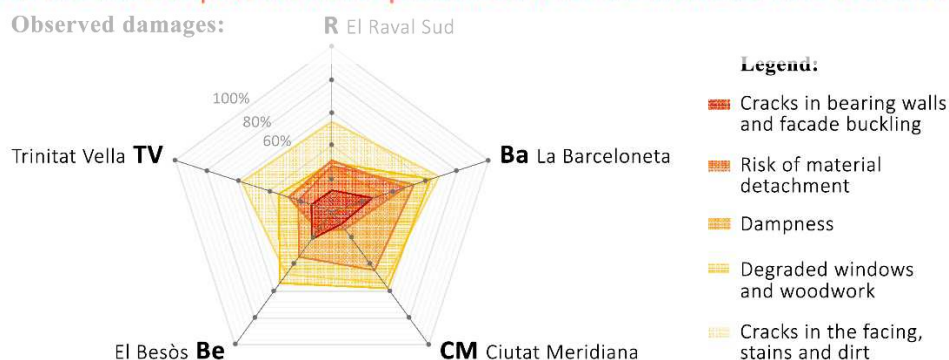
Figure 4. Proportion and distribution of observed damages.

The graphic in Figure 4 presents the distribution and relevance of the different observed damages in the total sample of studied buildings according to each neighbourhood:

The most abundant observed damages are those that are strictly related with a lack of ordinary and extraordinary maintenance actions: cracks in the facing, stains and dirt, as well as damages in windows and woodwork and carpentries. Their proportion according to neighbourhood varies between 55-68%. The proportion of cases with dampness is still quite relevant and a little bit more variable among neighbourhoods: between 50% in La Barceloneta

and Ciutat Meridiana, 30% in El Besòs and El Raval, and 20% in Trinitat Vella. There is a considerable number of cases with risk of material detachment, particularly in La Barceloneta (near the 50%), and still importantly in El Raval and Trinitat Vella (around the 30%), while it is very low in El Besòs and Ciutat Meridiana (15%). Finally, the proportion of cases presenting damages of mechanic structural origin such as cracks in the bearing walls is a lot lower and it presents high variability from La Barceloneta and el Besòs, the locations with a highest percentage (25%), to Ciutat Meridiana (10%). The graphic in Figure 5 presents the distribution of three groups of indicators that are classified in four levels in order to assess the state of maintenance of the whole sample:

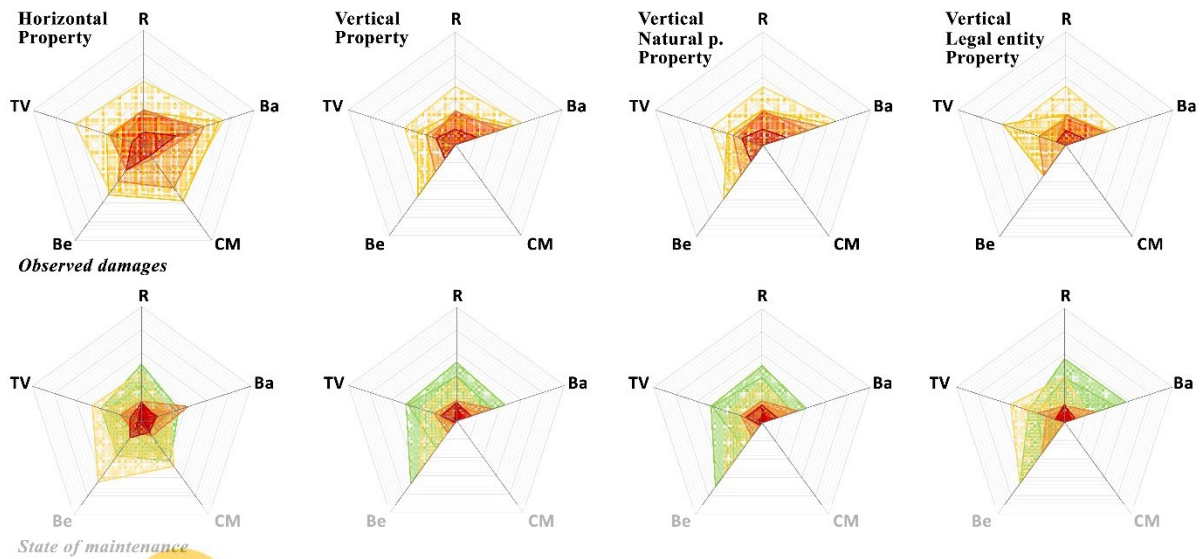
Figure 6. Proportion of observed damages and the state of maintenance in relation to property regimes.

The cross-analysis of the distribution of damages and the indicators of the state of maintenance according to different property regimes is presented in Figure 6. The proportion of observed damages within cases of horizontal property is slightly higher if compared to the results of the full sample in Figure 4, and clearly higher if compared to the results for cases with a vertical property regime. Besides, there is a clear decrease of the proportion of cases presenting damages of mechanic structural origin as well as risk of material detachment for vertical properties. More particularly, vertical juridical properties clearly present lower percentages of all types of damages in comparison to vertical physical properties.

Regarding quantitative and qualitative indicators of the state of maintenance and conservation of the building stock, similar results can be observed. The proportion of cases presenting an adequate state (Level 4) is clearly inferior for horizontal properties. Vertical properties include a much higher percentage of buildings in an adequate state, particularly in El Besòs, and most specifically in the case of vertical properties owned by of La Barceloneta. Instead, vertical properties owned by natural persons in Trinitat Vella concentrate the major number of cases with an adequate state. Regarding the poorest state of maintenance and conservation, the proportion of cases is more elevate for horizontal properties in all studied neighbourhoods and it is particularly lower in the case of vertical juridical properties in la Barceloneta and El Besòs.

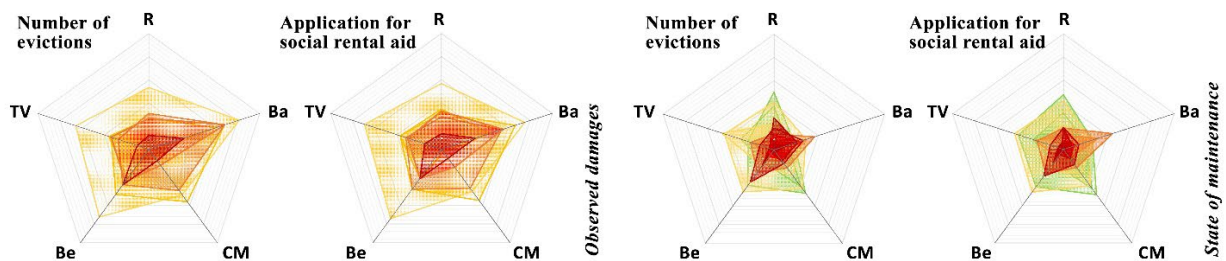
Figure 7. Proportion of observed damages and state of conservation according to risk of residential exclusion.

In comparison to the results presented in Figures 4 and 5, Figure 7 clearly shows how the proportion of observed damages and the proportion of cases with a lower state of maintenance is much higher for those buildings in which the resident community has faced eviction processes in the last years. Results according to buildings in which many residents apply for rental social aid are very similar. This observation is particularly clear in La Barceloneta, El Besòs and Trinitat Vella, while it is also significant in El Raval and Ciutat Meridiana.
