## STATIC CYCLIC TESTS ON URM WALL BEFORE AND AFTER RETROFITTING WITH COMPOSITES

M. ElGawady<sup>1</sup>, J. Hegner<sup>2</sup>, P. Lestuzzi<sup>3</sup>, M. Badoux<sup>4</sup>

### Abstract

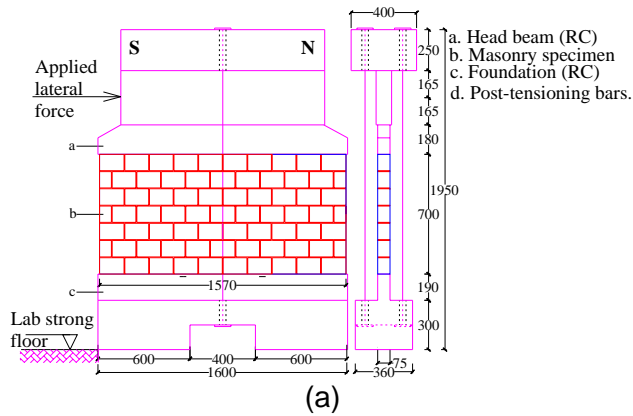
Figure 1 Specimen (a) dimensions [mm], and (b) ready to test

The test specimens are representative of an unreinforced clay masonry wall in the upper floors of a typical Swiss building of the 1950's. Half-scale squat masonry walls were built by experienced masons using half-scale hollow clay masonry (HCM). The walls were constructed in a single wythe, in a running bond pattern with a mortar joint of 5 mm thickness, which is consistent with the half scaled bricks. The nominal dimensions of the walls are 710 mm height, 1570 mm length, and 75 mm width. Both the head beam and foundation pad were pre-cast concrete. The main geometric features of the constructed walls are illustrated in Figure 1.

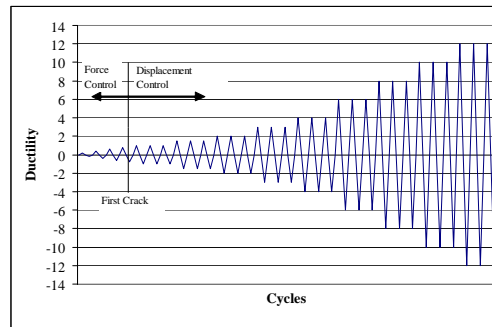
Figure 3 Loading sequence

The predefined sequence of displacements was similar to that proposed in the ICBO (1997). At first cracking, the measured relative displacement at wall top was used to mark the “first yield displacement”. As shown in Figure 3, at each ductility level the specimens were subjected to three complete cycles.

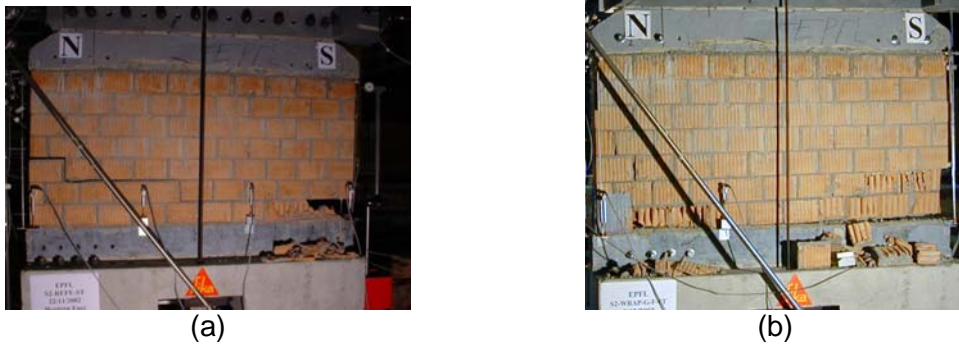
Figure 5 Specimens (a) S2-REFE-ST and (b) S2-WRAP-G-F-ST (unreinforced face) at the test end

Table 2 presents a summary of the test procedure, the measured lateral forces, and drifts for selected test runs. Figure 5 to Figure 7 show the observed damage to the test specimens during and at the test end. In order to determine sliding between the masonry panel and the r.c. foundation, Figure 8 shows a comparison between the total displacement (i.e. the relative displacement between the wall top and foundation pad) and the relative displacement between wall top and the first brick course. The vertical

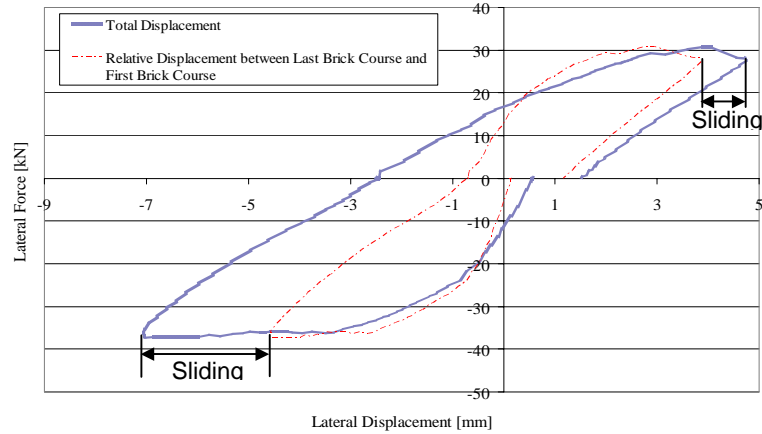
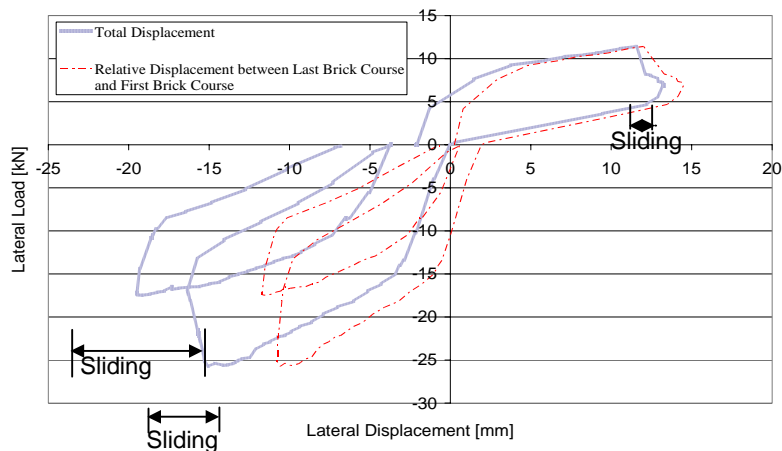
Figure 8 Measured sliding between masonry panel and r.c. foundation during test runs (a) 66, 67 for S2-REFE-ST, and (b) 57 to 59 for S2-WRAP-G-F-ST

- During test runs 66 and 67, sliding occurred with deformation concentrated through the first bed joint. The sliding was about 1 mm in the south-north direction and 2.5 mm in the north-south direction (Figure 8(a)).

- During test runs 58 and 59, sliding occurred with deformation concentrated through the first bed joint (i.e. between the masonry wall and its foundation). The sliding was about 7 mm in the south-north direction and about 1mm in the north-south direction (Figure 8 (b)).

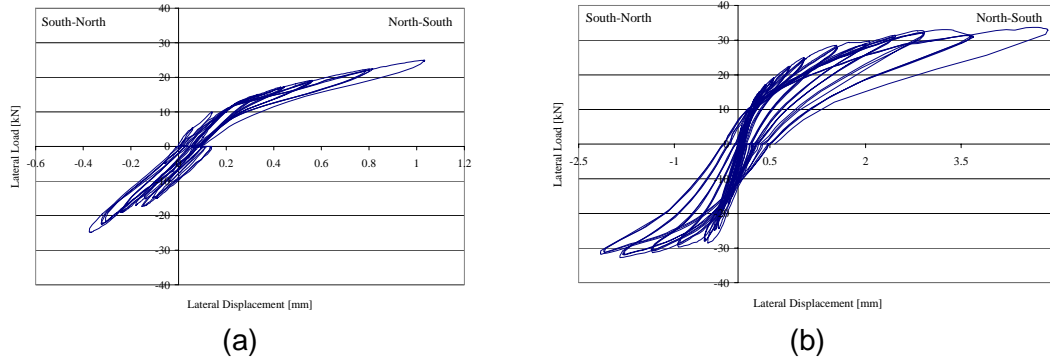
Figure 9 Specimen S2-REFE-ST, lateral forces vs. relative wall displacement until (a) test run 30, and (b) test run 65

- During test run 30, a first flexural crack formed in the second bed joint at southern side (Figure 9(a)). The crack propagated towards northern side during subsequent test runs (Figure 6 (b)).

- During test runs 45 to 52, a significant flexural crack (Figure 6(c)) extended between the fourth and third bed joints happened.
- During test run 65, the specimen displayed a characteristic rocking (Figure 9(b)) and a first toe vertical compressive crack happened in the southern side.

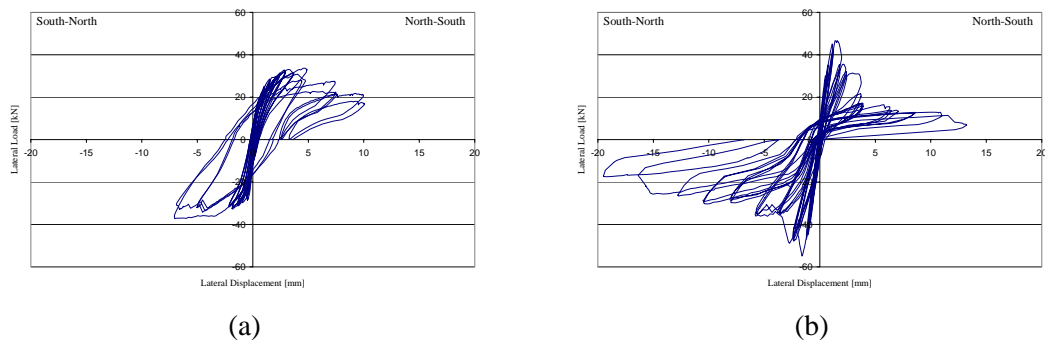
Figure 11 Lateral forces vs. relative top wall displacement for (a) S2-REFE-ST, and (b) S2-WRAP-G-F-ST

Figure 11 shows the hysteretic behavior of each test specimen. The axes are the relative horizontal displacement between the top and base of the masonry wall and the
