Kannan, M.B.; Dietzel, W.; Blawert, C.; Atrens, A.; Lyon, P.:
**Stress corrosion cracking of rare-earth-containing magnesium
alloys ZE41, QE22 and Elektron 21 (EV31A)
compared with AZ80**

In: Materials Science and Engineering A (2007) Elsevier

Stress corrosion cracking of rare-earth-containing magnesium alloys ZE41, QE22, and Elektron 21 (EV31A) compared with AZ80

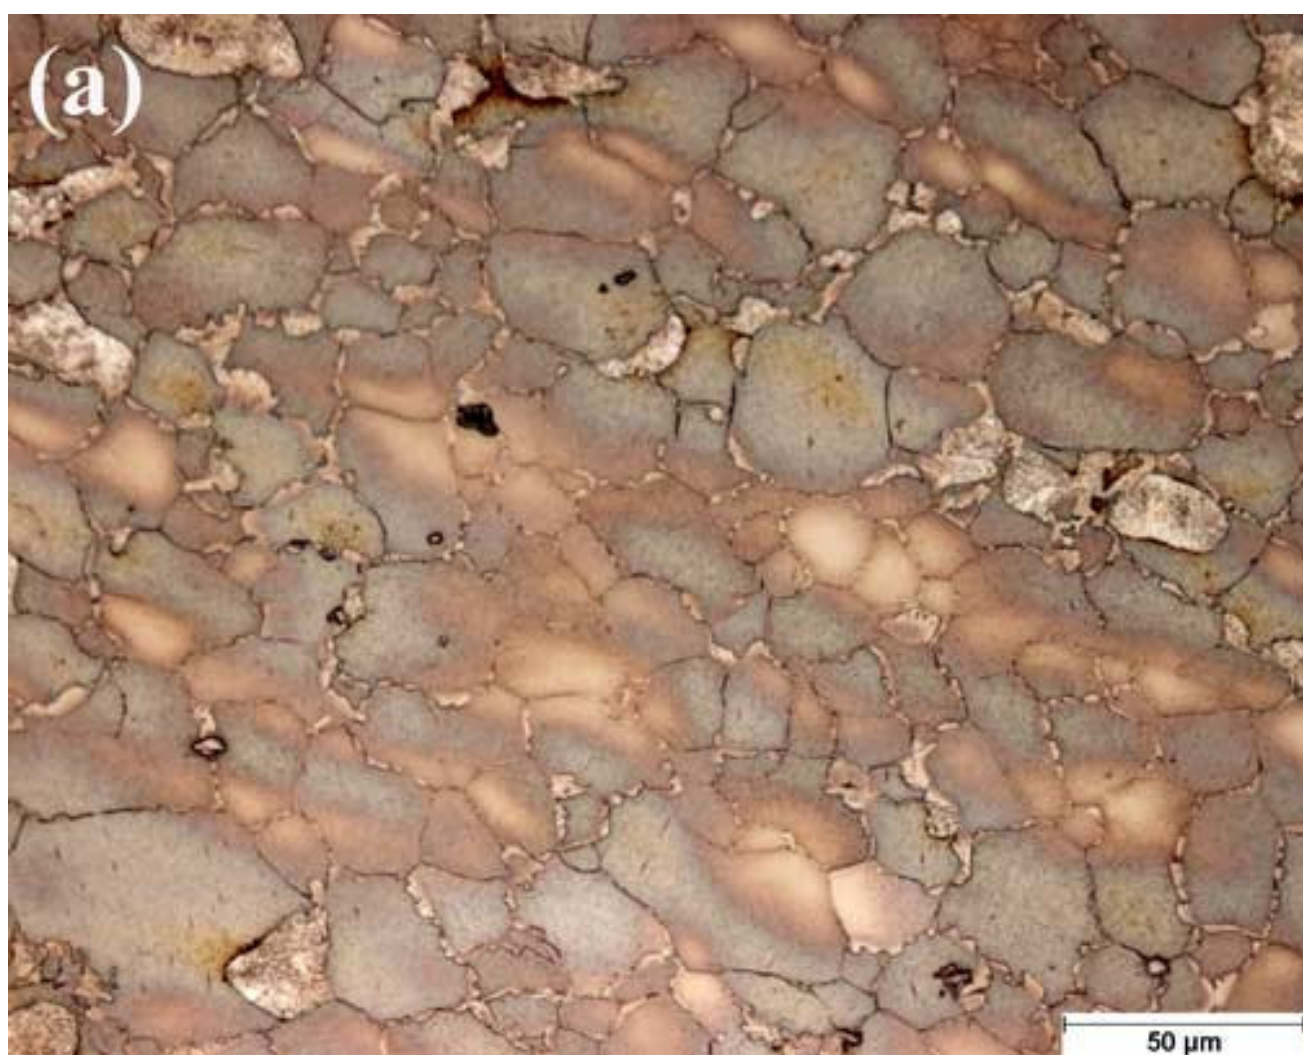
Fig. 2 a-d shows the optical microstructure of AZ80, ZE41, QE22 and EV31A. The micrograph of AZ80 shows α phase magnesium matrix with clusters of second phase particles particularly at the grain boundaries (Fig.2a). EDX analysis revealed that these are rich in magnesium and aluminium, which corresponds to $Mg_{17}Al_{12}$. Also some aluminium and manganese rich particles were observed, which corresponds to Al_8Mn_5 [31]. The micrograph of ZE41 shows second phase particles along the grain boundaries of the alloy (Fig.2b); in some regions there appears to be a continuous network of the second phase particles along the grain boundary. EDX analysis revealed that these particles are rich in magnesium and zinc with trace amount of rare earths. The micrograph of QE22 shows second phase particles decorated along the grain boundaries and precipitates inside the grain (Fig.2c). EDX analysis further revealed that the grain boundary particles are rich in magnesium, neodymium and silver, whereas the intragranular particles are rich in magnesium and zirconium. In a similar QE22 alloy, Lambri et al.[32] identified coherent hexagonal (Mg-Nd-Ag) and tetragonal (Mg-Nd) precipitates. The micrograph of EV31A shows a high density of fine second phase particles distributed inside the grains in addition to the few coarse precipitates in the grain boundaries (Fig. 2d). Here, the EDX analysis revealed that the grain boundary

particles are rich in magnesium, neodymium and zinc. Apps et al. [33] reported precipitates having a stoichiometric ratio of $Mg_5(Nd_{0.5}Gd_{0.5})$ in magnesium alloys containing neodymium and gadolinium (Mg- 7%Gd-2.25%Nd-0.6%Zr). Dirts et al.[11] suggested binary phases Mg_9Nd , Mg_7Zn_3 , $MgZn$ and ternary phases $MgNd_4Zn_5$, $Mg_6Nd_2Zn_7$, $Mg_2Nd_2Zn_9$ in Mg-Zn-Nd alloys containing up to 8 wt.% Zn and 3 wt.% Nd. The fine clusters of particles in the grain (Fig.2d) were found to be rich in magnesium, zinc and zirconium. Ben-Hamu et al. [10] also reported zirconium-rich fine cluster of intergranular particles in Mg-Y-RE-Zr alloy. These authors further reported that the cluster of precipitates does not contain rare earth (neodymium), and expected that these zirconium rich clusters could improve the strength of the alloy by dislocation-obstacle interaction mechanism, although the precipitates visible in Fig. 2d are probably too coarse to affect dislocation interaction.

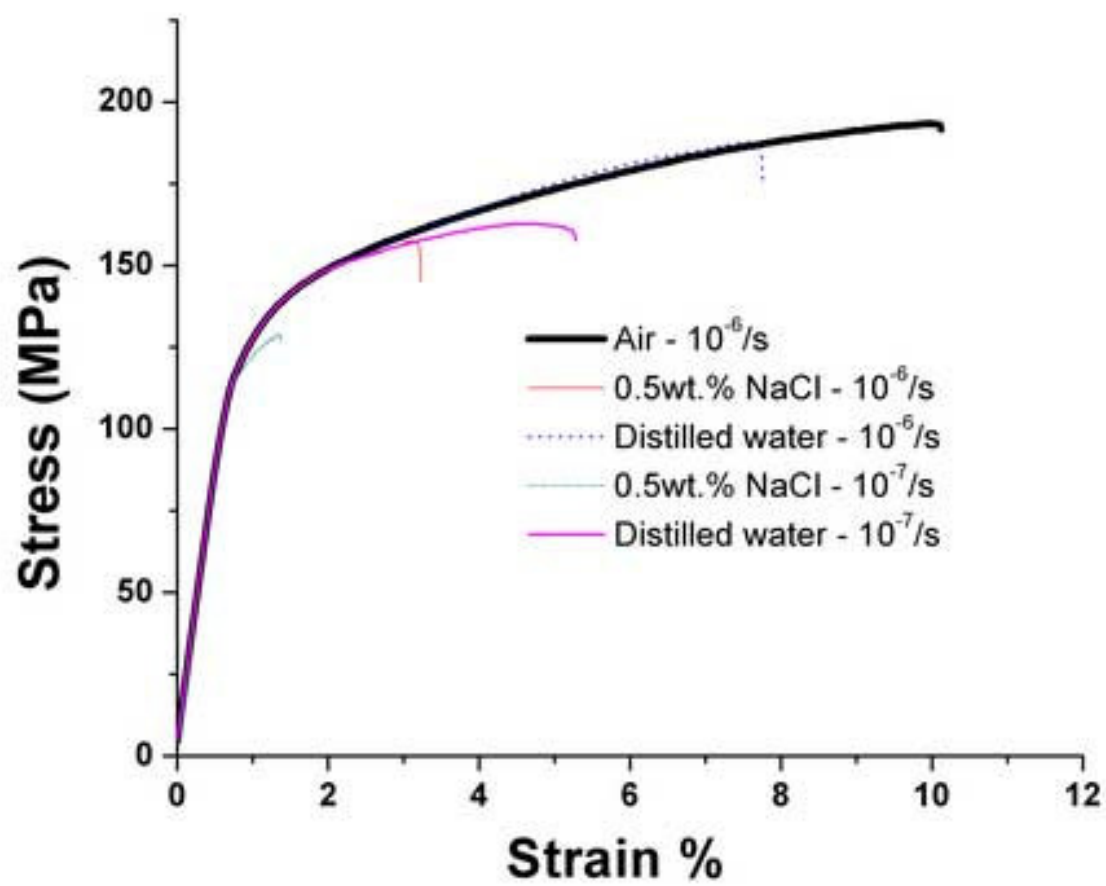
Figure 3b
[Click here to download high resolution image](#)

ZE41 when tested at a strain rate of 10^{-6} /s in air exhibited $\epsilon_f = 9$ % and UTS = 200 MPa (Fig.3b). At this strain rate, the tests in distilled water showed a slight decrease in the mechanical properties: $\epsilon_f = 8$ % and UTS = 190 MPa. However, in 0.5 wt.% NaCl solution the mechanical properties were significantly lower: $\epsilon_f = 3$ % and UTS = 160 MPa. The mechanical properties were the lowest when tested at a strain rate of 10^{-7} /s: $\epsilon_f = 5$ % and UTS = 160 MPa in distilled water and $\epsilon_f = 2$ % and UTS = 130 MPa when tested in 0.5 wt.% NaCl solution (Fig.3b, Table 4).

The stress-strain curves of AZ80, ZE41, QE22 and EV31A tested in air, and the apparent stress-strain curves in distilled water and in 0.5 wt.% NaCl solution at two strain rates i.e. $10^{-6}/s$ and $10^{-7}/s$ are presented in Fig. 3a- d. Mechanical property data of the four alloys in air are presented in Table 3, which includes comparison data in air at a strain rate of $10^{-4}/s$ and literature data. The summary of SSRT data of the four alloys tested in air, distilled water and in 0.5 wt.% NaCl solution is shown in Table 4. The mechanical property values reported herein from this study are an average of three test results.

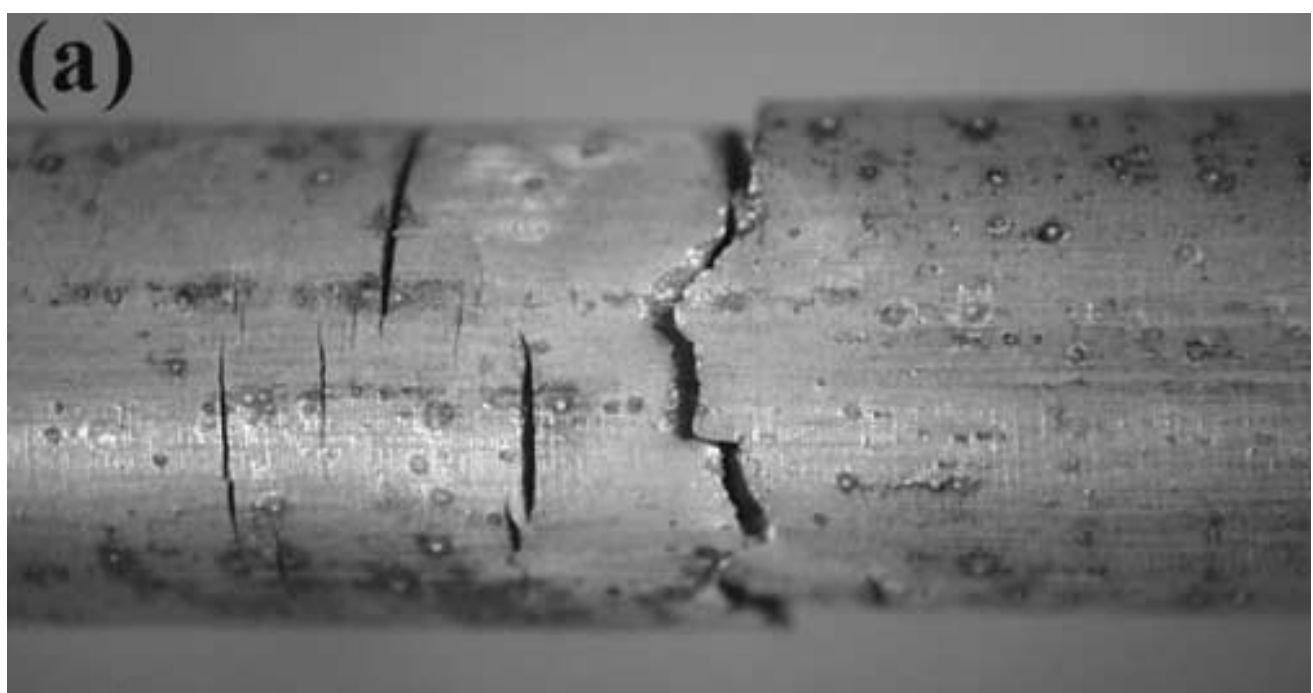
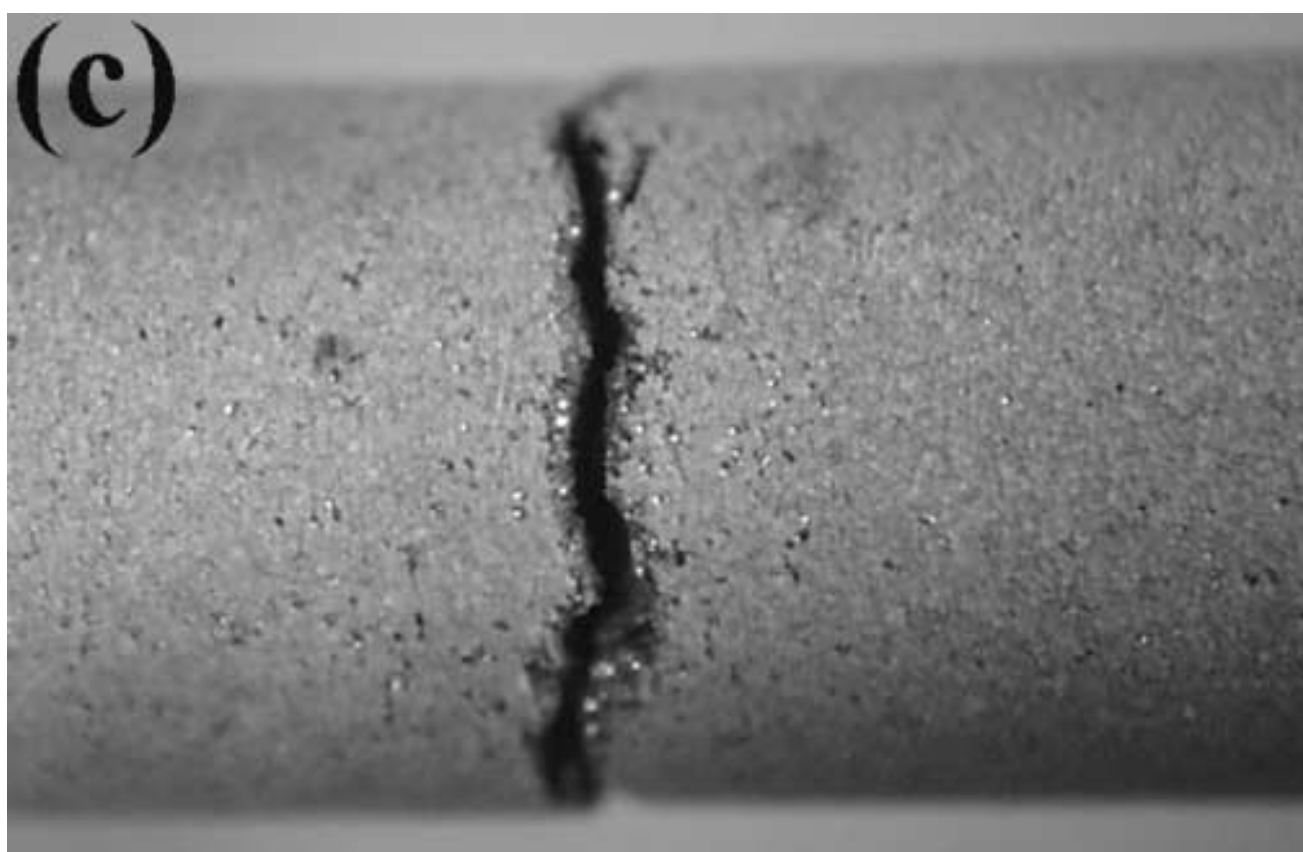
The macrographs of typical SSRT samples of all the four alloys after tests in distilled water and in 0.5 wt.% NaCl solution are shown in Fig. 4a-h. In distilled water, AZ80 did not undergo much corrosion; however there were many fine stress corrosion cracks throughout the gauge length (Fig.4a). In the 0.5 wt.% NaCl solution, the amount of corrosion was slightly higher than in distilled water (Fig.4b). The stress corrosion crack propagated along the fine streaks of second phase particles. ZE41 showed significant localized corrosion after the SSRT in 0.5 wt.% NaCl solution, significantly more than after the SSRT in distilled water (Fig.4 c, d). QE22 turned black in colour when tested in distilled water, with a high fraction of general corrosion (Fig.4e). In the 0.5 wt.% NaCl solution, QE22 exhibited significant localized corrosion and general corrosion (Fig.4f). EV31A showed relatively low uniform corrosion in distilled water, however no localized corrosion was observed. (Fig.4g). Similarly, in the 0.5 wt.% NaCl solution, EV31A showed uniform corrosion but no localized attack (Fig.4h).

Fig. 4 Macrographs of failed SSRT samples: in distilled water (a) AZ80, (c) ZE41 (e) QE22 and (f) EV31A; in 0.5 wt.% NaCl solution (b) AZ80, (d) ZE41 (f) QE22 and (h) EV31A.

The micrographs of the failed tensile samples show that QE22 and ZE41 have undergone more corrosion than AZ80. EV31A showed the highest resistance to corrosion of all four alloys. In AZ80, the corrosion was preferentially along the streak of β -precipitates and was much more prominent in the chloride containing solution. The corrosion along the precipitates could be expected because these precipitates are reported to be noble compared to that of the magnesium matrix [31]. The volta potential of β precipitates ($Mg_{17}Al_{12}$) was reported to be 152mV positive than the matrix [31]. In ZE41, the corrosion attack is higher than that of AZ80. Even though zirconium is present in ZE41, which is reported to be beneficial for corrosion resistance by reducing the iron content [10, 23], the zinc content (has negative effect on magnesium corrosion) [27] is quite high resulting in high corrosion. Moreover, it should be noted that the presences of rare earth elements has not improved the corrosion resistance of ZE41, even though it is often reported that rare earth addition to magnesium improves the corrosion resistance [20-24]. In QE22 alloy, even though neodymium is present which is reported to increase the corrosion resistance of the alloy [23, 34], the presence of silver had a very significant effect in promoting towards galvanic corrosion. Silver has a very high noble potential compared to magnesium [35] and hence can form micro-galvanic cells for the high corrosion attack. The corrosion attack was evident even in distilled water and was high in the chloride containing solution. In EV31A, the corrosion attack was minimum, probably the mixed oxide of the rare earth elements have protected the alloy surface from any corrosion attack. Ben-Hamu et al. [10] reported that the oxide film ($Mg-Me-O$ where Me is zirconium and neodymium) is more stable than the $Mg(OH)_2$ that magnesium produces in aqueous solution.

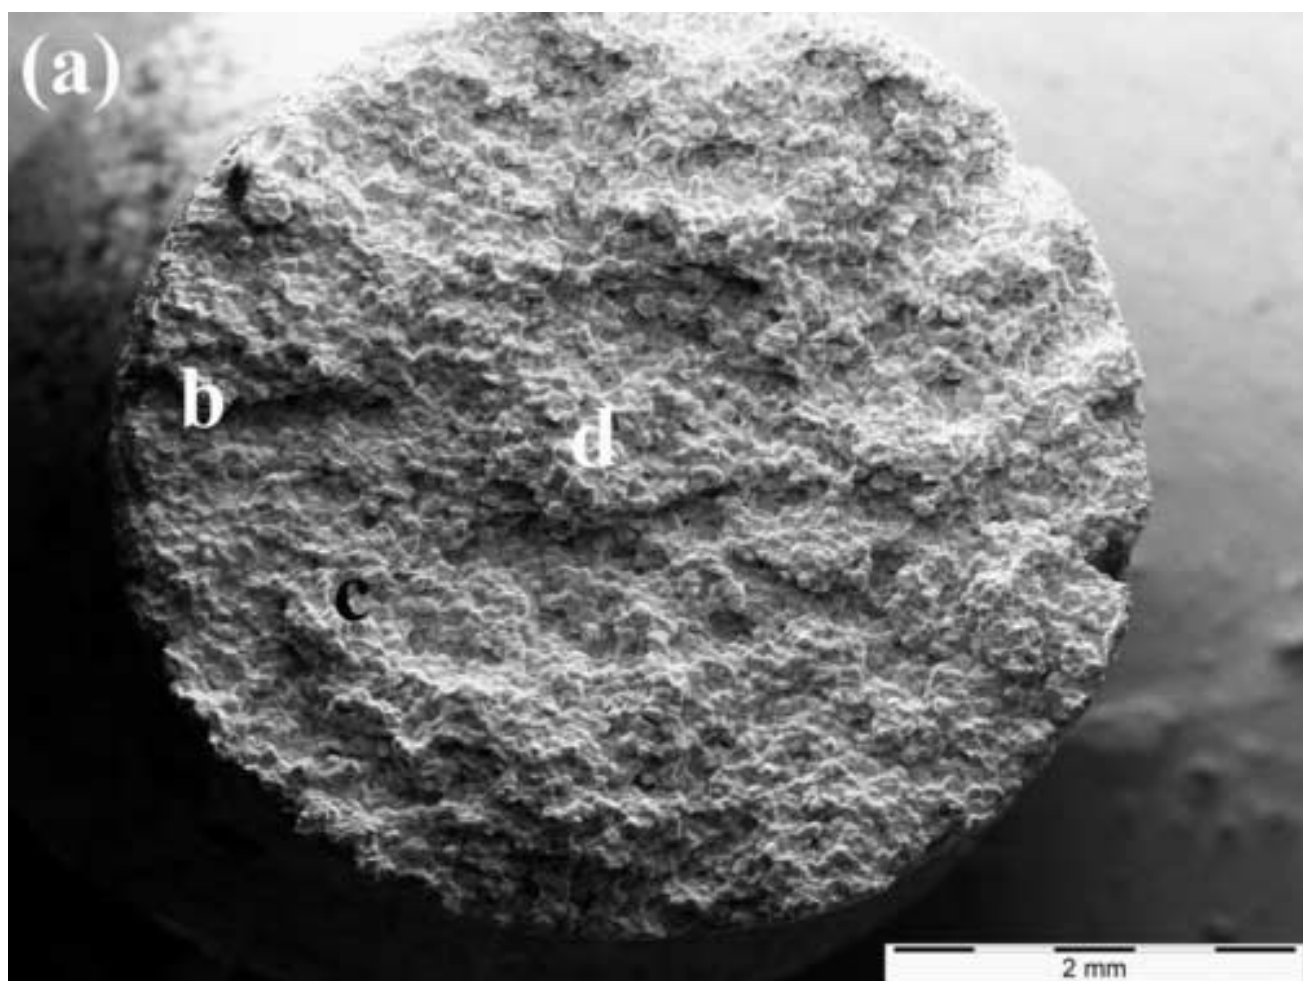
fracture modes there was considerable brittle fracture associated with the second phase particles. The fracture surface of ZE41 after SSRT in distilled water showed a generally smooth and undulated appearance, consistent with corrosion along the grain boundaries accelerated by micro-galvanic corrosion of second phase particles that formed a nearly continuous necklace along the grain boundaries (Fig. 9a- c). The grain boundary surfaces themselves appeared predominantly as if they had been chemically polished. There were isolated incidences of grain boundary attack into the plane of the fracture. An overview of the fracture surface of ZE41 after SSRT in 0.5 wt.% NaCl solution showed predominant brittle failure can be seen from Fig. 10a. Higher magnification showed that the fracture surface was consistent with dissolution of the grain boundary precipitates (Fig. 10b,c,d). There were only a few remnants remaining of the second phase particles remaining that were so evident on the fracture surface after SSRT in distilled water (Fig. 9b). The grain boundary surfaces appeared etched. There were also some isolated areas that could be consistent with transgranular brittle fracture (Fig. 10c).

Fig. 10 Fracture surfaces of ZE41 failed in 0.5 wt.% NaCl solution at 10^{-7} /s strain rate: (a) overview, (b), (c) and (d) shows predominant grain boundary corrosion.

by the second phase particles along grain boundaries. For IGSCC of EV31A and QE22 the fractography was consistent with micro-galvanic acceleration of the corrosion of α -magnesium by the second phase particles whereas it appeared that the second phase particles had themselves corroded in the case of ZE41 in chloride containing solution.

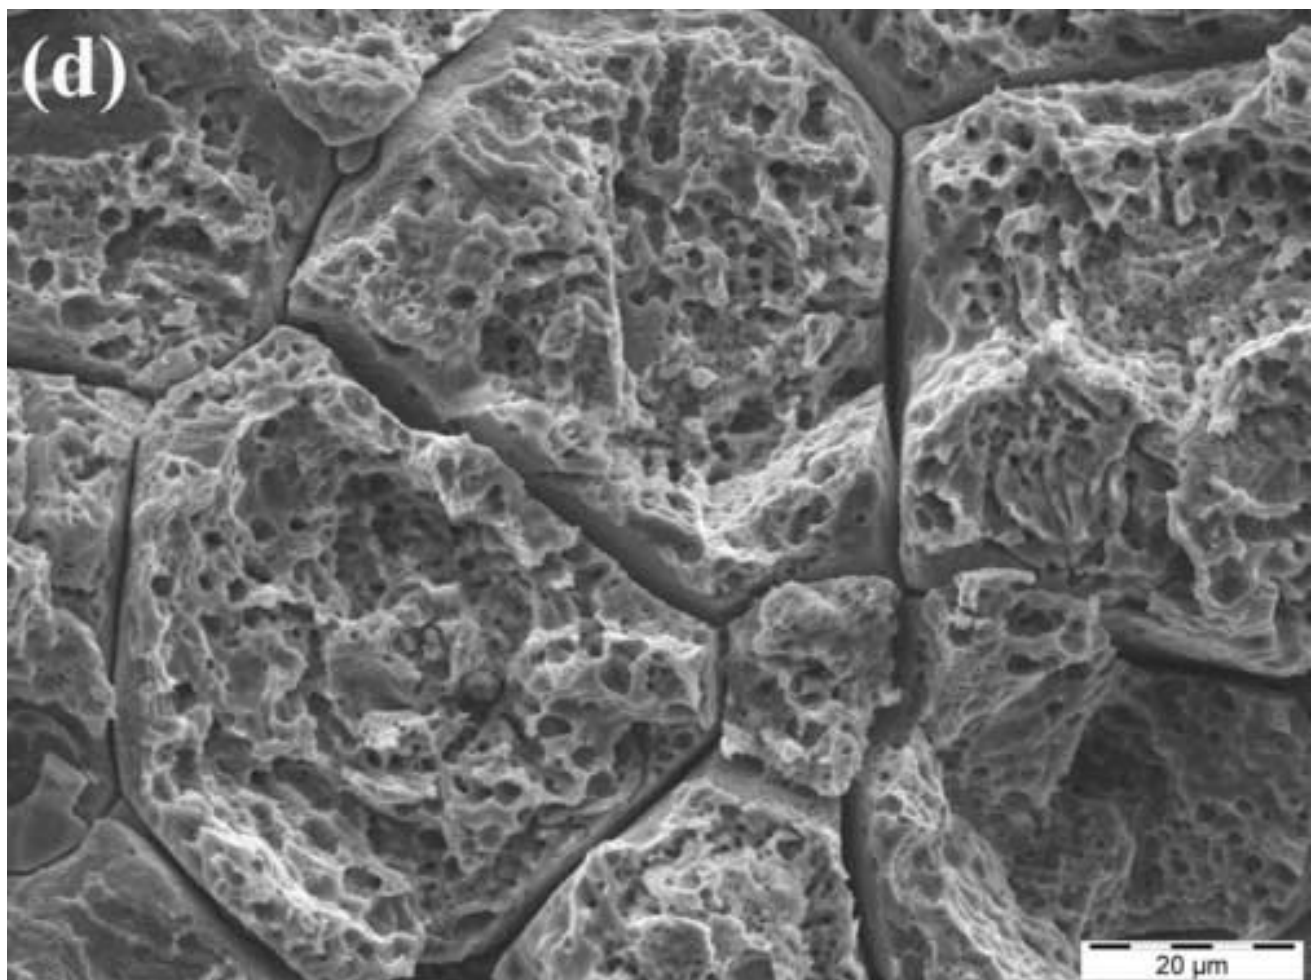
Typical fracture surfaces of EV31A after SSRT test in air at a strain rate of 10^{-6} /s, in distilled water and in 0.5wt.% NaCl solution at a strain rate of 10^{-7} /s are shown in Fig 14-16. Fig.14a shows an overview of the fracture surface of EV31A alloy after SSRT in air. Higher magnification showed a jumbled transgranular fracture surface containing (i) flat facets that may be associated with brittle fracture of a second phase particles, (ii) areas of dimple rupture and (iii) flat areas with some evidence of ductility (Fig.14b). The fracture surface of EV31A after SSRT in distilled water, showed similar fracture features containing ductile features as well as transgranular cracking (Fig. 15a-d). For EV31A after SSRT in 0.5 wt.% NaCl solution, the fracture mode was of mixed intergranular and transgranular nature (Fig. 16a-d). Fig. 16c shows clearly the intergranular nature of the fracture. Many features were consistent with the appearance of corrosion along grain boundaries. Other features were consistent with the corrosion of the grain on both sides of second phase particles extending a considerable distance along several grain boundaries, also with features consistent with the brittle fracture of this second phase particles. Considerable corrosion was observed on most of the

surfaces that appear consistent with grain surfaces, in some cases the appearance was consistent with a transgranular cracking (Fig.16d).

Fig. 16 Fracture surfaces of EV31A failed in 0.5 wt.% NaCl solution at 10^{-7} /s strain rate: (a) overview, (b) (c) and (d) shows mix-mode failure.
