NASA Technical Memorandum 102370

Structural Behavior of Composites With Progressive Fracture

STRUCTURAL BEHAVIOR OF COMPOSITES WITH PROGRESSIVE FRACTURE

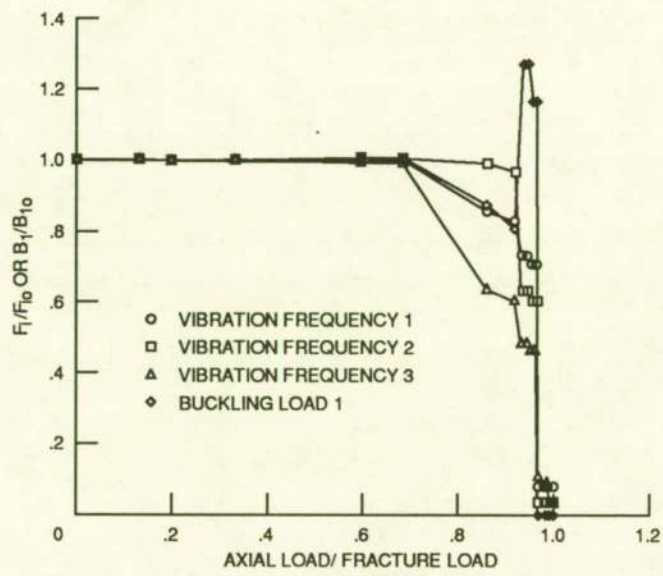
Figure 6.—Structural degradation for short plate; support condition 2.

Figure 6 shows the degradation of buckling load and natural frequencies for the same plate, but now simply supported on all four edges (support condition 2). The normalized plots for overall mechanical properties depicted in figure 6 are similar to those corresponding to support condition 1 (depicted in fig. 2). One significant difference is that the buckling load increases above the original undamaged value just before ultimate failure. This effect is caused by the fragmentation of the plate structural behavior under the combined influences of the buckling load and the boundary conditions. Because of local degradation, a partial flexural hinge forms at the center of the plate along the existing notch, effectively separating the plate into two halves from an elastic stability viewpoint. When the two halves of the plate behave independently, the buckling load is increased. Also, after a certain amount of loading, the second and the third vibration frequencies switch their mode shapes. These effects are examined further in later paragraphs with the help of the corresponding mode shape fringes.

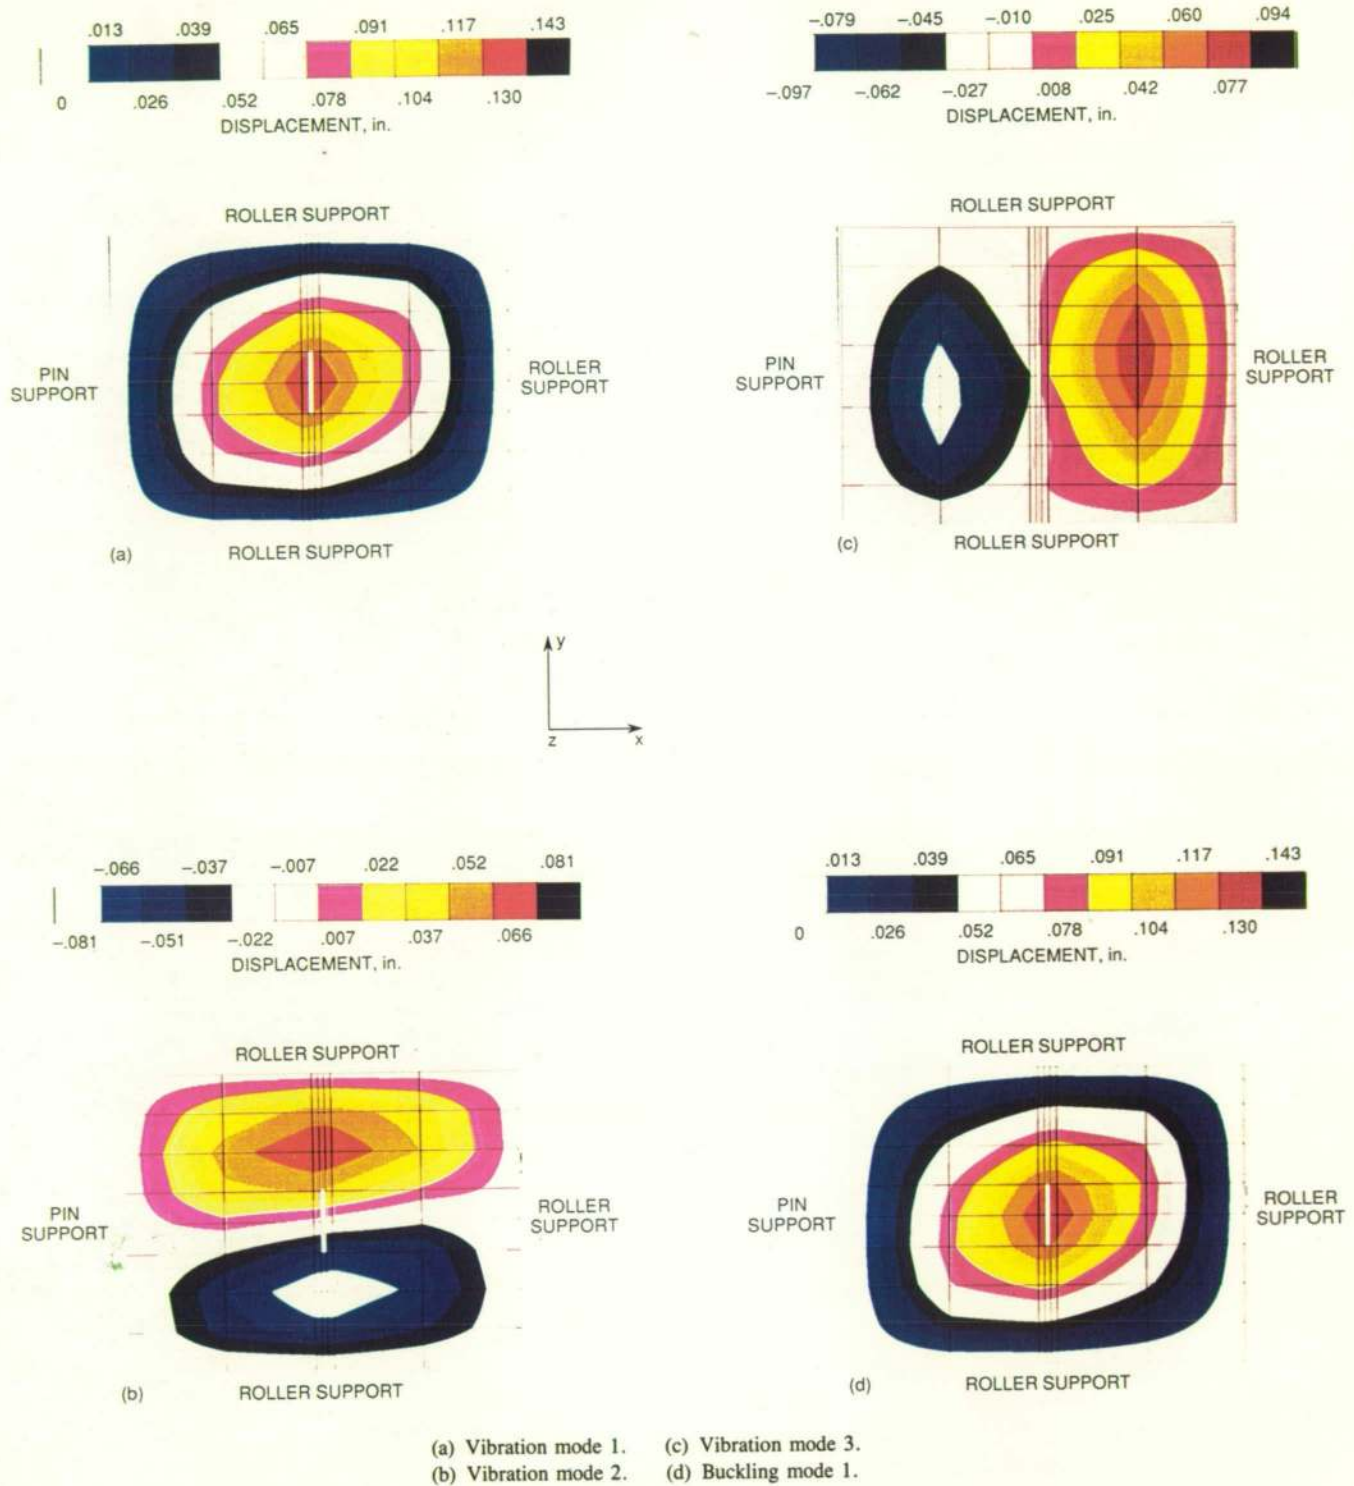
Figure 7.—Mode shape fringes before loading. Fracture load, 6082 lb; support condition 2.

Figure 7 shows the mode shapes for the first three free-vibration modes and the first buckling mode before loading. Because of the additional restraints at the boundaries for support condition 2, the mode shapes are more significantly affected by the boundary conditions. For that reason, the first vibration mode (fig. 7(a)) and the fundamental buckling mode (fig. 7(d)) are virtually identical, indicating that in this case boundary conditions, rather than external effects, have the controlling influence on structural behavior. It is also noteworthy that the second and the third vibration mode shapes are now more obviously affected by composite laminate fiber orientations that make the plate significantly more stiff in the axial direction. As a result and in spite of the transverse central notch in the plate, the vibration mode producing a transverse full wave, mode 2, is lower in frequency than the vibration mode producing a longitudinal full wave, mode 3. The mode 3 natural frequency is almost twice the mode 2 frequency.

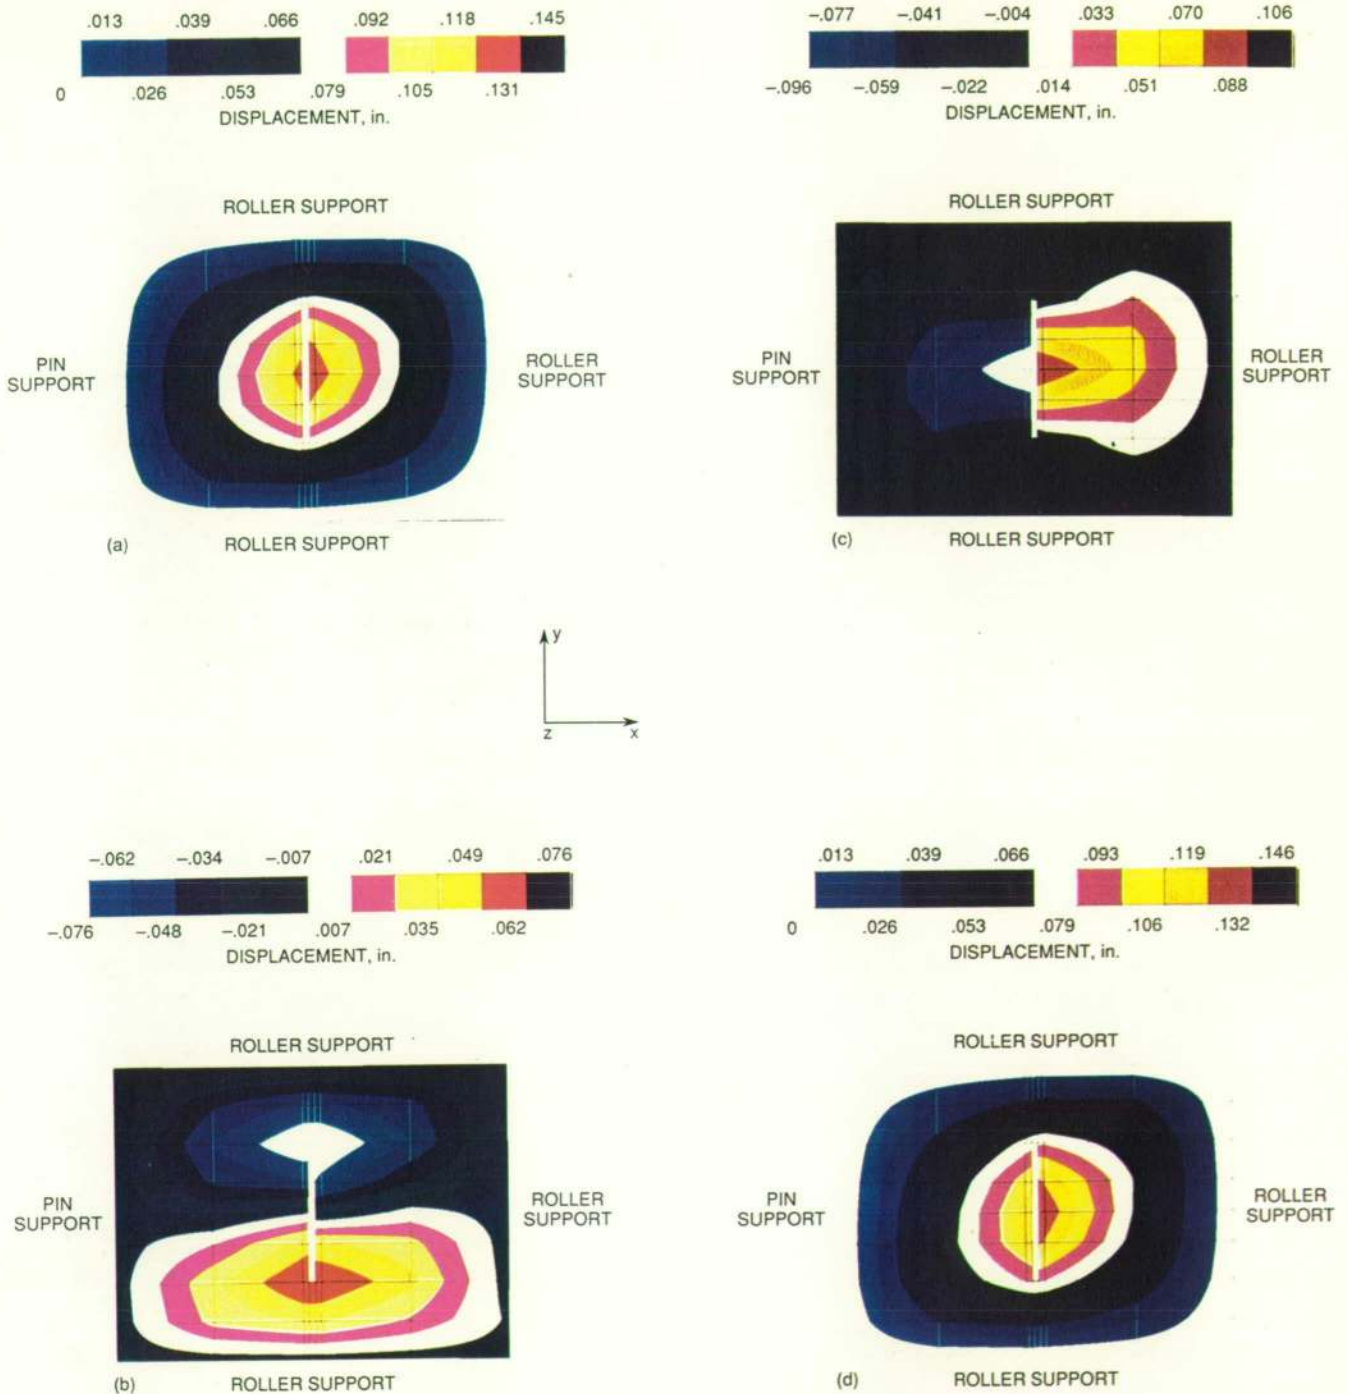
Figure 8.—Mode shape fringes after 91 percent loading. Fracture load, 6082 lb; support condition 2.

Figure 8 shows the same mode shapes for support condition 2, for 91 percent of the ultimate fracture load. At 91 percent of loading, the central notch extends in the transverse direction when the elements adjacent to the notch fail. There is some decoupling of the two sides of the plate separated by the notch as indicated by the reduction of modal symmetry across the center of the plate. This reduction in symmetry may be observed in vibration modes 1 and 3 and in the buckling mode. The overall mode shape configurations for the second and third free-vibration frequencies remain as they were prior to loading. There is some reduction in all three natural frequencies and the buckling load. However, because of the extension of the central notch, the third natural frequency is reduced more significantly than the second natural frequency; the vibration frequency of mode 3 is now only 18 percent higher than the vibration frequency of mode 2.

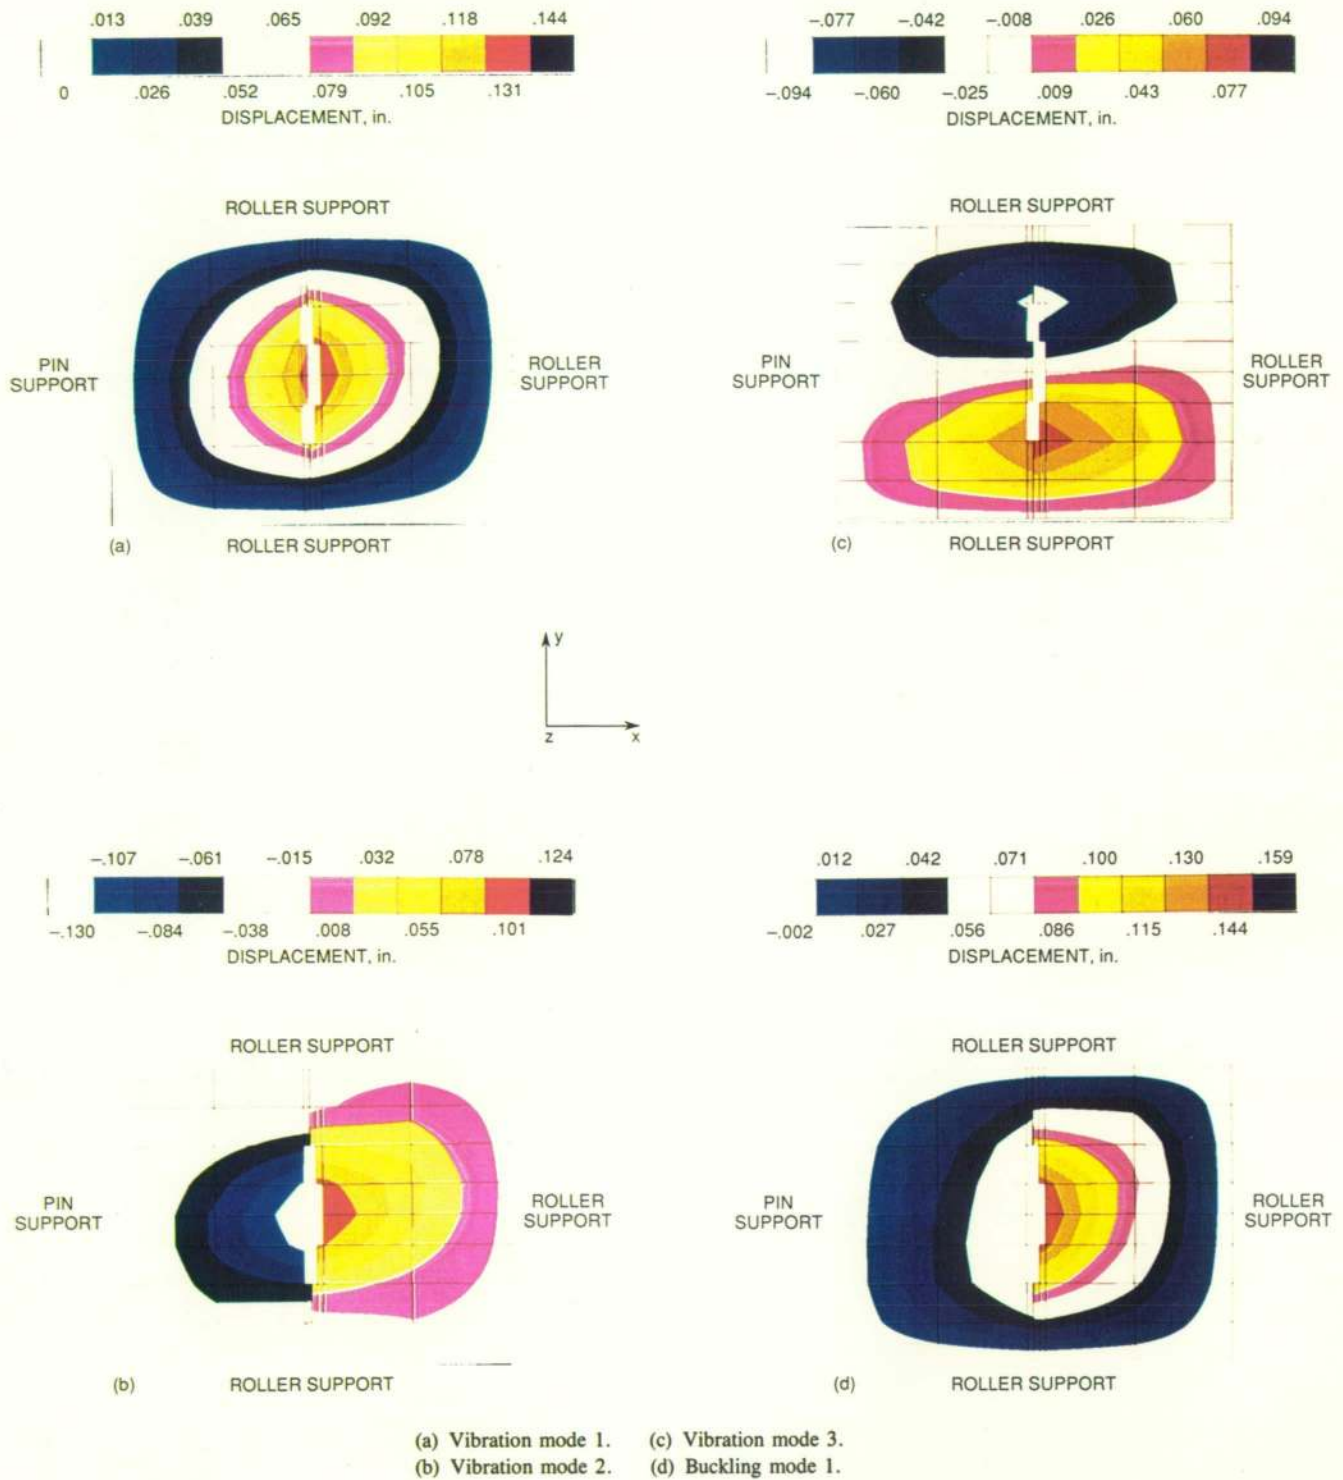
Figure 9.—Mode shape fringes after 94 percent loading. Fracture load, 6082 lb; support condition 2.

Figure 9 shows the mode shapes for support condition 2, for 94 percent of the ultimate fracture load. At this loading stage additional elements on either side of the central notch as well as the nodes at both ends of the notch have failed. As a result, the natural frequency corresponding to the vibration mode with the longitudinal full wave has been reduced below that of the mode with the transverse full wave. In other words, the second and third vibration modes have switched the order of their natural frequencies. Nevertheless, the structure still appears to behave as a continuous unit in spite of a significant amount of internal damage and fracture.

The buckling mode, as depicted in figure 9(d), shows significant decoupling of the two sides of the plate separated by the central notch. Because of boundary restraints, structural decoupling reduces the effective buckling length, and consequently, the fundamental buckling load at this advanced stage of local damage increases significantly.

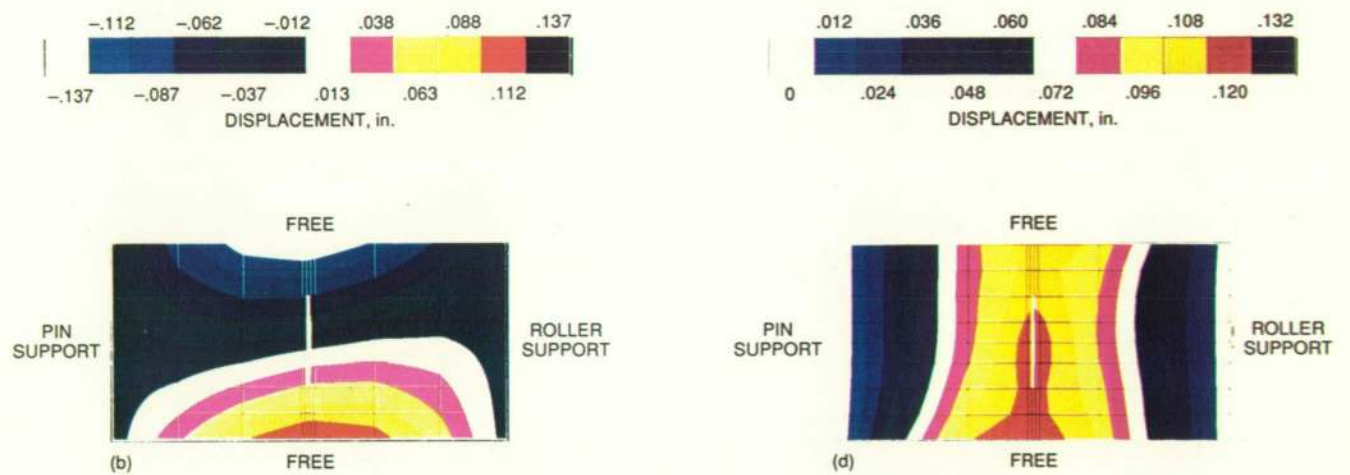
Figure 14.—Mode shape fringes after 91 percent loading. Fracture load, 6086 lb; support condition 1.

Figure 14 shows the same mode shapes at 91 percent of the ultimate fracture load. Similar to the case of the shorter model, the central notch extends in the transverse direction when the elements adjacent to the notch fail. Also similar to the shorter model under the same boundary conditions, there does not appear to be any significant change in the mode shapes at this stage of loading.

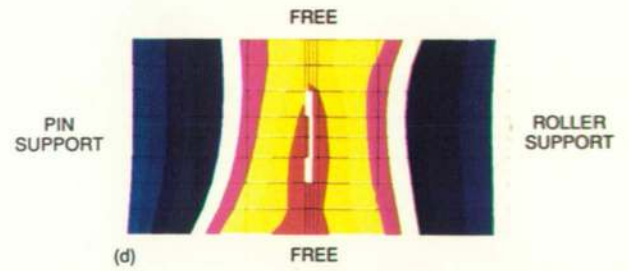
Figure 15.—Mode shape fringes after 95 percent loading. Fracture load 6086 lb; support condition 1.

Figure 15 shows the mode shapes after 95 percent of the ultimate fracture load has been applied. There is additional damage and failure at the central notch of the model. The second vibration mode switches to a transverse wave pattern because of the weakening of the center of the plate and increased structural decoupling of the two sides separated by the central notch. The other three mode shapes that are depicted do not appear to be significantly affected by the weakness of the center. However, any additional loading causes rapid structural deterioration and disintegration of the plate model.
