# **Structural Health Monitoring on Turbine Engines Using Microwave Blade Tip Clearance Sensors**

Mark Woike, Ali Abdul-Aziz, and Michelle Clem

National Aeronautics and Space Administration  
Glenn Research Center, Cleveland, Ohio 44135

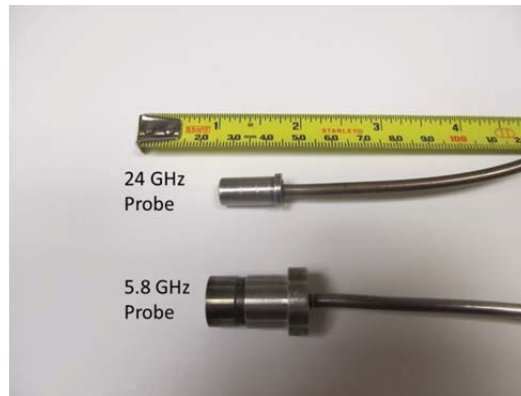
Figure 1. – Microwave blade tip clearance probes (Meggitt).

The microwave blade tip clearance sensor operates essentially as a field disturbance device. The tip clearance probe contains both a transmitting and receiving antenna. The sensor emits a continuous microwave signal and measures the signal that is reflected off a rotating blade. The sensor measures the changes in the microwave field due to the blade passing through the field. The motion of the blade phase modulates the reflected signal and this reflected signal is compared to an internal reference. Changes in amplitude and phase directly correspond to changes in the distance to the blade. The time interval of when the blade passes through the field is measured to provide blade tip timing. More detailed information on the sensor's theory of operation can be found in References 3 to 5. The microwave blade tip clearance probes are made of high temperature material and are designed to operate in temperatures up to 900 °C. The first generation probes (Fig. 1a) operate at 5.8 GHz and can measure clearance distances up to one-half the radiating wavelength which is 25 mm (~1.0 in.). The second generation probes (Fig. 1b) operate at 24 GHz and can measure clearance distances up to 6 mm (~0.25 in.). The 5.8 GHz sensor is targeted for use on large rotating machinery such as land based power turbines or in the fan sections of aero gas turbine engines. The 24 GHz sensor is being targeted for use in smaller rotating machinery applications such as the turbine and compressor sections of aero engines. This technology has an ultimate goal of obtaining clearance measurement

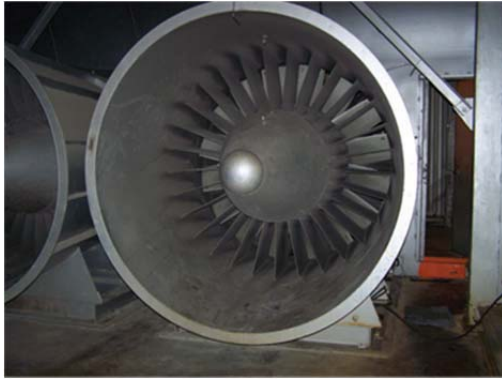
Figure 2. – Axial Vane Fan.

The first generation 5.8 GHz microwave sensors were used to make blade tip clearance measurements on a large Axial Vane Fan and a subscale NASA Turbofan (Ref. 6). The purpose of the test on the large Axial Vane Fan (Fig. 2) was to develop the infrastructure required for the calibration of the sensors and the techniques for their use in the field to make clearance measurements on large rotating machinery. The motivation behind their use on the NASA Turbofan (Fig. 3) was to evaluate the first generation sensor's ability to acquire blade tip clearance data on an aero engine size test article and blades. Blade tip clearance data sets were acquired for several test runs of the NASA Turbofan. Data was acquired at a variable sampling rate that was synchronized to the fan's speed. Each measurement consisted of two revolutions of data with 10 000 samples acquired per revolution. Figure 4 shows the individual blade clearances measured for several fan speeds. It is clearly noted from the polar plot that the tip clearances decreased as the fan speed is increased.

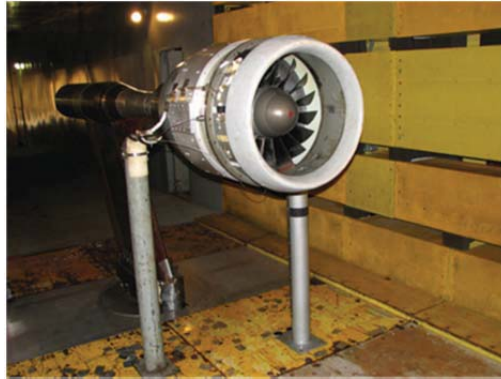
Figure 3. – NASA Turbofan.

This result is expected and is due to the growth and expansion of the turbofan's composite blades as the fan operates at higher speeds. An average decrease of 0.22 mm ( $\sim 0.009 \text{ in.}$ ) was observed as the rig speed was increased to 8 875 rpm. The change in clearance detected in this experiment was within the range predicted for these blades. In addition, the change in tip clearances measured by the microwave sensors was nearly identical to previously recorded values obtained with capacitive clearance sensors. In previous test entries, changes in tip clearances of up to 0.22 mm ( $\sim 0.009 \text{ in.}$ ) were also noted when the turbofan was operated over the same speed range. These two initial experiments served as test beds for the development of techniques and infrastructure required for the calibration of the sensors and successfully demonstrated the microwave clearance sensor's ability to make measurements on aero engine size hardware.

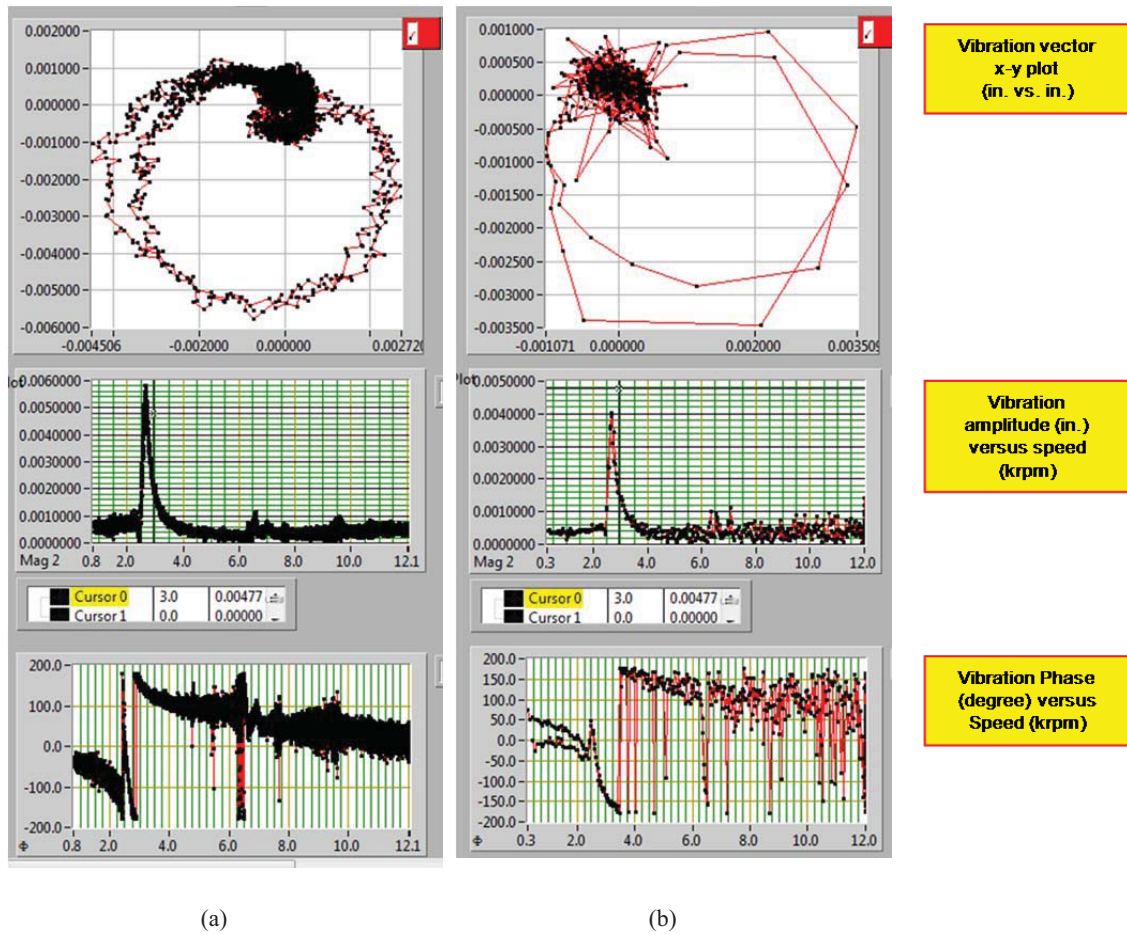
Figure 9. - 12 000-rpm cycle comparison. (a) Capacitive Sensor Results. (b) Microwave Sensor Results.

The vibration amplitude, phase Bode plots along with the vibration vector plots of the disk shaft system as measured by the both the capacitive and microwave blade tip clearance sensors from this test run are shown in Figure 9. These plots are used to monitor the structural response of the rotating disk. Changes in vibration as defined by the whirl amplitude and its phase as measured by the blade tip clearance sensors as the disk is transitioned through a range of speeds is used as a means of detecting cracks or flaws in the disk (Refs. 10-14). The data sets were analyzed and processed using an in-house Labview-based software module. The analysis software was specifically tailored to acquire and post process blade-tip-displacement data. The amplitude shown in the Bode plot displays the first harmonic component of the vibration in inches as a function of disk speed in thousands of revolutions per minute (RPM). The phase of the first harmonic component of the vibration in degrees as a function of disk speed in thousands of revolutions per minute is also shown. The vibration vector plot displays the vibration response in an X-Y (inches vs. inches) format. These plots are the primary analysis method used to determine if the simulated crack could be detected by the vibration response of the system as measured by the respective blade tip clearance sensors.

From analyzing the plots it is seen that the microwave sensor results closely track the readings from the capacitive sensor. The capacitive sensor measured a vibration amplitude of ~0.15 mm (~ 0.006 in.) while microwave sensor measured an amplitude of ~0.10 mm (~ 0.004 in.). This slight difference is likely due to the fact that the microwave probes (~2 Hz) do not sample as fast as the capacitive probes (~ 20 to 200 Hz) and did not capture the precise location of the peak measurement as the disk was quickly transitioned through the first critical speed of 2680 RPM. The phase Bode plots measured by each sensors closely match each other and show the expected 180 degree transition in phase as the disk moves through the first critical speed. While the vibration vector x-y plot defined by the microwave sensors does not contain as many data points as the one derived by the capacitive sensor, they closely match each other and follow the same overall pattern. From analyzing these plots, with the exception of having less data points, the microwave blade tip clearance sensors performed similar and in-line with the capacitive sensor (Fig. 9).

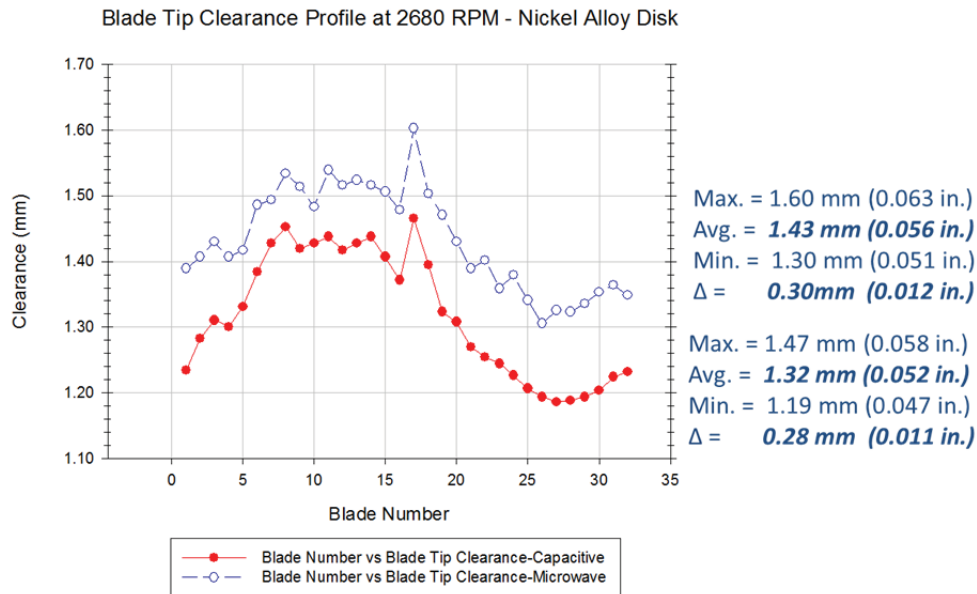
Figure 10. – Blade Tip Clearance Profile at 2 680 RPM

A more quantitative analysis was made by examining the blade tip clearance profiles measured by each sensor at several speeds that the disk was tested at. Figures 10-12 show the blade tip clearance profile recorded by each sensor at speeds of 2 680, 4 000 and 12 000 RPM respectively. Figure 10 shows the profile acquired at 2 680 RPM. This speed was chosen as it represents the point where the largest vibration (shaft whirl) amplitude variations are experienced because the disk rotor

system is transitioning through its first critical speed. From analyzing the blade profile it was seen that each sensor tracked the relative clearances of each blade within reasonable agreement of each other. For the capacitive sensor an average clearance of ~1.32 mm (0.052 in.) was measured with the difference between the minimum and maximum individual blade tip clearance being ~0.28 mm (0.011 in.). For the microwave sensor an average clearance of ~1.43 mm (0.056 in.) was measured with the difference between the minimum and maximum measured individual blade tip clearance being ~0.30 mm (0.012 in.). An offset in the absolute clearance distance of approximately 0.11 mm (~0.004 in.) on average was observed between the two sensors this is expected and within reason for this experiment. While all attempts were made to install the sensors at a nominal gap of 1.27 mm to 1.40 mm (0.050 to 0.055 in.), differences in the setup of the sensors and blade to blade variations make this difficult to accomplish. The approach for this experiment was to initially gap the sensors as best as could be done at a similar distance and focus on how the sensors varied from these initial positions as they were operated over the entire speed range.

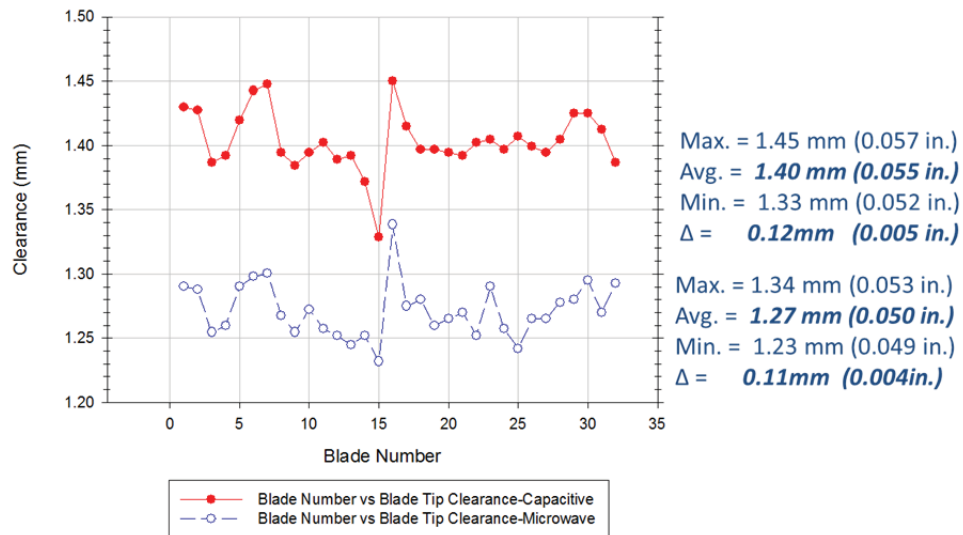
Blade Tip Clearance Profile at 12 000 RPM - Nickel Alloy Disk

Figure 12. – Blade Tip Clearance Profile at 12 000 RPM

Figures 11 and 12 depict the blade tip clearance profiles measured by each sensor at 4 000 and 12 000 RPM respectively. The speed of 4 000 was chosen because it represented a good baseline speed for acquiring reference readings, as it above the critical speed of 2 680 RPM, but not yet at the point where the response is influenced by loading and any flaws in the disk. The speed of 12 000 RPM was chosen because it was the maximum speed that the disk was operated at and represented the maximum loading condition. From analyzing both of these figures, the profiles for each sensor matched each other and it was shown that the each sensor tracked the relative individual blade tip clearances with-in fairly good agreement of each other. For the capacitive sensor at 4 000 RPM an average clearance of ~1.30 mm (0.051 in.) was measured with the difference between the minimum and maximum individual blade tip clearance being ~0.12 mm (0.005 in.). For the microwave sensor an average clearance of ~1.39 mm (0.055 in.) was measured with the difference between the minimum and maximum measured individual blade tip clearance being ~0.14 mm (0.006 in.). Again, the difference in average clearance measurement was due to the difference in the initial gapping of the sensors. The differences between the “delta” (max-min) measurements are nearly within the +/- 0.025 mm (+/- 0.001 in.) accuracy expected for these sensors.

Again, good agreement was observed in the measurements of the individual blade tip clearances in the profile acquired at 12 000 RPM (Fig. 12). In this case the capacitive sensor measured an average clearance of ~1.40 mm (0.055 in.) with a ~0.12 mm (0.005 in.) difference measured between the minimum and maximum individual blade clearances. The microwave sensor measured an average clearance of ~1.27 mm (0.050 in.) with the difference measured between the minimum and maximum individual blade clearances being ~0.11 mm (0.004 in.). This again, is within the expected accuracy of the sensors. It should be noted for this speed, the relative position of the absolute clearance measured by each sensor changed from the baseline condition measurements at 4 000 RPM. At 12 000 RPM the clearances measured by the capacitive sensor were ~0.10 mm (0.004 in.) higher than what it measured at 4 000 RPM. Similarly, the average clearance measured by the microwave sensor was ~0.12 mm (0.005 in.) lower than what it measured at 4 000 RPM. This phenomenon is real and the explanation for this is as follows. It was observed during all of the test runs, at the very high speed conditions of 10 000 to 12 000 RPM, the overall disk-rotor system pulls or moves in the direction that it is being rotated at. For our test case this was causing the entire disk and shaft system to pull towards the microwave sensor located at the 180 degree position (the back position) and away from the sensor located at the 0 degree position (the front position). Hence, at the high speed conditions, it was observed that the absolute clearances between the microwave sensor and the rotating disk shrank while the clearances between the capacitive sensor in the 0 degree position and the disk grew. Conversely, the opposite of this was observed when the disk was rotated in the opposite direction. Again, this was the first time we had two active sensors working on the rig and it was good to find that this phenomenon occurs so we can take it into account for future experimentation. In summary, based on the analysis presented above, the microwave blade tip clearance sensor proved to provide accurate and reliable readings and matched very well to the capacitive sensors that had been used in previous crack detection experiments.

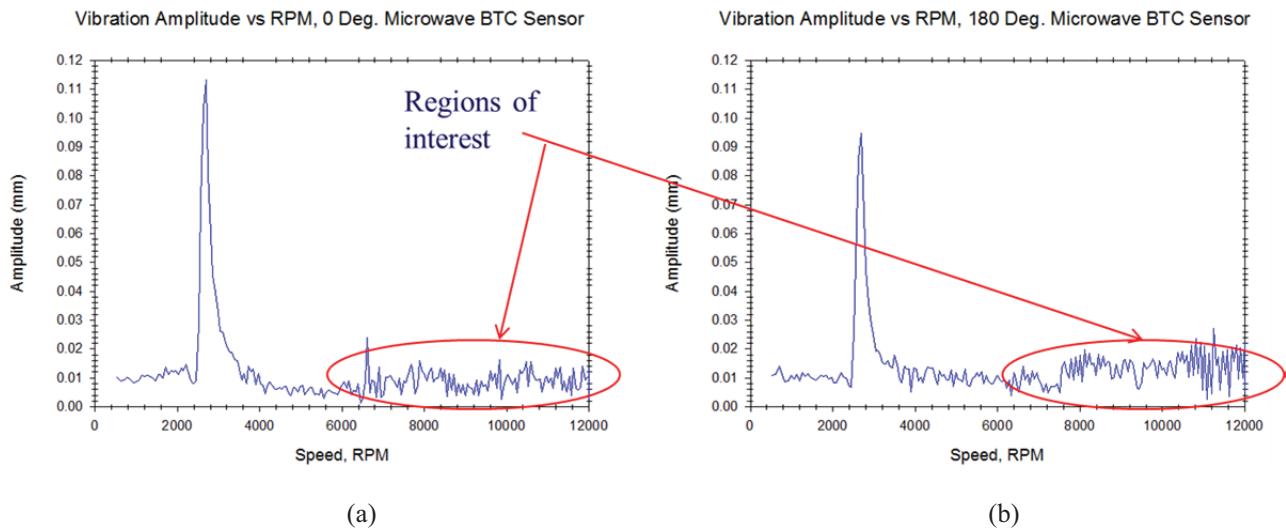
Figure 13. - 12 000-rpm cycle comparison. Microwave BTC Sensors (a) 0°, Front Location (b) 180° Back Location

The vibration amplitude plots derived from the microwave blade tip clearance sensor measurements in both the 0 degree and 180 degree positions are shown in Figure 13. As observed in the plots the amplitude appears to be growing as the speed of operation is increased, which may be indicative of a crack. Curve fitting was attempted in the region above 5 000 RPM to look for the expected increase as a function of speed squared,  $\omega^2$ . This curve fitting was not conclusive and the level of observed growth was not sufficient enough to convincingly state that the sensor detected the presence of the notch, (simulated crack) in the disk. The changes observed were in the  $\mu\text{m}$  (sub thousandths of an in.) range and just above the noise floor level. However, this was not viewed as a failure and the results shown in Figure 13 do look promising. Similar results have been obtained using the capacitive sensor. Previous experimentation has found that the Nickel Alloy disk, even with the notch machined in it to simulate a crack, retained its structural integrity with minimal changes experienced even at the high speed, and highly loaded conditions. Hence at the time of the writing of this report, the lighter Aluminum disk is being installed on the spin rig for the purposes of conducting proof-of-concept crack detection experiments using the microwave blade tip clearance sensors. Further analysis is planned for the data acquired from the Nickel alloy disk. The results of this experimentation using the microwave sensors will be presented in the future.

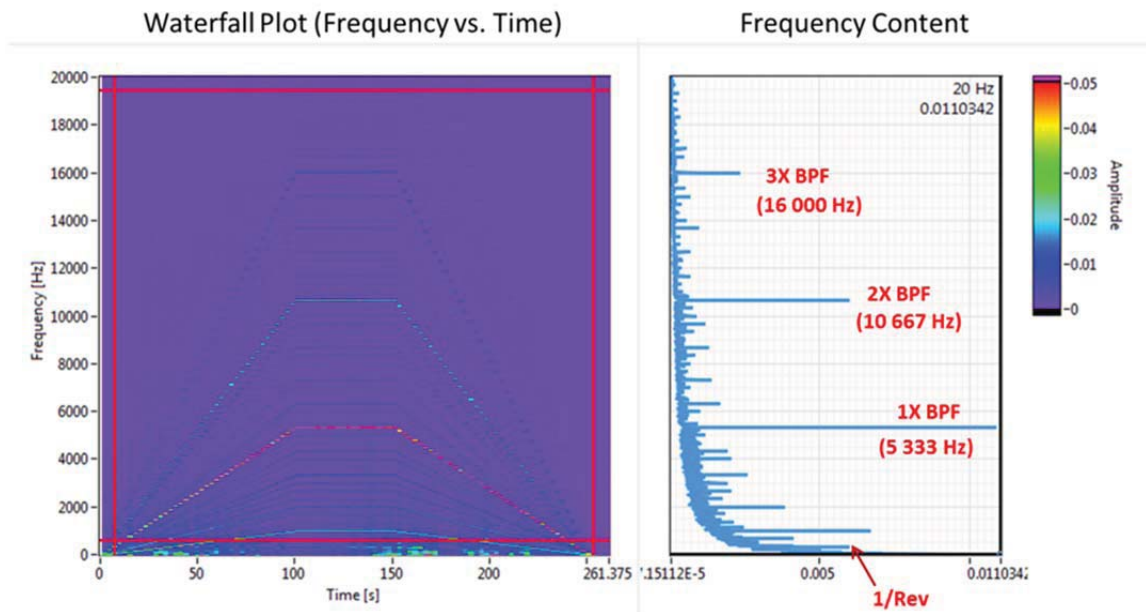
Figure 15. - Waterfall plot, frequency vs. time, 10 000 RPM Cycle

The plot of Figure 15 shows the results acquired from one of the test runs using the non-contact blade vibration measurement sensor. In this case the test run was a simple speed cycle, very similar to the cycle described earlier in the paper. The disk was ramped from 0 RPM to 10 000 RPM at an acceleration rate of 100 RPM per second, held at a constant speed of 10 000 RPM for 60 seconds, then ramped back down to 0 RPM at a rate of 100 RPM per second. All during this test run a continuous stream of radar data was acquired from the microwave based vibration sensor while it was aimed at the disk from a distance of ~406 mm (16 in.). The plot on the left is a waterfall plot showing the magnitude and frequency content of the signal acquired from the microwave vibration sensor. The plot shows that the measured vibration frequencies closely track the speed of the disk. The predominate signal frequencies that were measured were the 1/rev frequency (167 Hz), the blade passing frequency (5 333 Hz) and its second and third harmonics (10 666 Hz and 16 000 Hz). There were also significant signals at 1 000 Hz and 2 000 Hz which were believed to be attributed to vibrations induced by the motor that is used to spin the disk on the rig. Several other test runs were conducted at various speeds and showed similar results where the measured vibration frequencies tracked the speed of the disk and its blade passing frequencies. While this was a simple test of the system, future experimentation is being planned to further use this system to measure blade vibrations on a spinning disk for structural health monitoring purposes.
