Studies on Screening of Paint Degrading Microorganisms Isolated from Wall Scrapings

Yamuna G.¹, Anooj O.², Roopika K.³, Sabitha Rani⁴ & Rashmi D.^{5*}

¹⁻⁵Assistant Professor, Department of Biotechnology & Microbiology, Padmashree Institute of Management and Sciences, Bangalore-560060, Karnataka, India. Email id: rashmi.pcr@gmail.com*

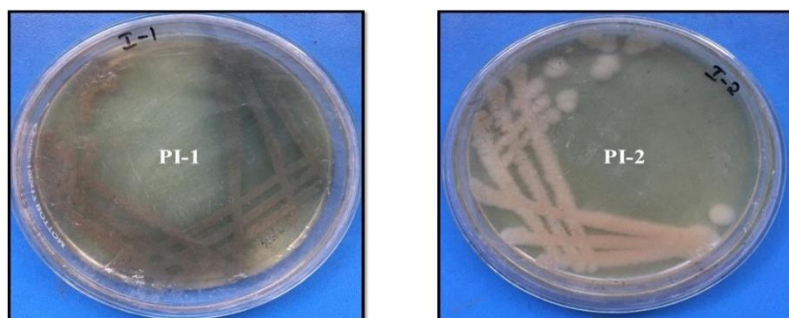
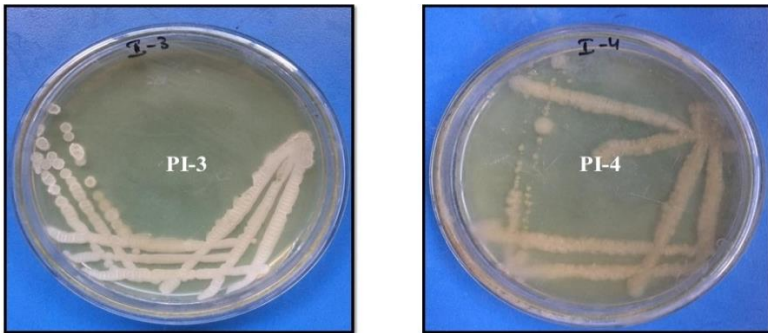
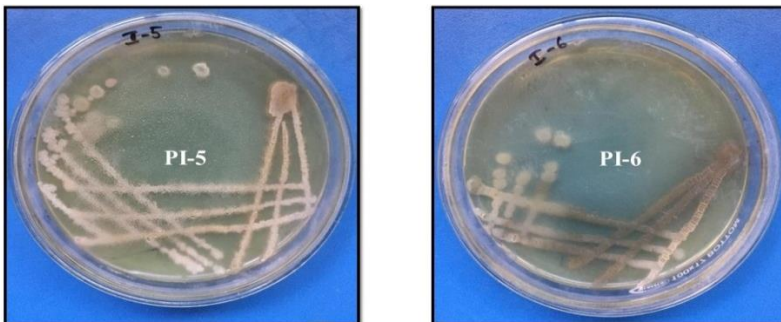
Fig.1. Bacterial isolates of wall scrapings on LB agar

Fig.2. Bacterial isolates of wall scrapings on LB agar

Fig.3. Bacterial isolates of wall scrapings on LB agar

Growth was observed on LB agar plates. Among six isolates PI-1, PI-5 and PI-6 was found to be gram negative rods. PI-2, PI-3 and PI-4 was found to be gram positive rods (Figs. 1,2 and 3).

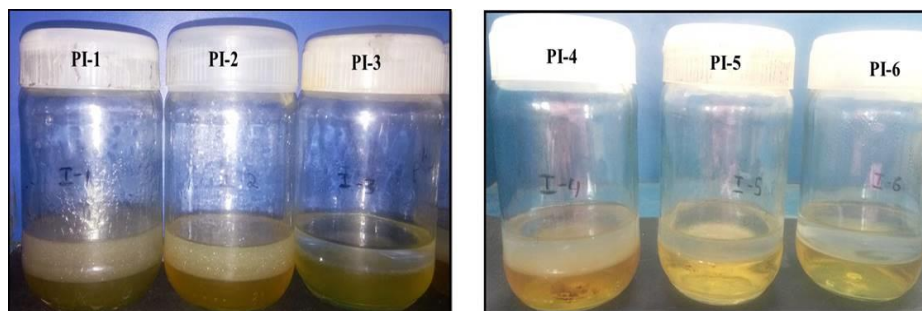
By the addition of ethyl acetate for supernatant obtained, secondary metabolite present in bacteria are dissolved and precipitation was seen (Fig.4).

Fig.4. Secondary metabolites extraction

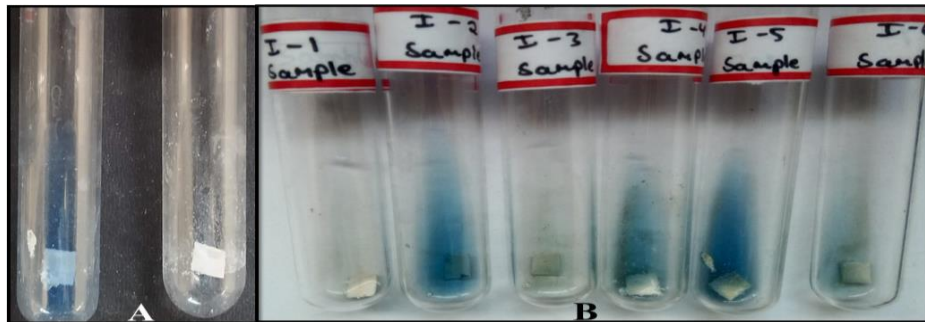
Leaching of paint was observed on the metal strip that was coated with paint. Graph was plotted using the optical density taken (Fig.5).

Fig.5. A= +ve control and -ve control and B= samples showing paint leaching

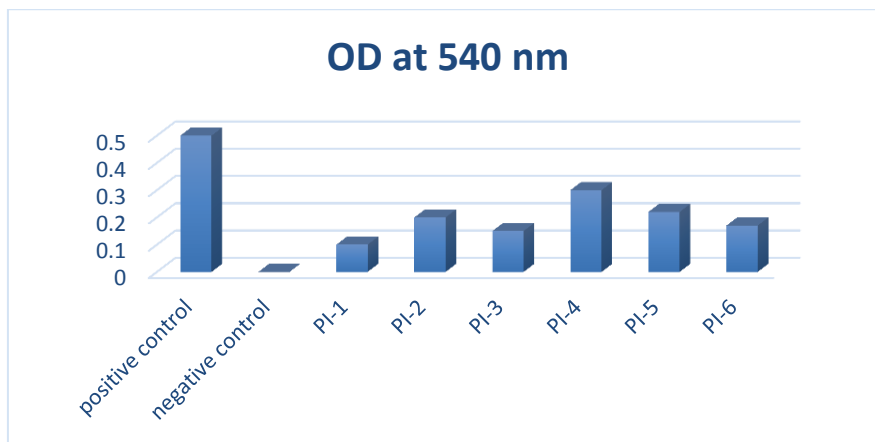
The graph was plotted on the basis of OD value taken. Comparison of positive and negative control with six isolates indicated that PI-4 was showing more degradation (Graph 1).

Graph 1. Isolates showing rate of degradation

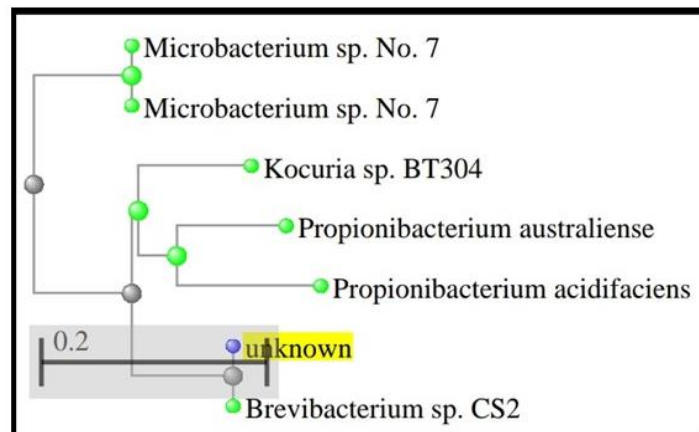
Molecular identification was done by amplifying genomic DNA followed by sequencing of 16s rRNA gene. Isolate was identified by The Basic Local Alignment Search Tool (BLAST) analysis of obtained 16s rRNA sequence. Further we concluded PI-4 isolate as *Brevibacterium* sp by phylogenetic analysis.

Fig.6. Phylogenetic tree of PI-4 isolate
