Performance of porous European mix (PEM) pavements added with crumb rubbers in dry process

Article in *International Journal of Pavement Engineering* · February 2015

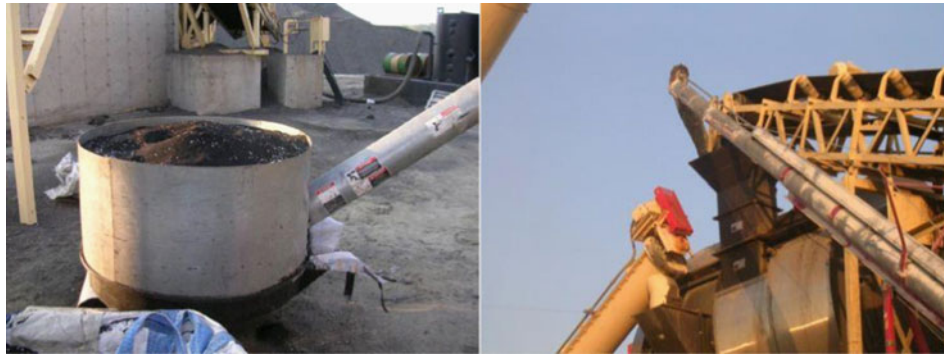
Figure 1. Blended crumb rubber/TOR feeder container and pipe (Sheila 2007).

For the rubberised PEM test section, — 30 mesh was used at 10% of the weight of the base binder of PG 67-22. CRM is introduced and mixed directly with aggregates and PG 67-22 asphalt in the drum to produce the PEM. The cross-link agent (TOR) was used at 4.5% of the weight of the CRM (TOR were the white particles in the container on the left of Figure 1). A volumetric feed system was set up at the asphalt plant to incorporate the blended crumb rubber/TOR material (see container on the left side of Figure 1) into the reclaimed asphalt pavement collar through the pipe (see the right side of Figure 1) at the drum.

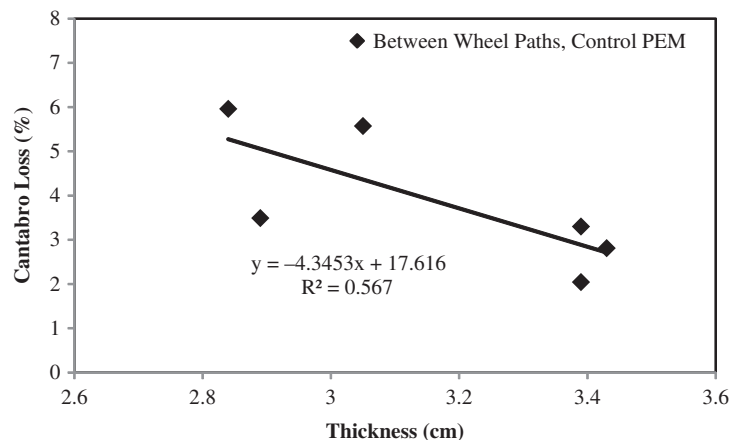
Figure 3. Relationship between thickness and Cantabro loss after 40 revolutions in core samples, I-75 Valdosta.

63.5 mm. The core samples taken from the test sections, like 'hockey puck', were much thinner than the standard Marshall sample. The results of Cantabro test showed that core sample thickness influenced significantly the Cantabro loss. Figure 3 showed a typical relationship between the mass loss and the thickness for samples from I-75, Valdosta. A trend was obvious: the thicker the sample, the less the Cantabro loss. Tests on the samples from other two sections had similar trend as those from I-75 Valdosta.

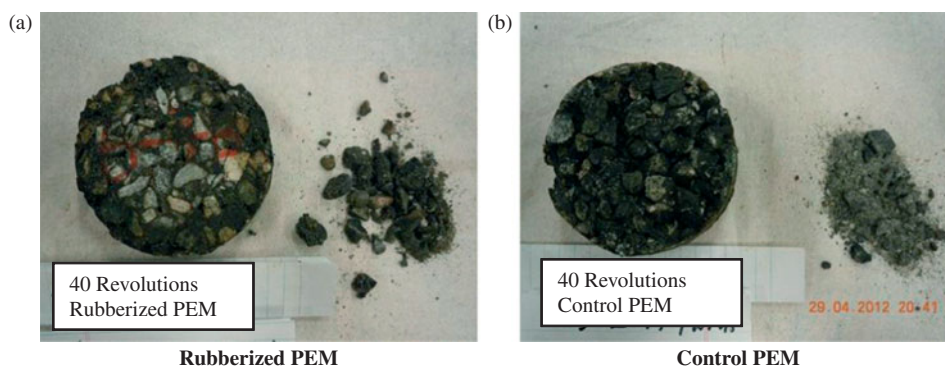
Figure 4. Condition of 3-year service cores after 40 revolutions. (a) Rubberised PEM and (b) control PEM.

In addition, the aged severity of asphalt mix had significant effect on the Cantabro results. Figures 4 and 5 show the samples of 3- and 5-year periods after 40 revolutions, respectively. The rubberised sample of the 3-year period (Figure 4(a)) had much more whole aggregates falling from the sample while the control example (Figure 4(b)) had much more fine particles abraded from the sample. The rubberised sample (Figure 5(a)) of the 5-year period obviously was broken more seriously than the control sample (Figure 5(b)).

3-year core samples from I-75 Valdosta showed some abraded particles (Figure 4), while the 5-year core samples from I-75 Perry broke into pieces (Figure 5). In both rubberised and control PEM, the Cantabro loss became larger with increased service life.

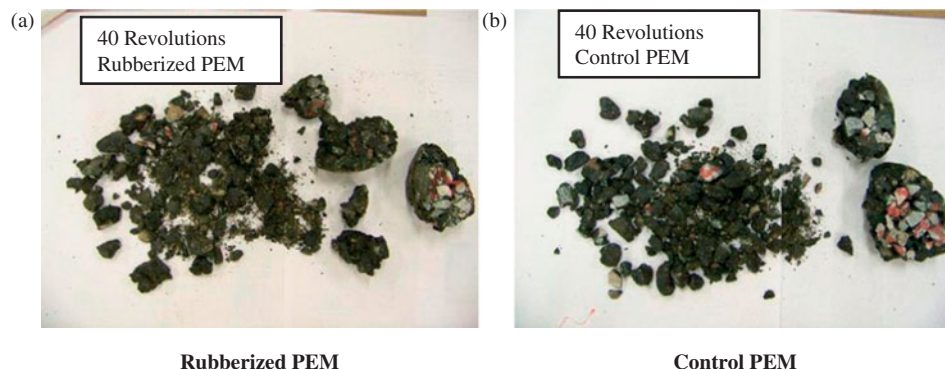
Figure 5. Condition of 5-year service cores after 40 revolutions. (a) Rubberised PEM and (b) control PEM.

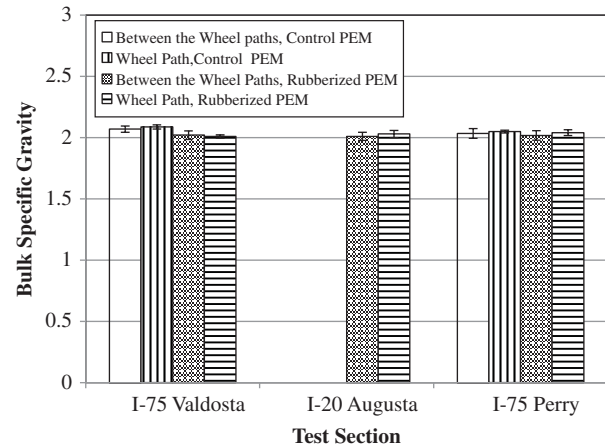
Figure 6. Average bulk specific gravity of PEM core samples.

Figures 6 and 7 show that the wheel path of the rubberised PEM pavement has similar values of bulk specific gravity and air voids to the pavement between the wheel paths. Figure 8 showed that the wheel path has slightly higher values of permeability than that of the centre of the lane. Figure 9 illustrates Cantabro loss of the wheel path to be higher than that of the centre of lane. It may be contributed to more traffic loading on the wheel path than the centre of lane. In the Cantabro test, loss was calibrated to a thickness of 3.3 cm for cored sample according to the regression equation.

Bulk specific gravity values for both the wheel path and the area between were slightly lower for the rubberised PEM pavement than the control (Figure 6). The air voids of the rubberised PEM wheel path and centre lane were 11.6% and 6.4% lower, respectively, than those of the control PEM (Figure 7). Permeability values for the rubberised PEM were lower than the control's due to fewer air voids. Difference rates for the wheel path and between were 17.0% and 18.8%, respectively (Figure 8). Statistical analysis in Table 6 indicates that there were no significant different specific gravity and permeability values between the rubberised and control PEM, except air voids.

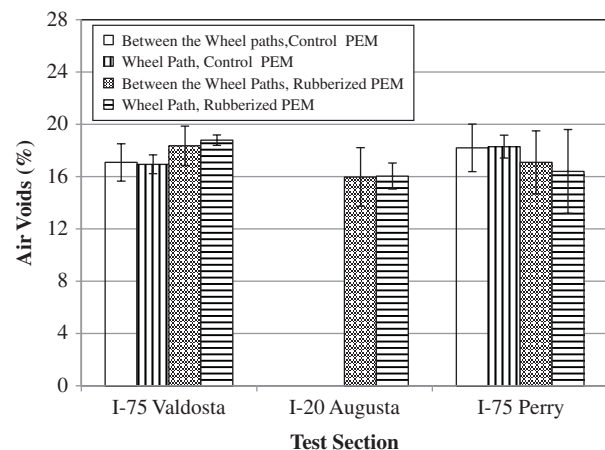
Figure 7. Average air voids of PEM core samples.

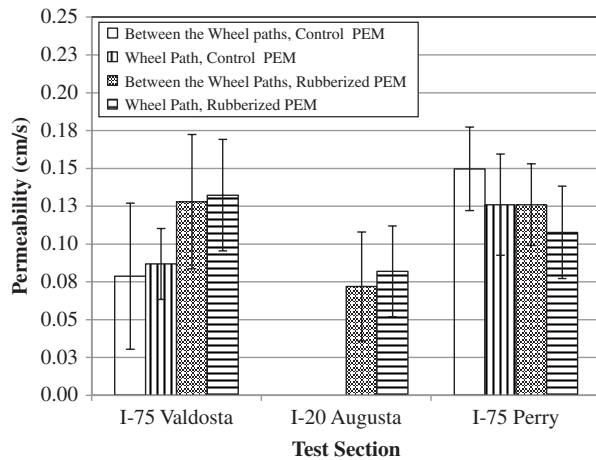
Figure 8. Average permeability of PEM core samples.

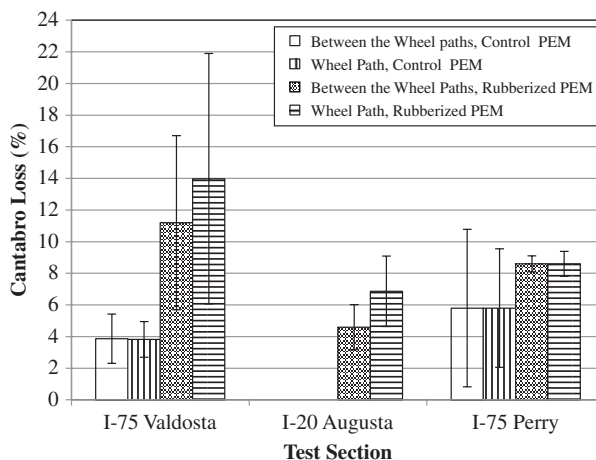
Figure 9. Average Cantabro loss of PEM core samples.

Figure 9 shows that the rubberised PEM samples had higher values of Cantabro Loss than the controls. Table 6 indicates that Cantabro Loss of rubberised PEM samples was significantly different from that of control PEM. It was observed that the rubberised samples were easier to have abrasion than the controls. However, it was also

Figure 9 shows that the rubberised PEM had higher Cantabro loss values than the control even though the void ratio was lower than that of the control samples. Table 6 indicates that Cantabro Loss of rubberised PEM samples was not significantly different with that of control PEM. The test comprised 10 revolutions, and loss was calibrated to the value of a 2.8 mm core samples using the regression equation. These results did not distinguish wheel path from the centre lane because of too few core samples.
