SARA PERALES MOMPALER; Hernández Crespo, C.; Vallés Morán, FJ.; Martín Moneris, M.; Andrés Doménech, I.; Andreu Álvarez, J.; Jefferies, C. (2014). SuDS efficiency during the start-up period under Mediterranean climatic conditions. *CLEAN - Soil, Air, Water*. 42(2):178-186. doi:10.1002/clen.201300164.

# SuDS efficiency during the start-up period under Mediterranean climatic conditions

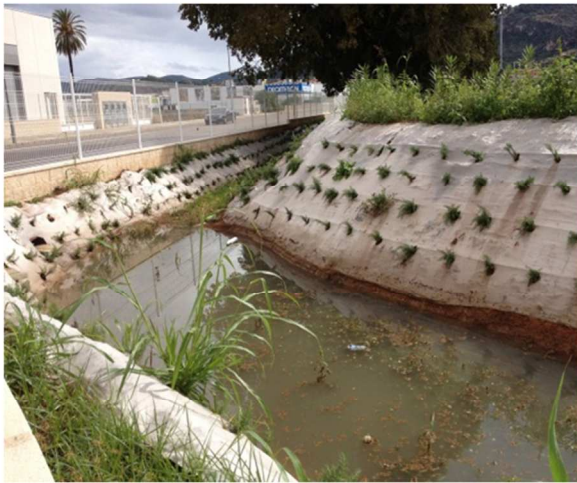
Site 1. Infiltration basin. Photo (left) and monitoring points scheme (right).  
254x190mm (96 x 96 DPI)

41 Two of the new SuDS were in a new urban area to the north of Xàtiva and one was in the city  
42 centre. Site 1 (38°59'47.13"N 0°31'53.67"W) provides a 170 m<sup>3</sup> storage volume (Figure 1).  
43 This volume manages runoff from 1900 m<sup>2</sup> of the adjacent road pavement and around 11100  
44 m<sup>2</sup> from the Sports City (a new sports complex). It comprises a 1.1 m wide (on average), 75 m  
45 long swale which is linked to an infiltration basin (50 m<sup>2</sup> base area), both retrofitted within the  
46 Sports City. Overflows occur to a nearby stormwater pipe.  
47  
48

54 A total of nine water sampling points were used (Figures 1, 2 and 3). There were three  
55 sampling points at sites 1 and 2 corresponding to the two inputs and the output from the  
56 swales to the sewer system. For site 1 (Figure 1) they were from the Sports City (11) and the  
57  
58  
59  
60

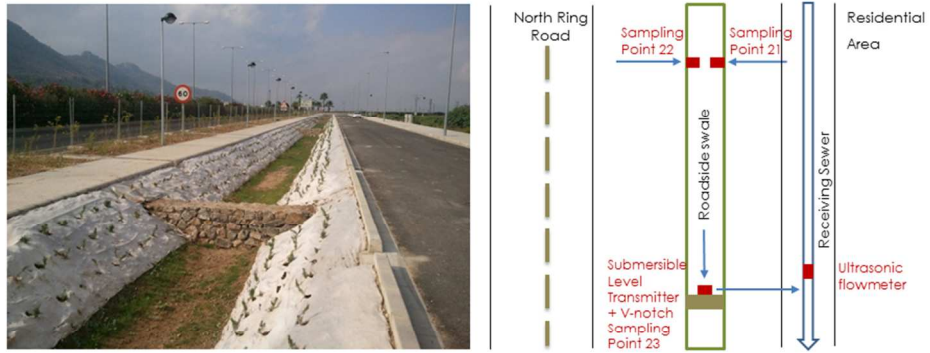
Site 2. Roadside swale. Photo (left) and monitoring points scheme (right).  
254x190mm (96 x 96 DPI)

49 Site 2 (38°59'25.21"N 0°32'04.80"W) is located between a new urban development and a  
50 section of a ring road that had no drainage infrastructure and contributed to flooding of an  
51 industrial area downhill (Figure 2). A 1.7 m wide swale has been constructed in the verge of  
52 the road, replacing the flat green area that was in the original plans. Four pedestrian crossings  
53 and 5 transverse structures act as barriers of low permeability to slow the flow. The swale is  
54 divided in two sections of 275 m and 95 m length respectively, and there are two emergency  
55 spillways to direct overflow to a stormwater pipe nearby. The monitoring focused on the  
56  
57  
58  
59  
60

1  
2  
3 adjacent roadway (12). For the North Ring Road (Figure 2) the inflows were from the  
4 residential area (21) and the adjacent North Ring Road itself (22). In both systems the water  
5 was collected using two litre plastic bottles with one bottle per sampling point per event. The  
6 bottles were filled at the beginning of each rain event. Accordingly, the water quality  
7 corresponded to the first wash off. The output bottles (13 and 23) were filled only if there  
8 were discharges and, consequently, the water quality was the result of all the processes  
9 (sedimentation of total suspended solids, sorption, biodegradation, volatilization) that  
10 occurred inside the swales during the event, whose performance depends on hydraulic  
11 retention time (HRT) and other environmental factors. However, when HRT is low, the output  
12 is mainly related to the input pollutograph as there is no time for treatment other than
