Surface Tracking on Polymeric Insulators Used in Electrical Transmission Lines

Abstract

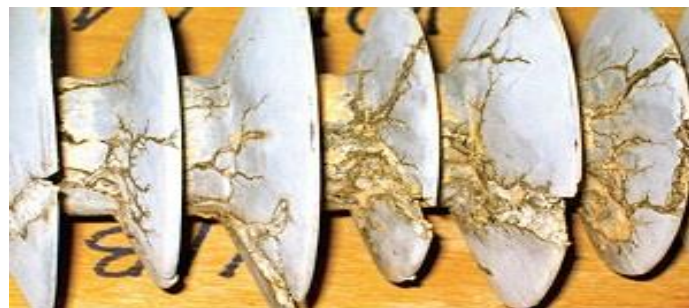
Figure 4. Severe tracking on EPDM sheathed arrester in Oman. Insulator Performance Resolving

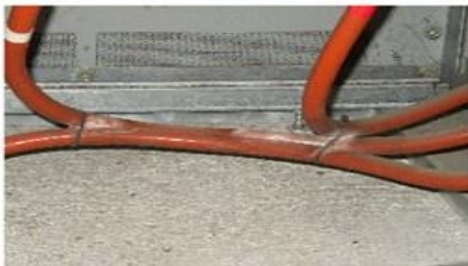
Figure 5. Dust Deposit on Tie-Wrapped Cables [18]

Most common cause of Coronas are the little air space left between conductors [18]. The initial onset of a corona is hard to detect as the only by-product that is produced at this time is the ozone. However, after a longer period of existence, a white fibrous powder or dust residue can be seen on the rubber based insulators [19]. This dust or residue is the physical sign of the breakdown of the insulation. Cables that are tie-wrapped together often experience a corona, and the results are as illustrated in the Figure 5 below.

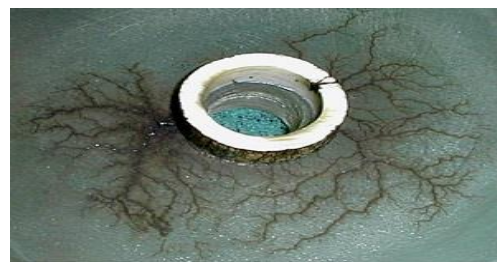
Figure 6. Treeing in Underground Cable Insulators

The Figure 6 (image retrieved from (https://en.wikipedia.org/wiki/Electrical_treeing)) shows an advanced stage of formation of the electrical trees. The tracks have been carbonized as they appear dark in color. At this stage, the tracks can conduct electricity and thus the insulating properties of this dielectric material cannot be recovered.
