Surface Treatment of Powder-Bed Fusion Additive Manufactured Metals for Improved Fatigue Life

David B. Witkin, Dhruv N. Patel, Henry Helvajian, Lee Steffeney, and Agustin Diaz

High-cycle fatigue (HCF) tests were conducted on samples fabricated by two powder-bed additive manufacturing techniques. Samples were tested with as-produced surfaces and after various non-contact surface improvement treatments. Ti-6Al-4V samples were made using both electron beam melting (EBM) and selective laser melting (SLM), while Inconel 625 was fabricated using SLM. Ti-6Al-4V was treated with a commercial chemically accelerated vibratory polishing process, with target material removal of approximately 200 μm from each surface for EBM samples and 100 μm for SLM samples. This technique led to increases in both the number of cycles before failure at a given loading condition and endurance limit (at 10^7 cycles) compared to samples with as-produced surfaces. The results are interpreted as the reduction in elastic stress concentration factor associated with surface defects where fatigue cracks initiate. SLM 625 was treated with both an abrasive polishing method and laser surface remelting. Both methods led

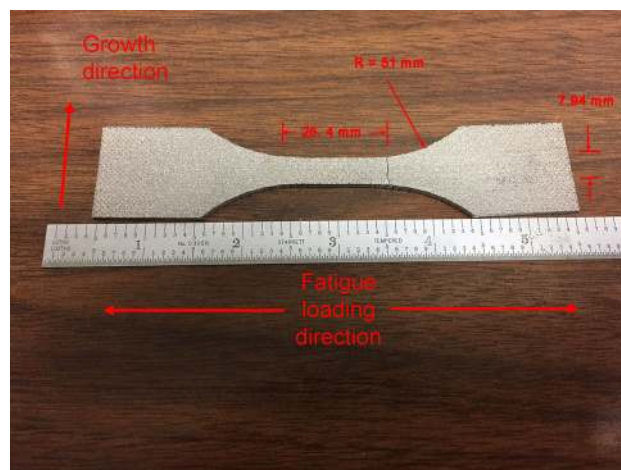
Fig. 1 Photograph of EBM Ti-6Al-4V flat dog bone specimen, with EBM growth and fatigue loading directions indicated

All AM materials used in this study were purchased from commercial AM service providers. Suppliers were instructed to use their best AM practices in fabricating the test samples, but no special controls or requirements were imposed. Samples were designed to be compliant with requirements found in ASTM E466 (Ref 19) for load-controlled fatigue testing. EBM Ti-6Al-4V flat dog bones (Fig. 1) were purchased from CalRAM, Inc. (Camarillo, California). Specimens were fabricated at CalRAM using Arcam S12 EBM equipment. The gauge section of the specimen as designed was 25.4 mm long,

7.94 mm wide and 2.38 mm thick. Transition regions between the gauge and grip sections had a radius of 51 mm. One design consideration was that specimens be fabricated in a horizontal orientation as shown in Fig. 1 without use of build supports, so that testing in the as-built condition could be performed without alteration of the as-produced surface on any face or edge of the test specimen.

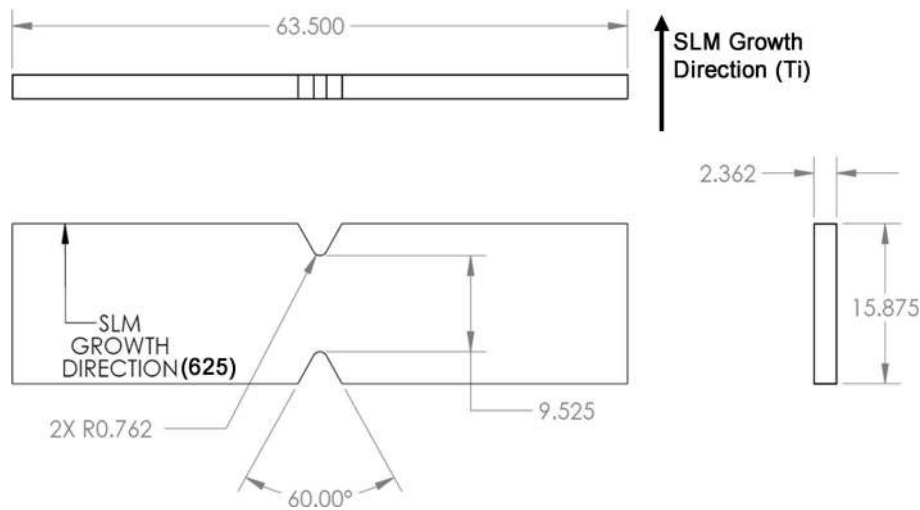
Fig. 2 Design of the notched fatigue specimen with $K_t = 3$ that was used to build SLM Ti-6Al-4V and Inconel 625 specimens (All values are in mm)

SLM test specimens were produced as flat notched specimens ($K_t \sim 3$) as shown in Fig. 2. The main intent of using a notched specimen was to limit the total surface area that needed to be treated with a laser. The Inconel 625 specimens were built at Stratasys Direct Manufacturing (Austin, TX), on edge as shown in Fig. 2. This enabled both top and bottom notches to be built without supports, again allowing comparison of true as-produced surfaces to treated surfaces. The Ti-6Al-4V specimens were built at Incodema3D (Ithaca, New York), but were built flat on the build plate to reduce printing time and specimen cost. Consequently, one side of the specimen had a surface that had been altered by electrical discharge machining (EDM) to remove it from the build plate. In this case, however, the notch root was a vertically oriented wall so the EDM surface on one face is not expected to have significantly impacted fatigue behavior.

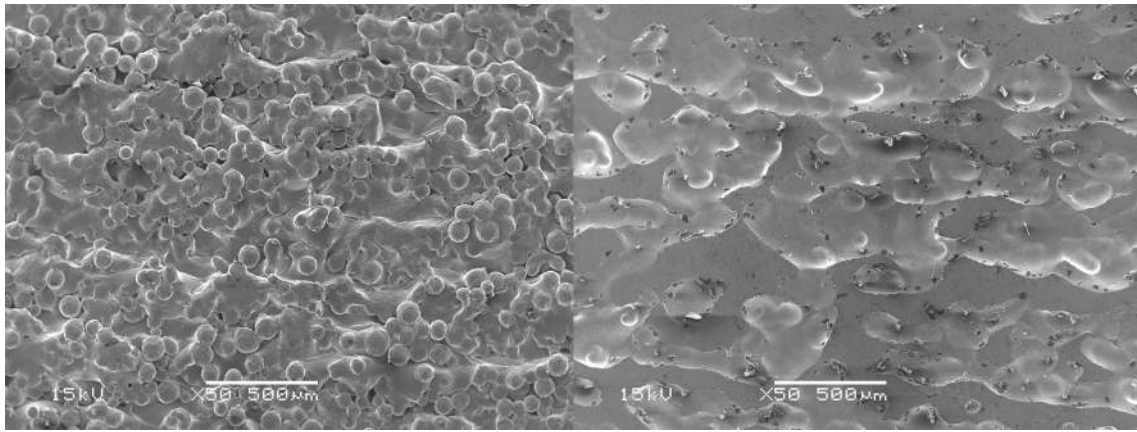
Fig. 3 Scanning electron micrographs of the surface (vertical wall) of EBM Ti-6Al-4V fatigue specimens in the as-built condition (left) and after CAVF treatment (right)

A qualitative means to assess the change in surface roughness is to look at micrographic images of the treated surface. In Fig. 3, a vertical wall of an EBM Ti-6Al-4V flat dog bone specimen is shown before (left) and after CAVF treatment (right). The as-built surface is characterized by nearly uniform coverage of the surface by semi-sintered or partially melted powder particles, along with horizontally oriented textures with spacing of several hundred micrometers, representing the individual melt layers. After CAVF treatment, the powder particles have been completely removed, but some surface topography remains. While the CAVF process is capable of rendering titanium surfaces smoother than that shown in Fig. 3, as previously discussed, a maximum removal depth was imposed to maintain integrity in comparing fatigue results. EBM equipment models developed subsequent to the S12 used to produce these materials may give different results for EBM Ti-6Al-4V surface roughness in both as-built and improved surfaces.

This approach provides some explanation of why the fatigue performance of the EBM Ti-6Al-4V improves even though there are still surface defects present, as shown in Fig. 3 and 11. The CAVF process may not reduce the deepest penetration of surface features, as seen in R_v , but the combination of mechanical and chemical polishing reduces the stress concentration associated with those defects. The same is true of the SLM Ti-6Al-4V. Although the EBM equipment used to produce these materials (Arcam S12) is no longer considered state of the art for electron beam powder-bed fusion, the general conclusions in terms of the CAVF process used with titanium would be applicable to different surface roughness conditions in more recent vintage equipment.

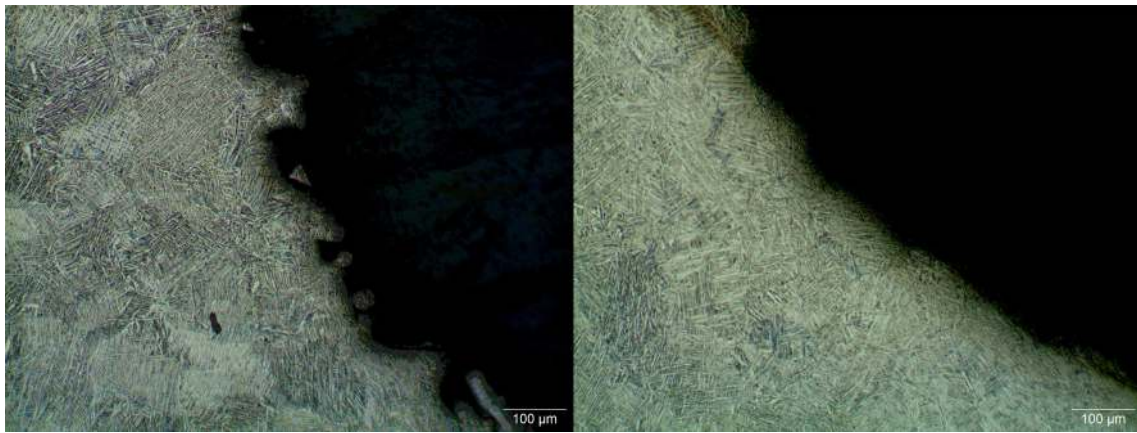
Fig. 4 Optical micrographs of polished and etched cross section of SLM Ti-6Al-4V notch root with as-built surface (left) and after CAVF (right)

For SLM Ti-6Al-4V, fatigue crack initiation occurs in the vicinity of the notch root. Notched Ti-6Al-4V samples were printed in a flat orientation, so the surface of interest is the vertical wall of the notch itself. Metallographic images in Fig. 4 show polished sections looking down the wall of the notch in tested specimens. Surface features on the as-built surface on the left-hand side are not present in the CAVF surface-treated specimen in the right-hand image.

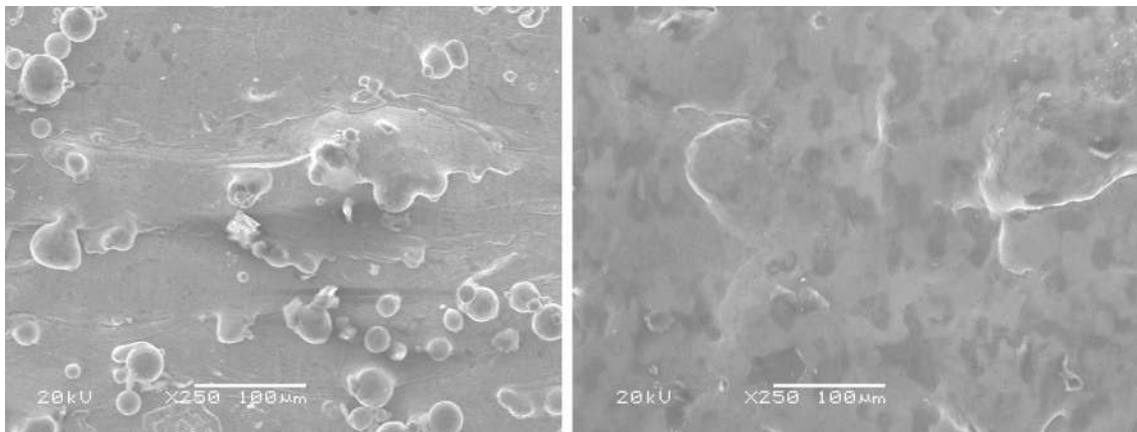
Fig. 5 Scanning electron micrographs of the surface (vertical wall) of SLM Inconel 625 notched fatigue specimen in the as-built condition (left) and after laser remelting (right)

Figures 5 and 6 show the result of laser remelting and abrasive polishing, respectively, of SLM Inconel 625. Powder particles have again been removed by both processes. The laser remelting process leaves some surface waviness, while the abrasive treatment leads to very smooth surfaces, although some surface depressions remain, as shown in the right-hand image of Fig. 6. A metallographic cross section of a laser remelted surface (Ref 20) (taken from a test article, not a fatigue specimen) is shown in Fig. 7. The remelted layer is characterized by a uniform melting depth and no apparent heat-affected zone in the parent material. Because the sample was HIP'ed prior to laser treatment, the remelted layer has a different microstructure that is characteristic of as-built SLM 625 with no subsequent thermal treatment.

The case of laser polished Inconel 625 is more complicated than that of Ti-6Al-4V. On the one hand, Fig. 5 shows that the surface roughness is decreased by the laser remelting, but that other surface topographic features or asperities are either not fully melted or not removed by the process. SEM images of fracture surfaces of as-built and laser remelted specimens

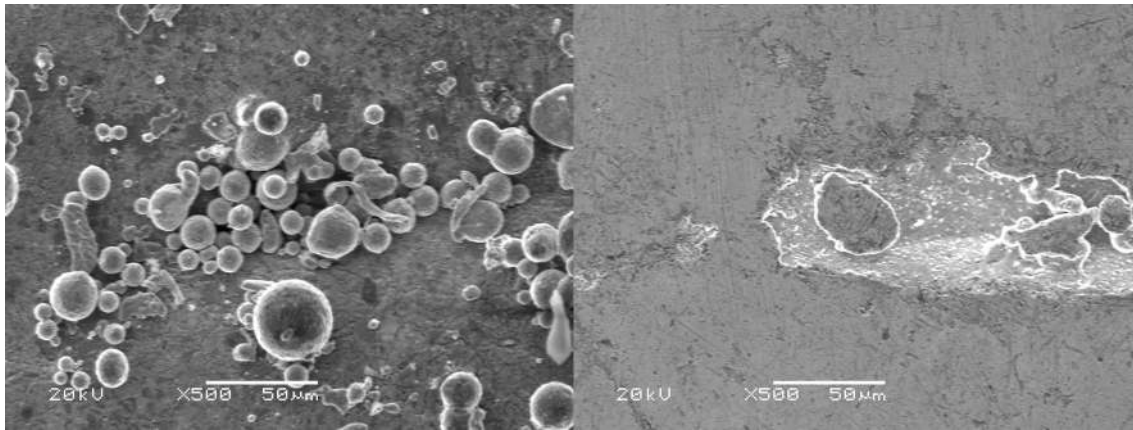
Fig. 6 Scanning electron micrographs of the surface (vertical wall) of SLM Inconel 625 notched fatigue specimen in the as-built condition (left) and after abrasive polishing (right)

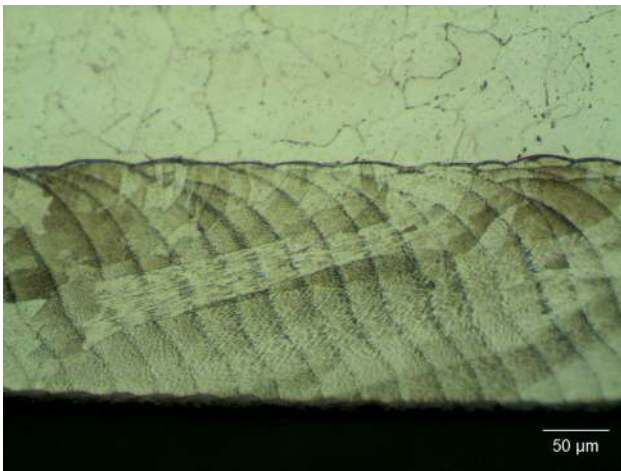
Fig. 7 Optical micrograph of a laser remelted layer on a SLM Inconel 625 parent material

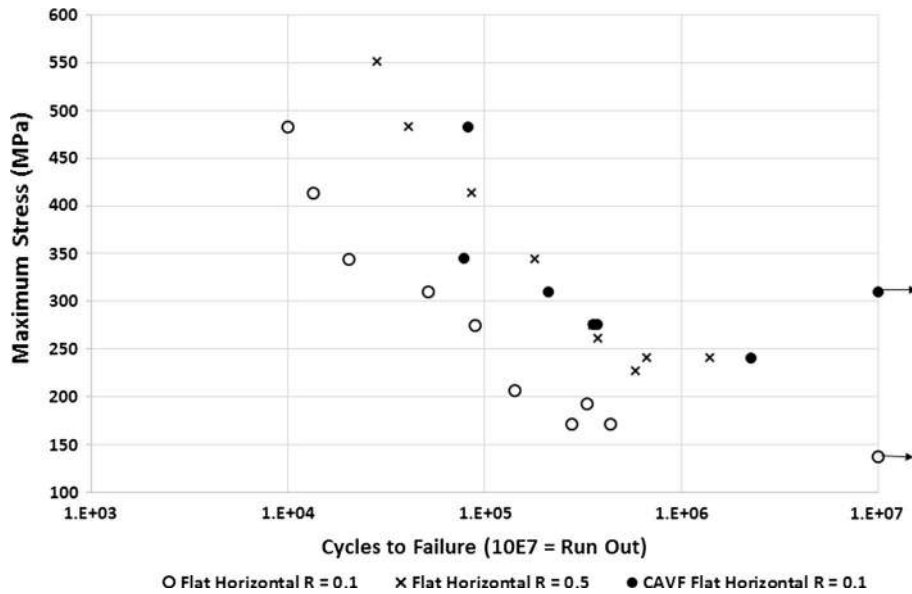
Fig. 8 S–N plot of fatigue results for EBM Ti-6Al-4V. Data points for suspended tests are marked by arrows

Fatigue results are presented as S–N plots. In Fig. 8, results are shown for flat EBM Ti-6Al-4V dog bones at $R = 0.1$ and 0.5 with as-produced surfaces and $R = 0.1$ for specimens treated by CAVF. In this plot, one CAVF-treated specimen

tested at a maximum stress of 310 Mpa ($R = 0.1$) did not fail after completing 10 M cycles. This was a much greater number of cycles than another specimen tested at 310 MPa, which failed after approximately 200 K cycles. The sample that did not fail at 310 MPa was retested at a maximum stress of 485 MPa, failing after 82 K cycles. Results at 310 and

485 MPa are seen to be somewhat greater than the rest of the trend described by the treated samples, and subsequent inspection of the fracture surfaces using SEM did not reveal any unusual features in comparison with other EBM Ti-6Al-4V samples that received the same surface treatment.

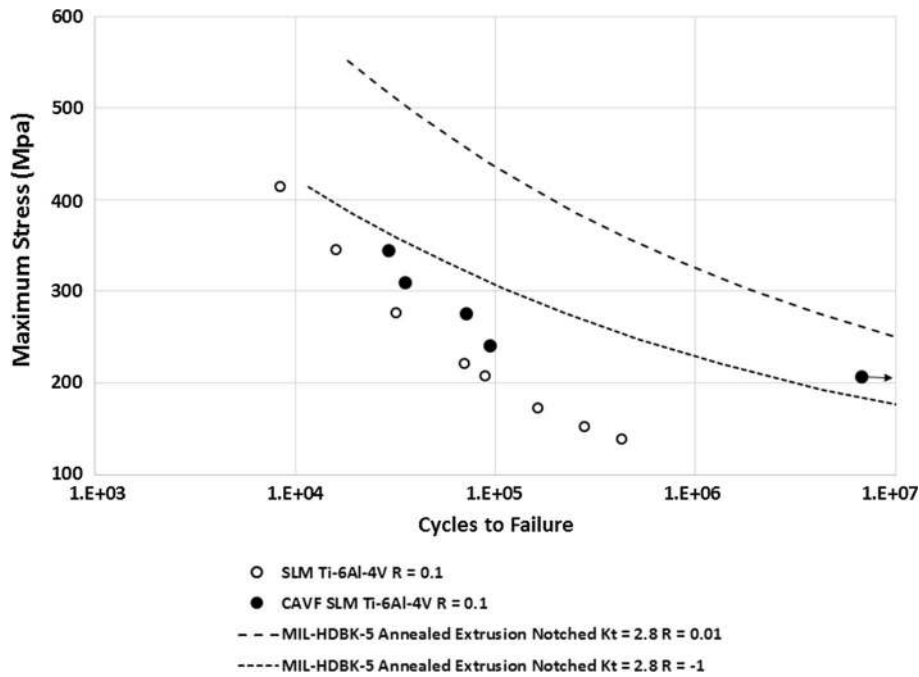
Fig. 9 S–N plot of fatigue results for SLM notched Ti-6Al-4V

S-N curves for notched specimens of Ti-6Al-4V made by SLM are shown in Fig. 9, along with models of notched fatigue ($K_t = 2.8$) for annealed Ti-6Al-4V extrusions from MIL-HDBK-5 for comparison. In this case, the CAVF treatment leads to approximate doubling of the number of cycles to failure at a given load. The test run at 205 MPa was halted after 6.7 M cycles. Based on the test results, 205 MPa is estimated as a practical endurance limit for the SLM material in the presence of a notch with $K_t \sim 3$ and $R = 0.1$ after CAVF treatment. The lowest test load for the untreated notched Ti-6Al-4V specimens was 138 MPa, which failed after 428 K cycles. This is too few cycles to estimate the endurance limit for this condition, but given typical characteristics of S-N curves for SLM, EBM and wrought Ti-6Al-4V materials, it is expected that the CAVF treatment would lead to an improvement in endurance limit of 50-100%, or from 100 to 140 MPa to the measured 205 MPa.

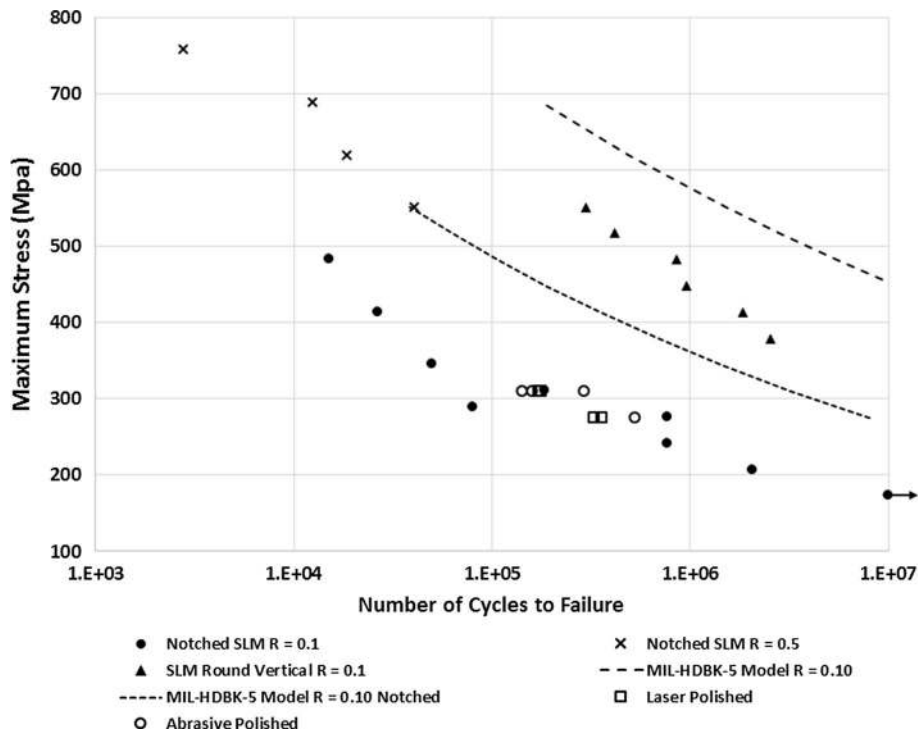
Fig. 10 S–N curve of fatigue results for SLM notched Inconel 625

The final set of fatigue results is for SLM Inconel 625, as shown in Fig. 10. Included in Fig. 10 are data for vertical round SLM alloy 625 specimens tested at $R = 0.1$ with as-produced surfaces (Ref 9), along with models based on MIL-HDBK-5 data for wrought annealed Inconel 625 tested at $R = 0.1$ for both notched ($K_t = 3$) and unnotched samples. The vertical SLM specimens' fatigue behavior in comparison with these two models was the basis for an estimate that the fatigue behavior of this alloy in SLM form with an as-produced surface could be conceived as roughly equivalent to a notched bar with K_t approximately 2.4-2.8 (Ref 9). The actual notched specimens that are plotted are for horizontally oriented samples with a notch elastic stress concentration factor of 3. The notched samples with as-produced surfaces have S-N curves that are offset from the wrought annealed model with $K_t = 3$ by roughly the same magnitude as the vertical samples are offset from the unnotched wrought annealed material. In this case, however, surface improvement did not lead to any apparent improvement in fatigue behavior. SLM 625 notched samples were split between abrasive surface polishing and laser remelting, and all such samples were tested at either 275 or 310 MPa maximum stress. The results in Fig. 10 for the surface-treated specimens are at best ambiguous, and unlike the results for Ti-6Al-4V, improvement in fatigue performance cannot be inferred.

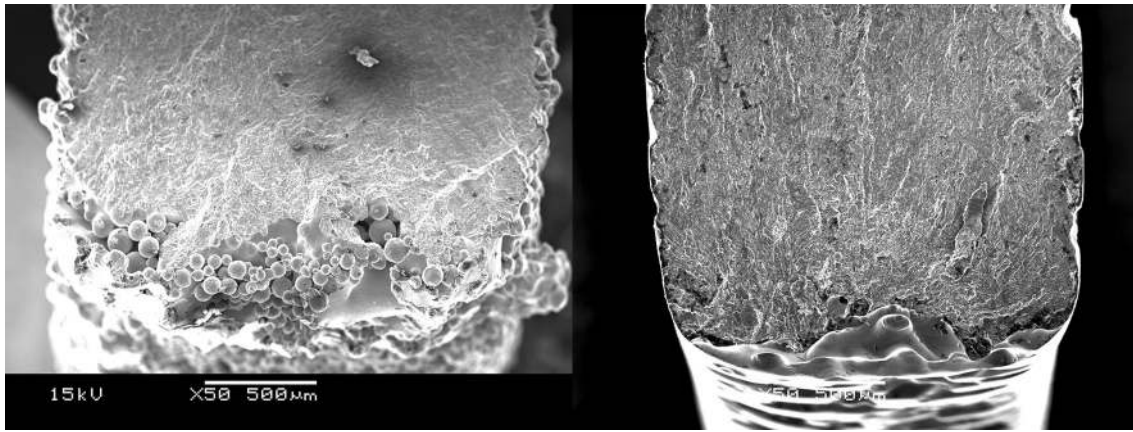
Fig. 11 Fracture surfaces of EBM Ti-6Al-4V fatigue specimens with as-built EBM surface (left) and after CAVF (right)

The surface features that contribute to reduced fatigue lifetimes or endurance limits in as-built specimens can be seen in fracture surfaces of tested fatigue specimens. Fracture surfaces for as-built and CAVF-treated EBM samples are shown in SEM images in Fig. 11. The orientation of the fracture surface in these images is identical to the orientation in which the specimens were printed. This perspective also shows some degree of rounding of the corners of the specimen after the CAVF process, an effect that would not have been accounted for in dimensional measurements, but would also tend to raise the actual stress in the test specimen due to slightly lower cross-sectional area compared to measuring width and thickness and assuming a rectangular cross section.

In all cases, the fatigue crack initiation occurred at the bottom surface of the EBM specimens. In the as-built specimen, the bottom surface is uneven, and unmelted regions can be seen penetrating upward approximately 500 μm into the net section. The surface treatment leads to a more even surface roughness, but as discussed previously by stopping the process after total material removal of 300–400 μm , some of the surface

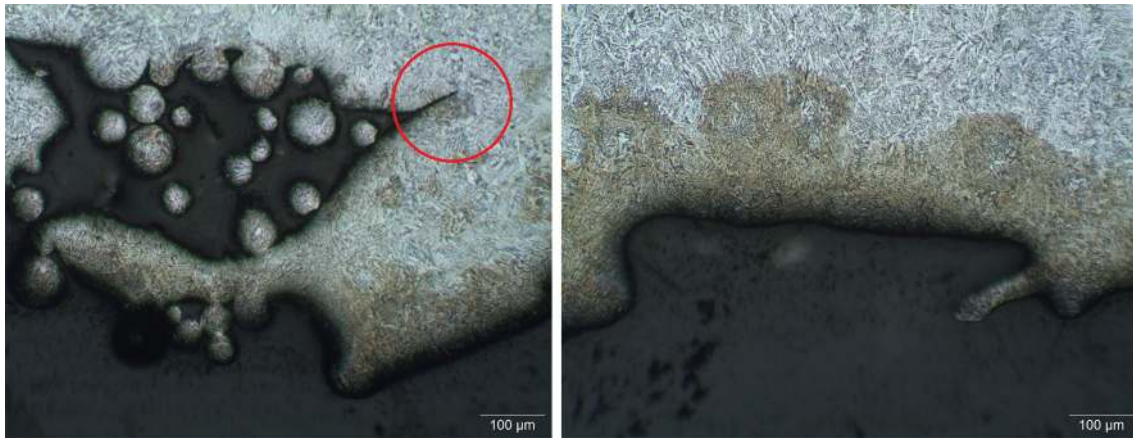
Fig. 12 Optical micrographs of polished and etched cross sections of EBM Ti-6Al-4V with as-built surface (left) and after CAVF (right). The surfaces shown correspond to unsupported horizontal surfaces facing downward in the vertical direction with respect to the EBM growth direction. The circled feature in the left-hand image is inferred to be typical of high stress concentration where fatigue cracks initiate, and is not present after CAVF treatment

defects are still present, and it is at these types of features where fatigue cracks initiate in the treated samples. It is notable, however, that the interior surface of these flaws has been smoothed and rounded relative to the starting condition. Considering the similarity in R_v for the as-built and treated EBM Ti-6Al-4V (although this was measured on vertical walls, not bottom edges of these samples), the CAVF process is eroding the surface of these surface defects, so the peak depth relative to the sample surface does not change, but the shape of the defect has changed. This is illustrated in metallographic cross sections from the bottom surface of a fatigue specimen in Fig. 12. The circled feature on the left-hand image is a crack-like feature that may have resulted from lack of fusion between adjacent electron beam passes or incomplete melting of powder particles. In the right-hand image, not only has the depth of the surface features been reduced, but this type of fatigue crack starter feature has been removed.

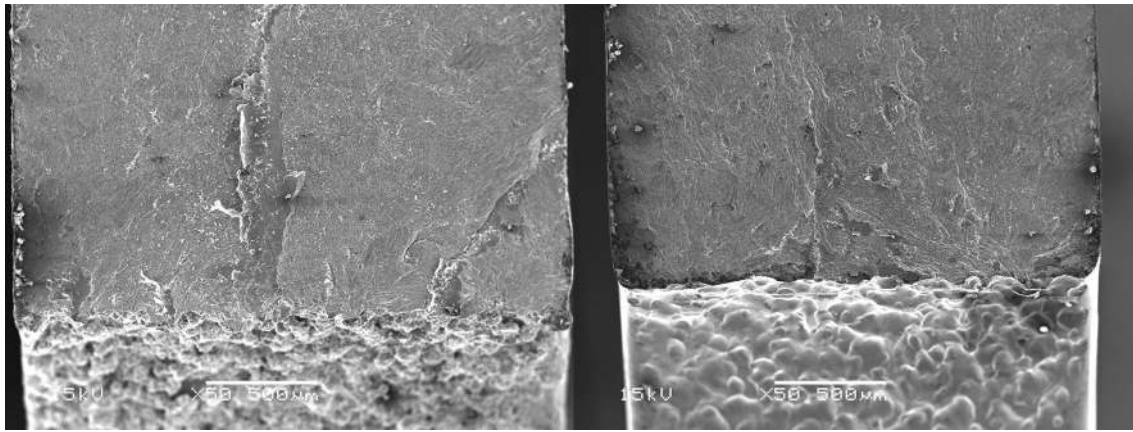
Fig. 13 Fracture surfaces of SLM Ti-6Al-4V fatigue specimens with as-built SLM surface (left) and after CAVF (right)

Fracture surfaces of the SLM samples are shown in Fig. 13. The edge of the specimen in the as-built tested specimen is much more even than the EBM Ti-6Al-4V specimen, not only due to intrinsic differences in the two processes but also because of the orientation of the specimens in the printer. In addition, the edge of the fracture surface in the treated specimen shows that defects penetrating the net section are rounder and

their interior surfaces are smoother in comparison with the as-built specimen.

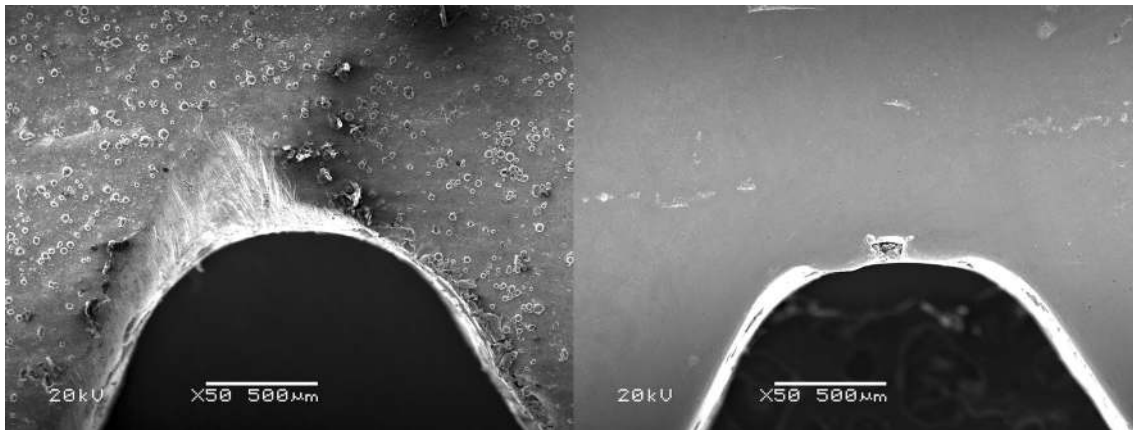
Fig. 14 Scanning electron micrographs of the notch in SLM Inconel 625 specimens in the as-built condition (left) and after abrasive polishing (right). Although the improvement in apparent surface roughness is obvious, the surface feature at the notch root likely responsible for lower fatigue performance compared to wrought or machined specimens is not removed by abrasive polishing

In the case of SLM Inconel 625, the shortcomings of the abrasive polishing from a fatigue perspective are illustrated by SEM images of the surfaces of notches in as-built and polished specimens that were facing downward vertically during printing

and built without supports (Fig. 14). Downward facing or highly inclined surfaces in powder-bed AM have higher surface roughness than vertical walls, so while the surface roughness of the vertical wall surrounding the notch has been smoothed to sub-micrometer R_a values, the notch root itself shows that a defect is still present. This is a similar outcome of abrasive polishing to that shown in Fig. 6 for a vertical wall, where the roughness due to the adhered powder particles has been removed, but surface defects remain even though measured surface roughness was greatly reduced. Unlike the reduced stress concentration due to CAVF in titanium, the results of abrasive polishing can be considered a reduction in the effective depth of a crack-like surface feature, but not a blunting of its tip. In the case of the elastic stress concentration of a surface notch, small changes in the depth of the notch due to material removal of the surface, while the radius of the notch root is left mostly unchanged, will not lead to significant reductions in K_t (Ref 26; see, for example, Table 6-1, Case 2a, p. 275).

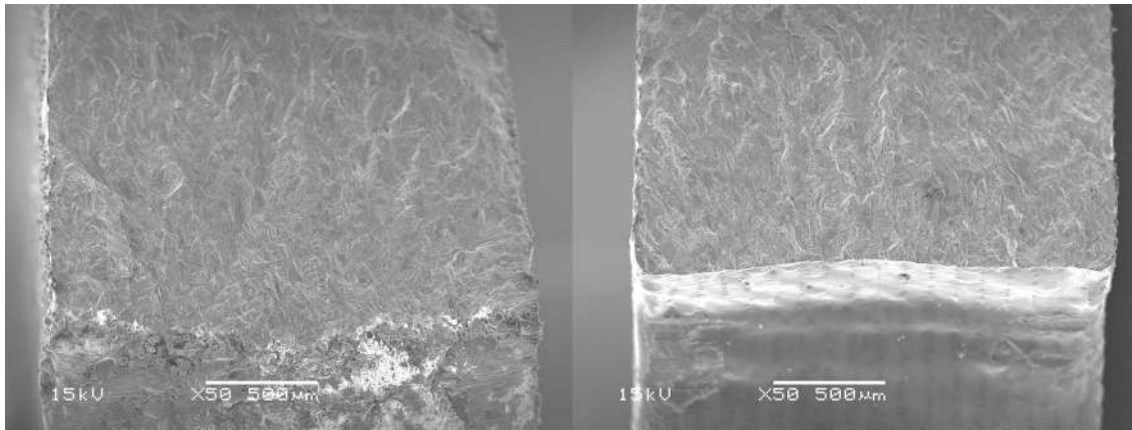
Fig. 15 Fracture surfaces of SLM Inconel 625 notched fatigue specimens with as-built SLM surface (left) and after laser remelting of the notch surface (right)

(Fig. 15) tested at the same stress levels (310 MPa) show considerable improvement in the smoothness of the edge of the notch where fracture initiated. At the same time, the remelted layer shown in Fig. 7 exhibits a rapidly solidified microstructure and an interface with the unmelted parent material, both of which may be more prone to crack initiation even though the outer surface is smoother. The transition from the laser remelted area to the parent material is not seen on fracture surfaces. It is thus not obvious whether the remelted layer is rapidly breached by a fatigue crack at the notch root, meaning that it plays no role in the fatigue of the specimen overall, or if it simply has a similar fatigue crack initiation behavior to the HIP'ed material with an as-produced surface, and is too thin to influence the number of cycles to failure even though its microstructure is different than the bulk material. While the authors are not aware of fatigue testing being performed on SLM specimens subjected to laser polishing, it is likely that a more appropriate approach to future testing will be to perform the polishing step on as-built material, and then HIP the samples so that the entire sample has a uniform microstructure to complement the smoother surface.
