TECHNOLOGY FOR INTEGRATED GROUYNE-VETIVER EROSION REDUCTION (TIGER): CASE STUDY IN A WEST AFRICAN RIVER

TECHNOLOGY FOR INTEGRATED GROYNE-VETIVER EROSION REDUCTION
(TIGER): CASE STUDY IN A WEST AFRICAN RIVER

A THESIS

In Environmental Engineering

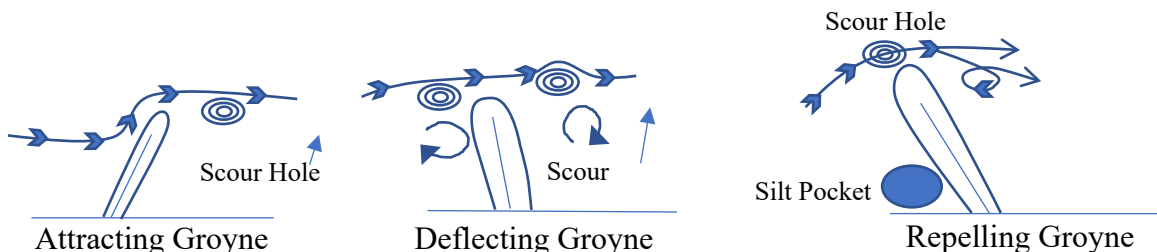
Figure 5. *Different types of groynes (image adapted from Pitroda, 1994).*

The last classification is how each groyne is designed in this demonstration case study. Figure 7 shows all the different ways that groynes can be constructed and each has its own benefits and drawbacks. This is why it is important to understand how each of these classifications works and what effect it has on stream flow (Yossef, 2002).

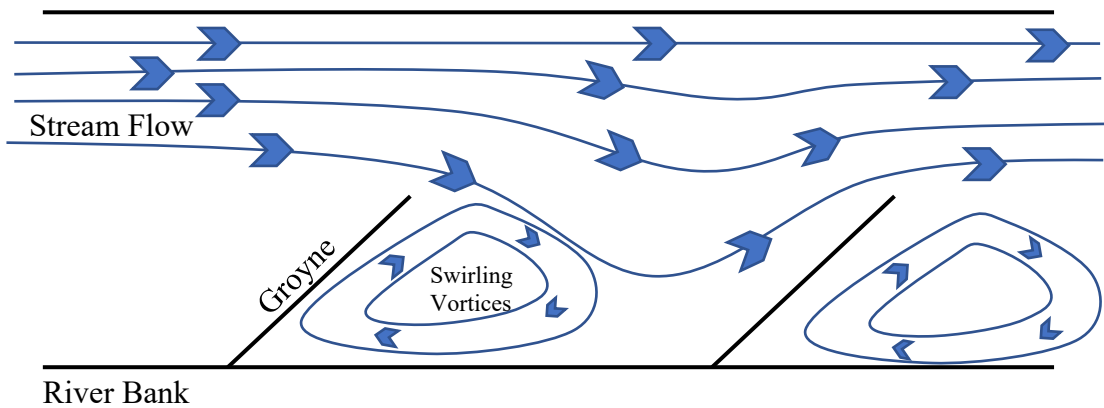
Figure 6. Swirling vortices created by groynes in a stream (photo created by author)

A big reaction that occurs once groynes are placed are vortices and scour as shown in Figures 8 and 9. Vortices are a mass of whirling fluid in a stream. These can occur when obstructions are added to the stream and the flow lines are interrupted. When a groyne is added, the velocity at that point increases because the channel width is decreased. This points to the need for inspecting and replacing groyne rocks when needed.

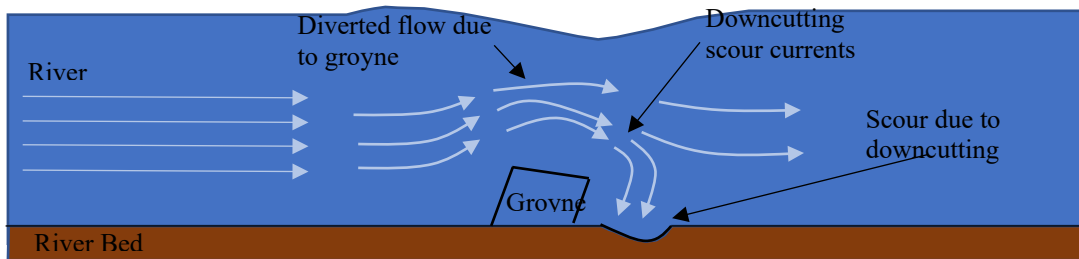
Figure 7. Stream flow lines interrupted by groyne placement (photo adapted from Jackson, 2015)

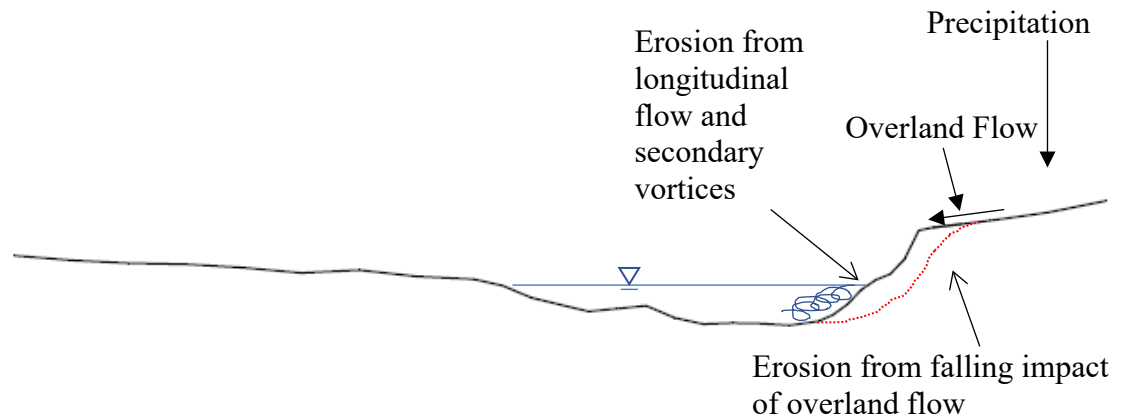
Figure 8. *Erosion mechanisms (image created by author)*

As shown in Figure 5 and mentioned earlier, when precipitation occurs and the ground becomes fully saturated from infiltration, the excess water then flows down slope called overland flow. This overland flow can become problematic when the land is not protected and can then cause impact erosion along the bank due to the overland flow falling into the stream. In the stream also, there is a mechanism called swirling vortices. This occurs in nonuniform sections of channels where the flow lines are interrupted. Having the overland flow falling into the stream along with swirling vortices from stream velocity, extreme erosion can occur at the bottom of the bank.

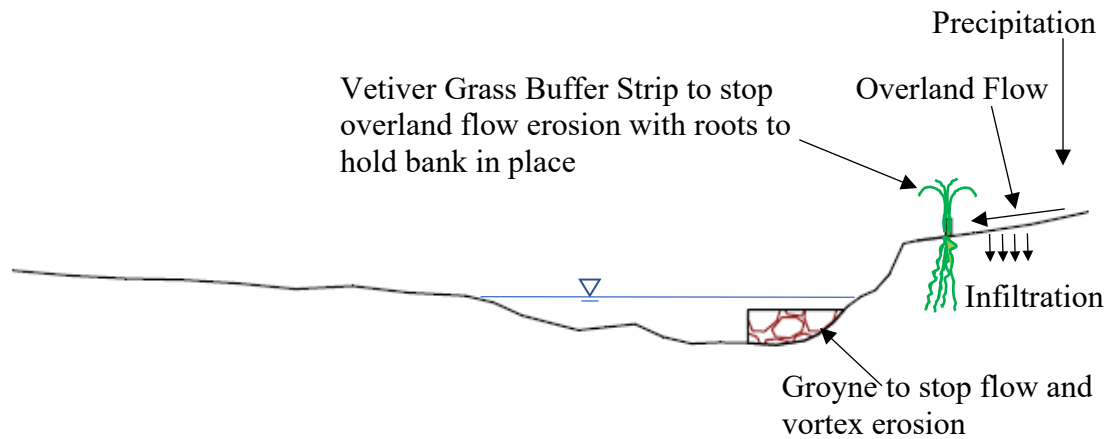
Figure 9. *Implementation of the TIGER method (image created by author)*

Implementing the TIGER method by building groynes in the stream bed and planting vetiver grass on the top of the bank is hypothesized here to help slow down impact erosion as shown in Figure 6. The vetiver grass on top of the bank will slow down overland flow by allowing it to infiltrate into the ground. This result is beneficial since

the vetiver grass will appropriately allow sediments to settle out as it meets the vetiver grass. This correction will help minimize the overland flow that falls into the stream. The groyne redirect the high velocity flows along the bank of the stream into the middle of the stream bed. This action minimizes erosion-inducing swirling eddies which ultimately reduces erosion along the bank toe.

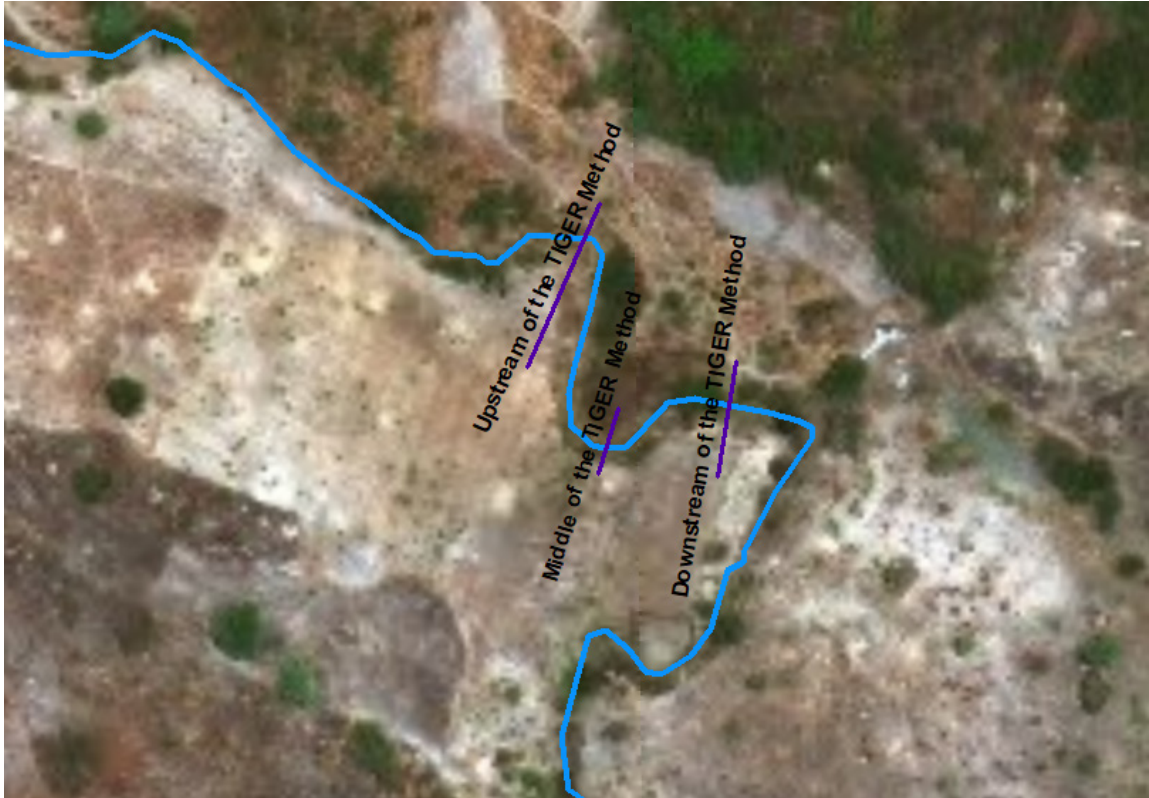
Figure 10. *Position of cross sections around the test site (Aerial photo obtained from ESRI Basemaps, diagram created by author in ArcGIS).*

The new TIGER Method was demonstrated on a section of the stream. The section of river was a horseshoe bend. There were high levels of erosion around the outside bank of the horseshoe and downstream of the bend. Because of these high levels of erosion and instability, the TIGER method was implemented here. Cross sections elevations were measured both upstream and downstream, to see the change in the stream bed over time. A cross section was also taken in the middle of the horseshoe section, where the TIGER method was implemented, to monitor how the method affected the stream as shown in Figure 10.

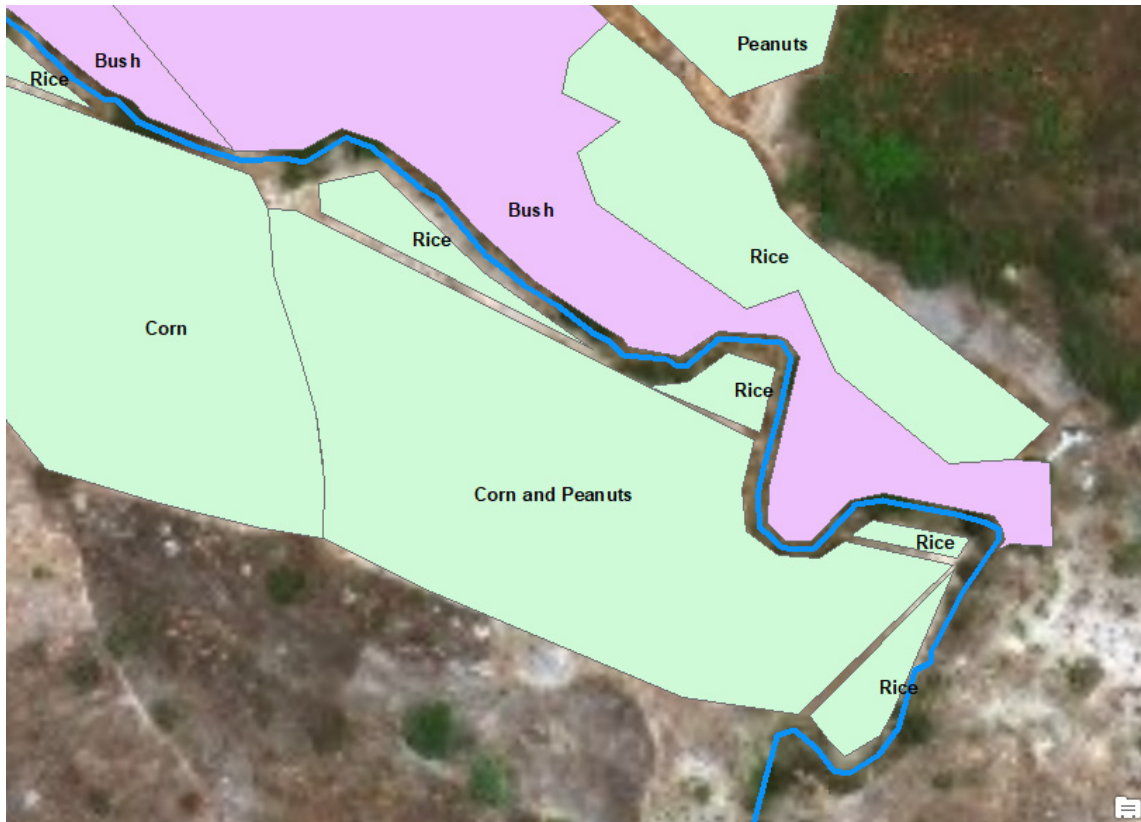
Figure 11. Land cover/Land use surrounding the test site (Aerial photo obtained from ESRI Basemaps, diagram created by author in ArcGIS).

The length of stream from upstream cross section to downstream cross section is approximately 90 meters. The section of stream runs through farmland. The right bank has rice fields up to the stream near the upstream and downstream cross sections, and corn fields along the middle cross section. The left bank is more natural, having rice fields around the upstream cross section. There is a little bit of a natural buffer strip left around the middle and downstream cross sections as shown in Figure 11.

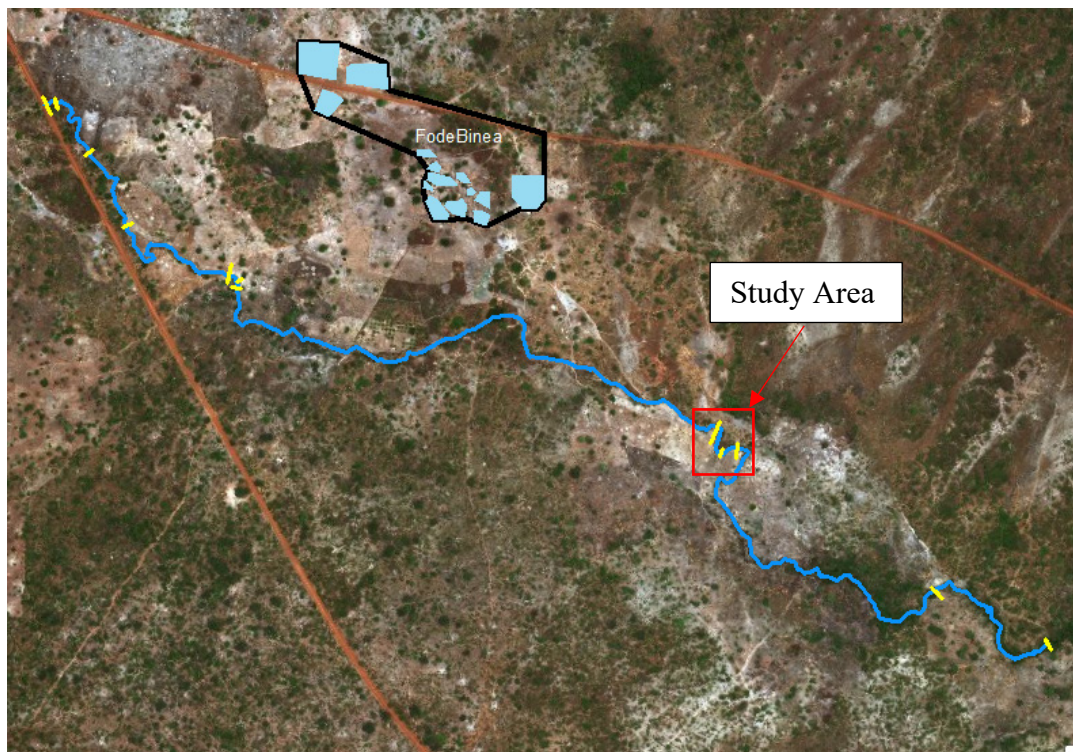
Figure 12. Extent of entire stream reach and where each cross section is located, and boundary of village to show for reference. (Ariel photo obtained from ESRI Basemaps, diagram created by author in ArcGIS)

Throughout the two years, 12 cross sections were taken. These sections became baselines to be compared over the time. These sections were chosen by getting a wide variety of stream stability conditions on the stream (prevalence of erosion). Some of the sections are healthy streams with very little erosion, while the other sections were unstable and had major erosion problems. There were also sections that fell in between these extremes. The channel was walked many times in the first rainy season to determine where this variety of cross sections could be measured. Most of the sections were chosen for ease of accessibility. Because of this ease of access, some of the sections shared banks with farmer's fields. Due to some thick brush and trees, some long stretches of the stream were not able to be measured. Figure 12 shows the extent of the 2.9 km river and where the cross sections were taken, along with the village.

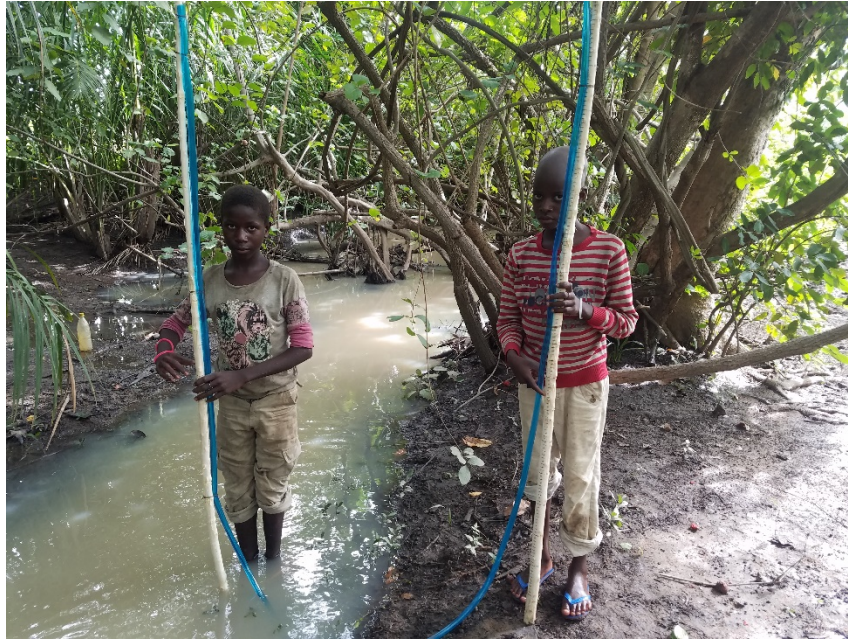
Figure 13. *Helpers using the Egyptian Water Level pointing at the water elevation on each stick. (photo by author)*

easy to use. The Egyptian Water Level is a device made up of sticks and clear tubing as shown in Figure 13. All the materials were gathered locally. The tubing was 400 CFA (\$0.68) per meter, and the sticks were collected locally from a neem tree, whose limbs are very straight.

The sticks are measured and marked. In this case, the sticks were two meters in length and measuring lines were marked every centimeter. This allows the change in elevation to be measured down to the nearest centimeter. Then the clear tube was tied onto the sticks. The tube was five meters in length and allowed for easy transportation and mobility. The tube was then filled with water, making sure that all the air bubbles and kinks were out of the tube, which can cause false readings. The water can be seen through the tube and readings can be seen on the marked sticks. The water surface is always horizontal, so the difference in the readings between sticks is the change in elevation over that known distance.

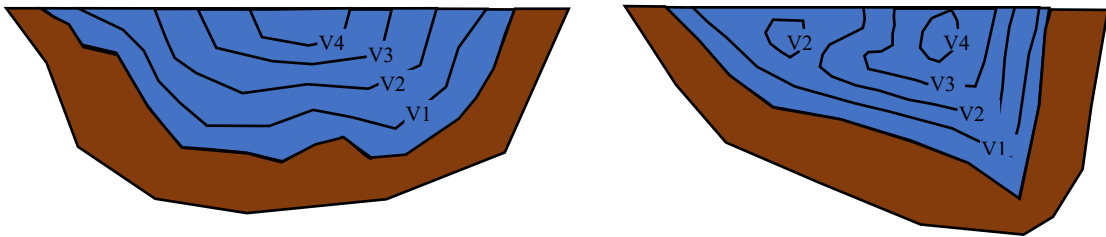
Figure 14. *Velocity contours at stream cross sections: (left) in a relatively straight section of channel, and (right) at a bend in the channel. In both cases, $V4 > V3 > V2 > V1$. Adapted from Gordon, McMahon, & Finlayson, 1992*

This float method determines surface velocity. The velocity of a stream varies throughout the vertical profile as well as longitudinally with the fastest velocity being near the center of the stream and just under the free water surface of the stream as shown in Figure 14.

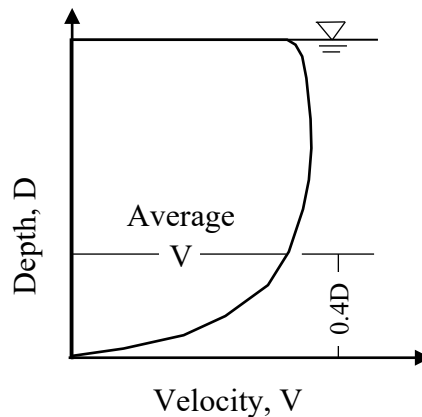
Figure 15. *Vertical Velocity Profile of a stream channel. Adapted from Gordon, McMahon, & Finlayson, 1992*

The understanding of how the velocity is distributed throughout an actual channel becomes important when calculating the actual flow. The average velocity of a velocity profile is approximately 40% of the way from the bottom of the stream as shown in Figure 15 (Gordon, McMahon, & Finlayson, 1992). However, this is for a uniform channel with uniform flow. The average velocity of the velocity profile will vary due to many different factors of a natural stream. One of those factors is stage height. (Table 2 shows the coefficients correlated with the corresponding stage height).

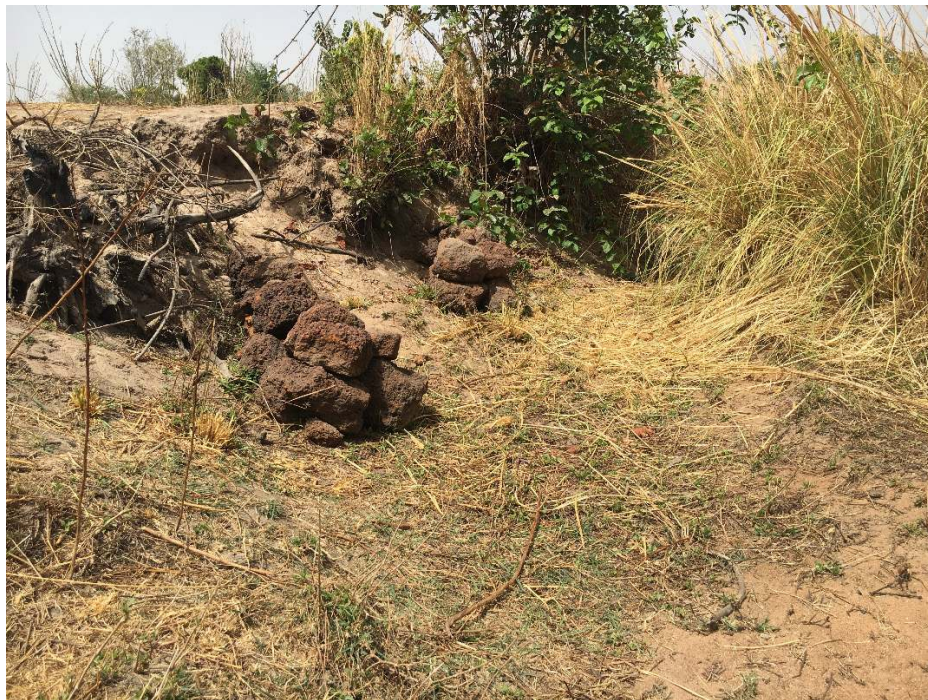
Figure 16. *Photo of 2 groynes built and placed at the end of the test site. (photo by author).*

Once all the rocks were collected, placement started. The first groyne was placed in the upstream portion of the horseshoe just upstream of the major erosion area. The type of groyne that was built was permeable, submerged, attracting, and straight. This was since the groynes can protect both upstream and downstream. So, the sediment will be starting to settle out just as the erosion areas are beginning as well as in front to reinforce the whole bank. The first one was built with a base of about 0.5 meters wide and measured one meter out from the bank into the stream as shown in Figure 16. Once the meter-long base was placed, rocks were carefully selected to sit on top of this base so that they will not dislodge during high flows. They were placed to a height of 0.5 meters. This was decided due to rock availability and the hard work of transporting and placing each rock. Once the first groyne was placed, the bank was measured 2.5 meters downstream from the first groyne, where the next groyne was placed. This was done until seven groynes were placed.

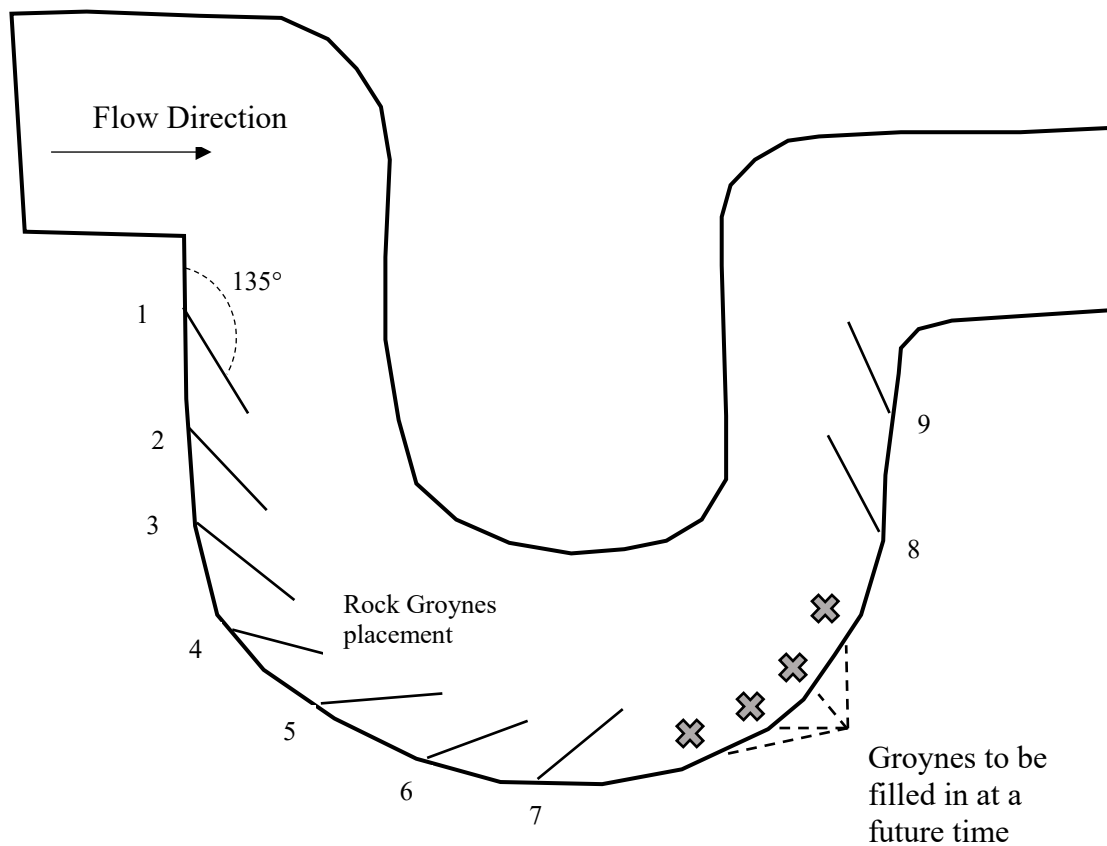
Figure 17. *Layout of groyne placement in test area (figure by author).*

The rock supply was running low and time before the rains started was getting shorter. Because of this, it was decided to measure out the rest of the places for the groynes and move downstream to the end of the horseshoe and built some there, working back upstream in attempts to fill the entire area. This area at the end of the horseshoe was the area of the highest erosion and needed the most protection. Wanting to protect the area, two groynes were placed at this point. The final layout of the built groynes can be seen in Figure 17.

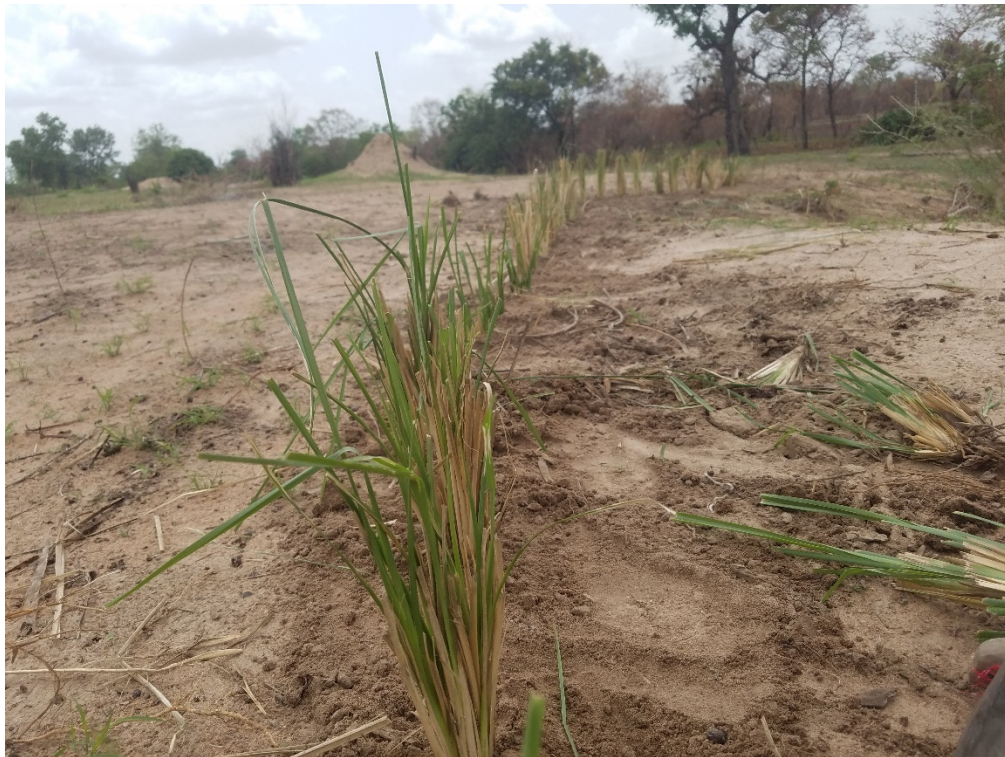
Figure 18. *Vetiver grasses spaced out at 20cm spacing along the bank (photo by author).*

Once all the slips were obtained, a line was drawn in the soil to indicate where they will be planted. This line was drawn with the contour line 1m away from the stream bank. The slips were planted along this line at 20cm spacing as shown in Figure 18. This spacing is a little bit sparse, but still starts to establish a hedge and will fill in over time. It was chosen due to timing issues and workload. The 20cm spacing is a good starting point and can then be filled in as time allows.

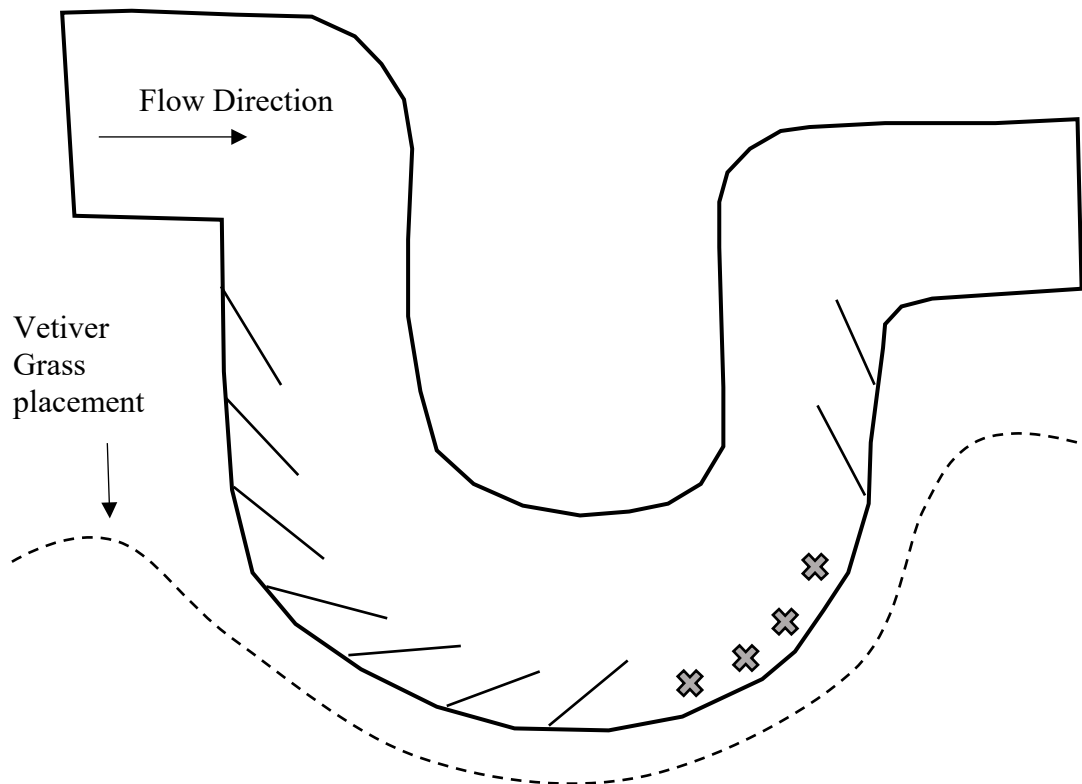
Figure 19. *Layout of vetiver grass placement at test site (figure by author).*

The vetiver hedge was then monitored through the beginning of the rainy season. As the new slips started to take root and grow, some of them died due to the planting retrieval process, and a few got washed away due to flood waters. In both instances, the slips that went missing or died were replaced to ensure a gap-free hedge. Figure 19 shows the layout of the vetiver grass along the bank of the stream.

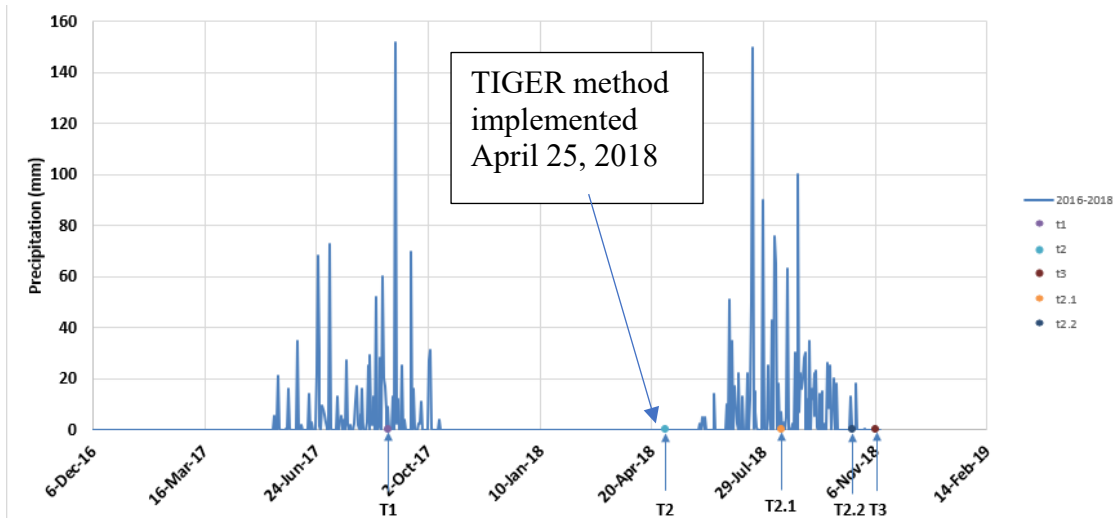
Figure 20. *Precipitation data at the Fode Binea Rain Gage and times of TIGER implementation and cross section data collection.*

Figure 20 shows the rainfall from 2016 to 2018. This is important to see when the cross sections, mentioned below, were taken compared to the rainfall. It is noted that in 2017, the heavy rainfall events were much later in the rainy season as compared to 2018 where the heavy rainfall events occurred much earlier. The timing of the heavy rainfall events

played a role on when the method was implemented. The times when the cross sections were taken are also plotted on the graph in order to see the relationship between the two. For erosion to be reduced, the cross sections would show reduced area.

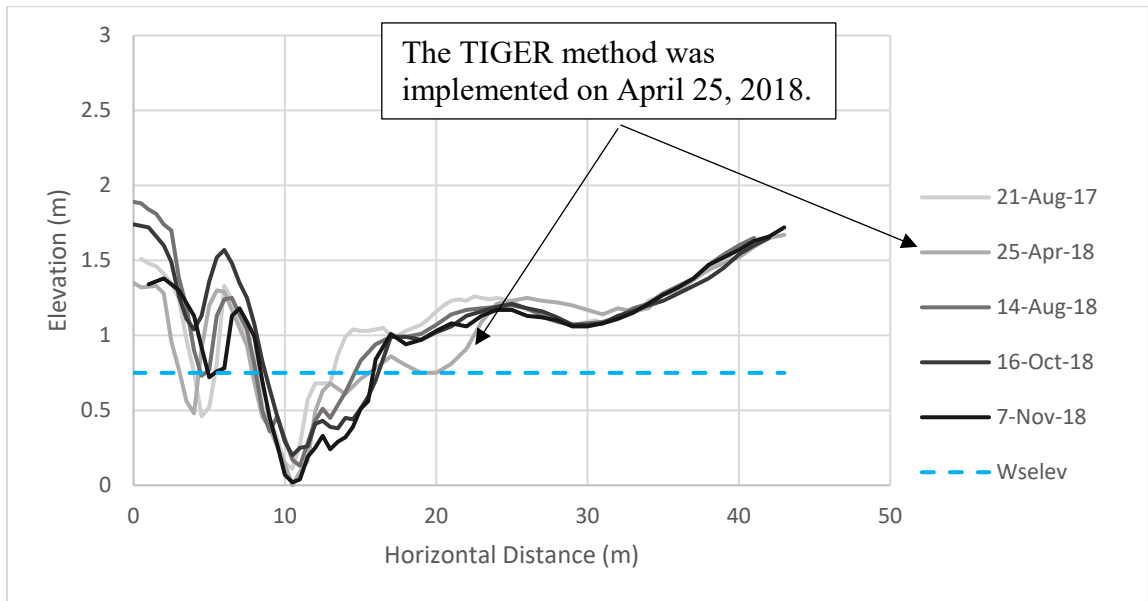
Figure 21. Cross section data for all times at a location upstream of the TIGER Method deployment.

Examining erosion at the section upstream of the TIGER Method location (Figure 10) to see if the TIGER Method affected erosion upstream, as seen in Figure 21, the stream channel bed was constantly increasing on the right bank. The right bank and right floodplain were where rice was farmed in this area. Because of this activity, the land and soil were always loose and free of vegetation which allowed for major erosion to occur during flood stages. There is also a 90° right bend just downstream of this section with a higher bank, so when the high flood stages occurred, the right side would flood first and the flow would be higher on that side. The stage-height-vs-velocity relationship is shown in Figure 22, and shows that, given the same stage height, the second-year velocities were faster than the first. This could be since the areas increase, allowing for more flow and faster velocities to occur. It should be noted that these measurements were taken when conditions were safe. There were many flood events that were higher than shown here, but to do safely, the sections were not able to be measured.

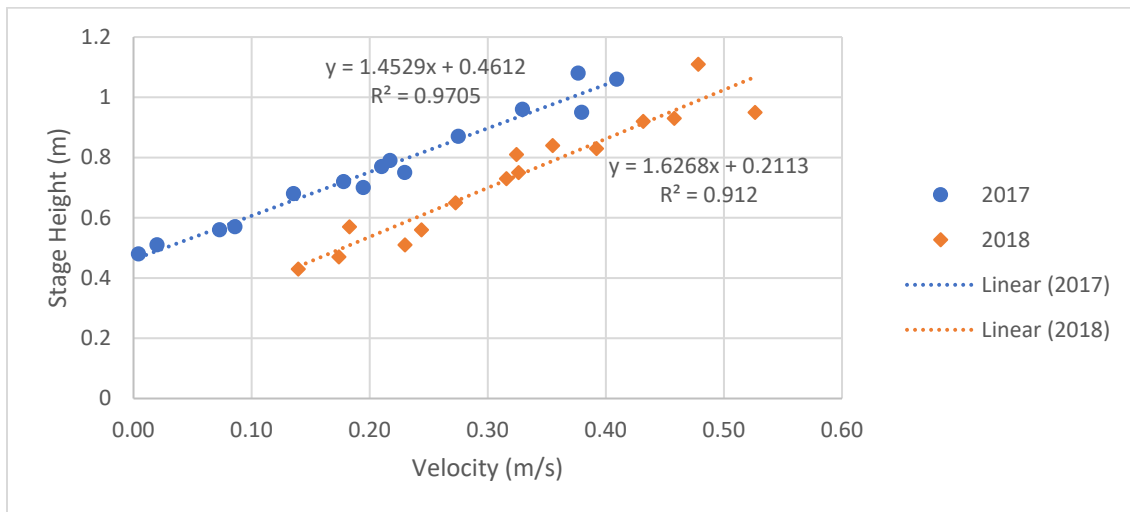
Figure 22. Stage-vs.-velocity graph upstream of the TIGER Method installation.

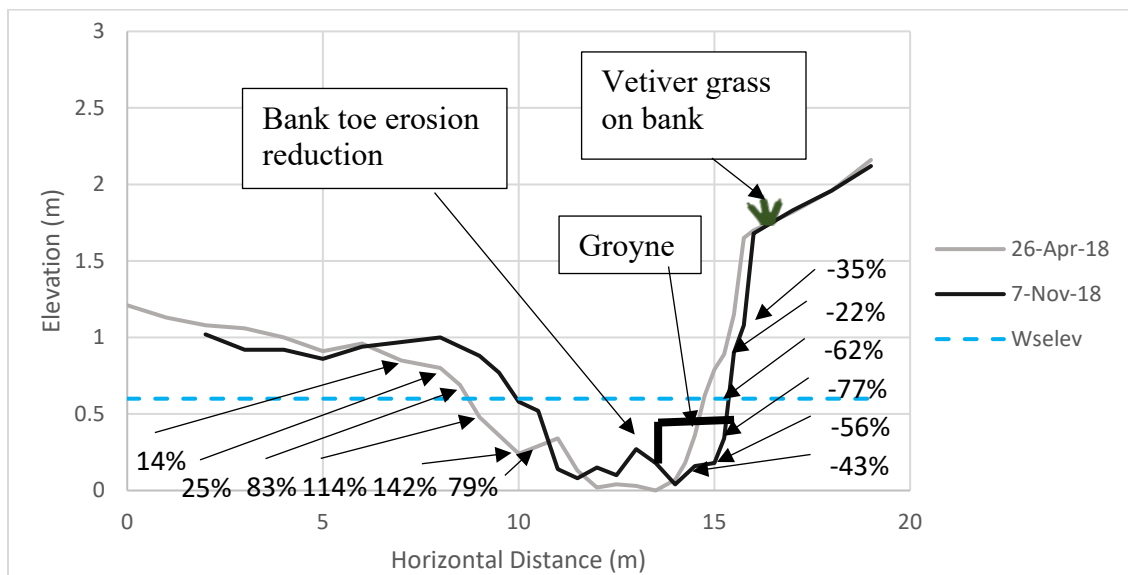
Figure 23. *Cross section data at the location of the TIGER Method implementation location.*

The location of the TIGER Method deployment is shown in Figure 23. This cross section shows that the right portion of the channel, the groyne side, had more change in bed elevation. This could be since during the beginning of the rainy season, there was sedimentation, but as the rains got heavier and the flows got faster, the recently settled sediment could have been eroded easier leaving the right channel vulnerable. On the left side of the channel, however, there seemed to be more sedimentation around the bank. This could be because as the upstream flow got directed towards the center of the channel and sediment deposited on the right bank. The middle of the channel also had sedimentation occur. This could be because there a decrease in velocity that occurred at the end of the groyne which could have allowed sediment to settle out. Only two cross sections were able to be taken at this location due to safe access difficulties. Vetiver grass was established but will fill in more in the future, thereby providing additional erosion and runoff reduction.

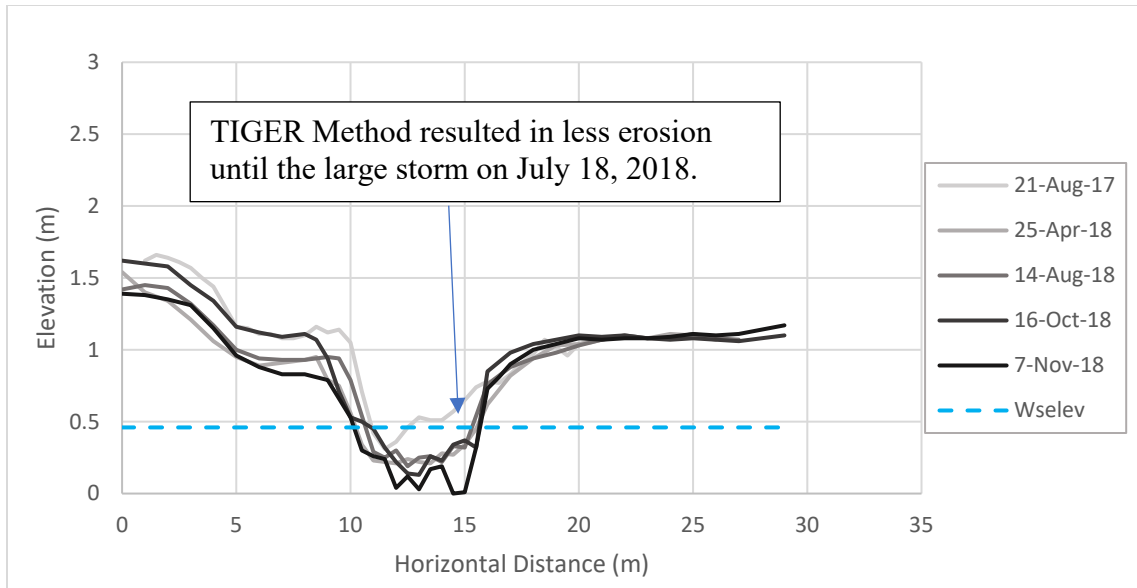
Figure 24. Cross section data downstream of the TIGER Method implementation site.

The section that was measured just downstream of the TIGER method implementation to see if the TIGER Method affected erosion downstream can be seen in Figure 24. These sections show that after the first year (2017), there was a large amount of erosion on the right side of the channel. In contrast, the second year (2018), when the TIGER method was implemented, shows that the channel held close to its original shape at the beginning of that year.

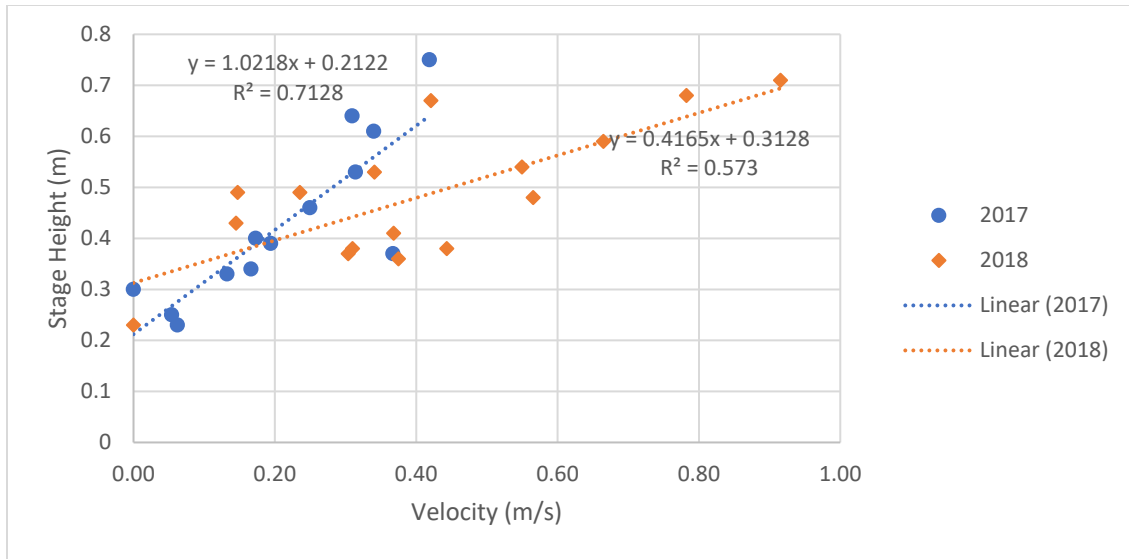
Figure 25. Stage-vs-velocity data downstream of the TIGER Method location.

Figure 25 shows the stage-height-vs-velocity relationship. This shows that, given the same stage height both years, the second year had higher velocities than the first year. This could be because the channel area increased allowing for more flow area which causes higher velocities.

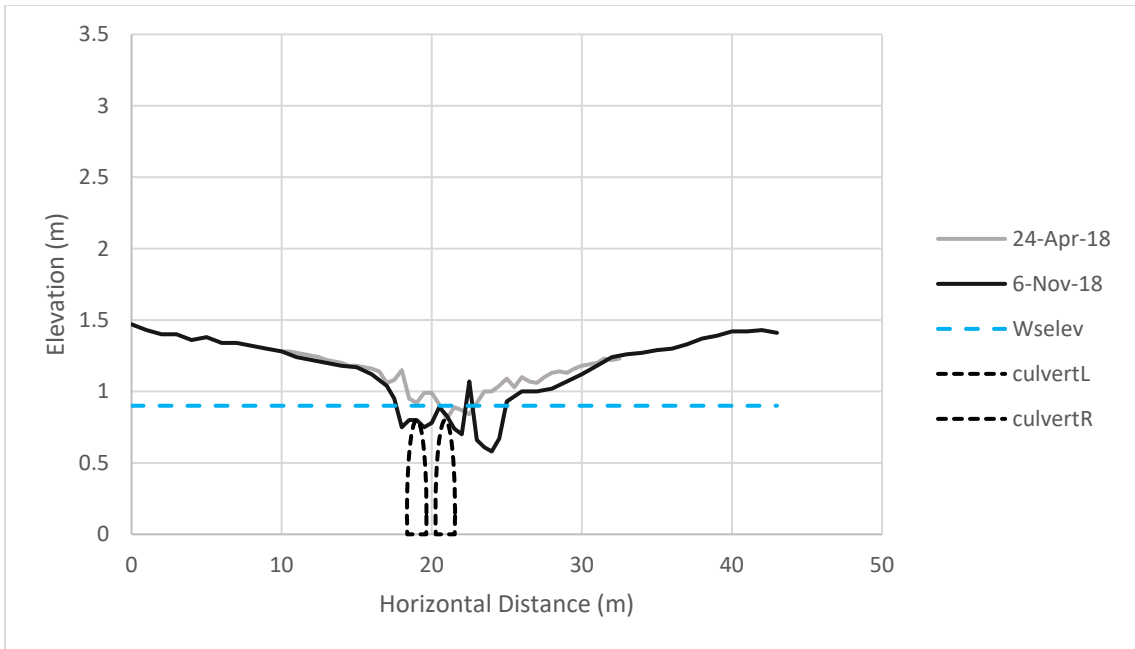
Figure A.2 *Cross section data at the Top of Reach location.*

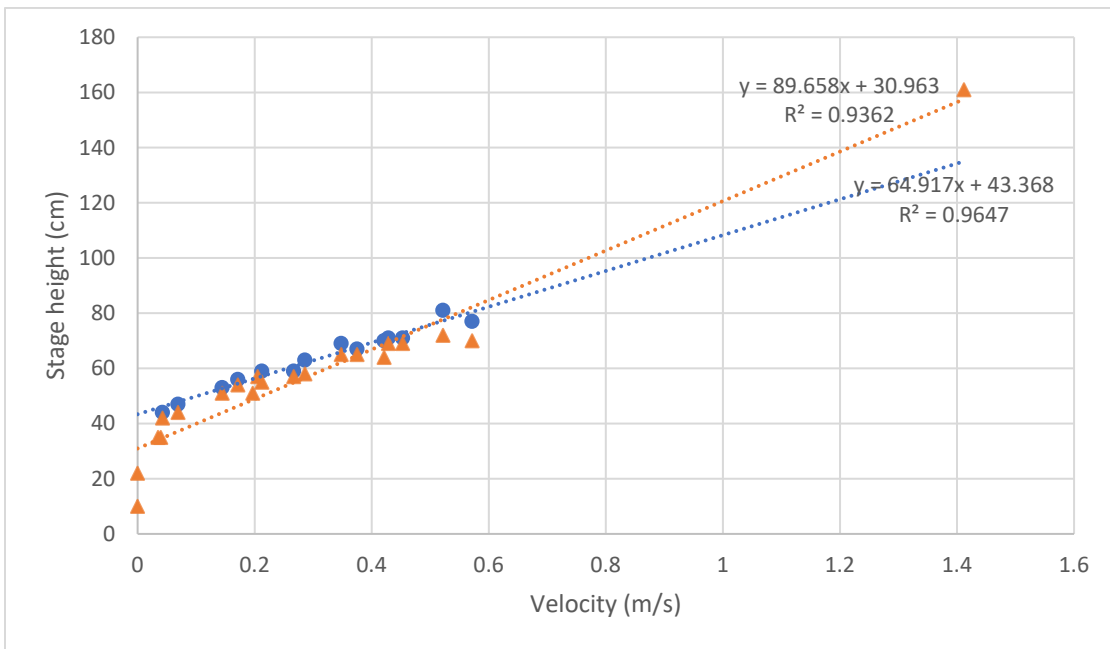
Figure A.3 *Stage-velocity data downstream of the Top of Reach location.*

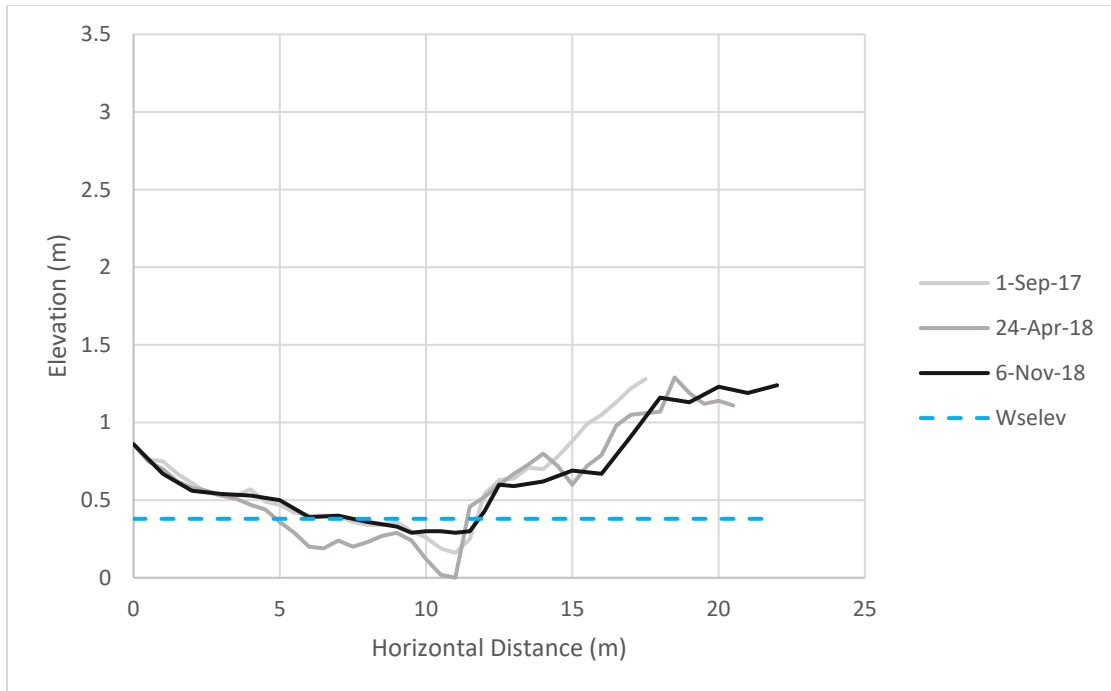
Figure A.4. *Cross section data at the Downstream of Top of Reach location.*

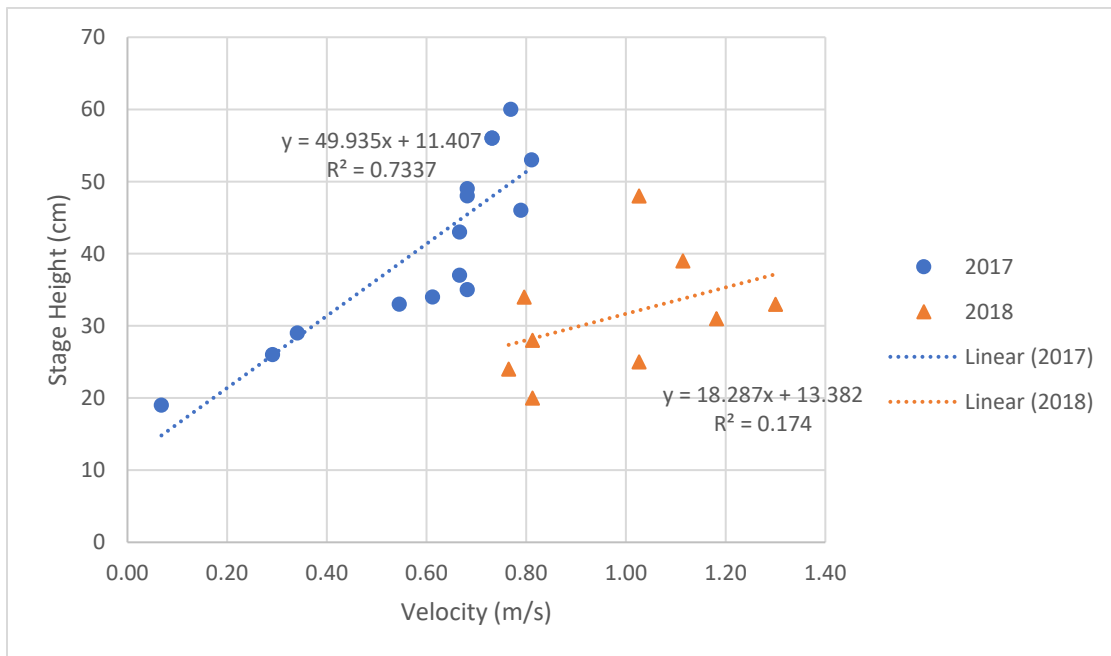
Figure A.5 *Stage-velocity data downstream of the Downstream of Top of Reach location.*

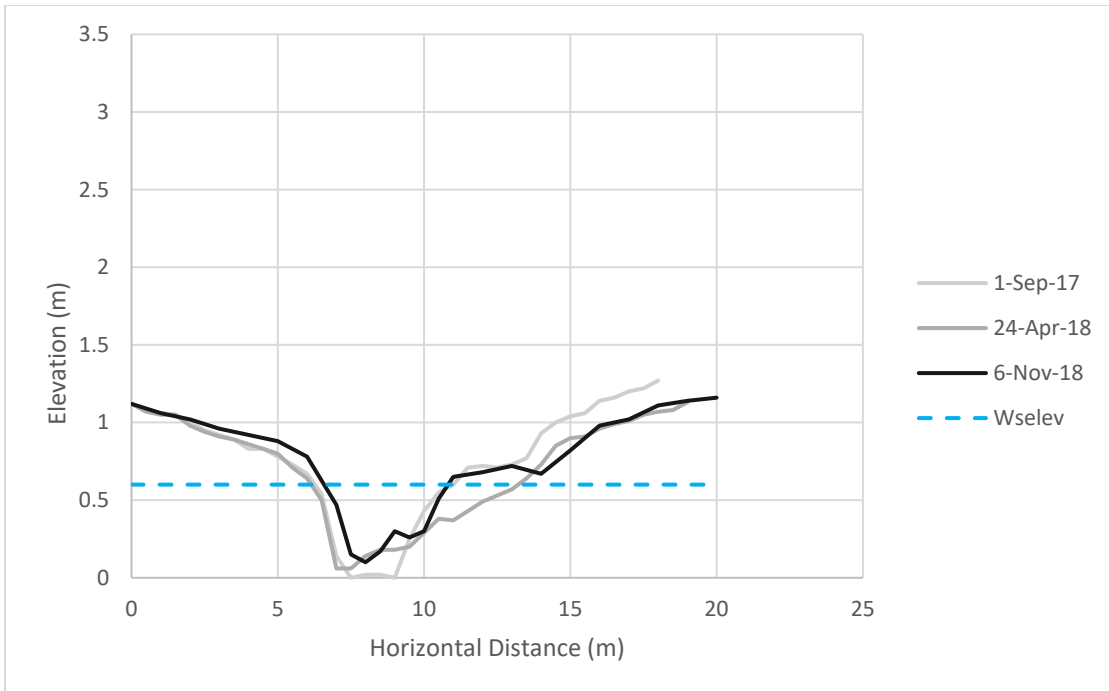
Figure A.6 *Cross section data at the 2nd Downstream of Top of Reach location.*

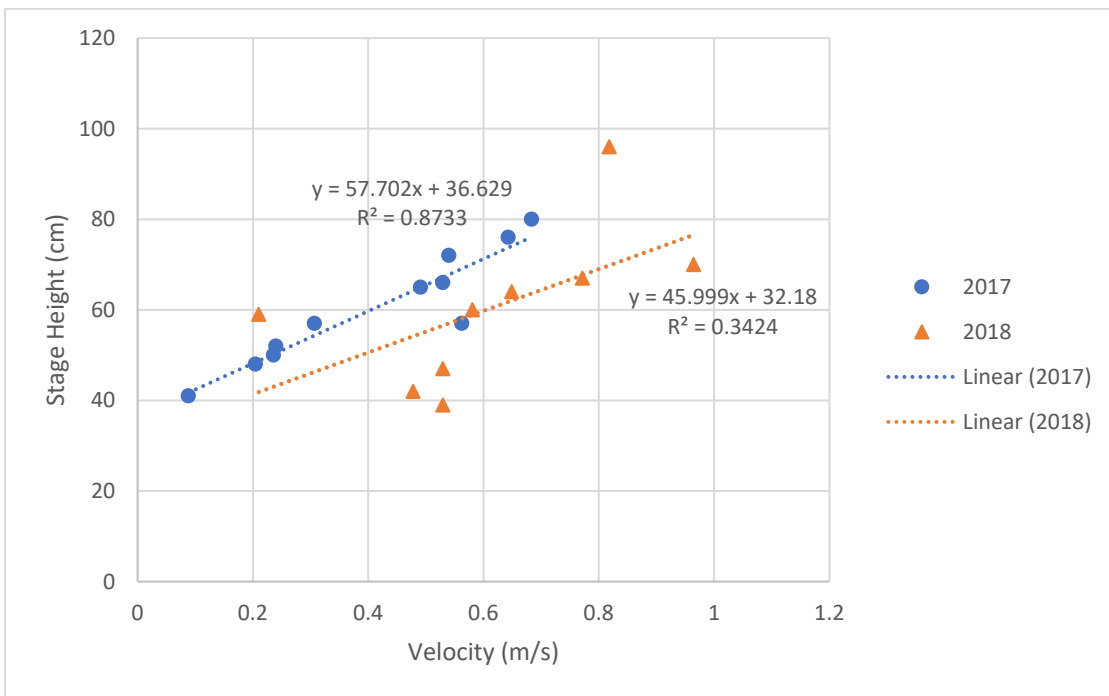
Figure A.7. *Stage-velocity data downstream of the 2nd Downstream of Top of Reach location.*

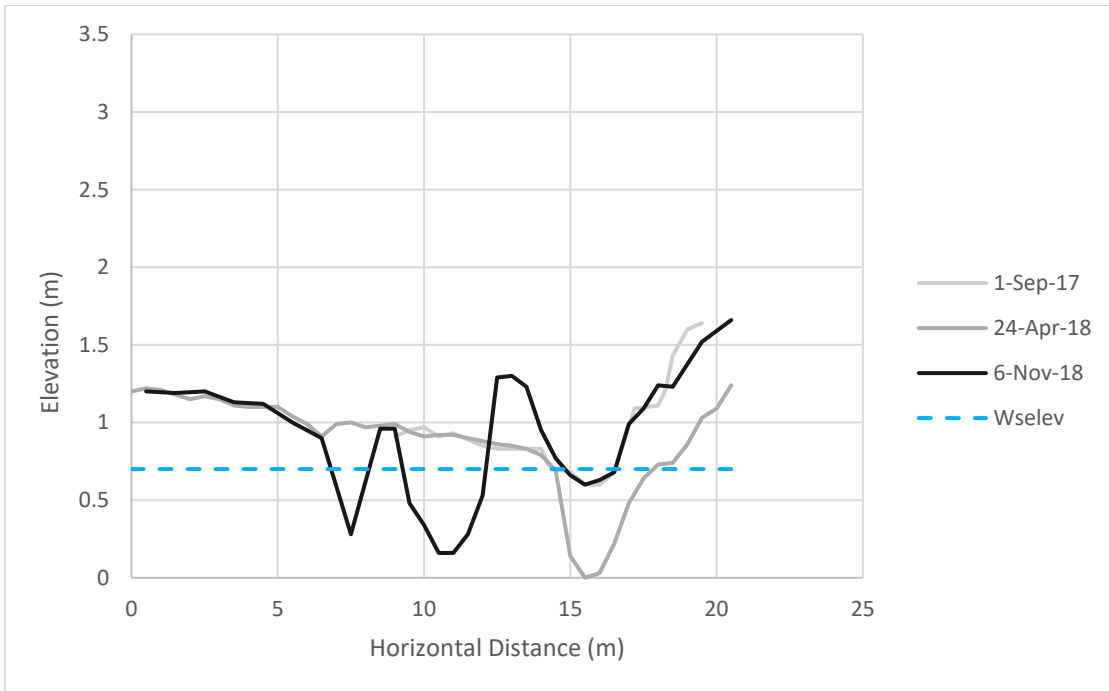
Figure A.8. *Cross section data at the 3rd Downstream of Top of Reach location.*

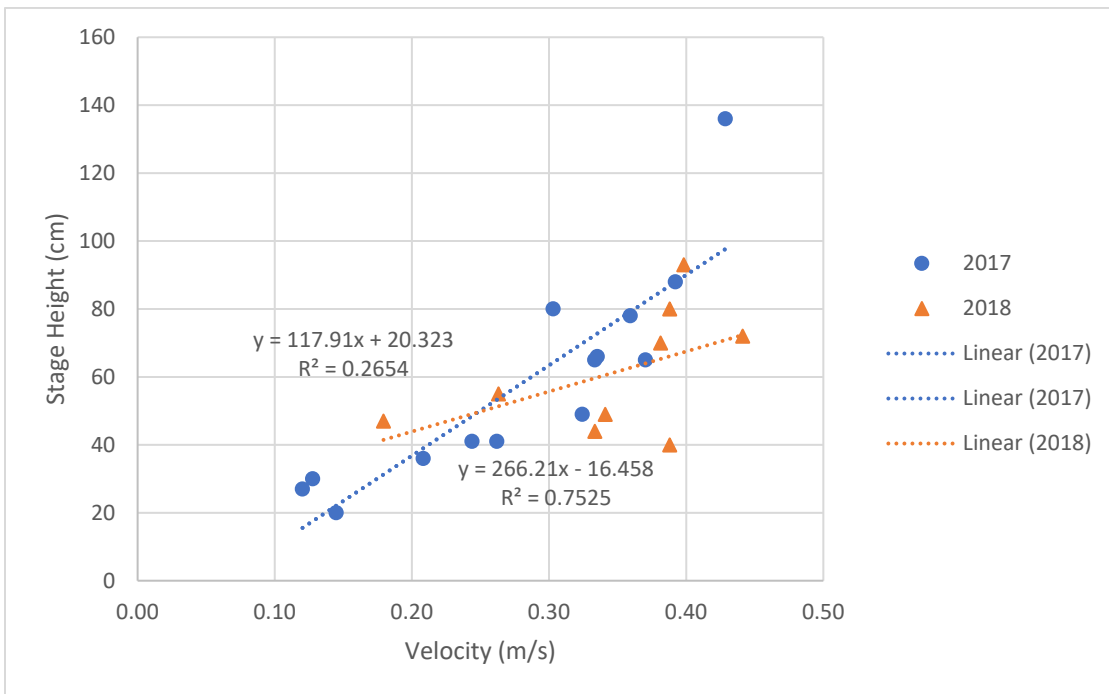
Figure A.9. *Stage-velocity data downstream of the 3rd Downstream of Top of Reach location.*
