TECHNOLOGY FOR INTEGRATED GROUYNE-VETIVER EROSION REDUCTION (TIGER): CASE STUDY IN A WEST AFRICAN RIVER

TECHNOLOGY FOR INTEGRATED GROYNE-VETIVER EROSION REDUCTION
(TIGER): CASE STUDY IN A WEST AFRICAN RIVER

A THESIS

In Environmental Engineering

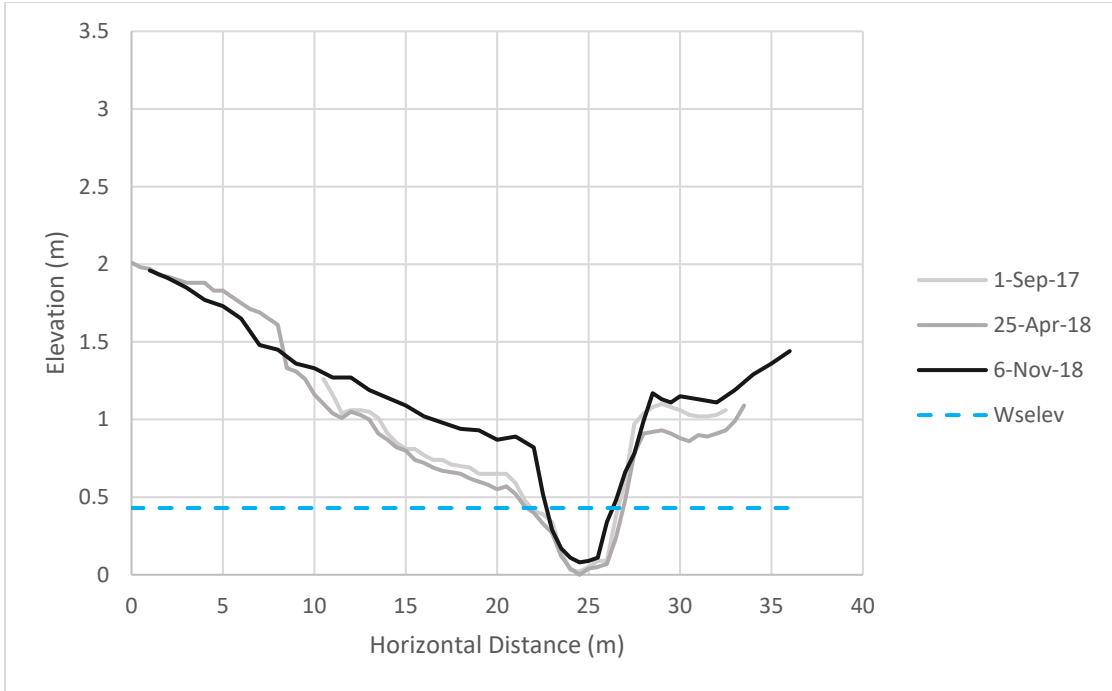
Figure A.10. *Cross section data at the Upstream of the Big Erosion Curve location.*

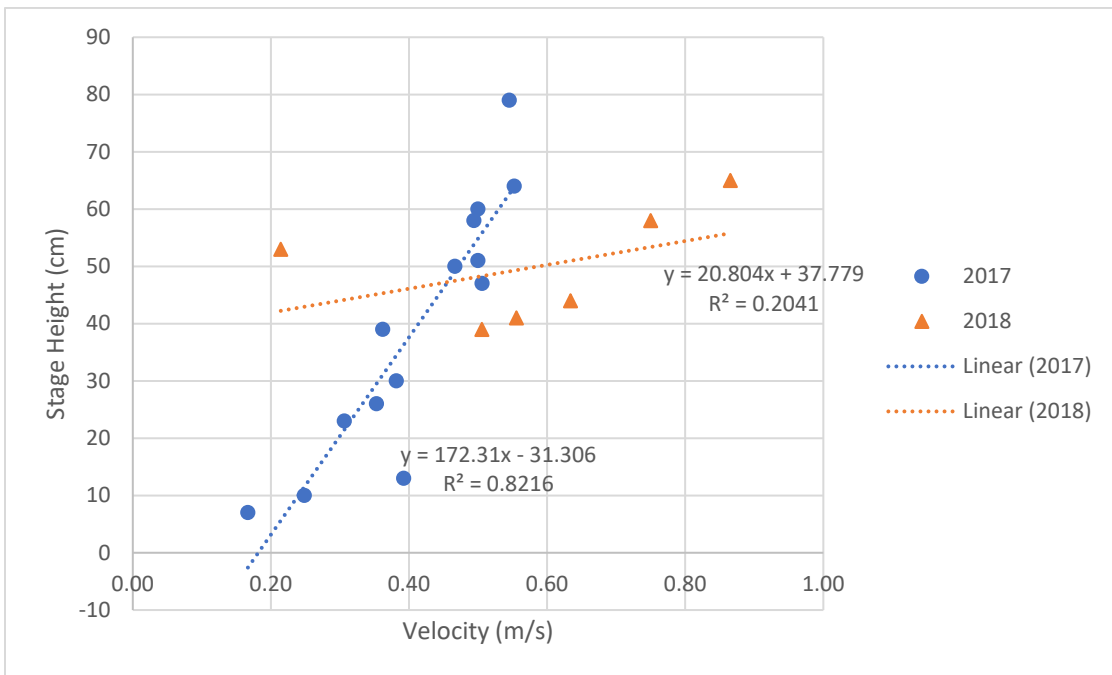
Figure A.11. *Stage-velocity data downstream of the Upstream of the Big Erosion Curve location.*

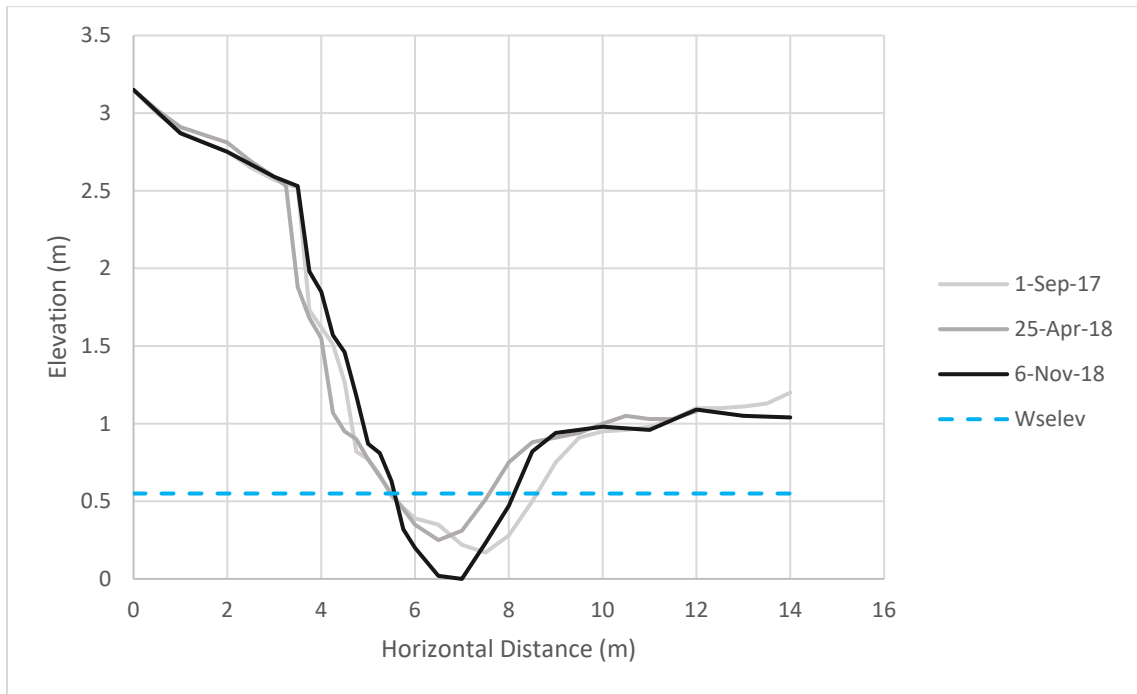
Figure A.12. *Cross section data at the Big Erosion Curve location.*

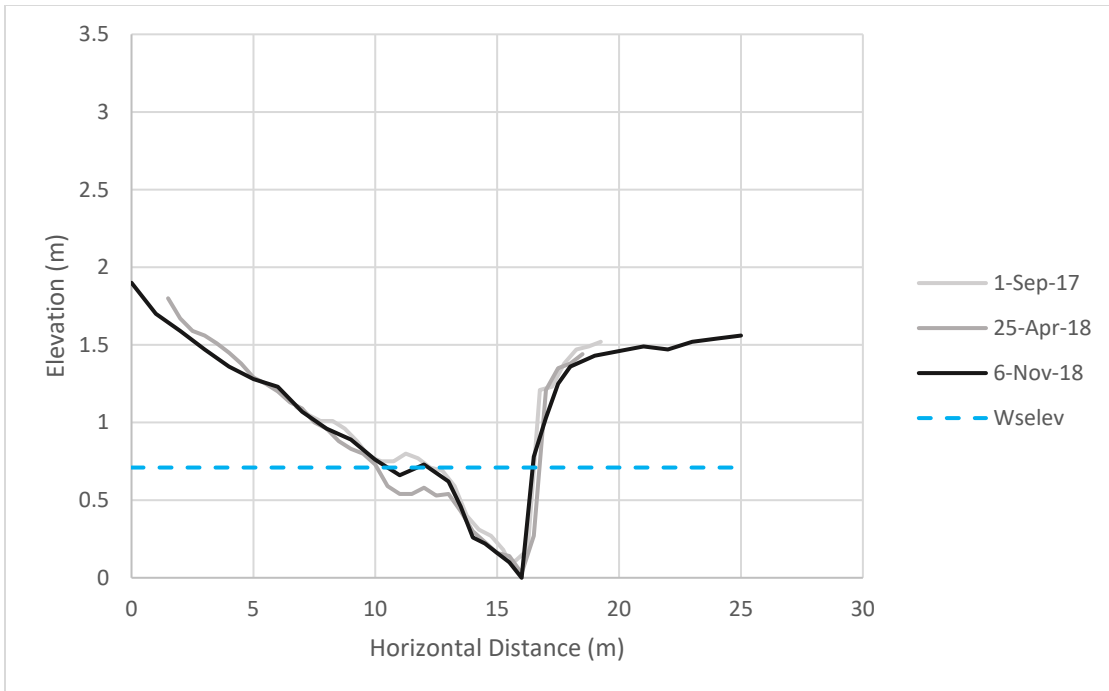
Figure A.13. *Cross section data at the Downstream of the Big Erosion Curve location.*

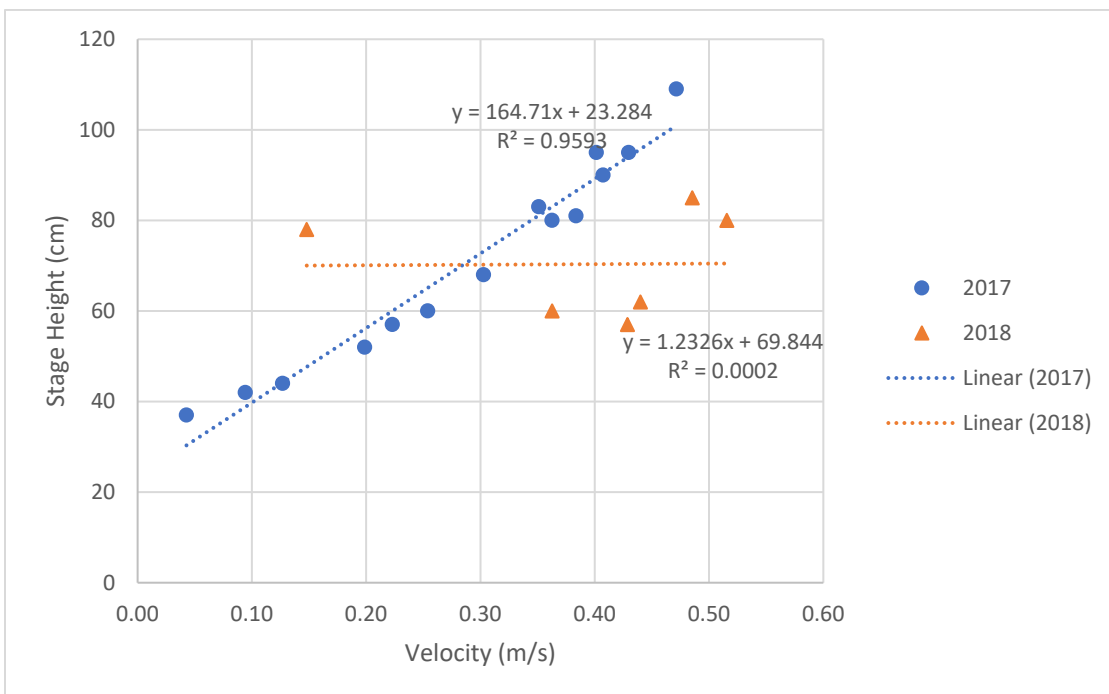
Figure A.14. *Stage-velocity data downstream of the Downstream of the Big Erosion Curve location.*

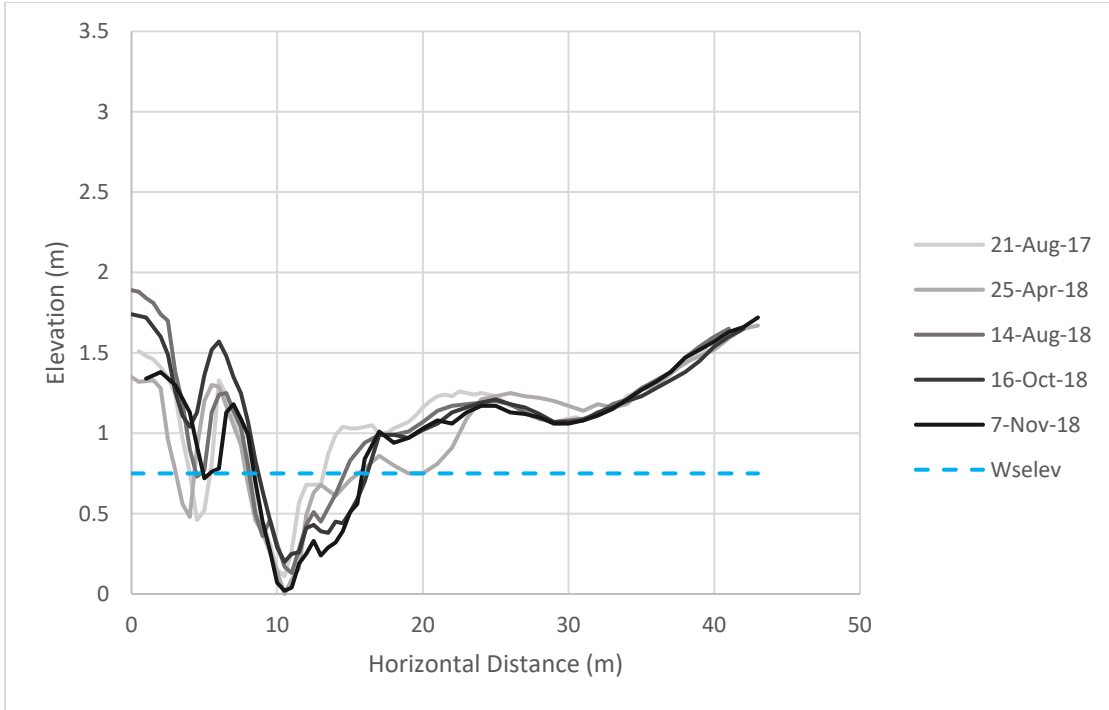
Figure A.15. *Cross section data at the Upstream of the TIGER Method location.*

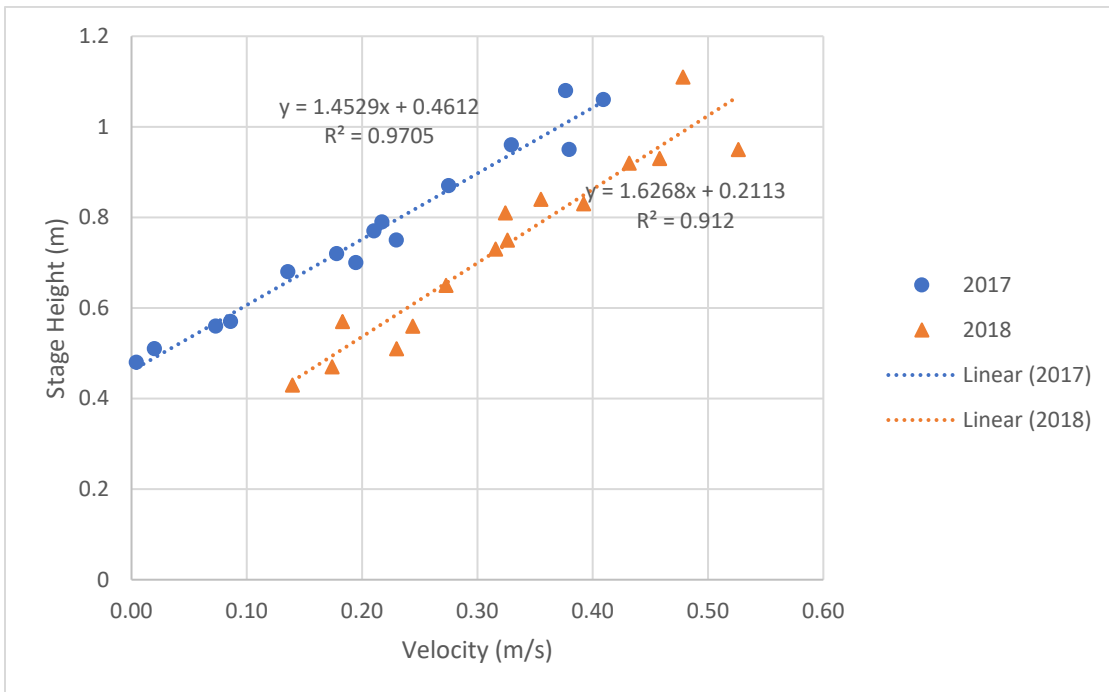
Figure A.16. *Stage-velocity data downstream of the Upstream of the TIGER Method location.*

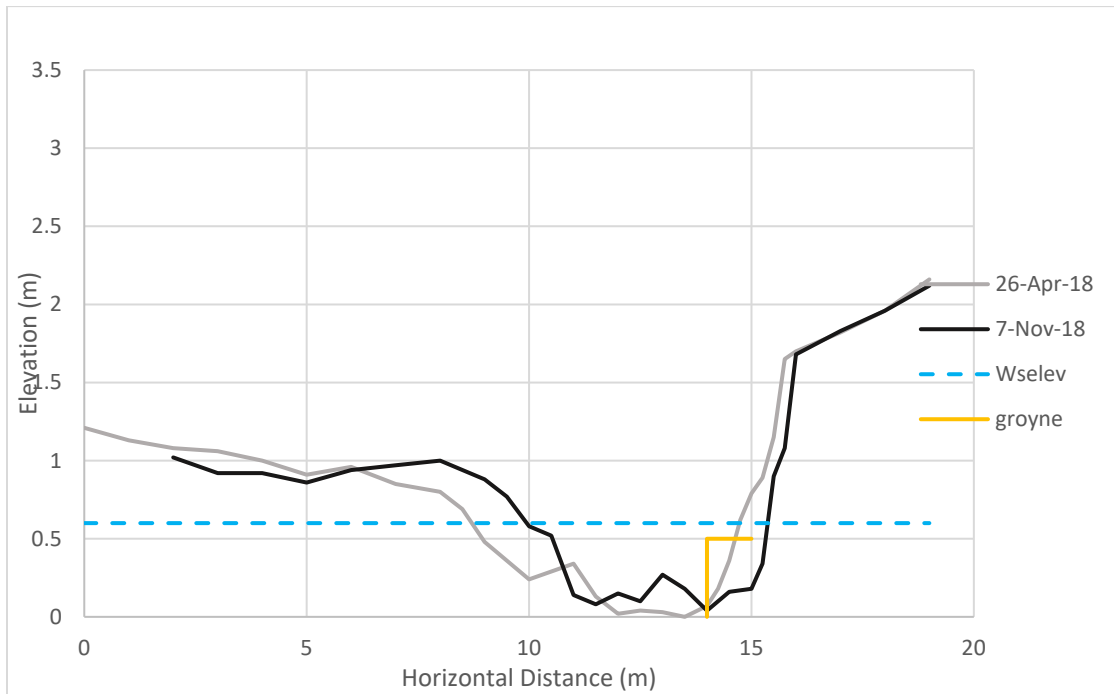
Figure A.17. *Cross section data at the Middle of TIGER Method location*

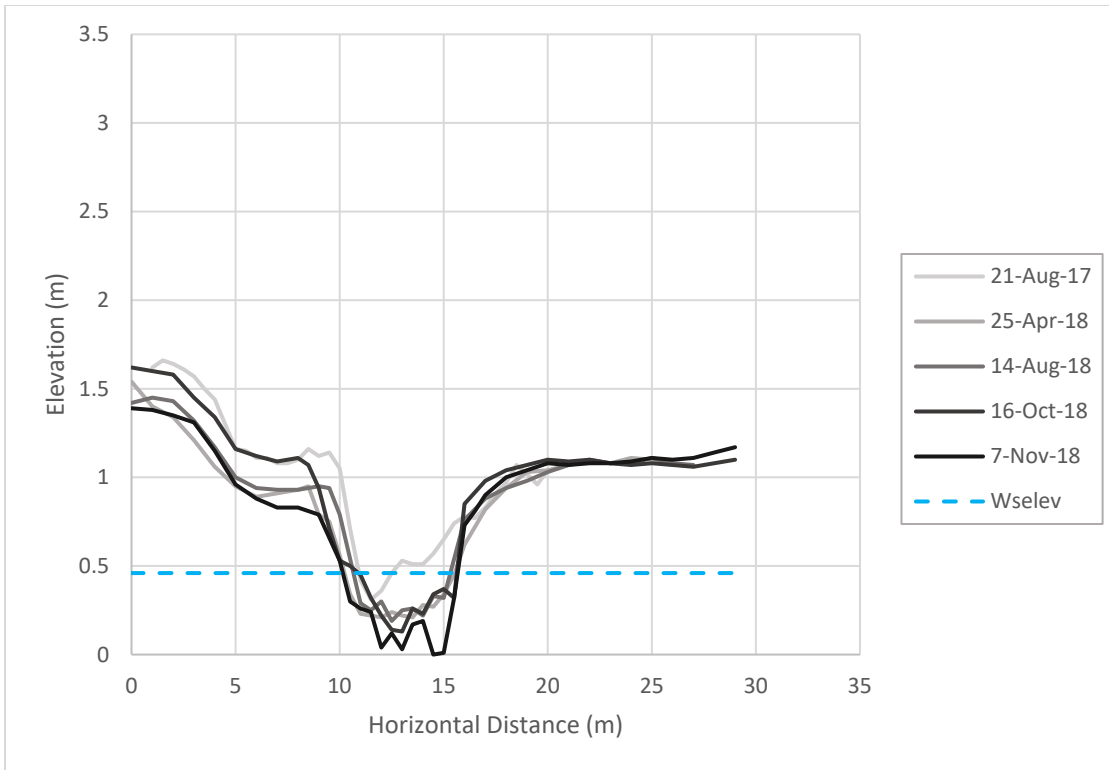
Figure A.18. *Cross section data at the downstream of TIGER method location.*

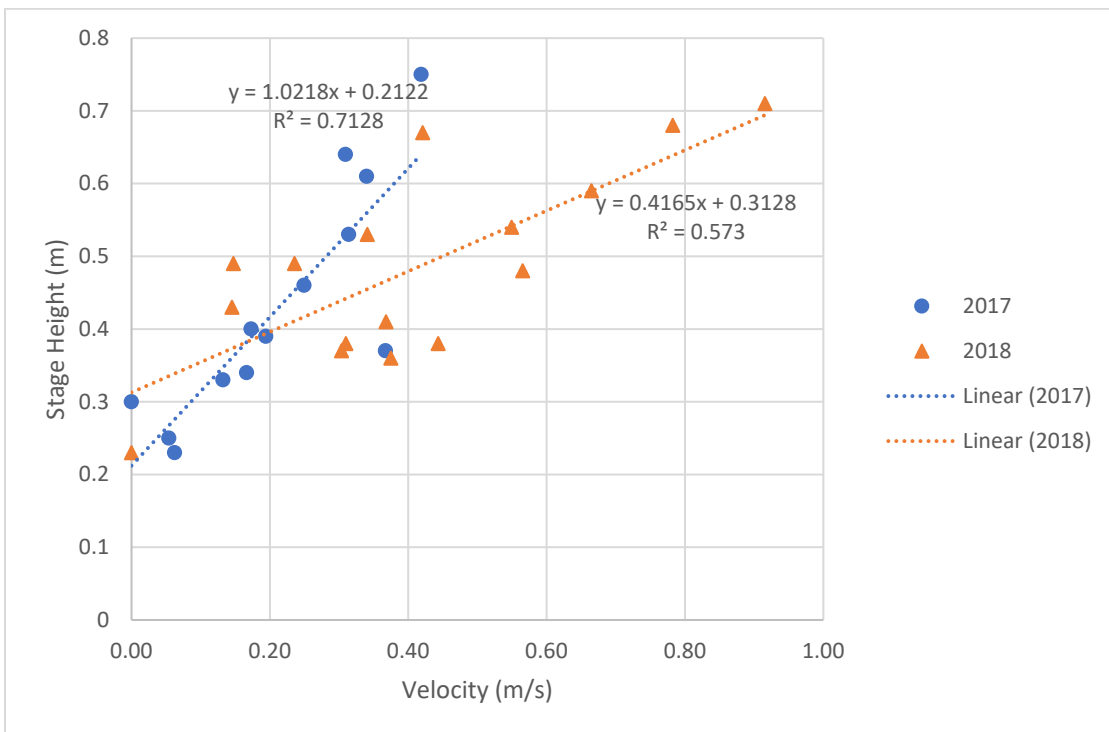
Figure A.19. *Stage-velocity data downstream of the TIGER Method location.*

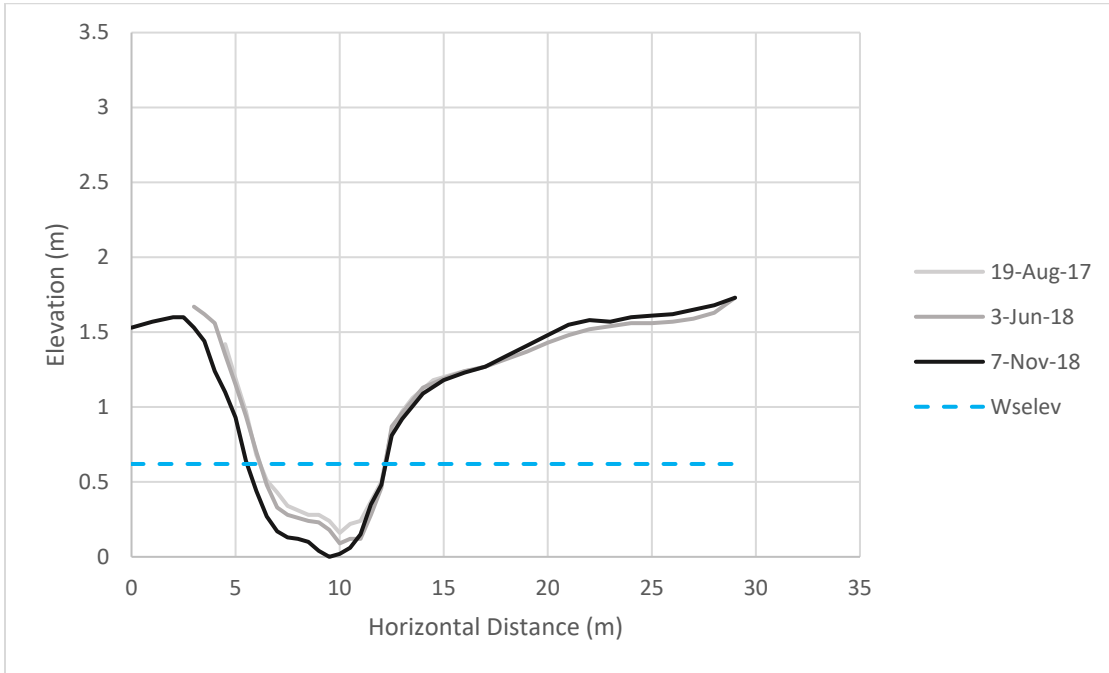
Figure A.20. *Cross section data at the 2nd Upstream of the End of Reach location.*

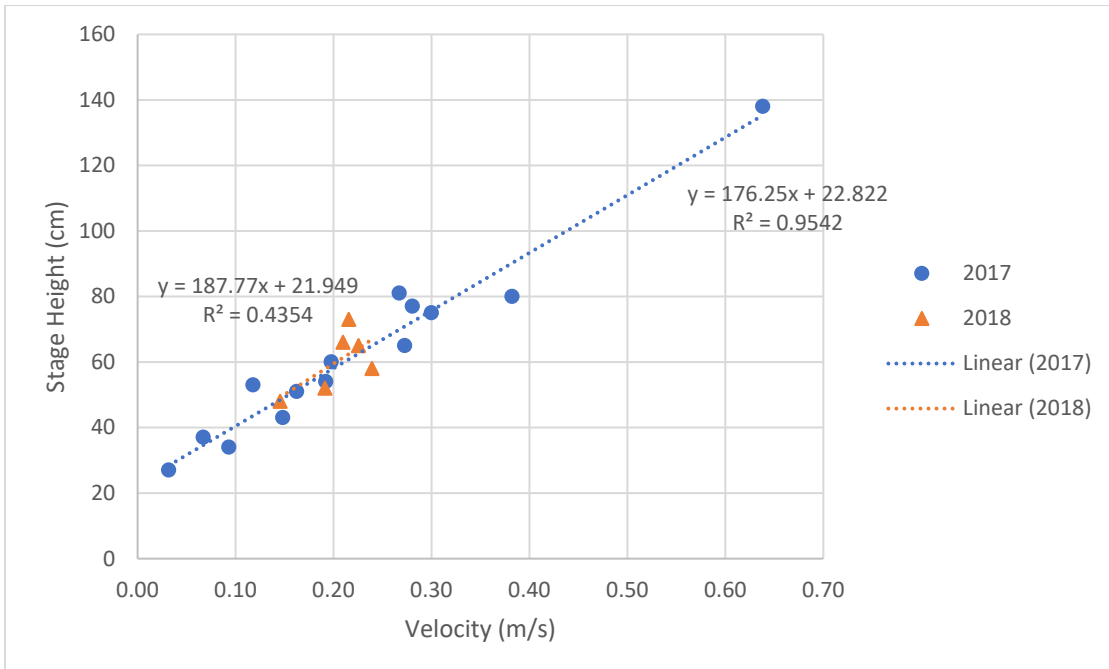
Figure A.21. *Stage-velocity data downstream of the 2nd Upstream of the End of Reach location.*

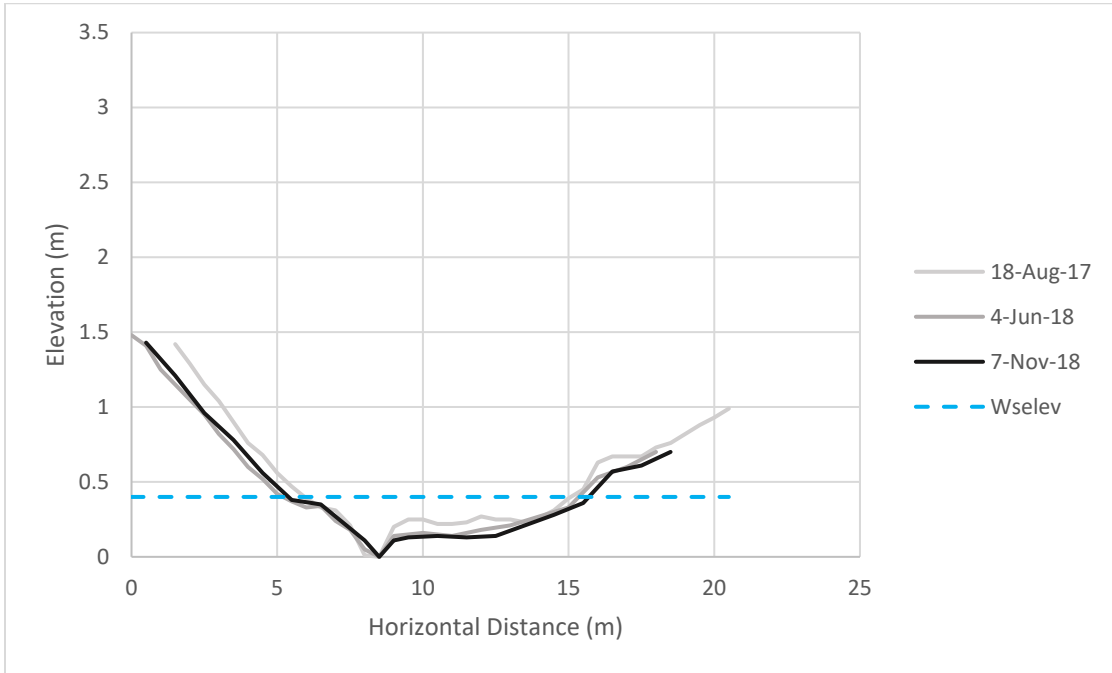
Figure A.22. *Cross section data at the End of Reach location.*

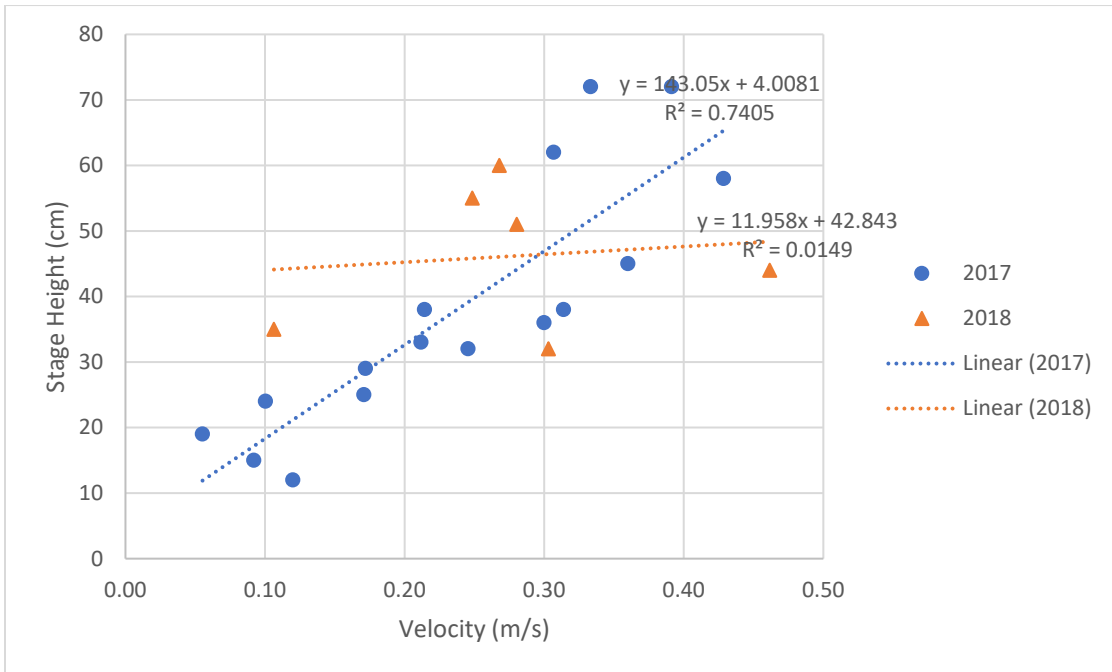
Figure A.23. *Stage-velocity data downstream of the End of Reach location.*
