# The 26 December (Boxing Day) 1997 sector collapse and debris avalanche at Soufriere Hills Volcano, Montserrat

**Abstract:** The southern sector of Soufriere Hills Volcano failed on 26 December 1997 (Boxing Day), after a year of disturbance culminating in a devastating eruptive episode. Sector collapse produced a c.  $50 \times 10^6 \text{ m}^3$  volcanic debris avalanche, and depressurized the interior of the lava dome, which exploded to generate a violent pyroclastic density current. The south-directed growth of a lava lobe and build-up of lava-block talus, since early November 1997, brought the hydrothermally weakened sector to a condition of marginal stability. Limit-equilibrium stability analyses and finite-difference stress-deformation analyses, constrained by geomechanical testing of edifice and debris avalanche materials, suggest that the sector collapse was triggered by a pulse of co-seismic exogenous lava shear-lobe emplacement. Slip-surface localization was influenced by strain-weakening.

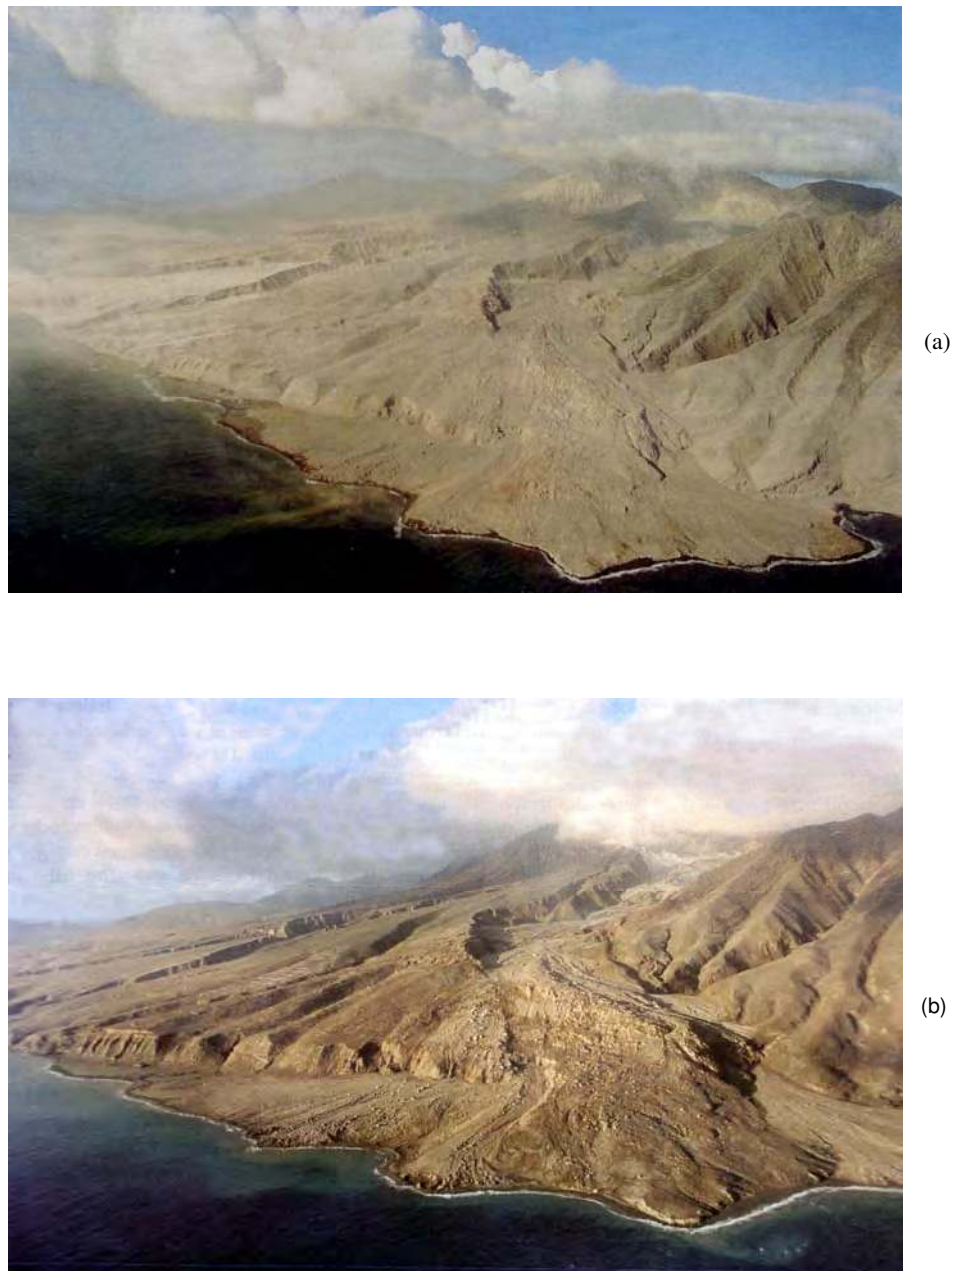
**Fig. 1.** View northwards from the mouth of the White River, showing Boxing Day debris avalanche and tephra deposits on the south flank of Soufriere Hills Volcano as seen (a) about four days after deposition (photo MVO), and (b) in summer 1998 (photo K. West). Fergus Mountain on middle right, towns of Morris' and St Patricks to left of White River channel. Much of the ground surface (a) was veneered by pyroclastic density current deposit and associated fallout deposits, but in (b) most of these deposits had been eroded, and the debris avalanche deposits were etched in greater detail. Boxing Day deposits had extended the fan built by pyroclastic flows associated with Vulcanian explosions in October 1997 and the dome collapses of early November 1997.

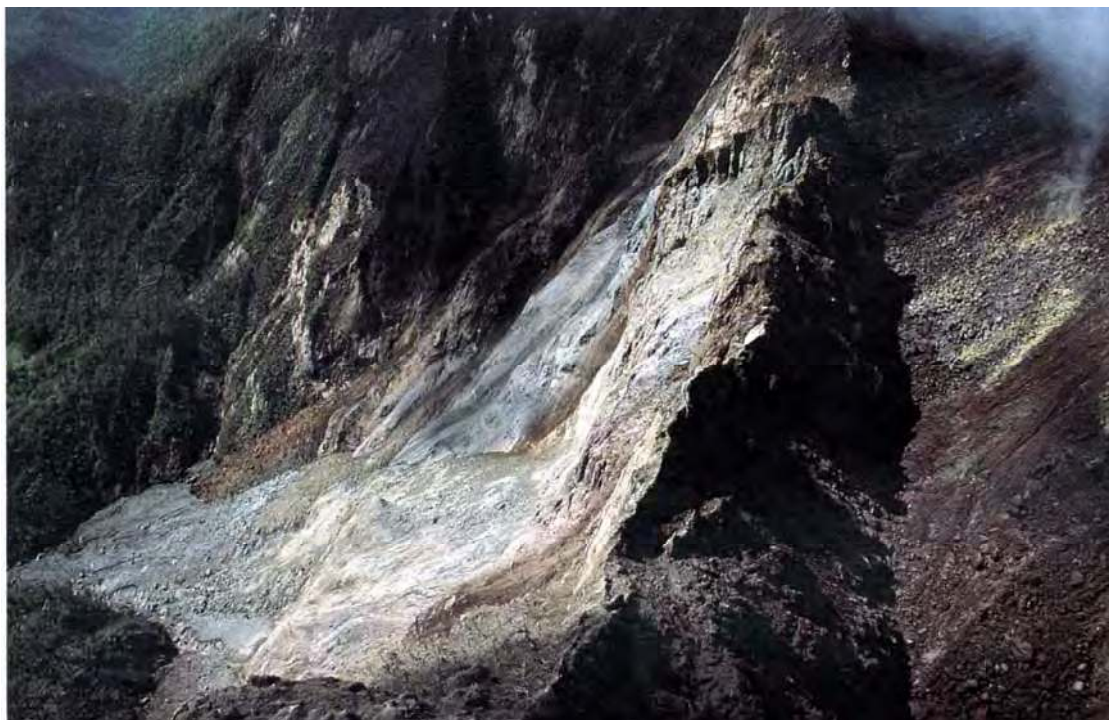
**Fig. 3.** View west along the axis of Galway's Wall in early December 1966. Chances Peak forms west buttress, White River valley is to the left, and the growing lava dome is to the right. At this time, the jointed tufts of Galway's Wall were collapsing in a series of earthquake-triggered slab rockfalls, and MVO scientists became concerned about the possibility of a larger wall collapse that might trigger a lateral dome explosion. By March the dome lavas began to overtop and erode the wall. Active dome growth in this sector recommenced in late 1997 and culminated in the 26 December sector collapse (photo B.V.).

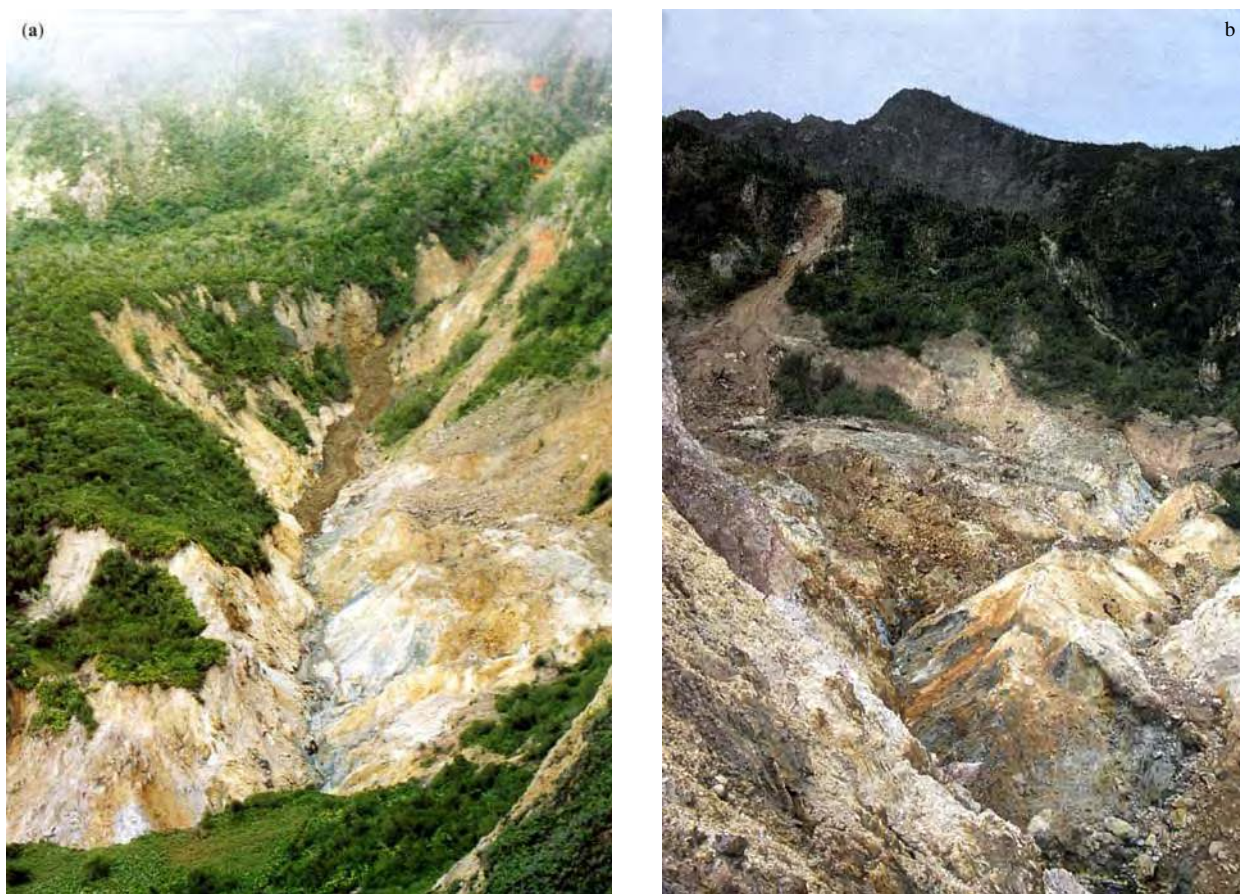
**Fig. 4.** Galway's Soufriere. (a) View NW into the soufriere on 7 December 1996. The Soufriere extends into the hill between the White River valley and Galway's Wall (photo MVO). Portions of this area moved in slump landslides in December 1996. Brown deposit in river valley is distal flow snout of fresh, earthquake-triggered rockfall from the Galway's Wall, (b) The soufriere, looking northward from valley bottom, 26 March 1996, showing varicoloured, weak, highly altered tuffs in the valley and adjacent hill, with the Galway's Wall in the background (photo B.V.).

The *Fumarolic Unit* was subdivided into two parts. The *Soufriere Subunit* comprised superficial deposits with materials showing intense epithermal alteration, derived originally from the Galway's Soufriere area (Fig. 4). The Soufriere Subunit constituted the white, orange or yellow suites (1 to 3 as described above) within the avalanche deposit, in texturally diverse deposits that ranged from matrix-rich lithified breccias to clast-supported unconsolidated breccias. The colours mainly reflected the original mineral associations observed in the highly acid, oxidized superficial part of the hydrothermal system of Galway's Soufriere, but may have also reflected stratigraphy or burial depth. Primary magmatic minerals were replaced by silica polymorphs, titanium oxide and sulphates (such as natroalunite, natrojarosite, gypsum and anhydrite) (Boudon

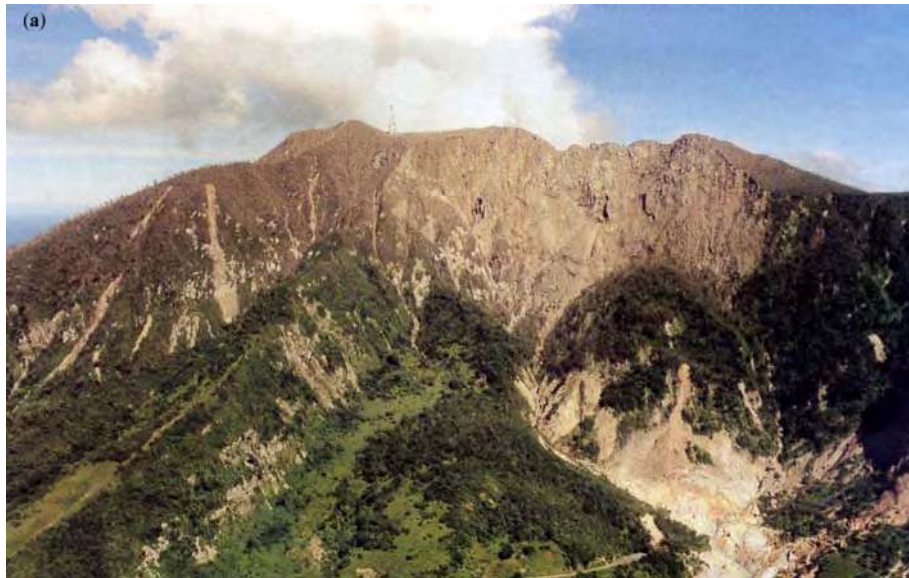
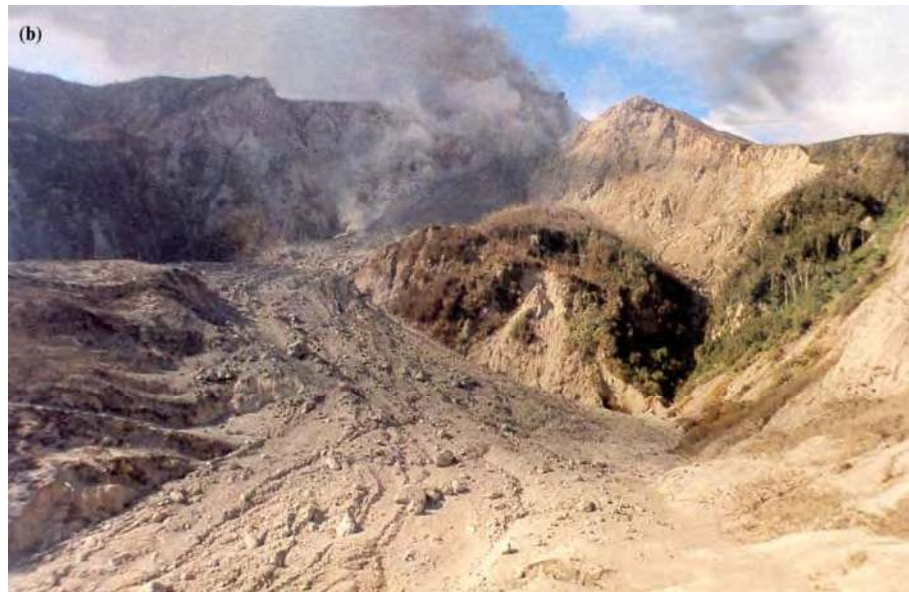
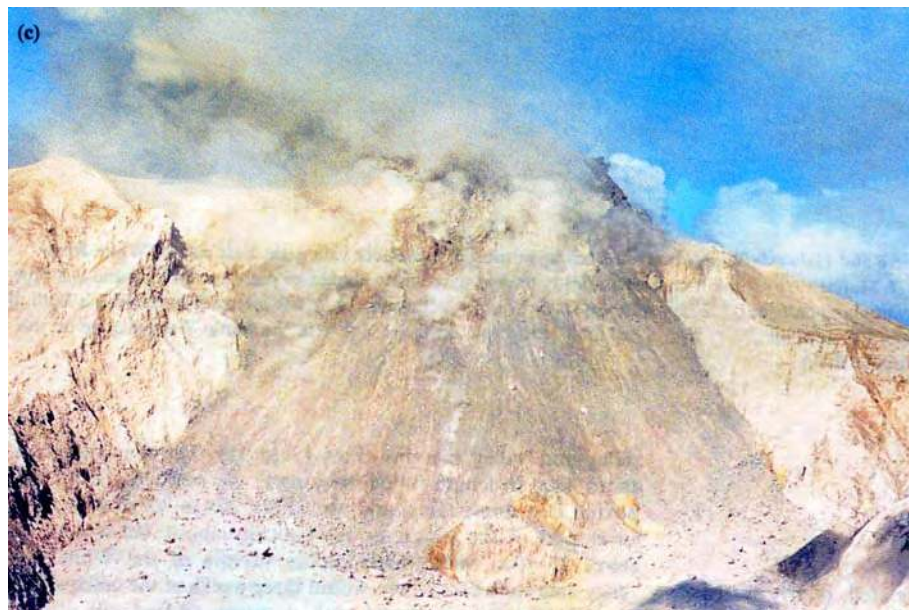
**Fig. 6.** Upper White River valley, as viewed from south, (a) In December 1996, Galway's Wall extended from Galway's Mountain on the right, to Chances Peak, where the radio tower marked a tiltmeter site. An access road led from the south coast to Galway's Soufriere, shown by pale colours in the river valley, with the alteration affecting also the mound-like hill between the valley and Galway's Wall (photo K. West), (b) By late April 1997, the river valley and much of the Soufriere were being buried by block-and-ash flow deposits produced by collapses from the active lava dome (photo K. West). (c) By 8 December 1997, extensive southerly growth of the lava dome had generated talus that almost completely buried the hill shown in (a) and (b) (photo MVO). Minor changes in talus volume occurred between this date and the sector collapse of 26 December 1997. The pale-coloured landscape reflects the dusting of ash from numerous rockfalls.

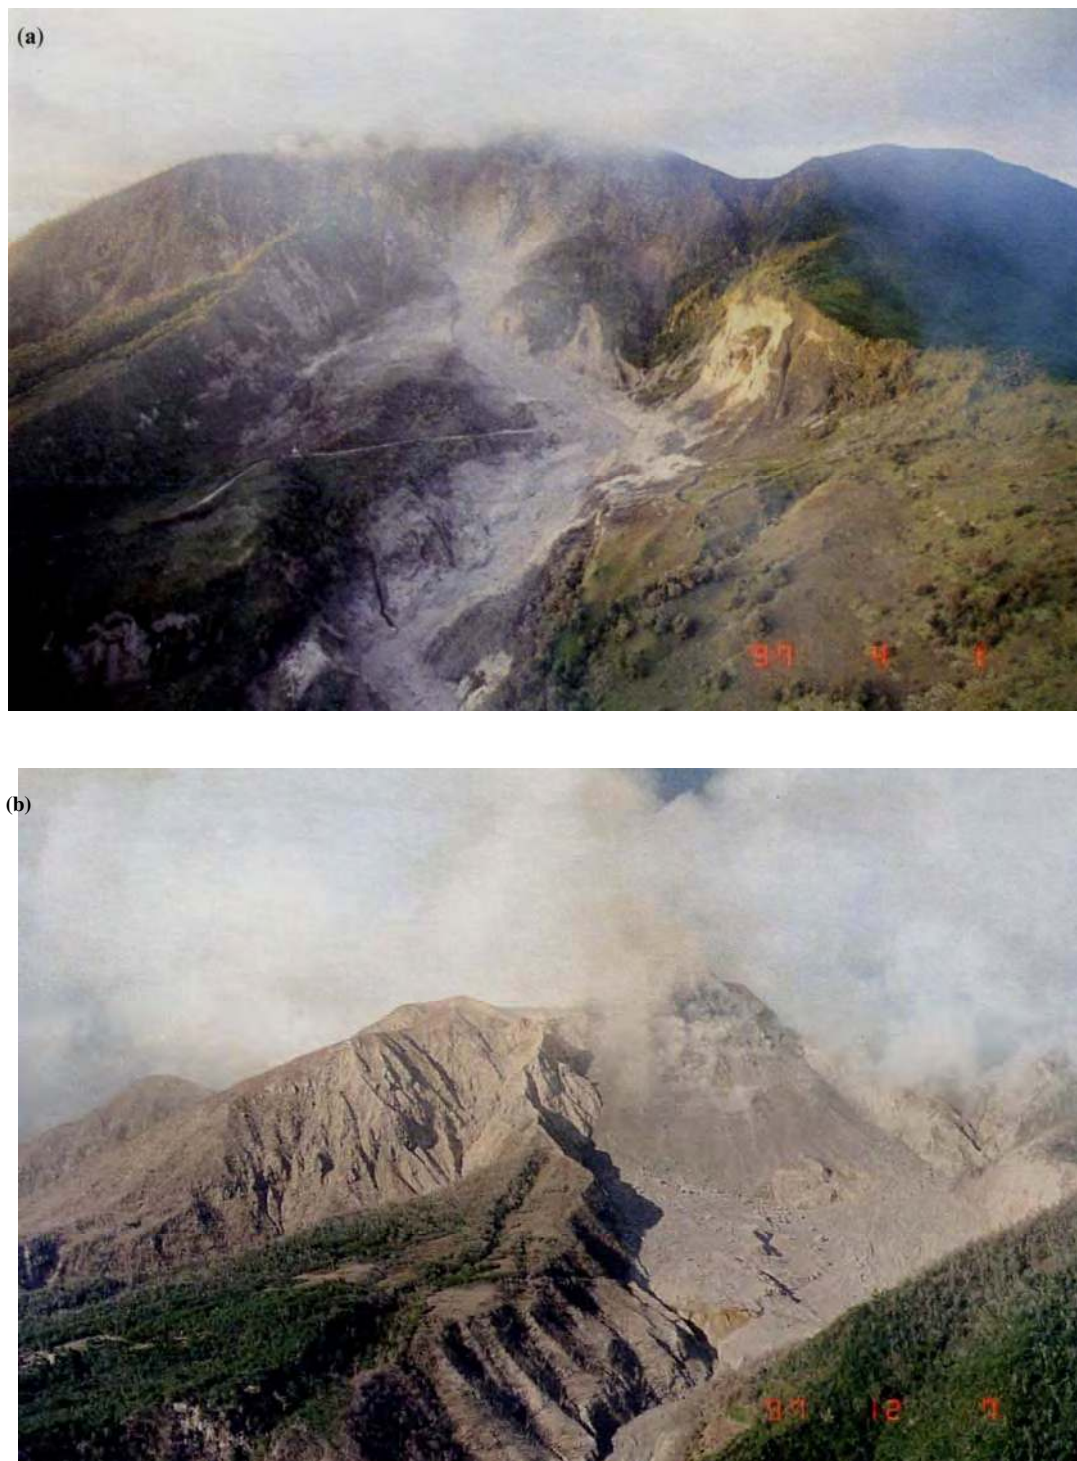
**Fig. 7.** Upper White River valley, as viewed from southwest. (a) By 1 April 1997, the valley and soufriere were being partly buried by rock falls from Galway's Wall, and by block-and-ash flow deposits from lava dome collapses. Access road at left centre. Notched hill is above soufriere, between valley and Galway's Wall (photo MVO). (b) By 8 December 1997, most features within the valley shown in (a) had been buried by a talus cone, setting the stage for edifice collapse about two weeks later. The talus was being fed by southward-moving lava at the top of the cone (photo MVO).

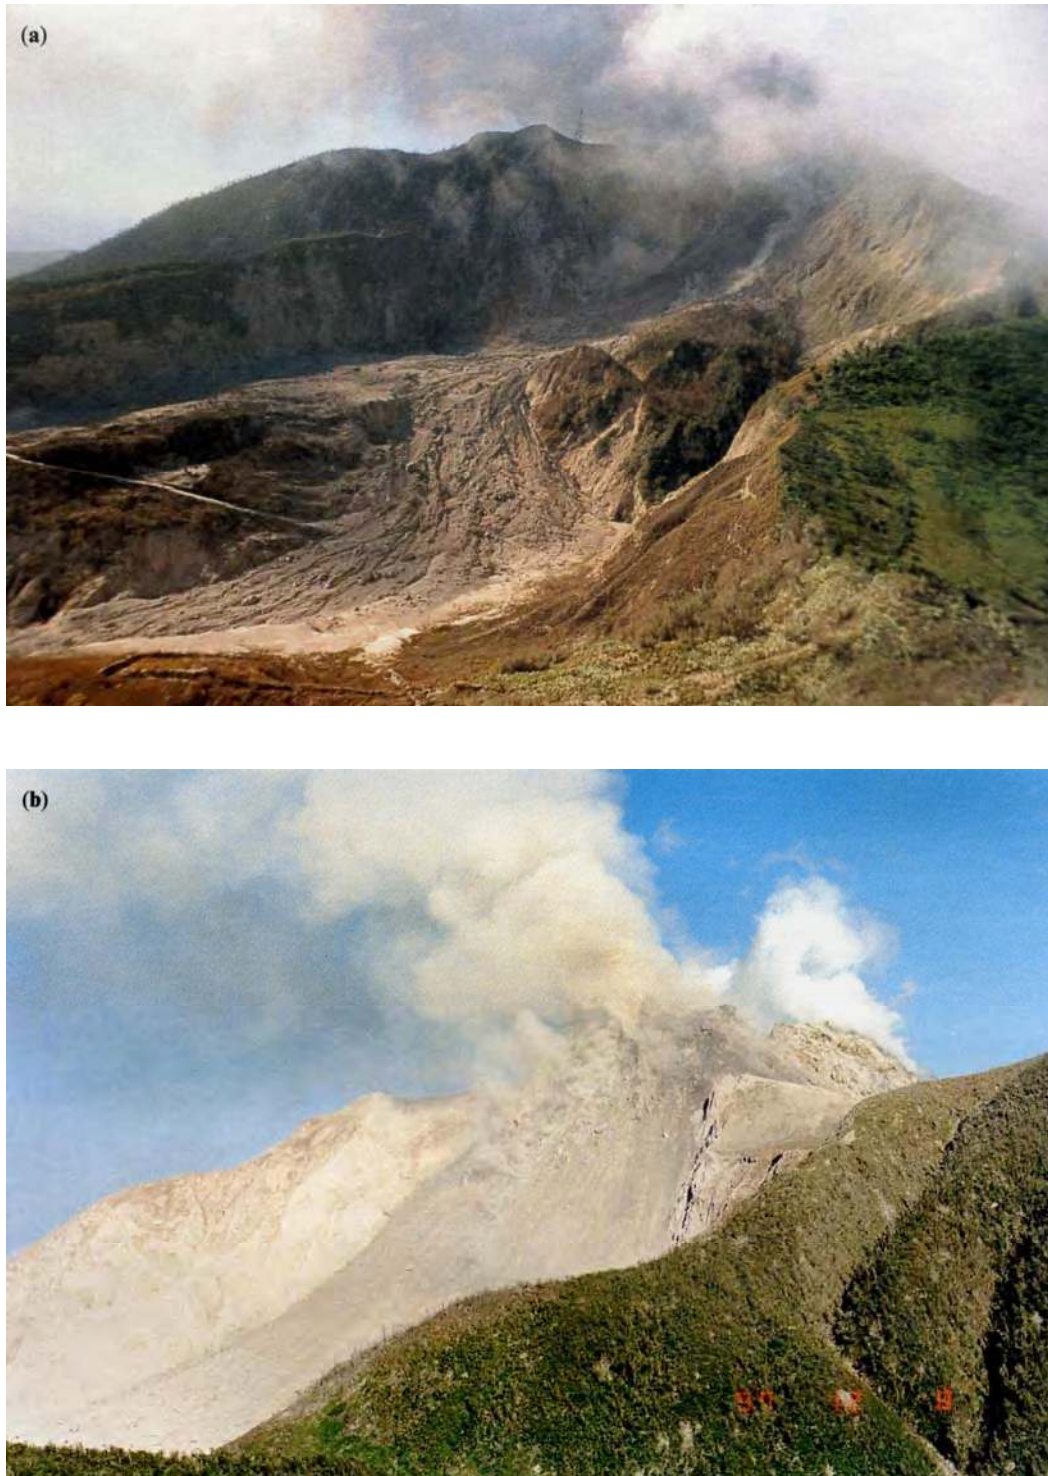
**Fig. 8.** Upper White River valley, as viewed from east, (a) By 22 April 1997, the river channel and Galway's Soufriere was buried by, mainly, block-and-ash flows from dome collapse. To the right of valley is notched hill, and farther to the right is Galway's Wall. Chances Peak is in the background (photo K. West), (b) By 8 December 1997, a talus cone had buried the topographic features of the uppermost valley. The talus was fed by a lava lobe that moved southward over the eroded Galway's Wall, seen at top right (photo MVO).

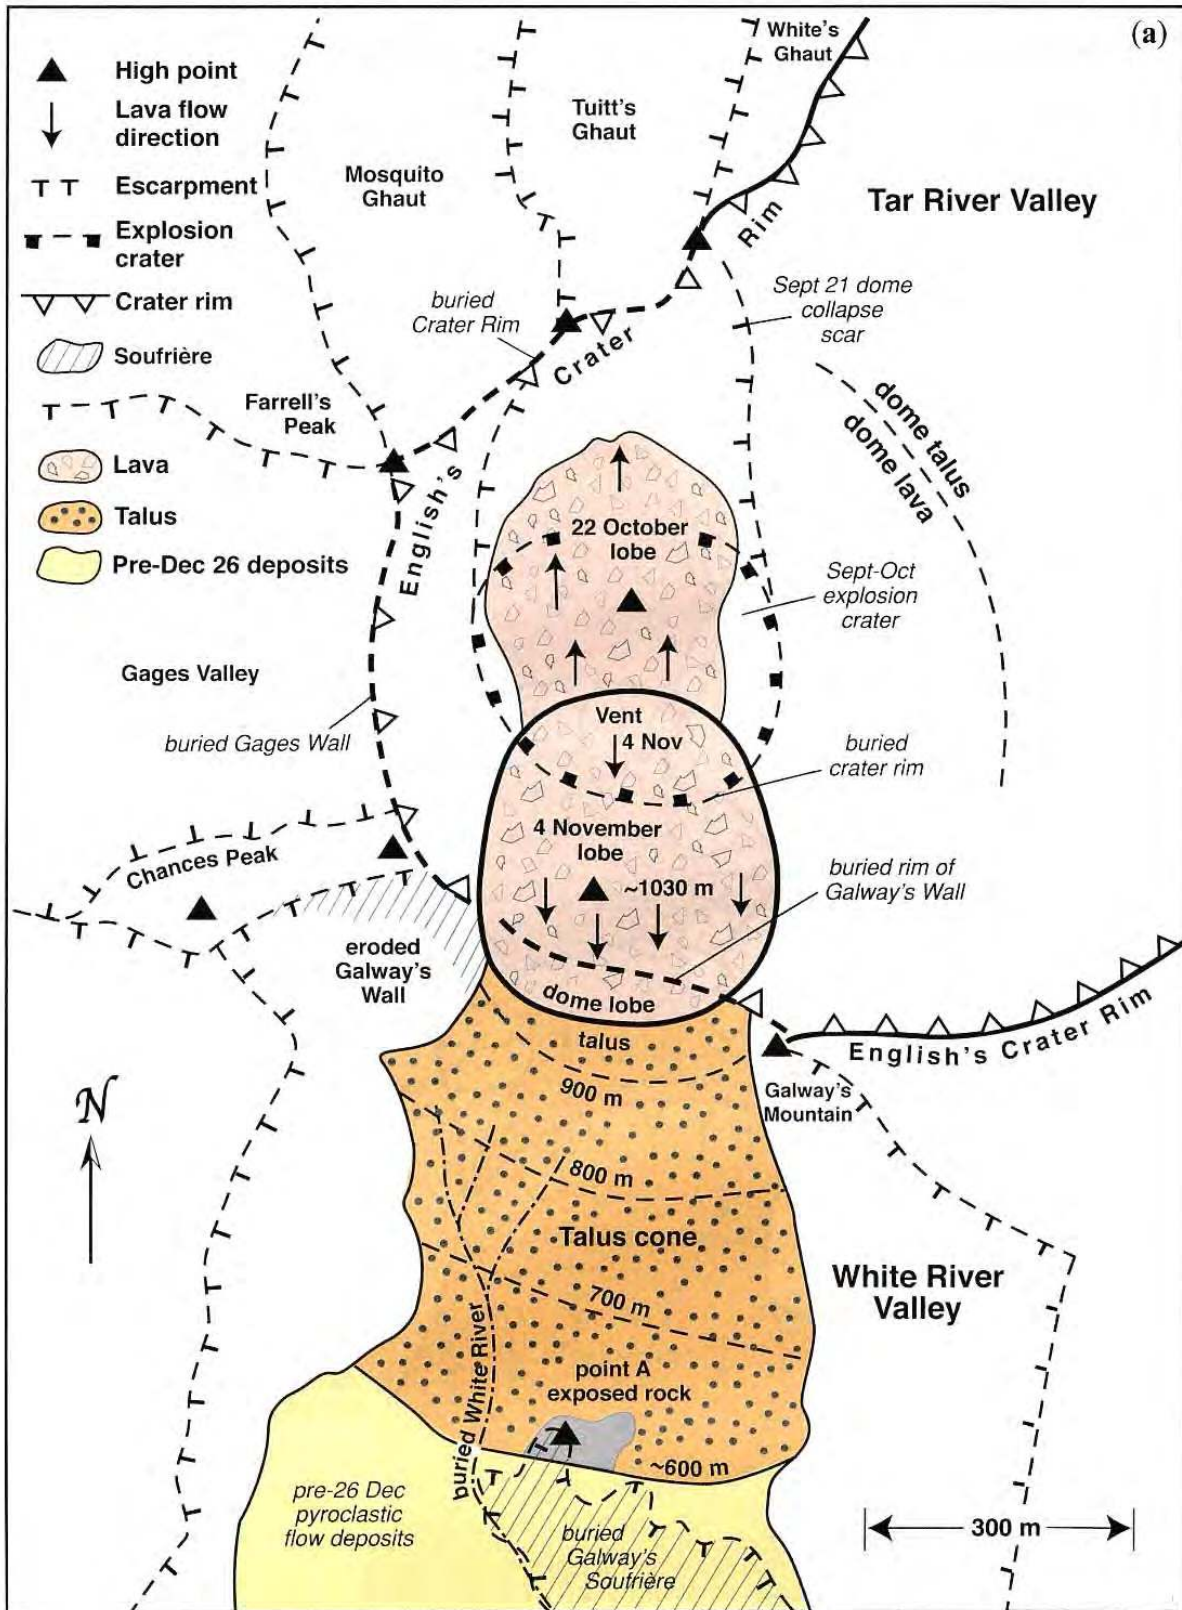
Fig. 9. Maps of Galway's Wall area (a) before and (b) after the 26 December collapse (cf. Fig. 12).

The upper scar was a spoon-shaped amphitheatre within the dome, as much as 400 m wide and extending about 450 m north of the step (Figs 9b and 13b). The upper scar is interpreted as originating by a combination of gravitational failure and spontaneous, explosive quarrying processes involving gas-pressurized, highly crystalline but partly molten dome rock. The southern part of the upper scar may have been produced by retrogressive collapse involving dome material and fragments from Galway's Wall.

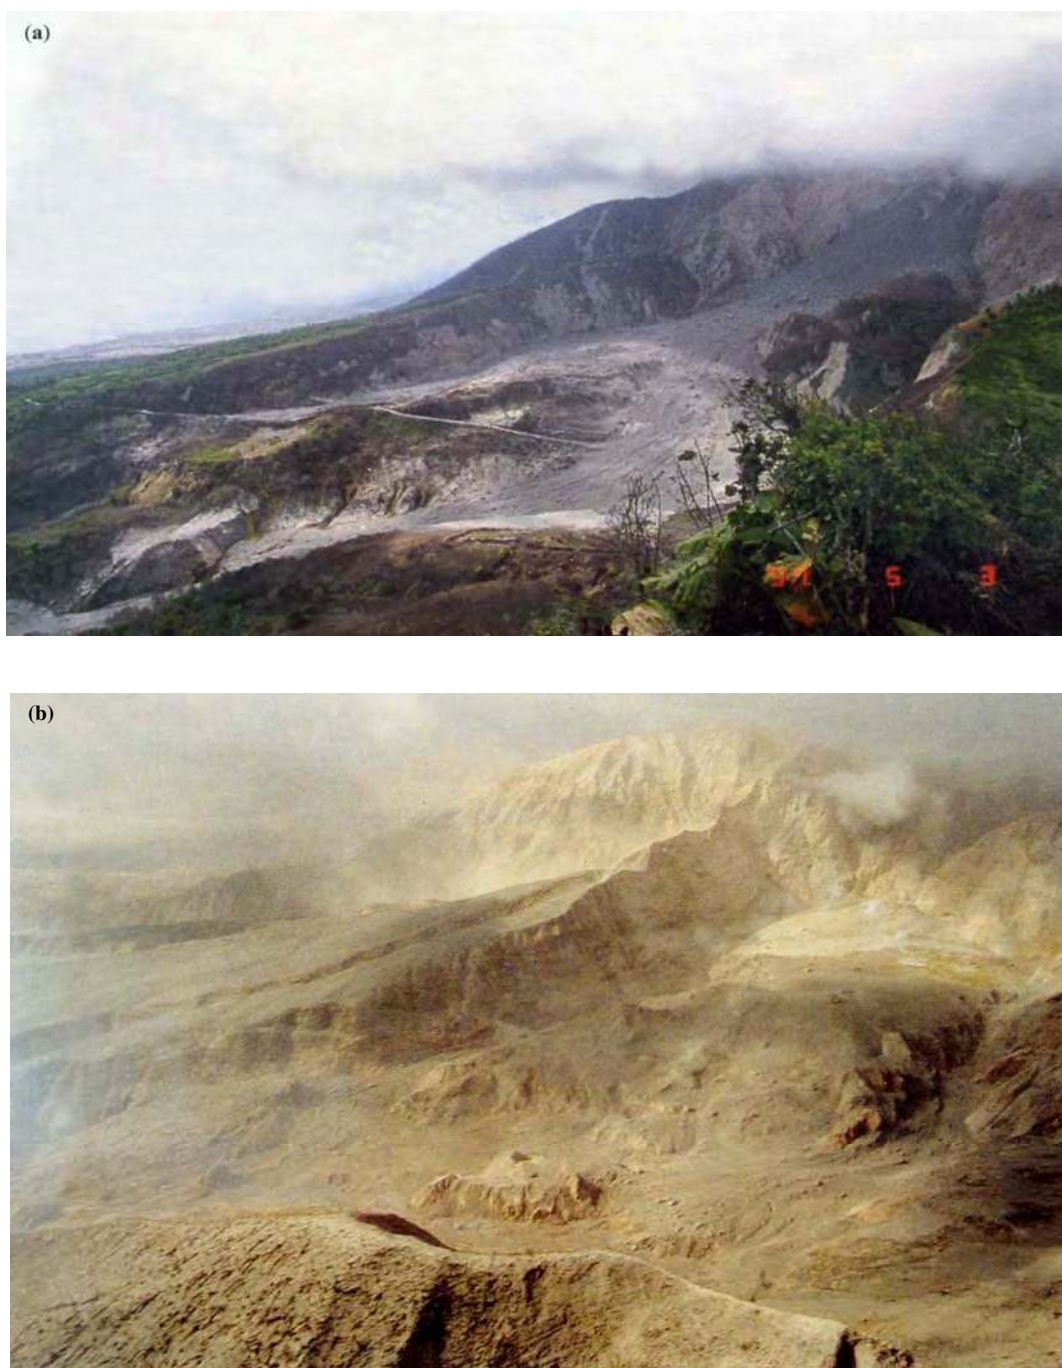
**Fig. 13.** Proximal part of White River valley, north of Fergus Mountain, (a) By 3 May 1997, the valley and soufriere were filled by block-and-ash flow deposits from lava dome collapses, and these deposits also partly blanketed the bedrock shelf west of the river channel, where, at the foot of the western escarpment, they reached the access road to Galway's Soufriere (photo MVO). (b) View on 30 December 1997, showing hummocky Boxing Day debris avalanche deposits (photo MVO). Fergus Mountain is in foreground, with the entire landscape dusted with tephra from the Boxing Day pyroclastic density current and associated ash cloud. Avalanche megablocks protrude from valley deposits. Yellowish coloration in deposits at right centre reflects fumarolic encrustations in deposits that have buried the decapitated Galways Soufriere. Beyond this, the sector collapse scar rises at Galway's Wall, with the notch in the wall leading to the dome collapse scar (see Fig. 9b).

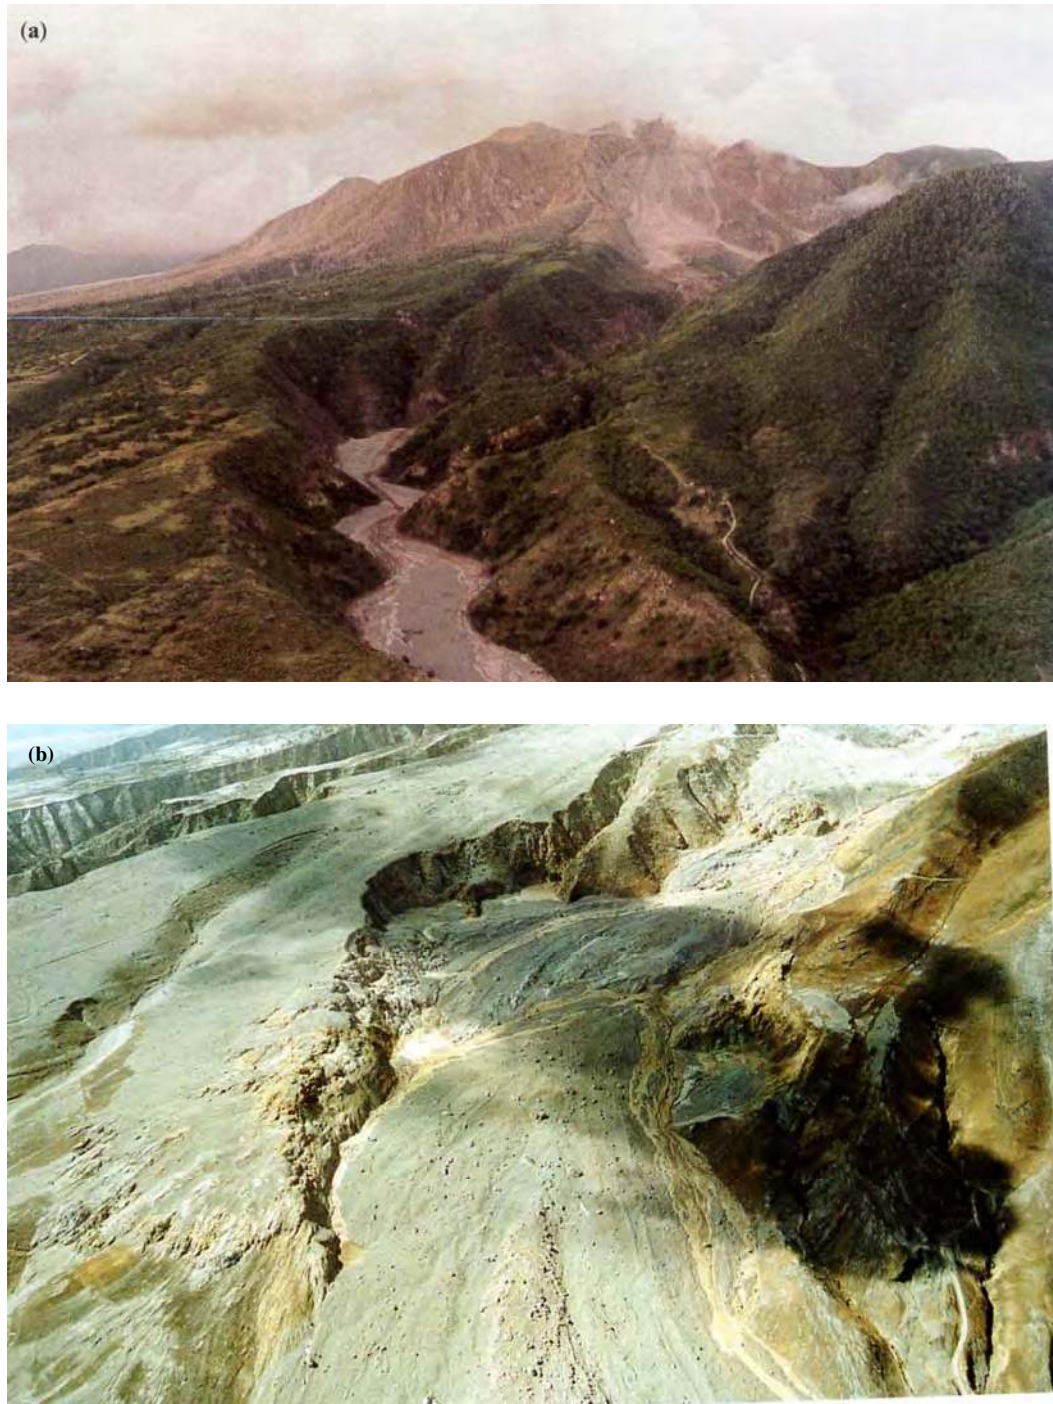
**Fig. 14.** Medial part of White River valley, viewed north, (a) 22 April 1997, with valley partly filled by block-and-ash flow deposits and materials reworked by lahars. Fergus Mountain at right, Morris' area to left on west bank. Soufriere Hills Volcano in background (photo K. West). Considerable additional filling occurred later (see Fig. 18a). (b) Boxing Day debris avalanche and coarse pyroclastic density current deposits mainly followed the drainage of the White River, but parts of these flows ramped over the western valley wall, toward Morris'. June 1998 (photo J.C.K.). Two prominent flow fronts in the avalanche deposit suggest two pulses of overspilling debris. On the opposite bank, the avalanche left a levee-like deposit of blocky avalanche debris on the flank of Fergus Mountain. Vegetation in (a) was removed by the violent pyroclastic density current, the grey deposits of which blanket the landscape in (b).

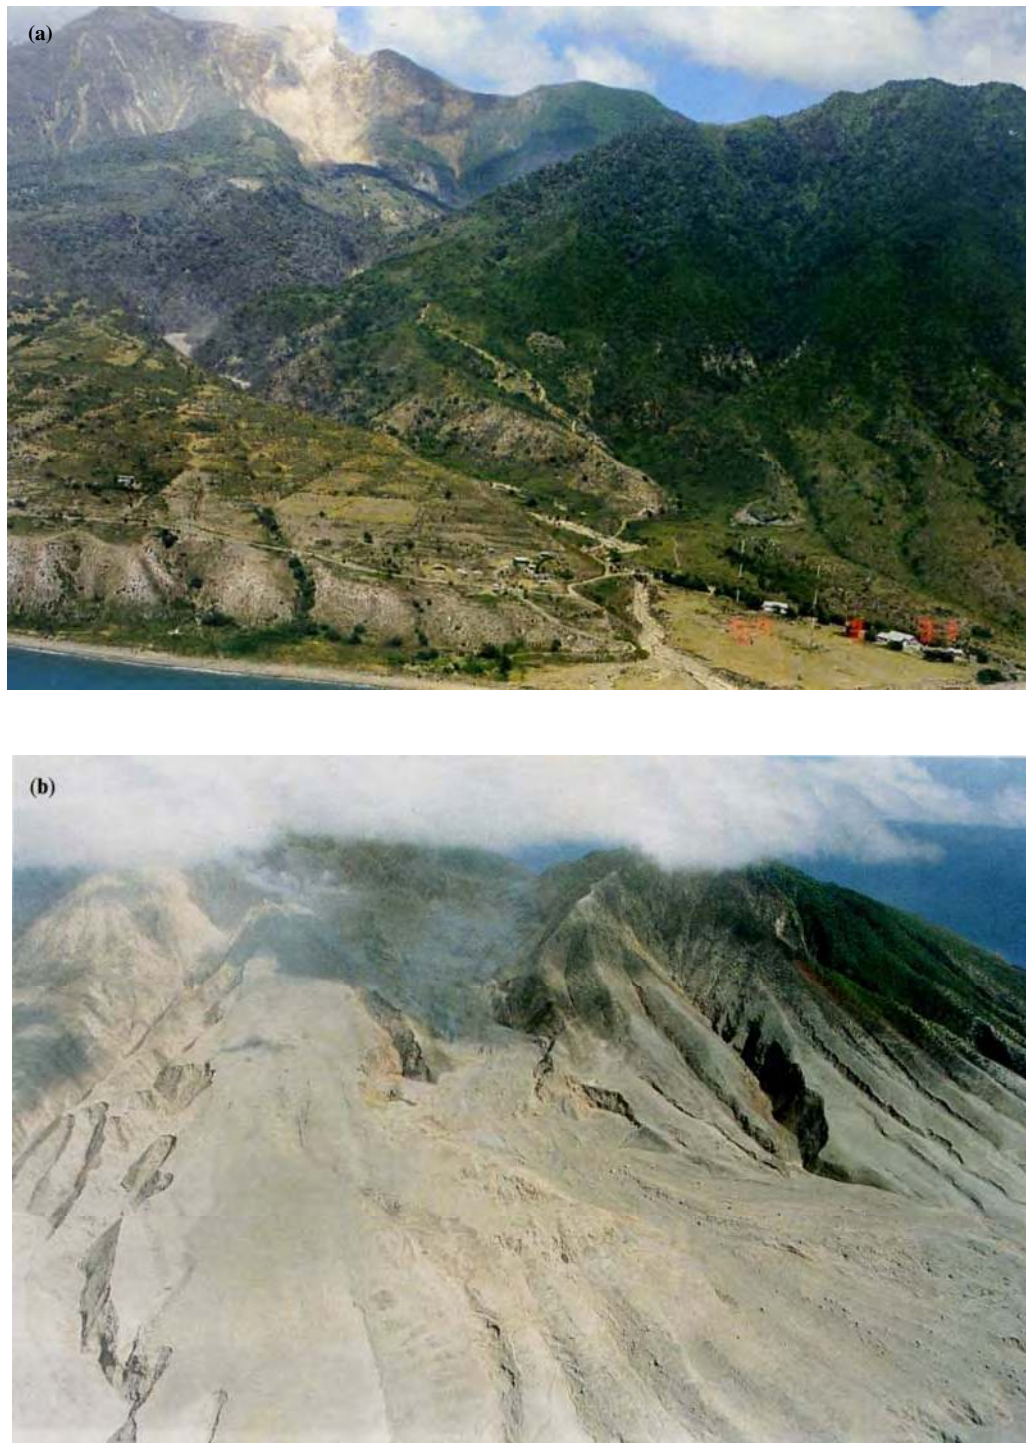
**Fig. 15.** Distal part of White River valley, (a) Mouth of White River at Old Fort Point on 31 March 1997. Morris' on left, Fergus Mountain and South Soufriere Hills on right, Galway's Wall in distance (photo MVO). (b) Same area a few days after 26 December 1997, with river valley containing deposits from the debris avalanche and coarse facies of the pyroclastic density current (photo MVO). Overspill deposits were emplaced above Morris' in foreground. Vegetation and buildings were largely destroyed by the violent pyroclastic density current, with its monochromatic grey tephra covering the landscape.

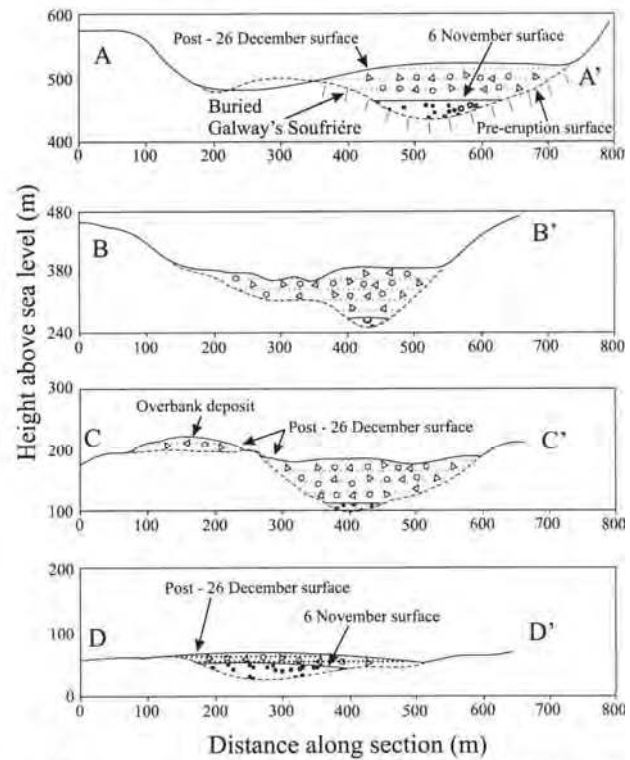
Fig. 17. Transverse cross-sections across the White River valley show the original topography (dashed lines), the infill of material from all earlier eruptions, including the 4–6 November 1997 pyroclastic flow deposits (lower solid line), and the infill of deposits from the 26 December 1997 collapse and explosion (upper solid line).

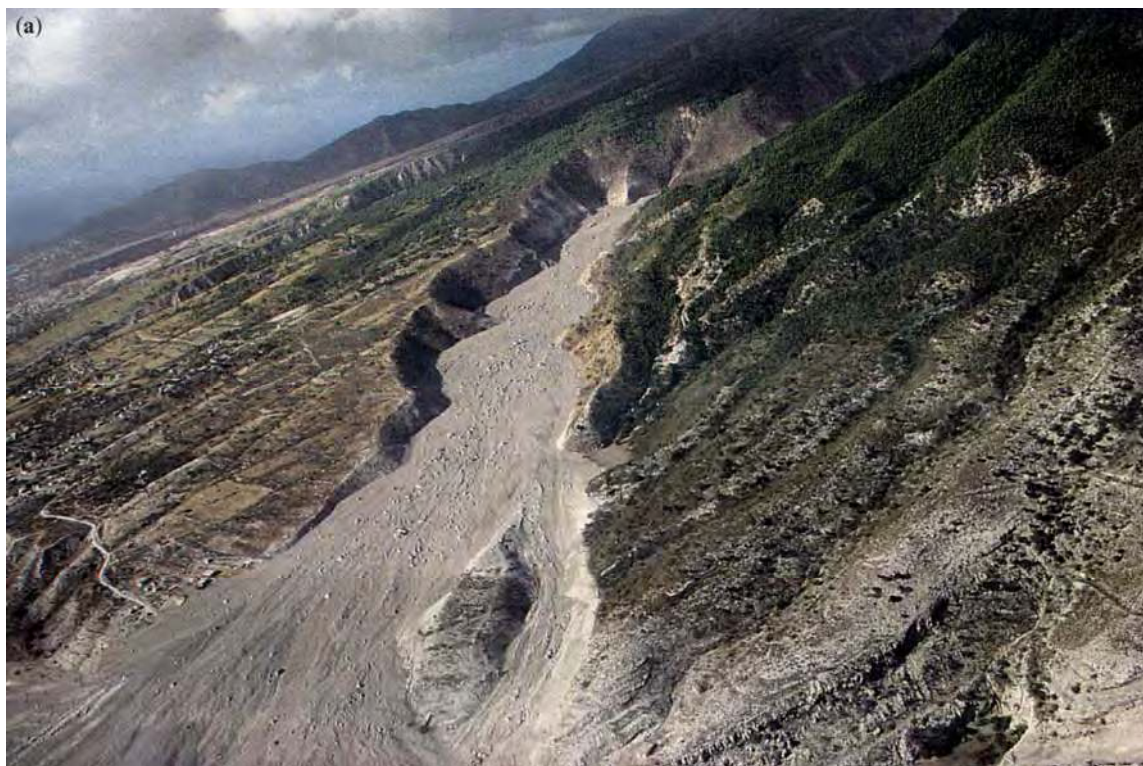
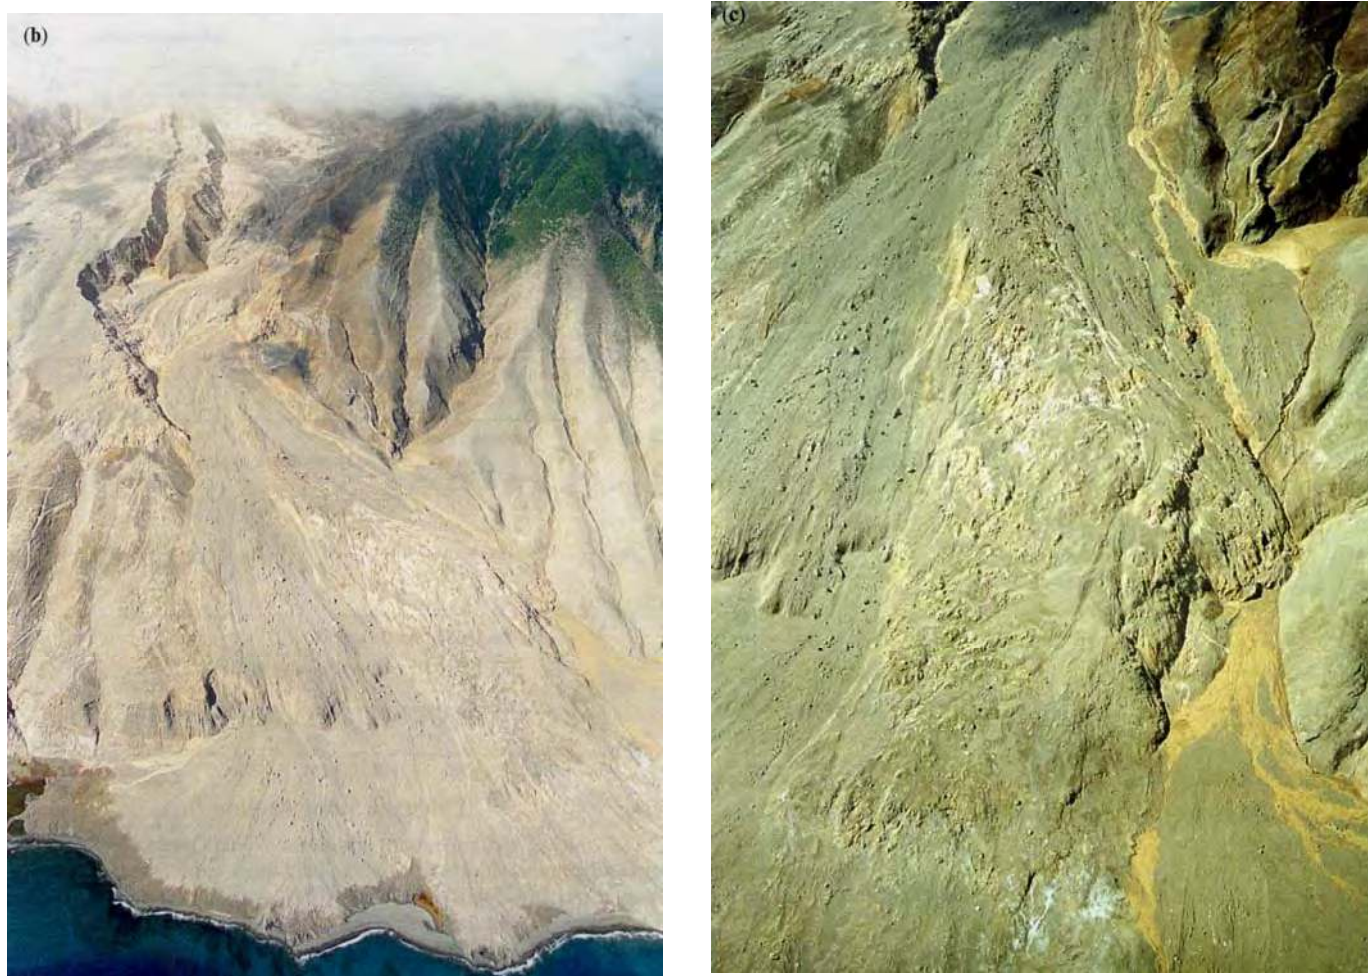
Fig. 18. Comparative panoramic views of distal White River valley, (a) View in early December 1997, three weeks before the collapse. Fergus Mountain flank to right, villages of Morris' and St Patricks' to left. Channelled block-and-ash flow deposits are derived from dome collapses on 4 and 6 November 1997. Note island surrounded by pyroclastic deposits at lower centre, representing a bedrock ridge from the original landscape (cf. Fig. 15a). As discussed below, this ridge influenced avalanche deposition on Boxing Day (photo B.V.). (b) Same area on 2 June 1998, showing debris avalanche deposit extending over fan nearly to the sea (photo J.C.K.). The current of avalanche debris in the central channel had continued in motion, while the eastern pan came to rest on the ridge within the channel shown in (a). As this main current thinned, larger blocks became grounded, and a sheet-like deposit was formed at the avalanche terminus, with sparse, small hummocks, (c). Structure in distal lobate, hummocky avalanche deposit, June 1998 (photo J.C.K.). Eastern part formed a series of stacked lobes where the flow grounded against the ridge within the channel in (a). Course pyroclastic density current flow lines diverge about avalanche deposit. Overspill deposits at Morris' at upper left.

and abrupt frontal snouts *c.* 20-40 m in height. Stoppage of the first prominent lobe, near the east channel margin, apparently was caused by the flow running up against a bedrock ridge exposed within the channel (Fig. 18; see *General description* section). This was followed soon after by a pile-up of successive flow fronts against the first. Each lobe contained the same stack of Chartreuse and Soufriere Subunits, with green-orange-white deposit types (Fig. 21a). The disposition of deposits suggested that the main current of avalanche debris in the central channel continued in motion while

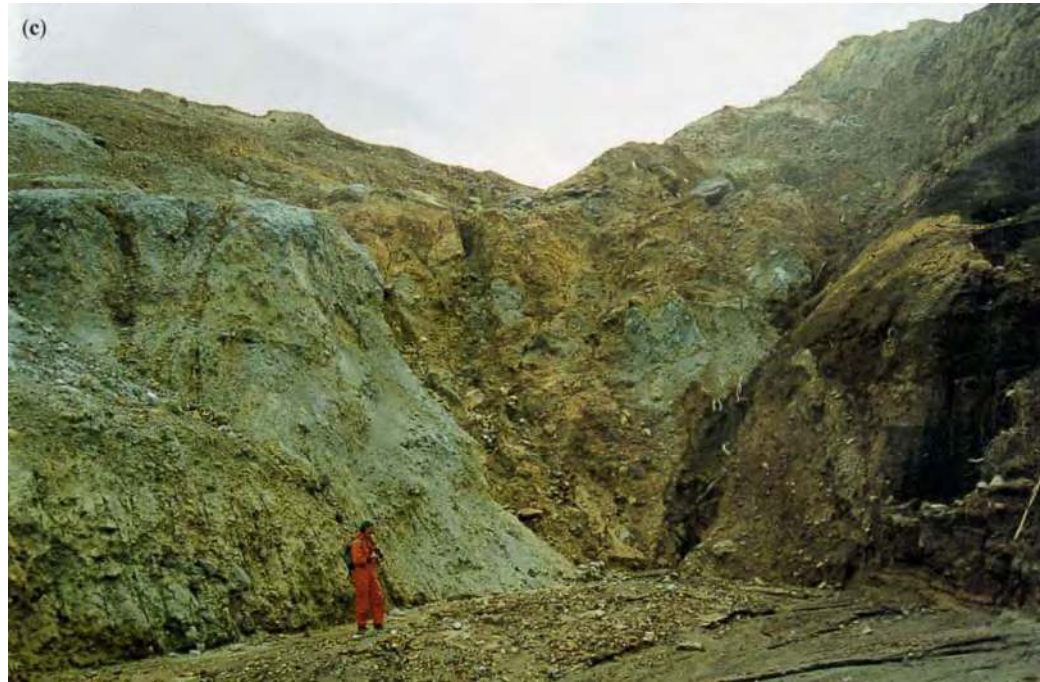
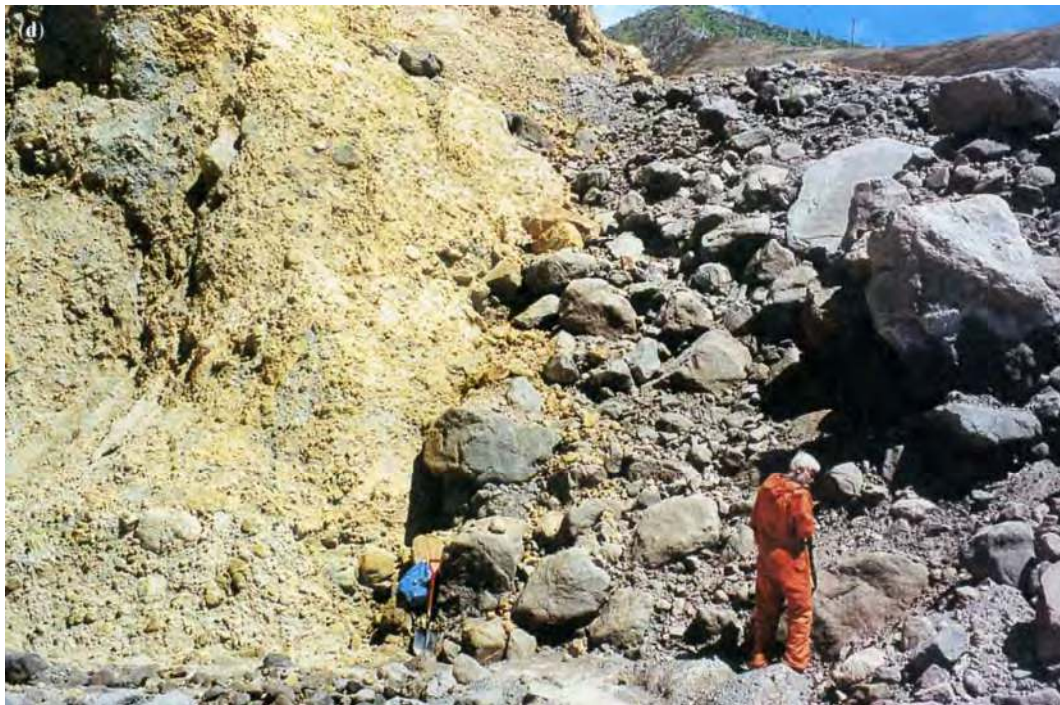
**Fig. 20.** Debris avalanche morphology and structure in proximal and medial regions, (a) View towards east at overlapping tilted avalanche megablocks that preserve original stratigraphy, with yellow-green Chartreuse Subunit overlain by reddish brown Soufriere Subunit in June 1998 (photo J.C.K.). Block on right capped by breccia of fresh lava blocks. Active fumaroles within some blocks suggest that these represent moved parts of the Galway's Soufriere fumarolic field, (b) Stacked sequence near Fergus Mountain narrows in June 1998 (photo J.C.K.). Oxidized Soufriere Subunit pyroclastic breccia (I) overlain by a lens of lava block deposits (LBD), in turn overlapped by Chartreuse Subunit breccia (II). (c) Avalanche megablock facies at foot of Fergus Mountain overspill, June 1998 (photo J.C.K.). Soufriere Subunit materials. Horizontally bedded rock of Fergus Mountain flank exposed on right, (d) Detail at sample location 1-4.5 (see Fig. 23) of contact between pale megablock facies breccia and adjacent subrounded blocky deposits representing probable Talus unit, in March 1999 (photo A.B.B.).

The Boxing Day debris avalanche deposit primarily showed typical avalanche megablock facies, with stratigraphically coherent domains affected by localized crushing (Figs 20 to 22). With increasing distance from source, the avalanche deposit displayed increasingly common development of shearing textures and limited mingling of lithologies on a small scale. Shearing textures were

Large patches of yellowish-green material (type 4) were located near the Fergus Mountain narrows and more proximally in the upper White River valley (Fig. 20). These were distinctive enough to map and are referred to as *Chartreuse Subunit* (Fig. 19). This material was inferred to represent the deeper, less-oxidising parts of the hydrothermal system, where magmatic or other influences created reducing conditions. We inferred that the colouration was due to reduced iron and sulphides, but detailed mineralogical and chemical studies have not yet been completed.

Some large proximal hummocks (overall >100 m wide, c.50 m high) appear to be overlapping, rotated slide blocks containing relatively little-disturbed pre-collapse stratigraphy (Fig. 20a). These were similar to the *toeva* blocks of Reiehe (1937), reported also from other volcanic debris avalanche sites (Wadge *et al.* 1995; Francis & Wells 1987; Belousov *et al.* 1999), and may have reflected retrogressive failure of large fragments of the edifice, including Galway's Wall. The spatial position of these hummocks, and the
